Bridge Inspection Report

05661

US 167/Independ.Co
over
WHITE RVR, CR 513

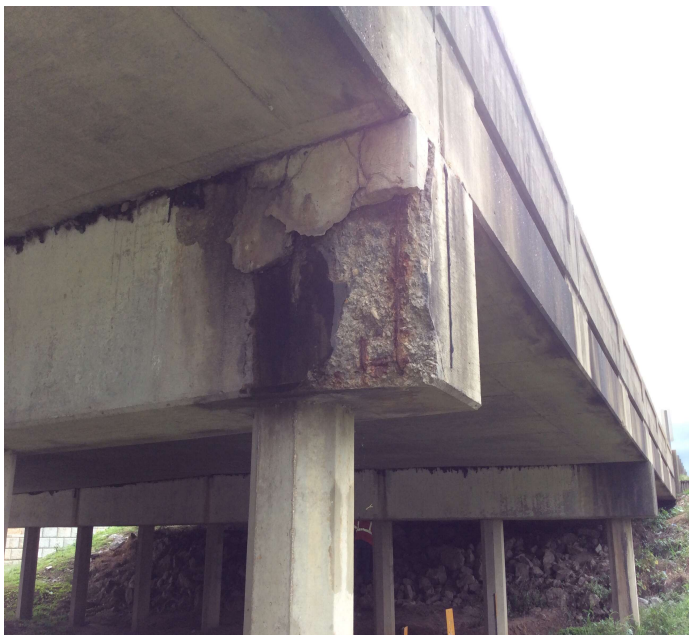
Caps at Bents 2 thru 12 & 18.

Spalls to the caps, some with rebar exposed.

PHOTO 1 Description Spalls with rebar exposed to Left end of cap @ Bent 2.

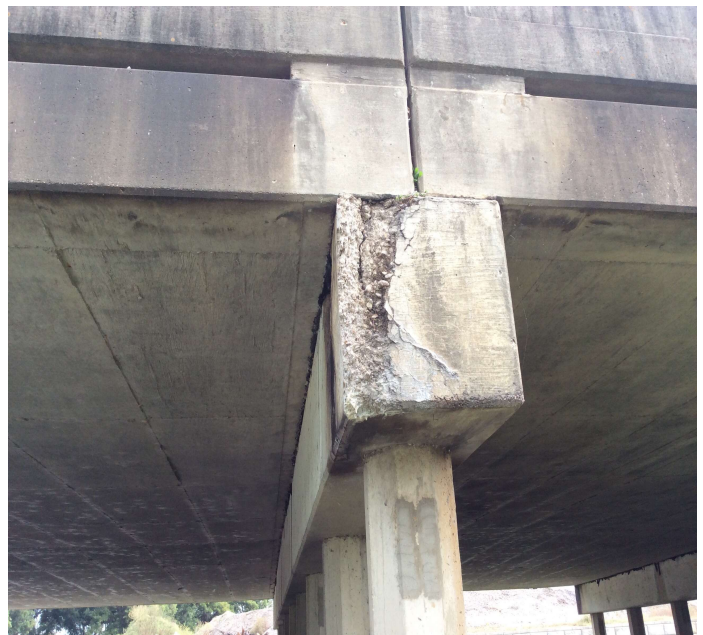
PHOTO 2 Description Large spall to Left end of cap @ Bent 3.

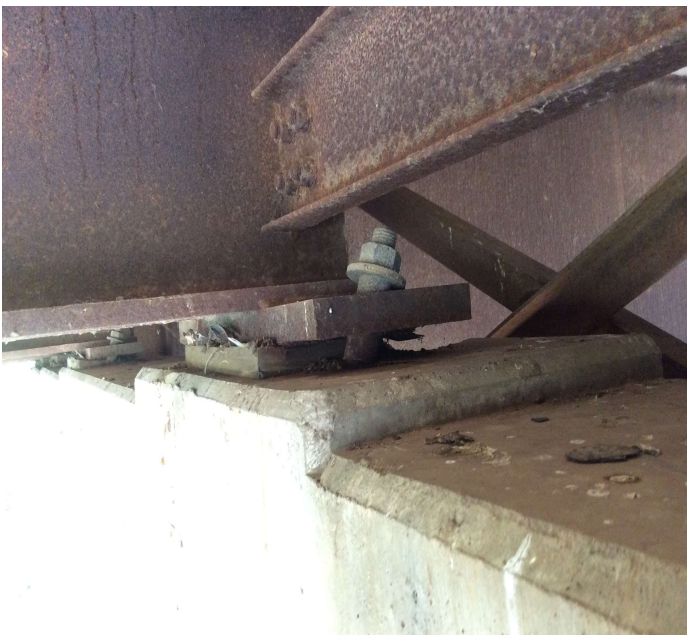
Bents 18 back & 23 ahead.

Elastomeric pads have moved to edge of cap or moved ahead.

PHOTO 1 Description Bearing @ Girder 5 Bent 18 back.

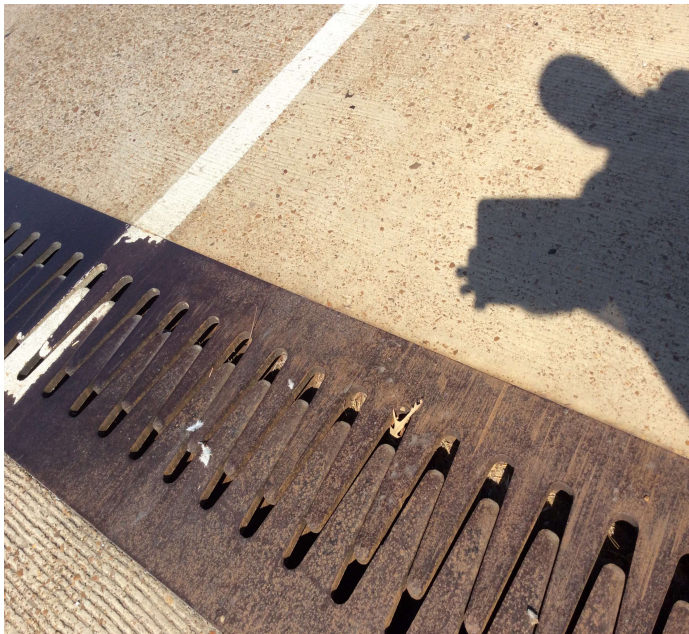
Finger Joints at Bents 18 & 23 Joint troughs are filled with debris.

PHOTO 1 Description Debris in finger joint @ Bent 23.

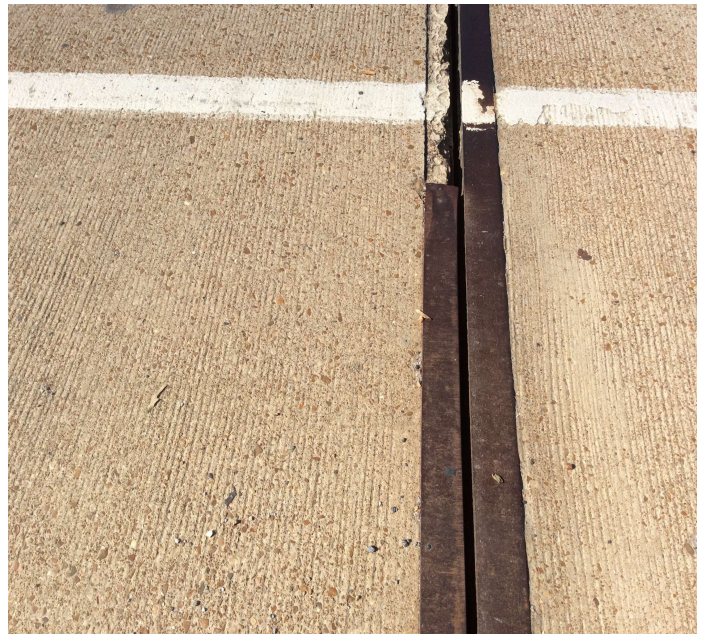
Joint material at Bents 17 & 24 has fallen out and is missing.

PHOTO 2 Description Joint material at Bent 17 Joint has fallen out and is missing.

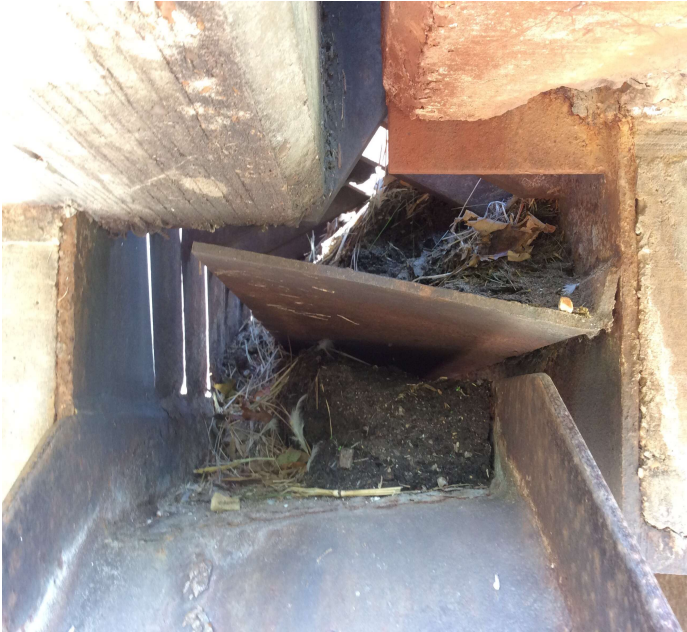
PHOTO 3 Description Debris in Finger joint @ Bent 18.

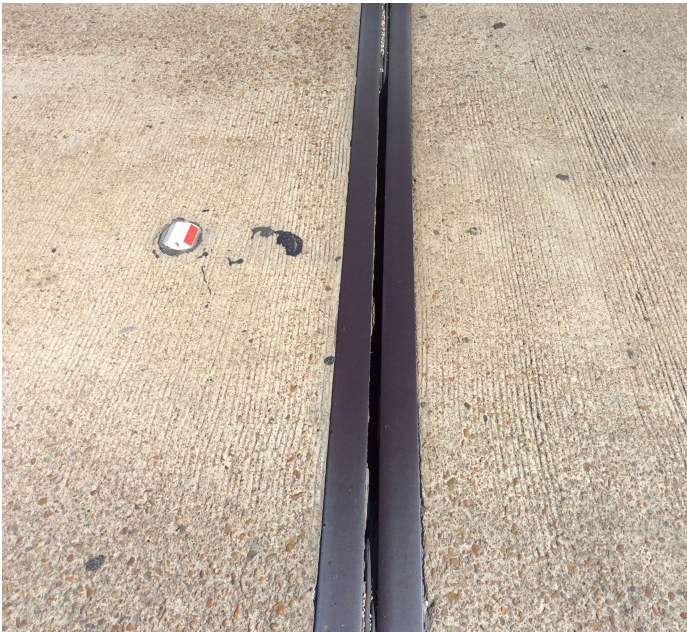
PHOTO 4 Description Joint material @ Bent 24 has fallen down @ is missing in Left lane.

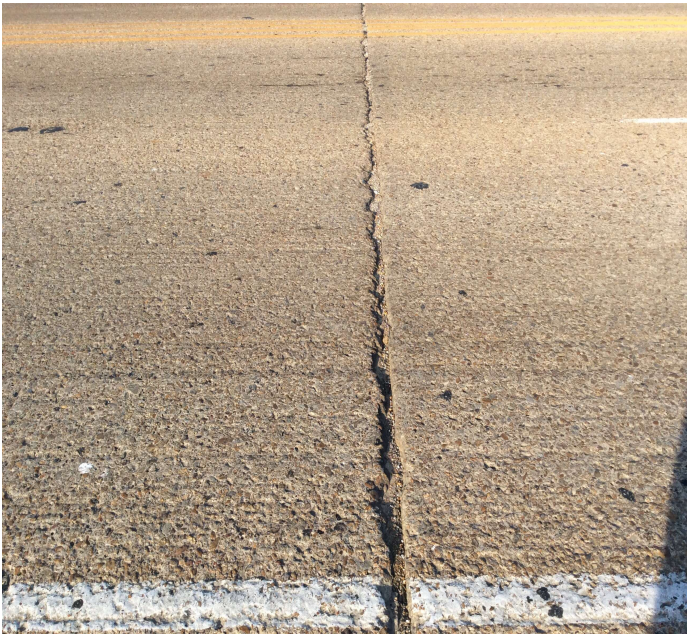
Poured joint seals material is cracked & deteriorated.
Joints are filled with debris.

PHOTO 1 Description Debris impaction @ Bent 2.

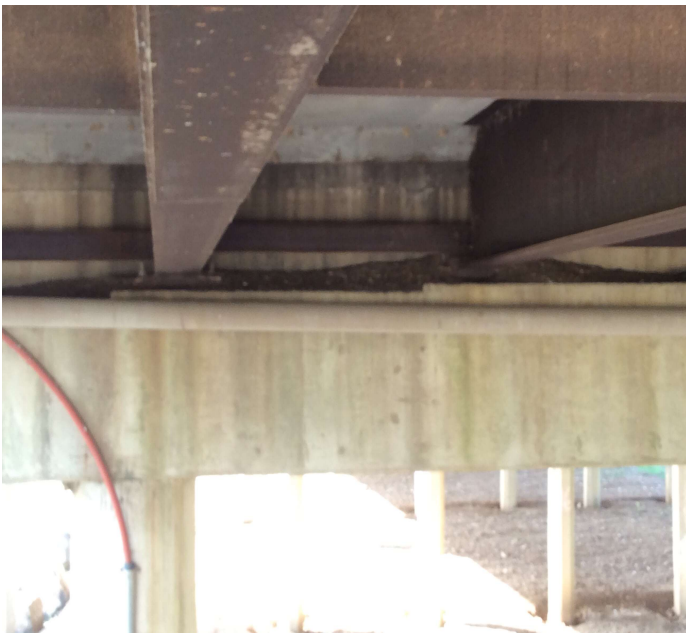
Debris on caps at Bents 17,18,23,24,25 & Abutment 2

PHOTO 1 Description Debris on cap @ Bent 17.

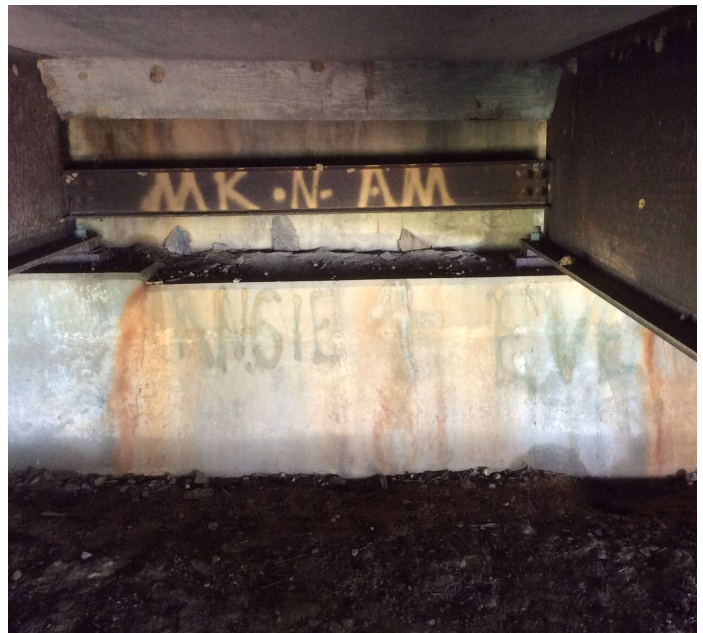
PHOTO 2 Description Debris on cap @ Abutment 2.

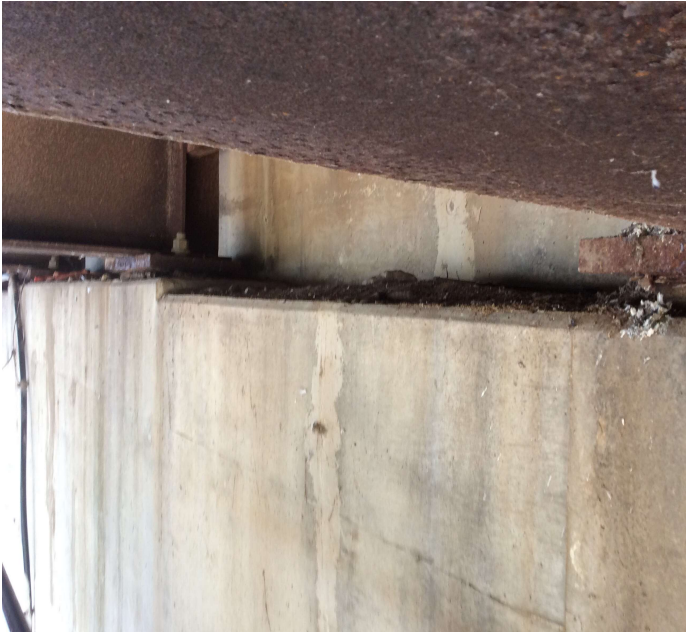
PHOTO 3 Description Debris on cap @ Bent 18.

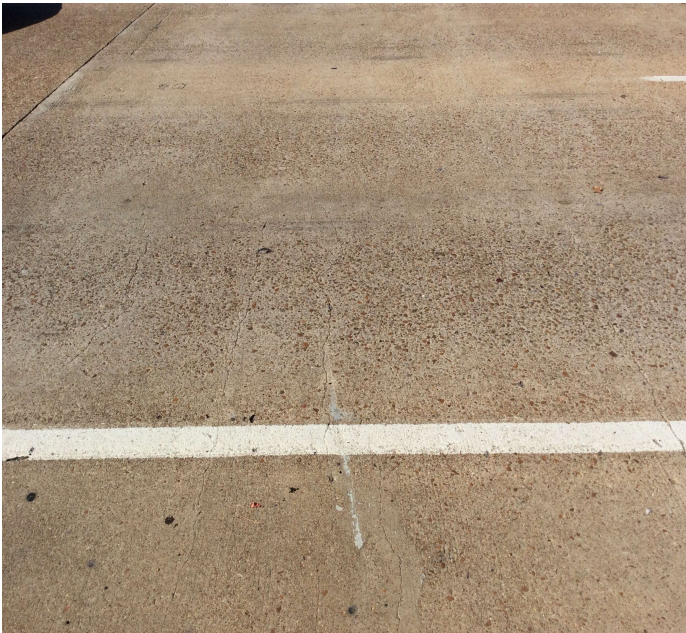
Deck at all spans several unsealed transverse and longitudinal cracks

PHOTO 1 Description Transverse cracking to deck @ Span 23.

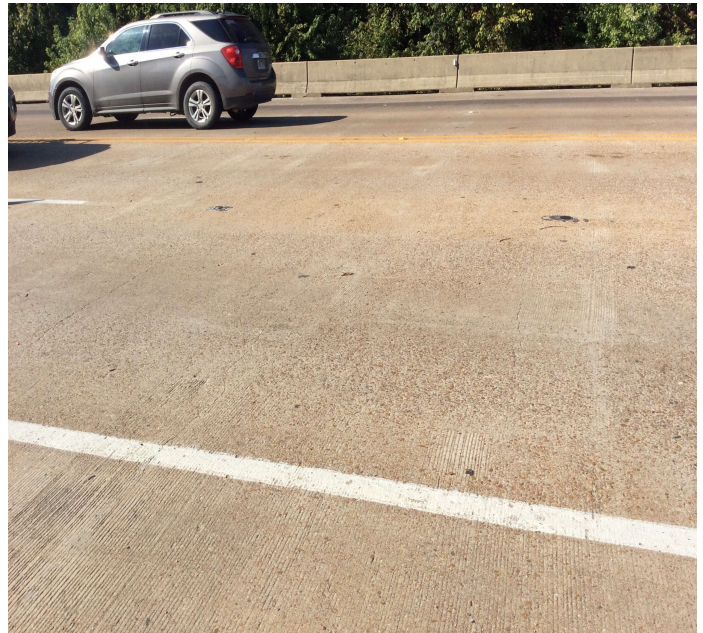
PHOTO 2 Description Transverse cracking to deck @ Span 20.

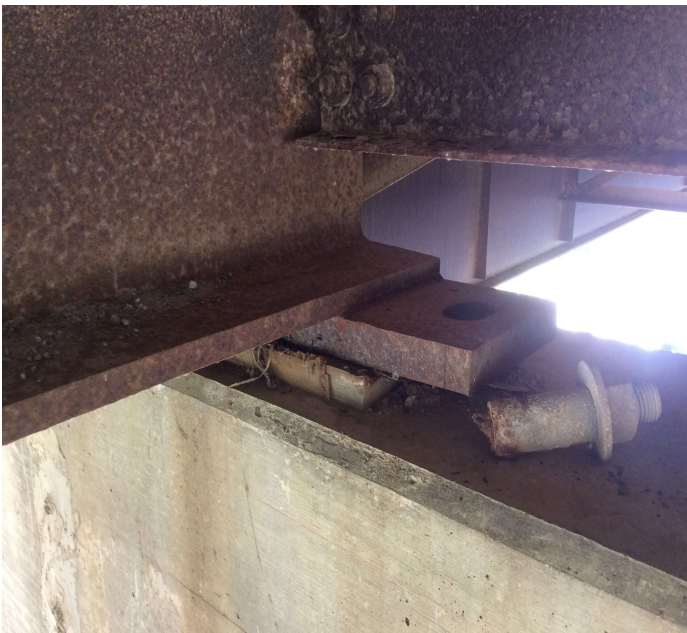
1 Anchor bolt broke at Bearings 1 & 3 at end of Span 18.

PHOTO 1 Description Bearing at Girder 3 Span 18 has broke anchor bolt.

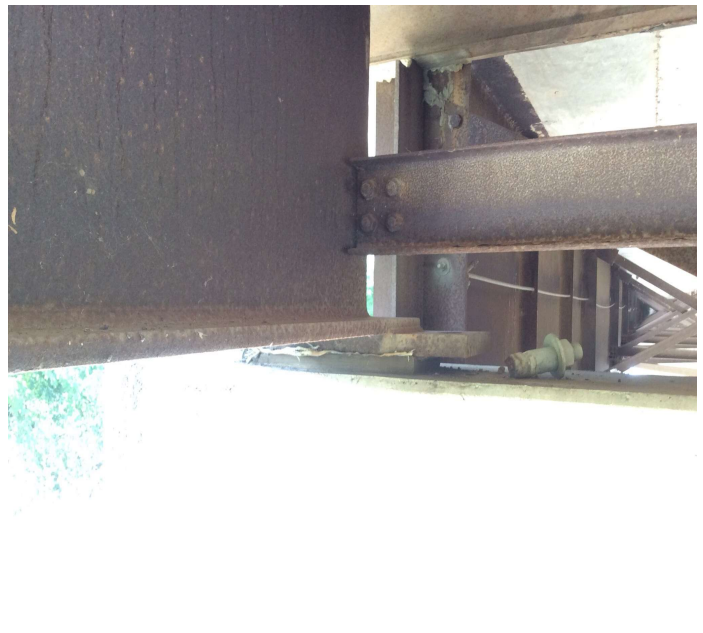
PHOTO 2 Description Bearing @ Girder 1 Span 18 has broke anchor bolt.
