Bridge Inspection Report

06810
US 167/Indepen Co.
over
SALADO CREEK

Structure Number: 06810

Facility Carried: US 167/Indepen Co.

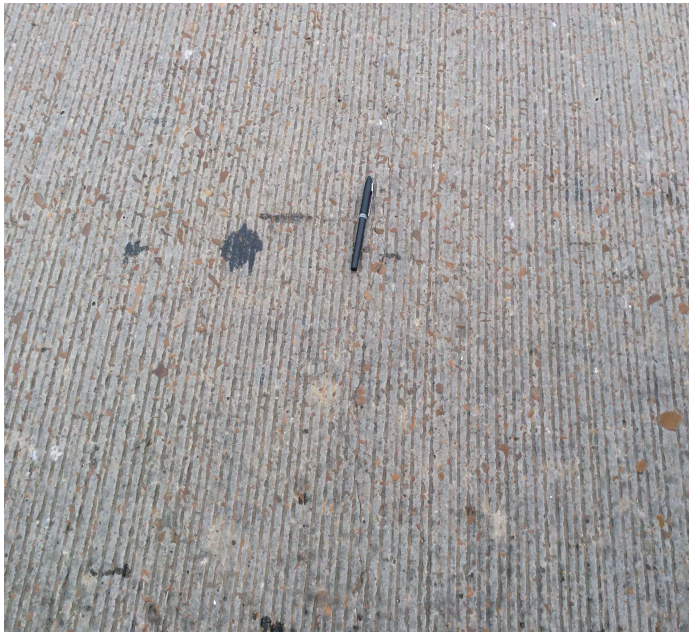
All spans
Several 1/8" wide unsealed cracks to deck.

PHOTO 1 Description Typical Deck crack.

Work Code: Repair

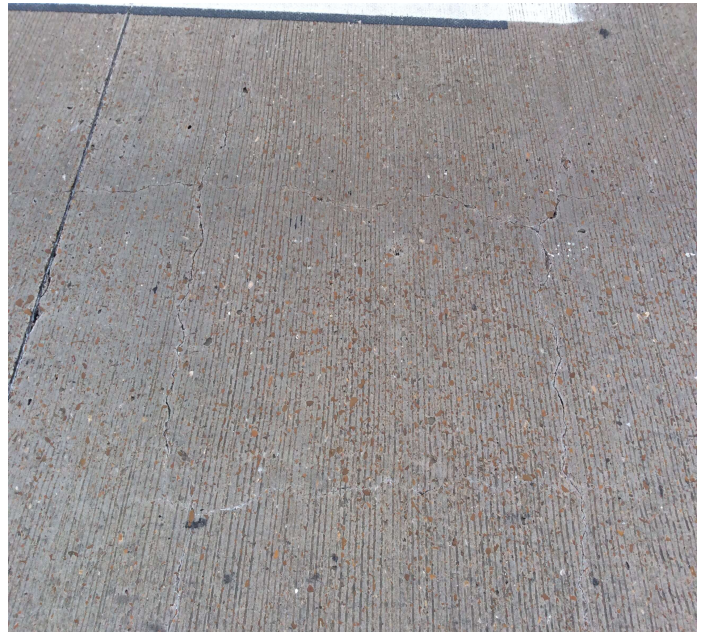
PHOTO 2 Description Typical Deck cracks.
