Bridge Inspection Report

A0560

**US 167 Independ Co
over
CANEY CREEK**

National Bridge Inventory

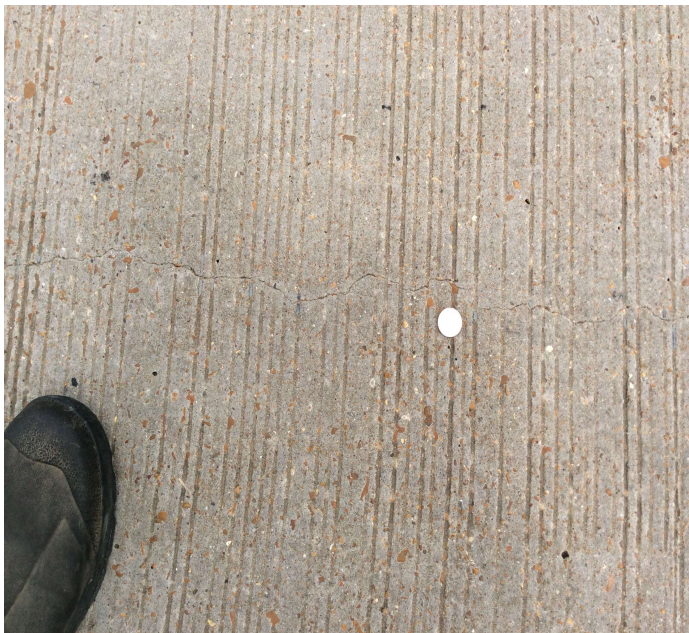
Numerous unsealed cracks to deck at all spans, and to Approach slabs at Abutments 1 & 2.

PHOTO 1 Description Typical unsealed deck cracks.

Work Code: Repair

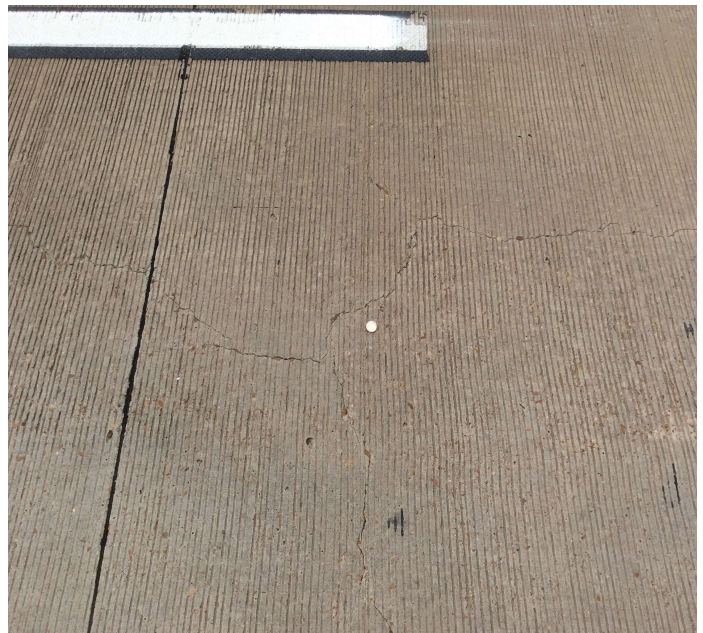
PHOTO 2 Description Typical unsealed cracks to Approach Slab.
