Asset #02308(Routine)

SH 56 Izard County over PINEY CREEK

Location: 2.8 M E OF SH 223

Team Lead: Kerry Little, Inspection Date: 04/20/2023

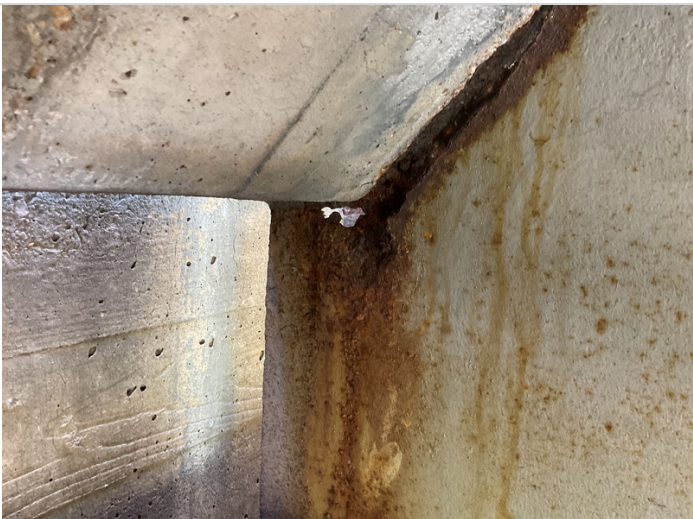
Hole to web below paving haunch to girder 4 @ abutment 2.

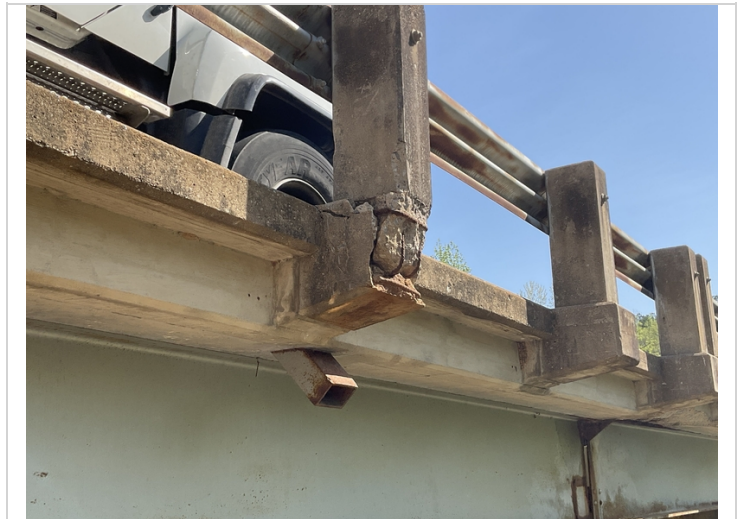
7th post of the right side of span 4 is damaged and has rebar exposed.

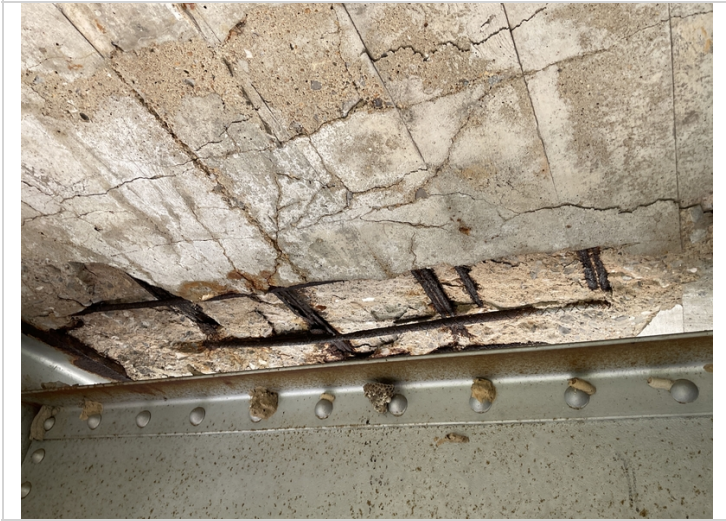
Spalls with rebar exposed, some with 100% s/l & loss of bonding area to concrete to soffit @ Span 4.

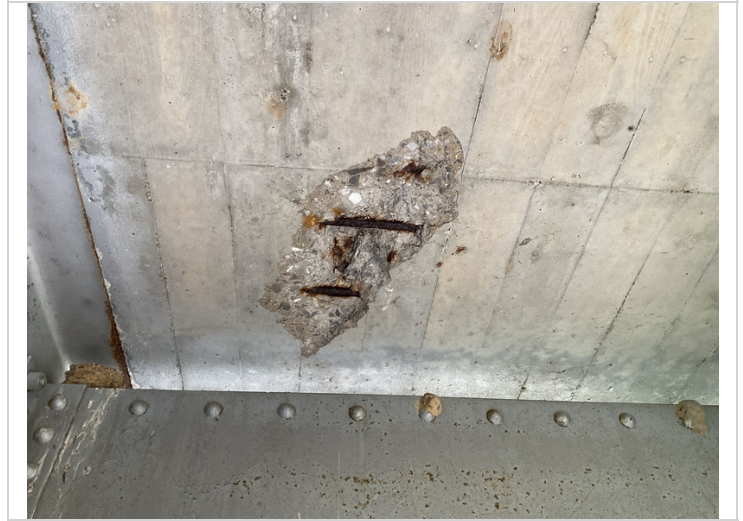
Deep spall with rebar exposed to soffit between girders 1 & 2.

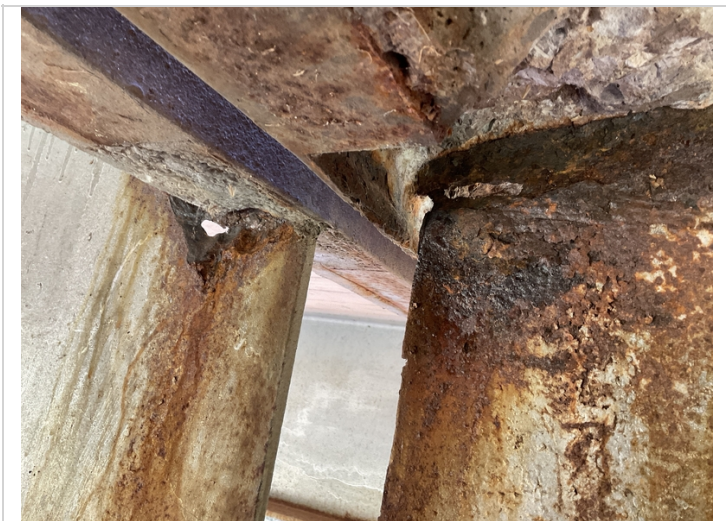
Girder 3 @ end of span 2 & girder 3 @ beginning of span 3 has holes to web below paving haunch.

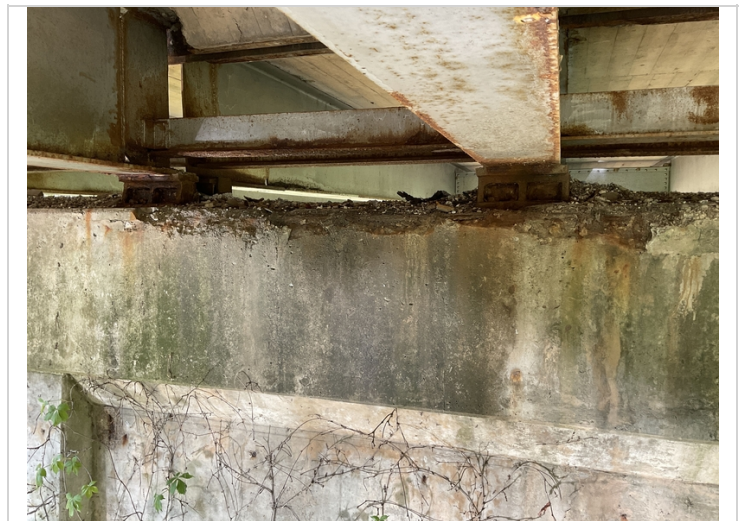
Large spall to ahead side of cap @ bent 1.

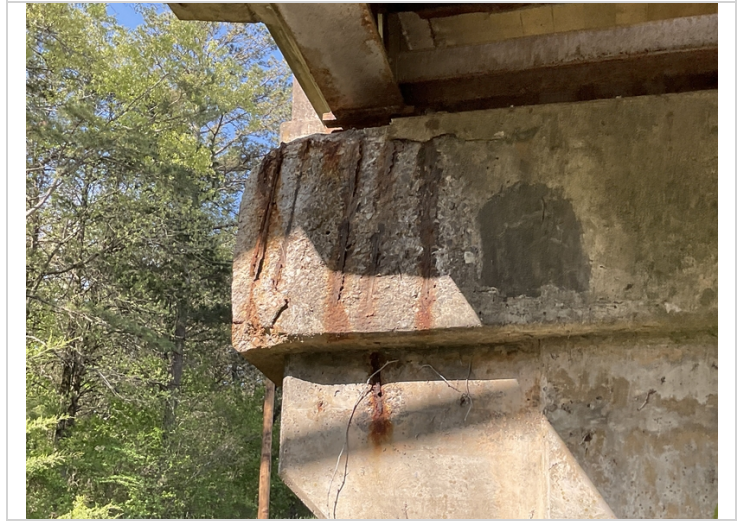
Large spall with rebar exposed to rt ahead side of cap @ bent 1.

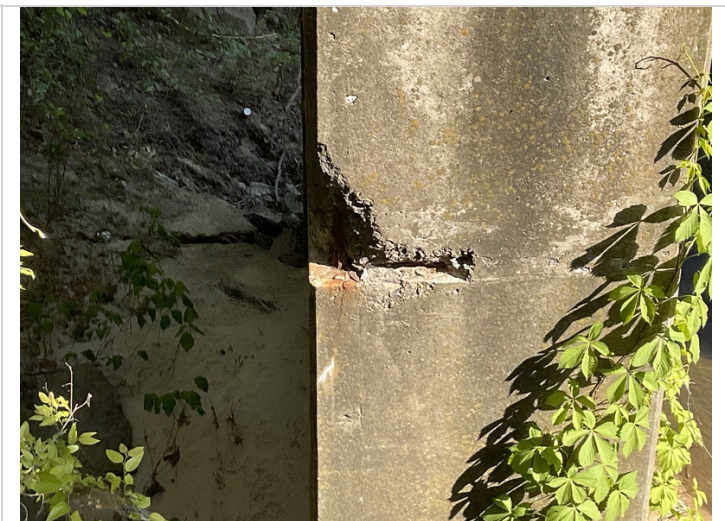
Deep Spall with rebar exposed with section loss to Column 2 @ Bent 1

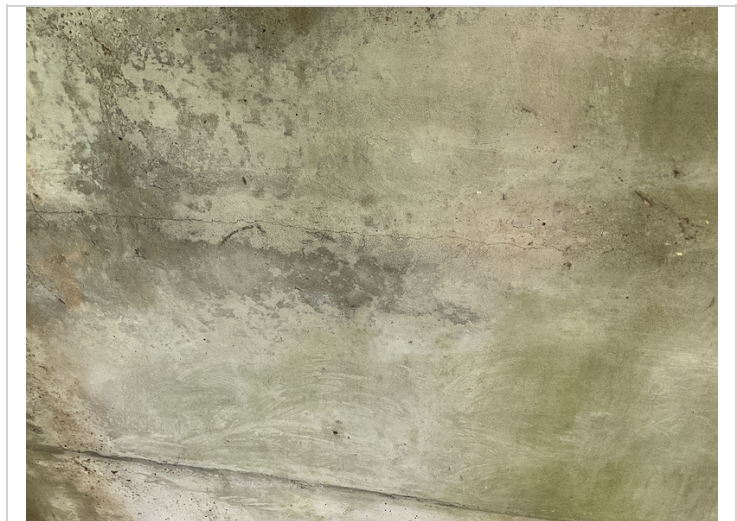
Horizontal cracking to Concrete Pier Wall @ Bent 1.

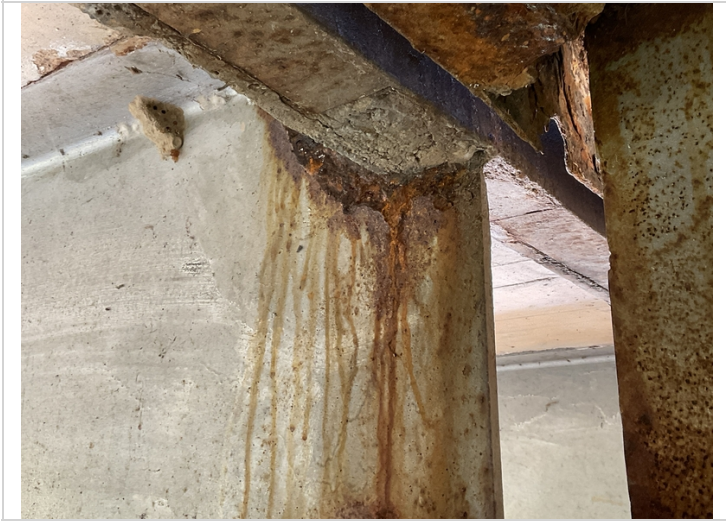
Rust with section loss to web @ girders 1 - 5 @ beginning of span 2.

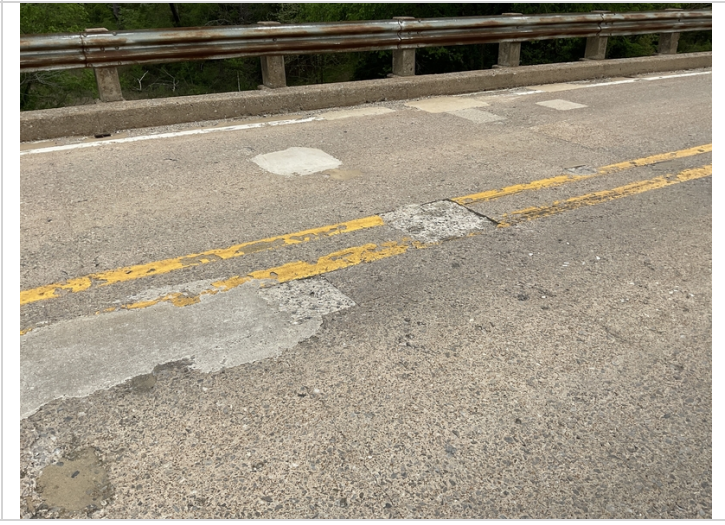
Typical spalls & patched areas to deck @ all spans

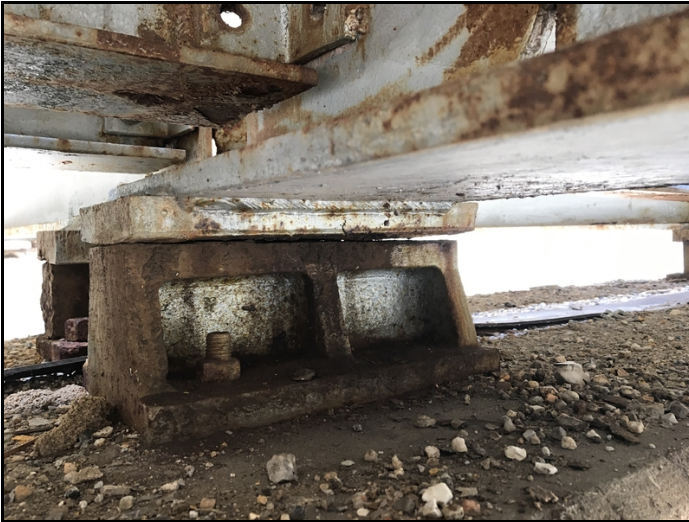
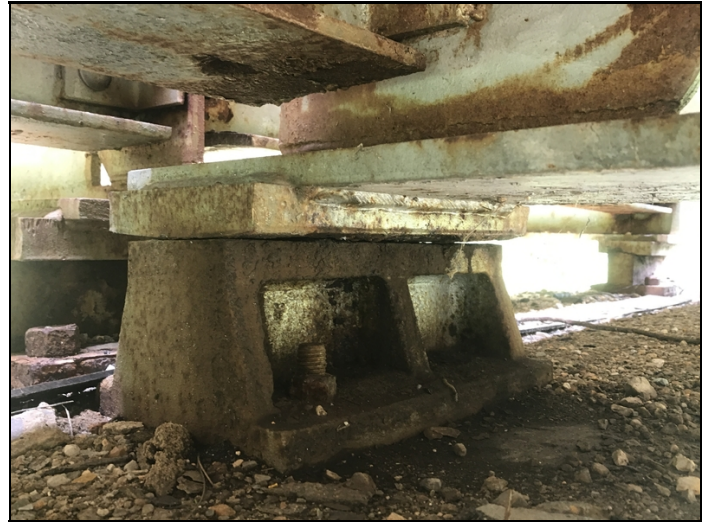
Bent 4 - Fixed Bearing 2 on ahd. Side is non-bearing until loaded.

Bent 4 - Fixed Bearing 2 on ahead side is non-bearing until loaded.

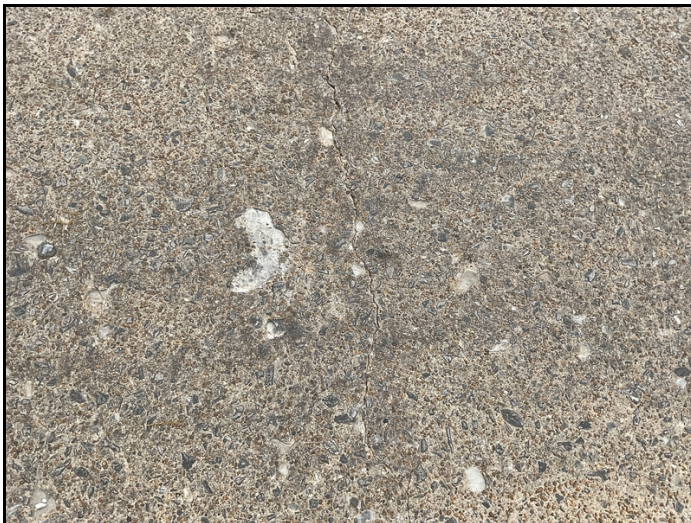
Unsealed cracks to Deck.

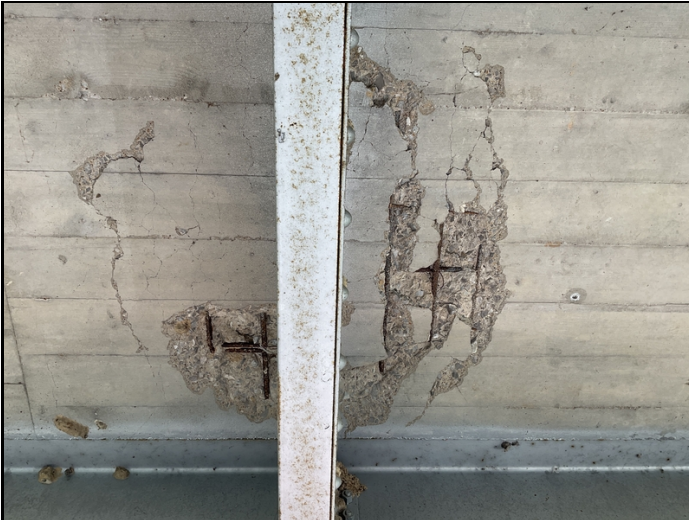
Deep spalls with rebar exposed to soffit at Spans 3, 4 & 5

Deep spalls with rebar exposed to soffit at Spans 3, 4 & 5
Span 3, between girders 4 & 5.

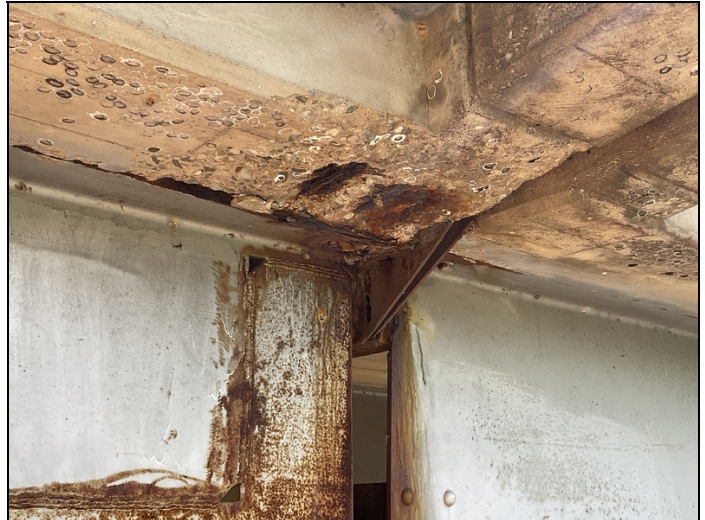
Large spalls with rebar exposed to Left & Right overhangs at Spans 2, 4, 5, & 6.

Large spalls with rebar exposed to Left & Right
overhangs at Spans 2, 4, 5, & 6.
Span 2, rt overhang.

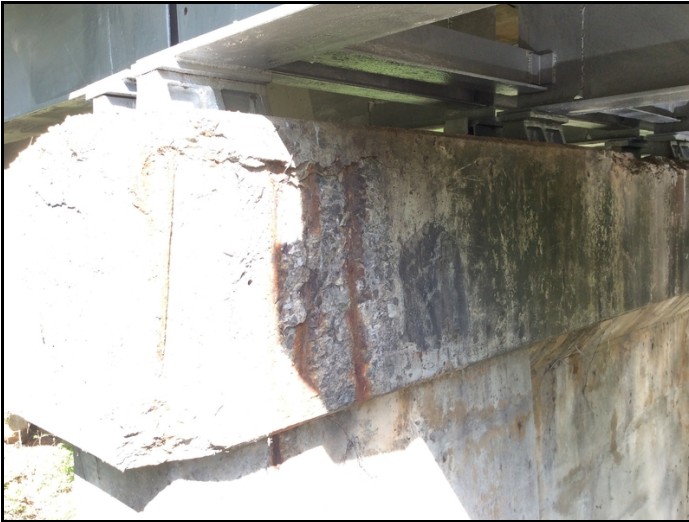
Spalls with rebar exposed to Right end of cap @ Bent 1.

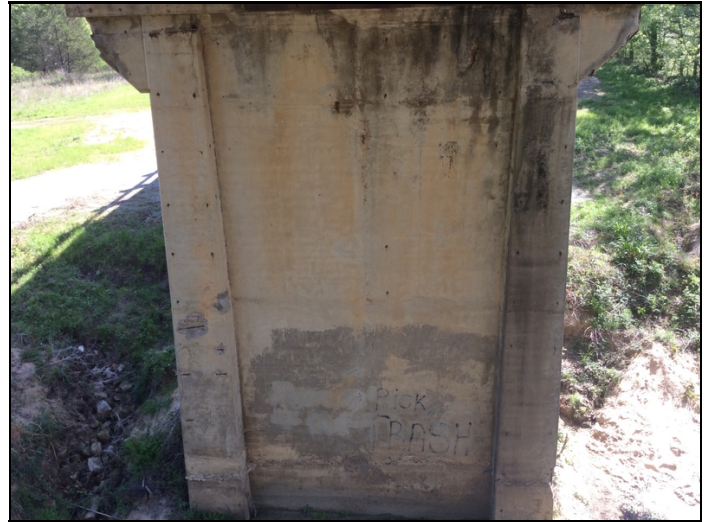
Spalls with rebar exposed to Columns 1 & 2 @ Bent 3.

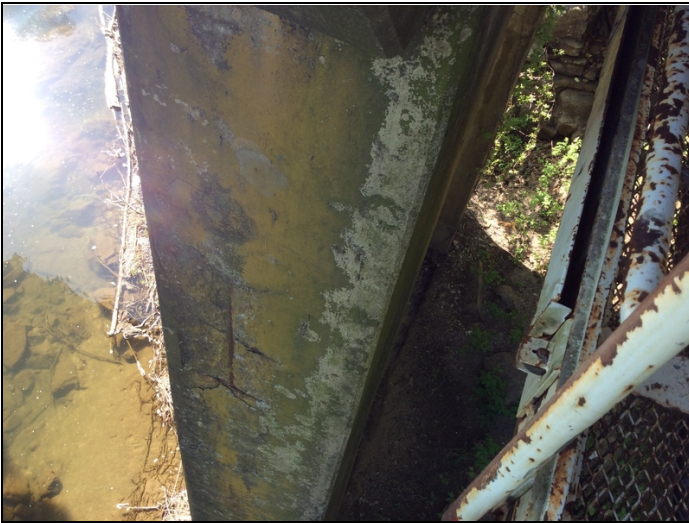
Spalls with rebar exposed to Left Column @ Bent 1.

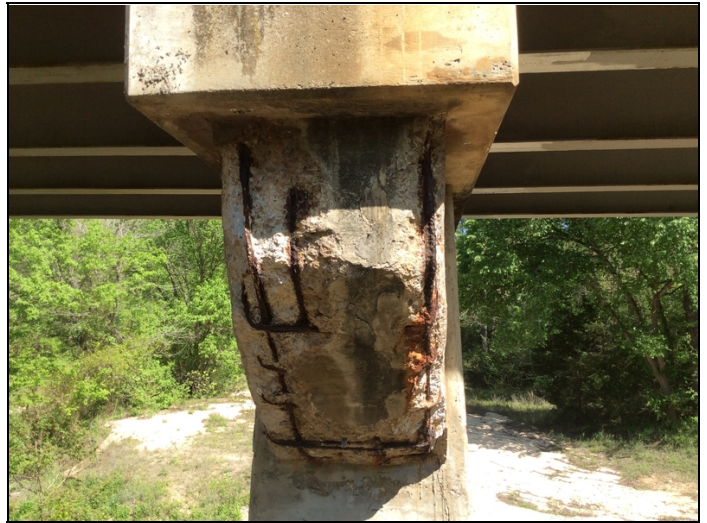
Spalls with rebar exposed to cap support haunch @ Bent 3 Right. Some with 100% section loss.

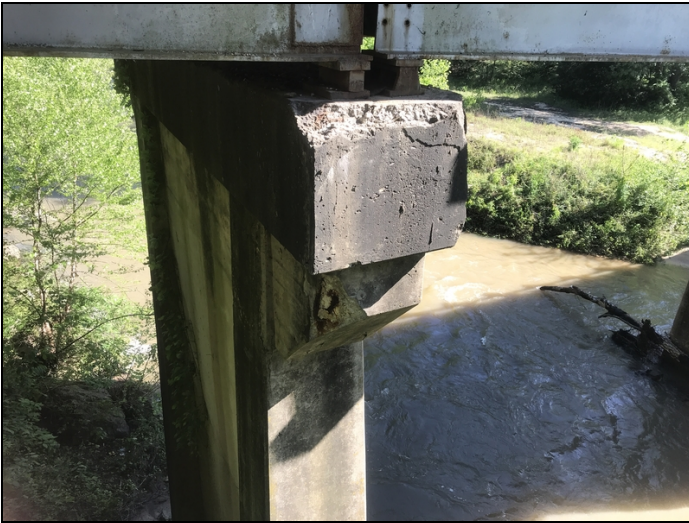
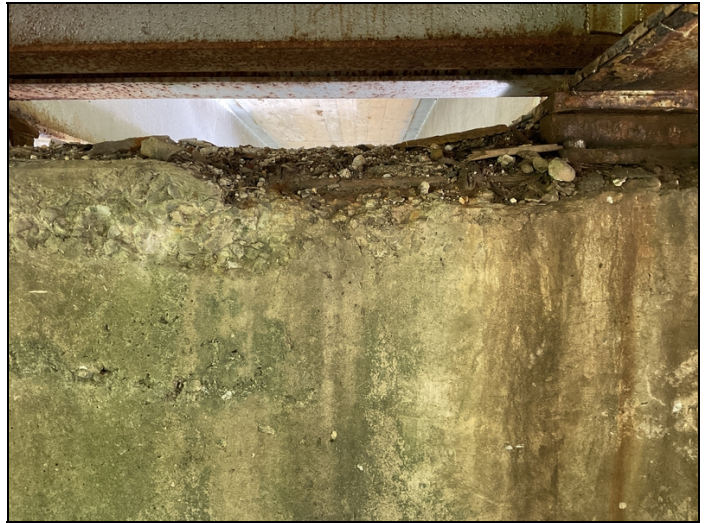
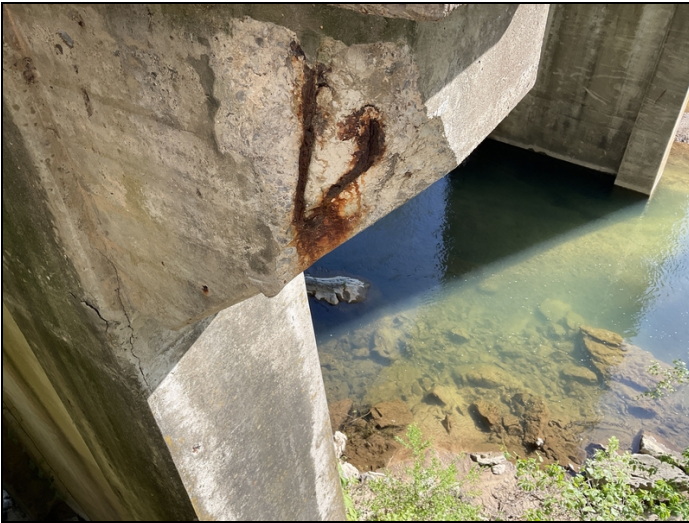
Heavy spalling with rebar exposed, delaminating & cracking to Caps & Columns at Bents 1-5.

Heavy spalling with rebar exposed, delaminating & cracking to Caps & Columns at Bents 1-5.
Bent 1.

Heavy spalling with rebar exposed, delaminating & cracking to Caps & Columns at Bents 1-5.
Bent 1

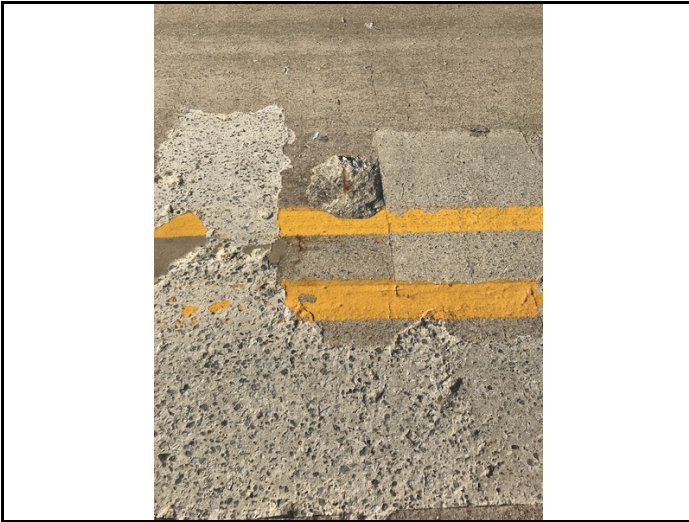
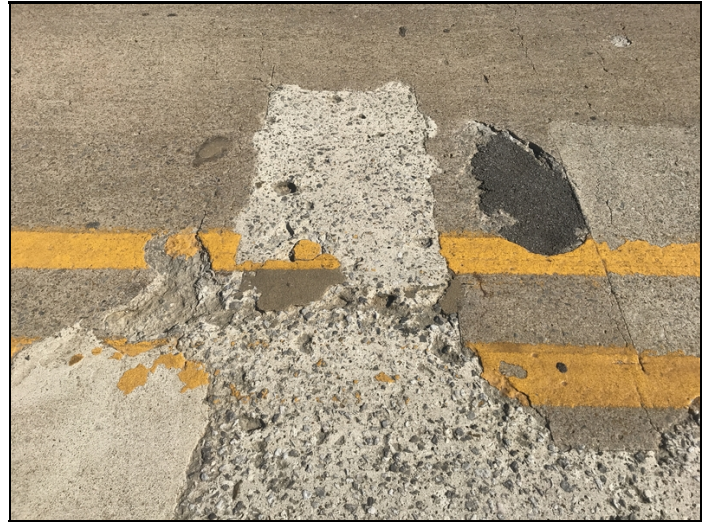
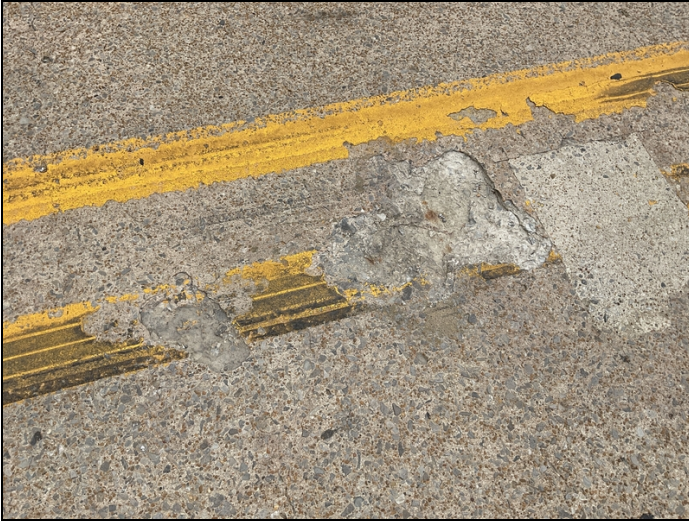
Span 5 - Spall with 1' rebar exposed to deck.

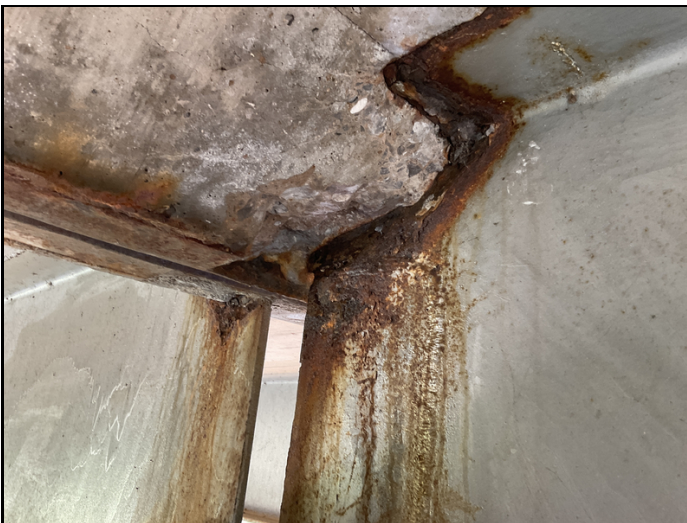
Rust with s/l & holes in web below haunch above repaired area @ Girder 3 @ end of Span 2.

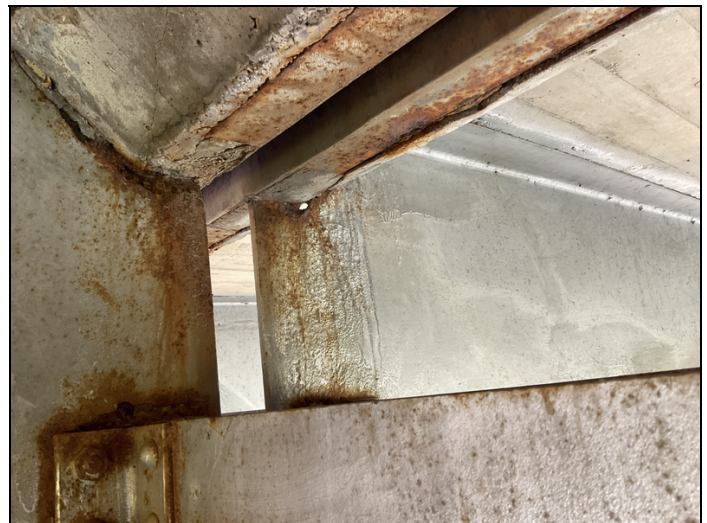
Rust with s/l & hole in web below haunch @ Girder 4 @ end of Span 2.

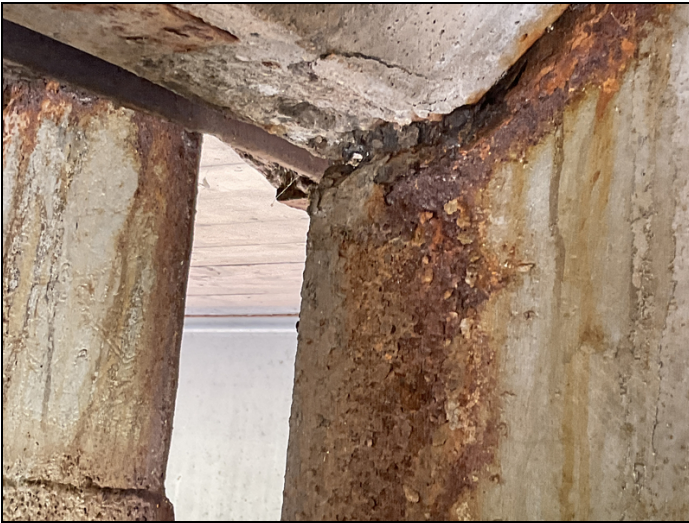
Rust with s/l to web below haunch @ Girder 3 @ end of Span 4.

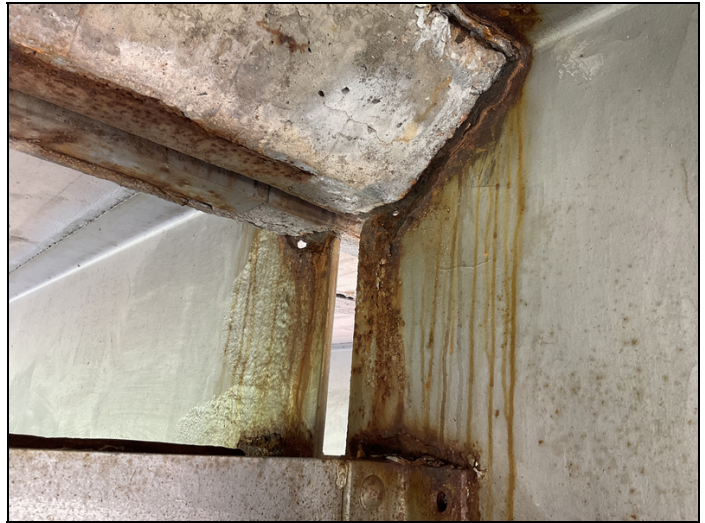
Rust with s/l & holes in webs below haunch @ Girder 3 @ end of Span 4 & beginning of Span 5.

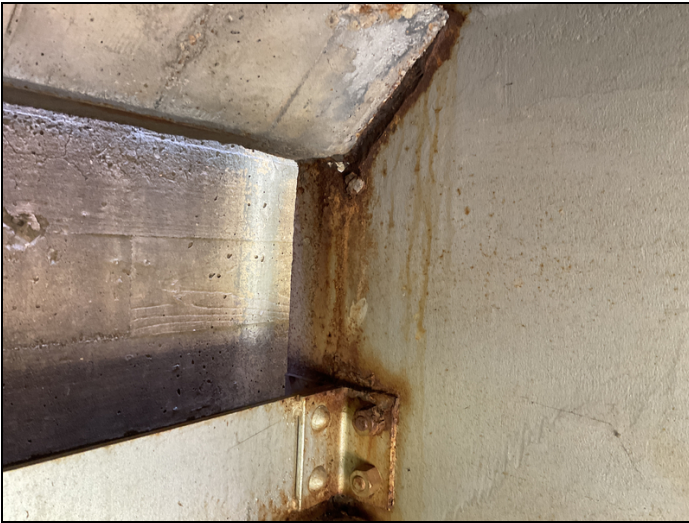
Rust with s/l & hole in web below haunch @ Girder 4 @ Abutment 2.

Rust with s/l & hole in web below haunch @ Girder 4 @
Abutment 2.

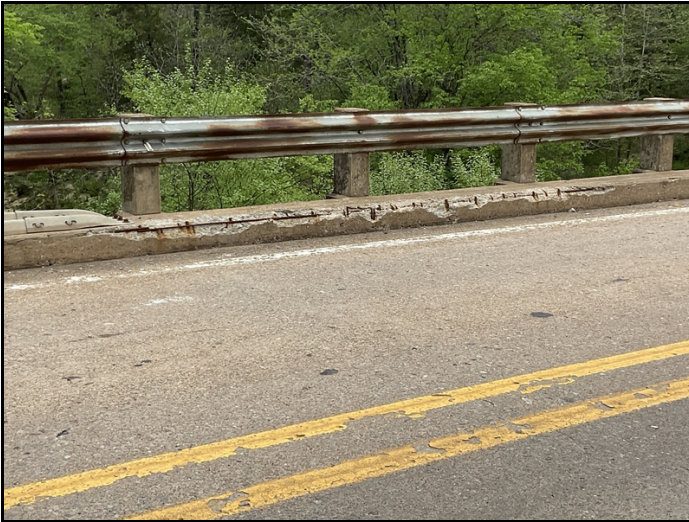
Spalls with rebar exposed to curb at Spans 1-6.

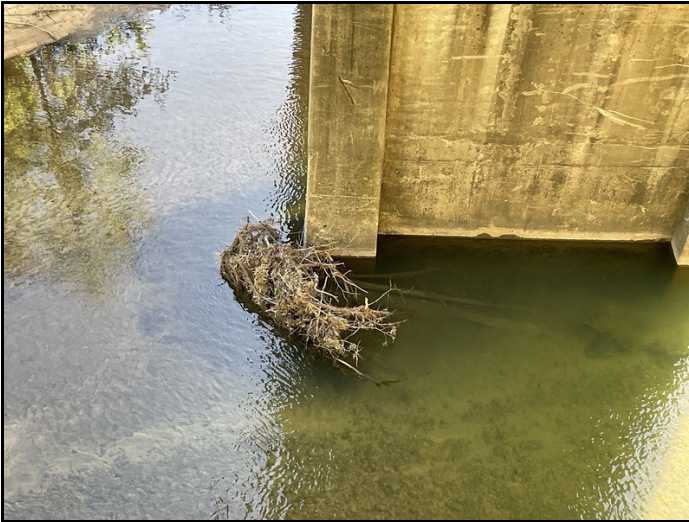
Drift @ Bent 2.

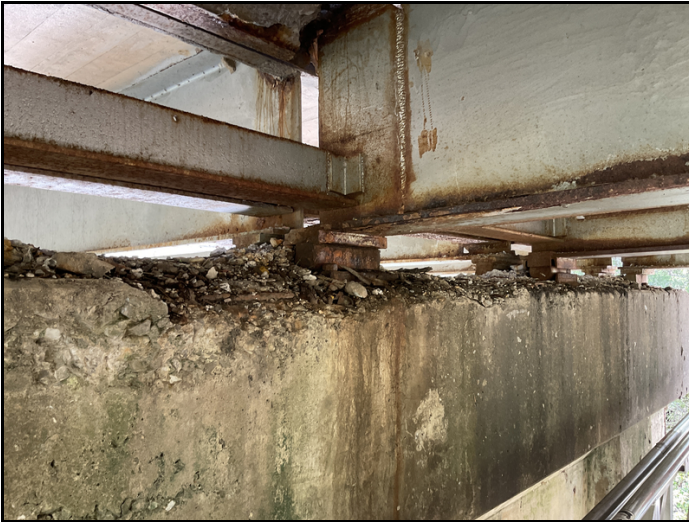
Debris on cap @ Bent 1.

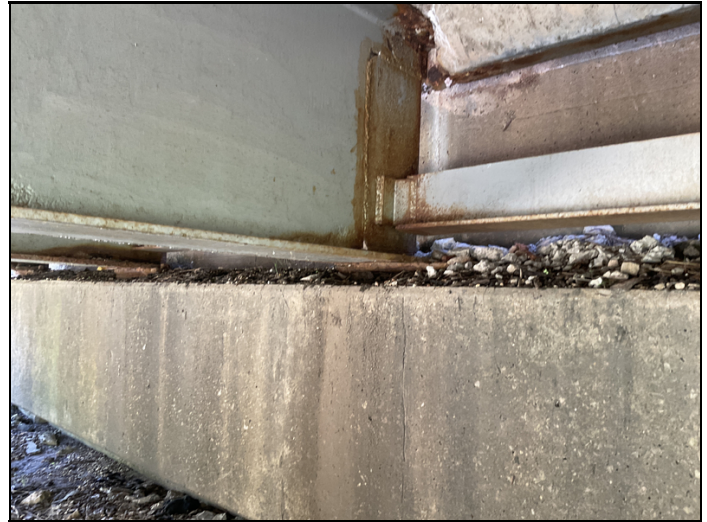
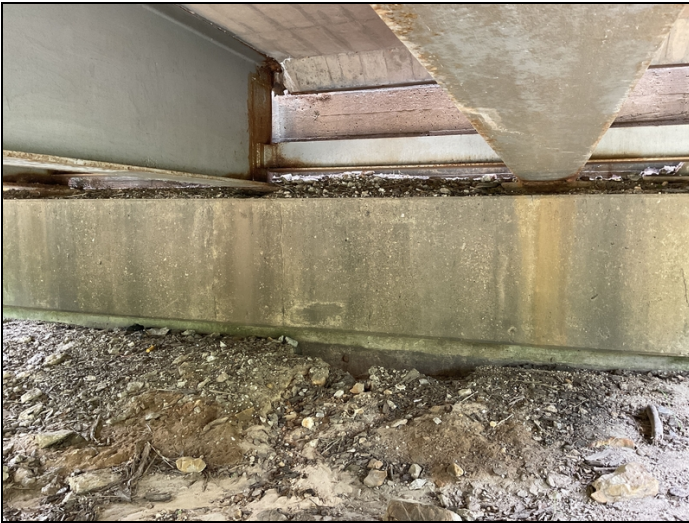
Debris on cap @ Abutment 2.

Debris on cap @ Bents 1 - 5 & Abutment 2.
Abutment 2.
