# Bridge Inspection Report

**02715**

**SH 5-8 Log 2.12**

**HURRICANE CREEK**

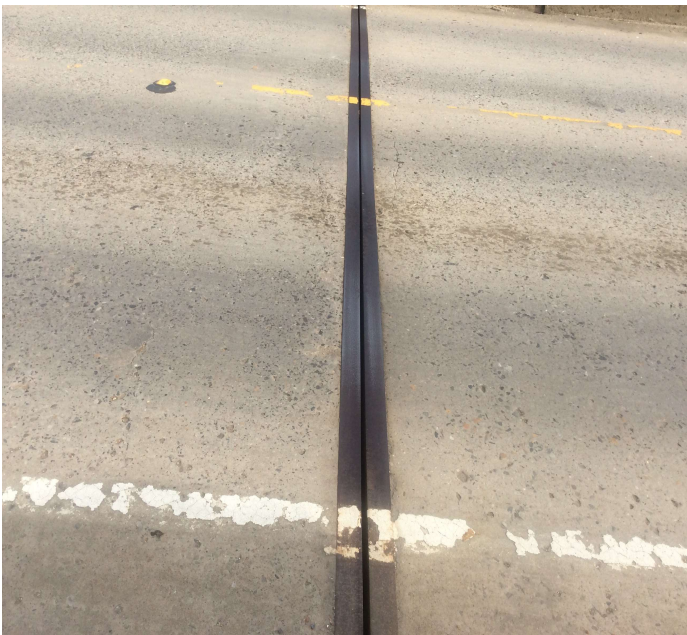
Bent 3 the joint seal is missing. Photo

PHOTO 1      Description      Joint seal at bent 3 is missing.

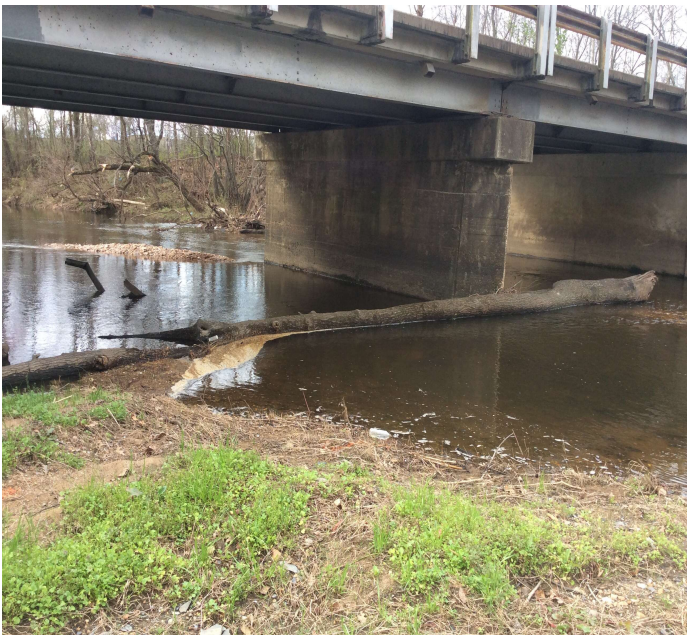
Large tree wedged at bent 3 and 4. (Photo attached)

PHOTO 1      Description      Log between bents 3 and 4.

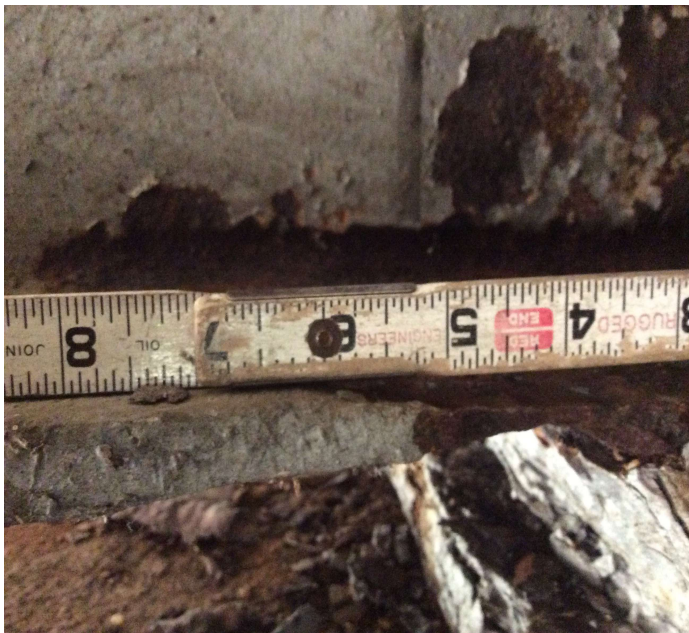
Bent 5 girder 4 section loss up to knife edge on bottom flange at bearing area girder. (Photo's attached)

PHOTO 1      Description      Bent 5 girder 4 section loss up to knife edge on bottom flange at bearing area right side girder.

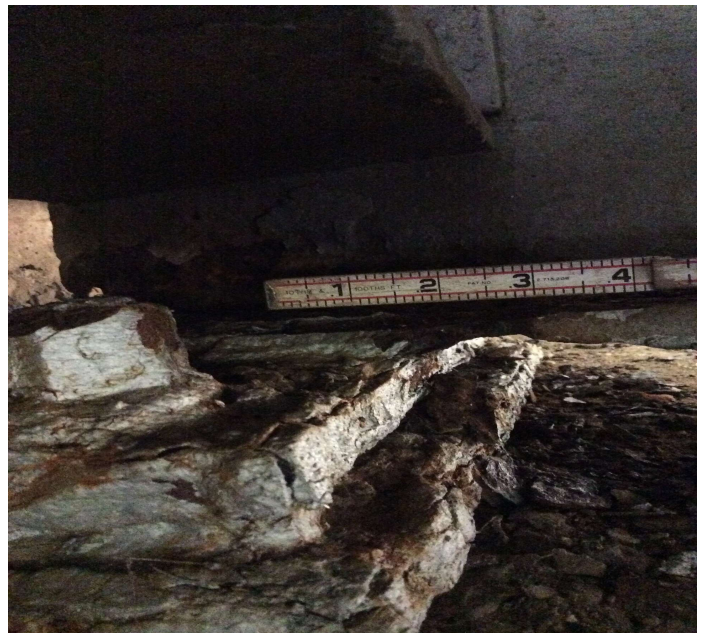
PHOTO 2      Description      Bent 5 girder 4 section loss up to knife edge on bottom flange at bearing area left side of girder.
