## Bridge 05333 Inspection Report

Team Lead: Bryan Saunders, Inspection Date: 05/21/2024

Asset #05333(Routine)  
SH 5 Log 0.14 over US 67-SEC 11Log 0.71  
Location: SH 5 AT US 67

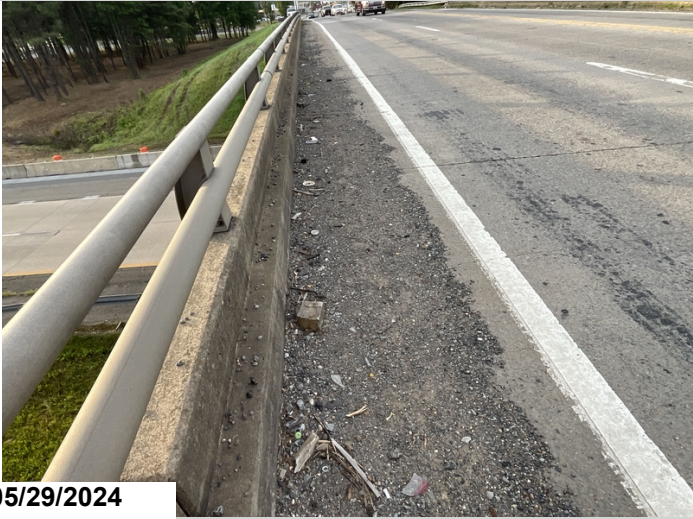
Dirt and gravel on both shoulders

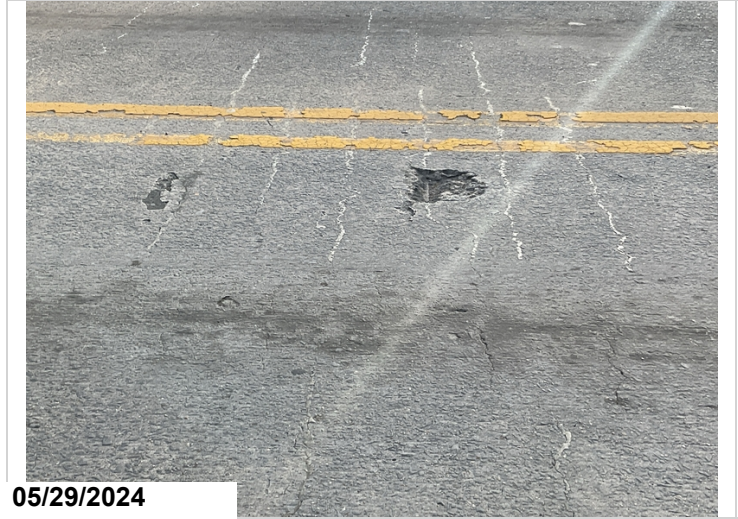
Span 1 at bent 1 southbound lane has a 1'x1' spall with rebar

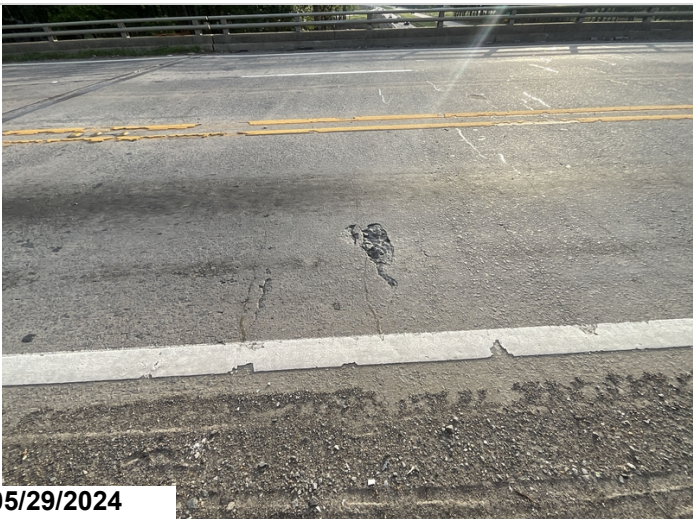
Span 2 at bent 3 1'x1' spall

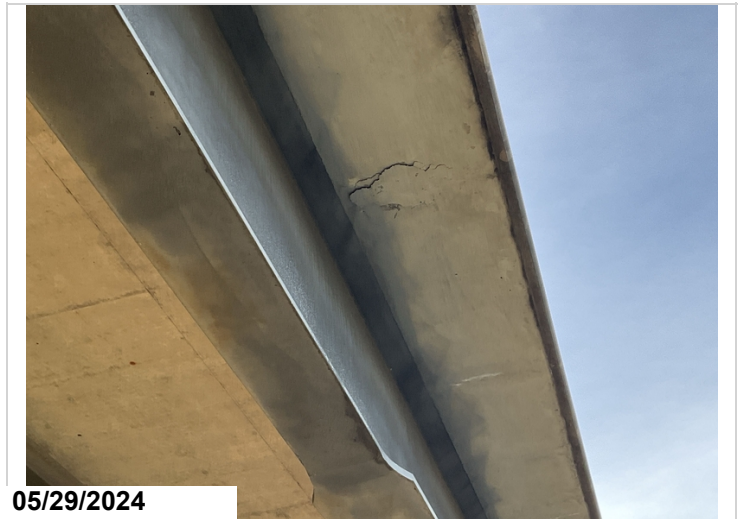
Span 2 at bent 3 left side has a 1'x1' delamination over slope pavement

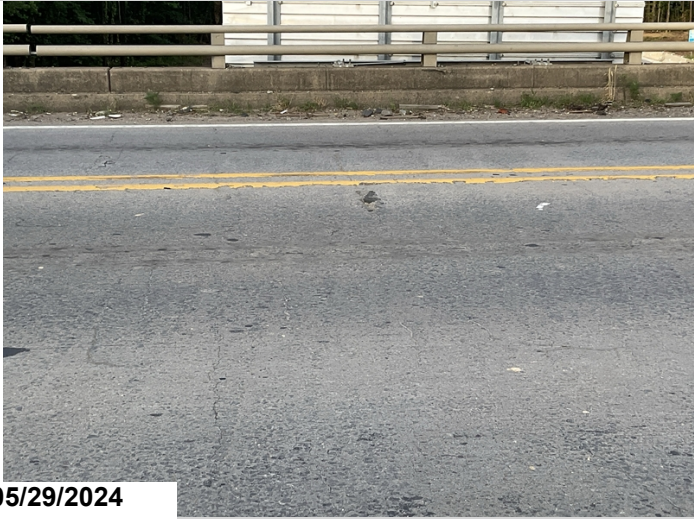
Span 1 middle lane has a 1'x1' spall cs2

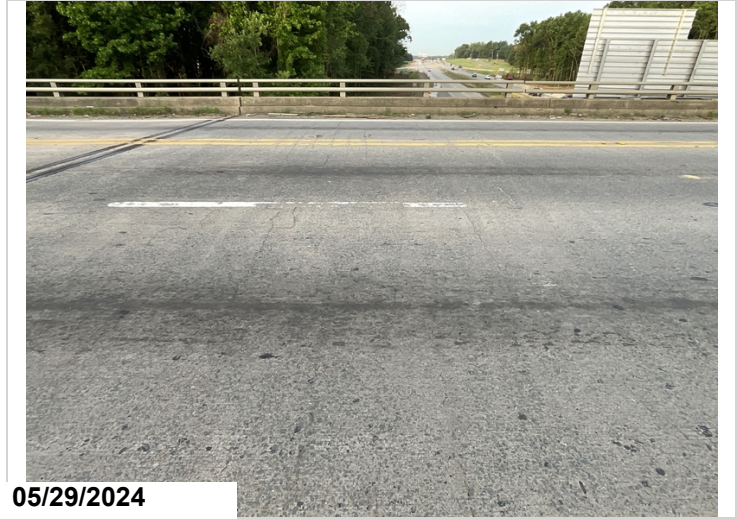
Sealed deck cracks in span 1.

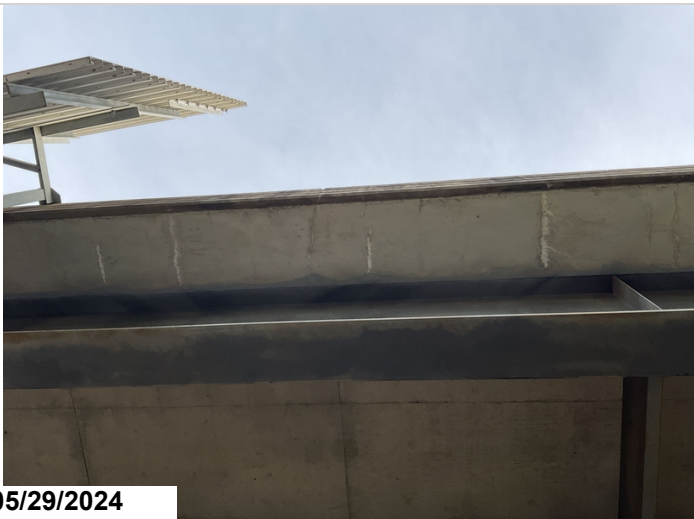
Efflorescence in the overhang

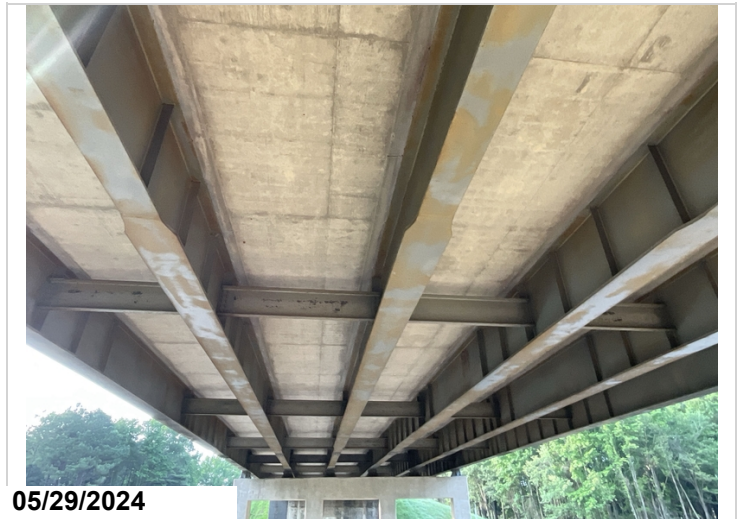
Typical condition of superstructure

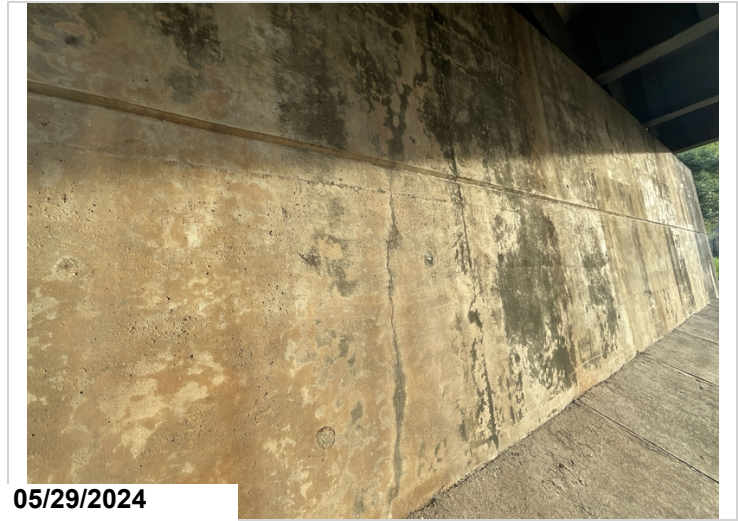
Vertical cracks in both abutments cs2

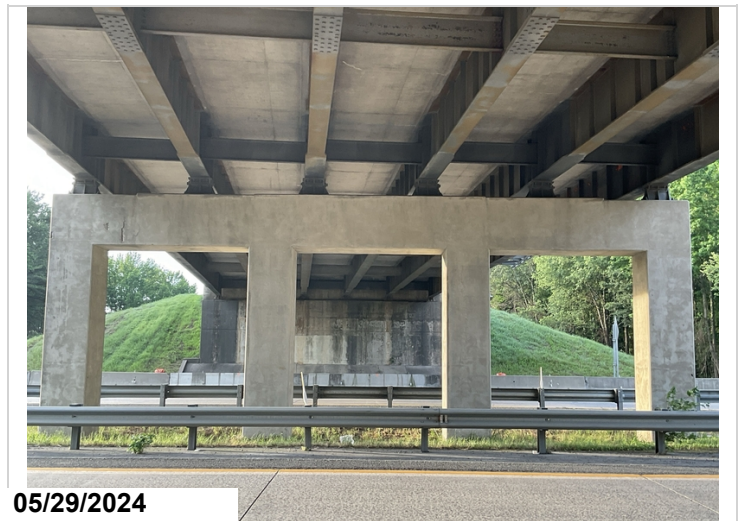
Bent 2 ahead right has exposed rebar at column 4

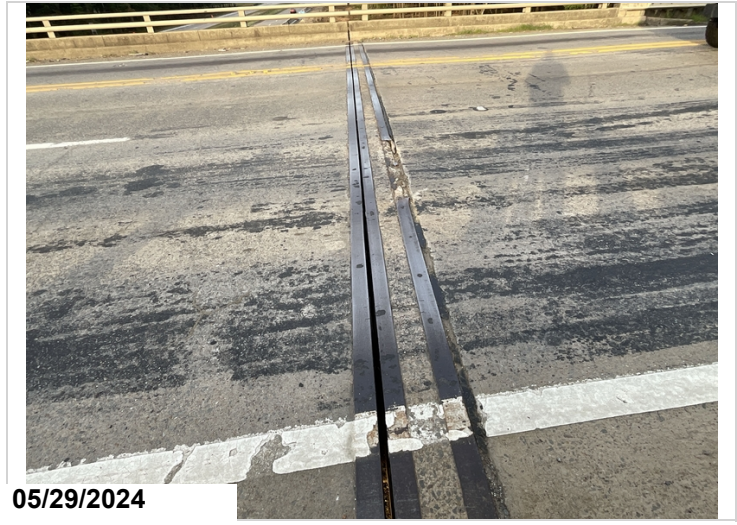
5' of armor is missing at bent 2 top of backwall

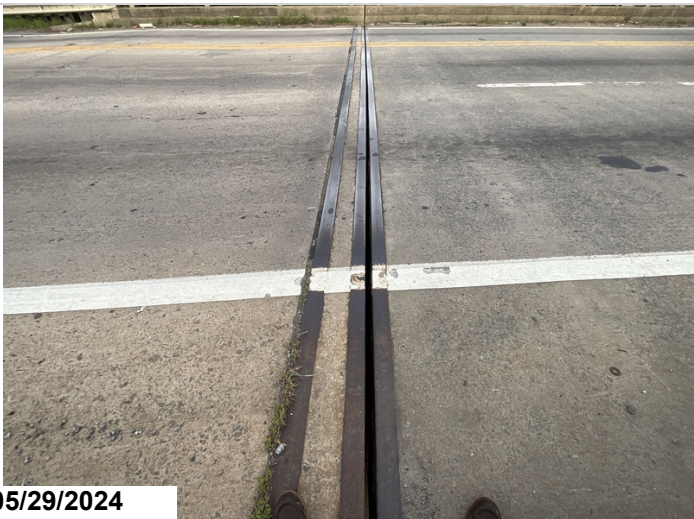
(302) All of the joint material is missing at Bents 1 & 3.							
311	Movable Bearing	EA	12	0	2	10	0

Bent 1 joint seal is missing

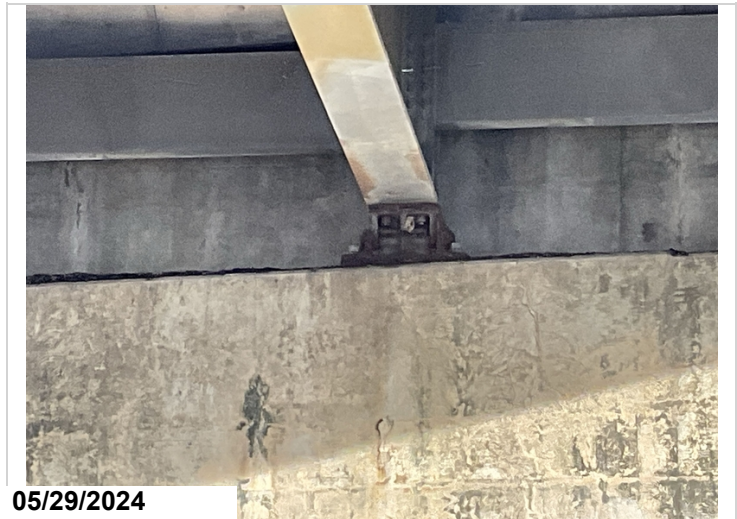
ELEMENTS	DESCRIPTION	UNITS	TOTAL	CS1	CS2	CS3	CS4
1000	Corrosion	EA	12	0	2	10	0
(311) All of the bearings have corrosion from missing joint seals.							
313	Fixed Bearing	EA	6	0	6	0	0
1000	Corrosion	EA	6	0	6	0	0

Bent 3 bearing 4 cs3 typical most bearings

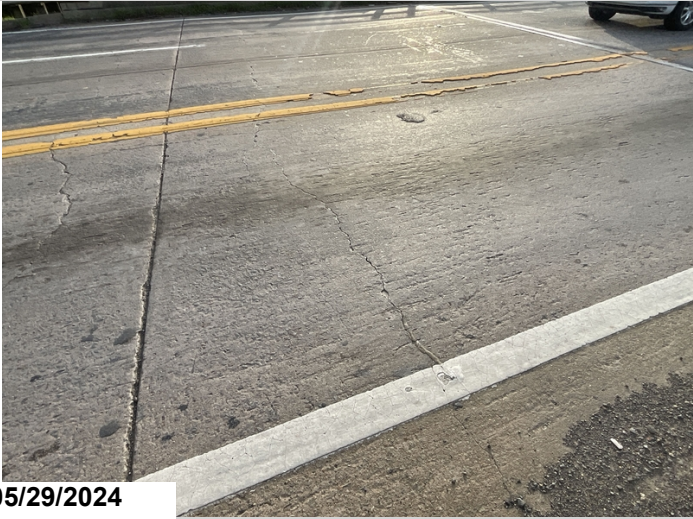
Bent 3 approach slab sealed transverse cracks

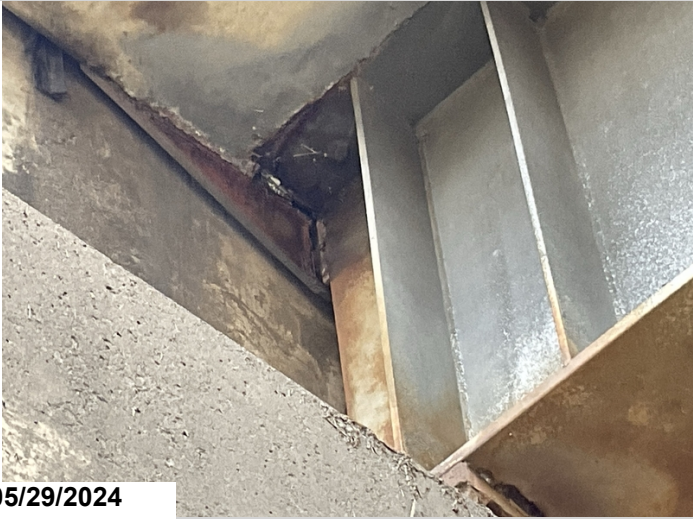
overall good condition/ paint system is failing allowing corrosion to form at beam ends due to leaking joints

Girder ends have corrosion forming due to leaking joints

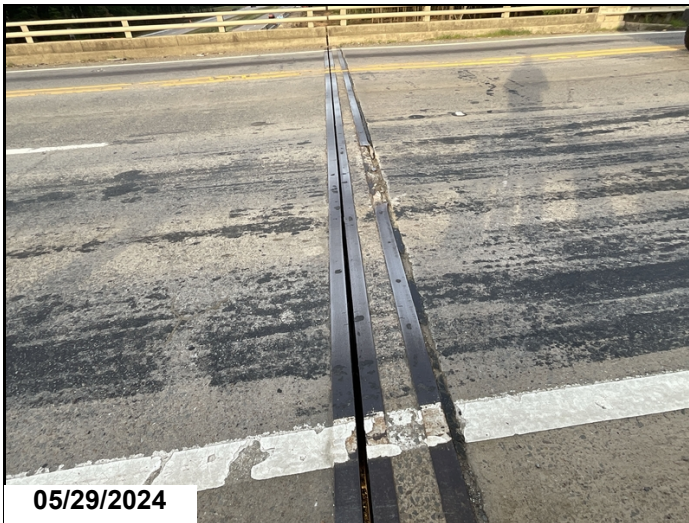
5' of armor is missing at bent 2 top of backwall

Type of Work: Joint Repair

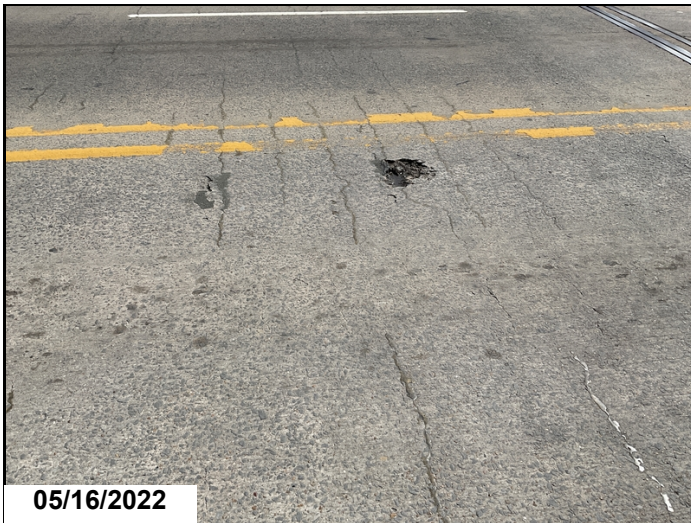
Small spalls in both spans

Span 1 spall with exposed rebar

Type of Work: Repair (General)

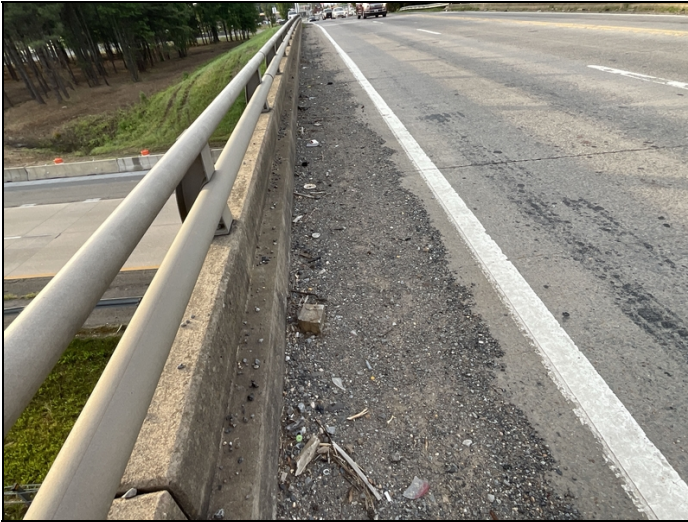
Dirt and gravel on both shoulders

**A-55 - Deck Washing Needed (Yes)**
