Bridge Inspection Report

01365
SH 367 Log 1.26
over
Dredge Ditch

Structure Number: 01365

Facility Carried: SH 367 Log 1.26

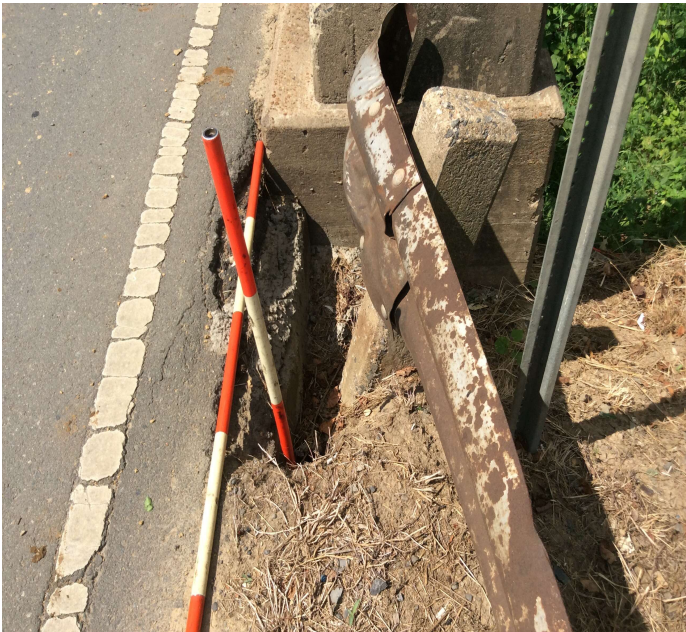
Priority: B - Pressing; 6 month completion goal

The southbound approaching roadway has a deep hole at the edge of the pavement and Void under the pavement. Erosion at this location has caused the approach rail to settle.

PHOTO 1 **Description** The approaching roadway southbound at bent 4 has deep hole and Void under the pavement. The embankment had eroded causing the approach rail to settle.

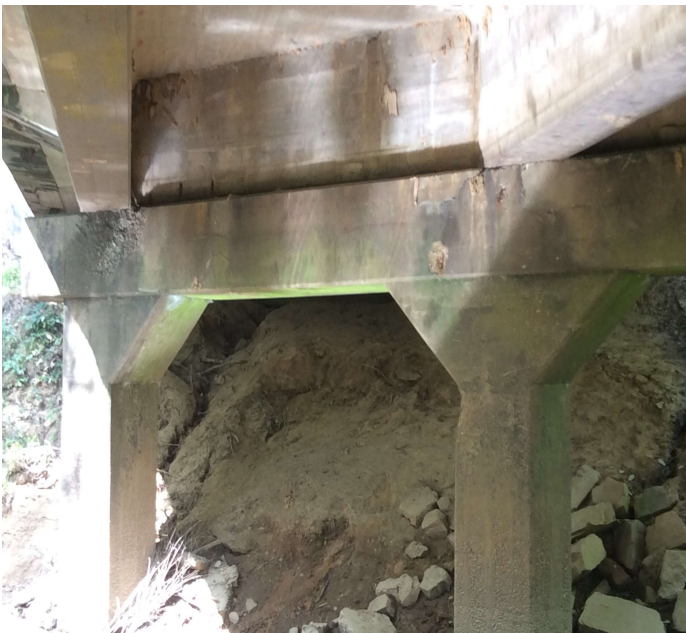
Priority: C - Important

The cap of bent 2 on the ahead face has spalls and delaminations under the girders.

PHOTO 1 Description Bent 2, looking back.
The cap has delaminations under girder
2 and
a spall with exposed rebar under girder
3

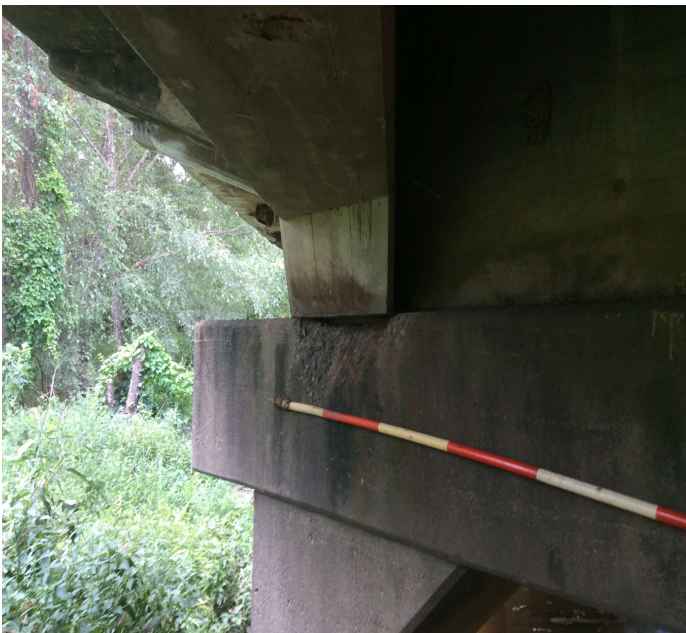
Priority: C - Important

The cap of bent 3 on the ahead face has a spall under girder 3. Photo attached.

PHOTO 1 Description Bent 3, ahead side under girder 3.
Spall with exposed rebar.

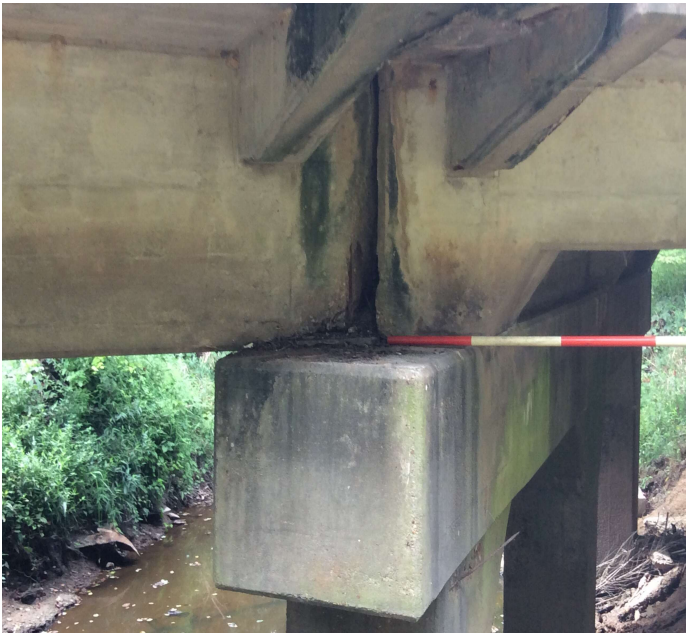
Priority: C - Important

Span 2, girder 1 at Bent 2 has a spall with exposed rebar on the left side. Photo attached.

PHOTO 1 Description Bent 2, looking at the left end.
Girder 1 of span 2 has a spall at the
end over the bearing.

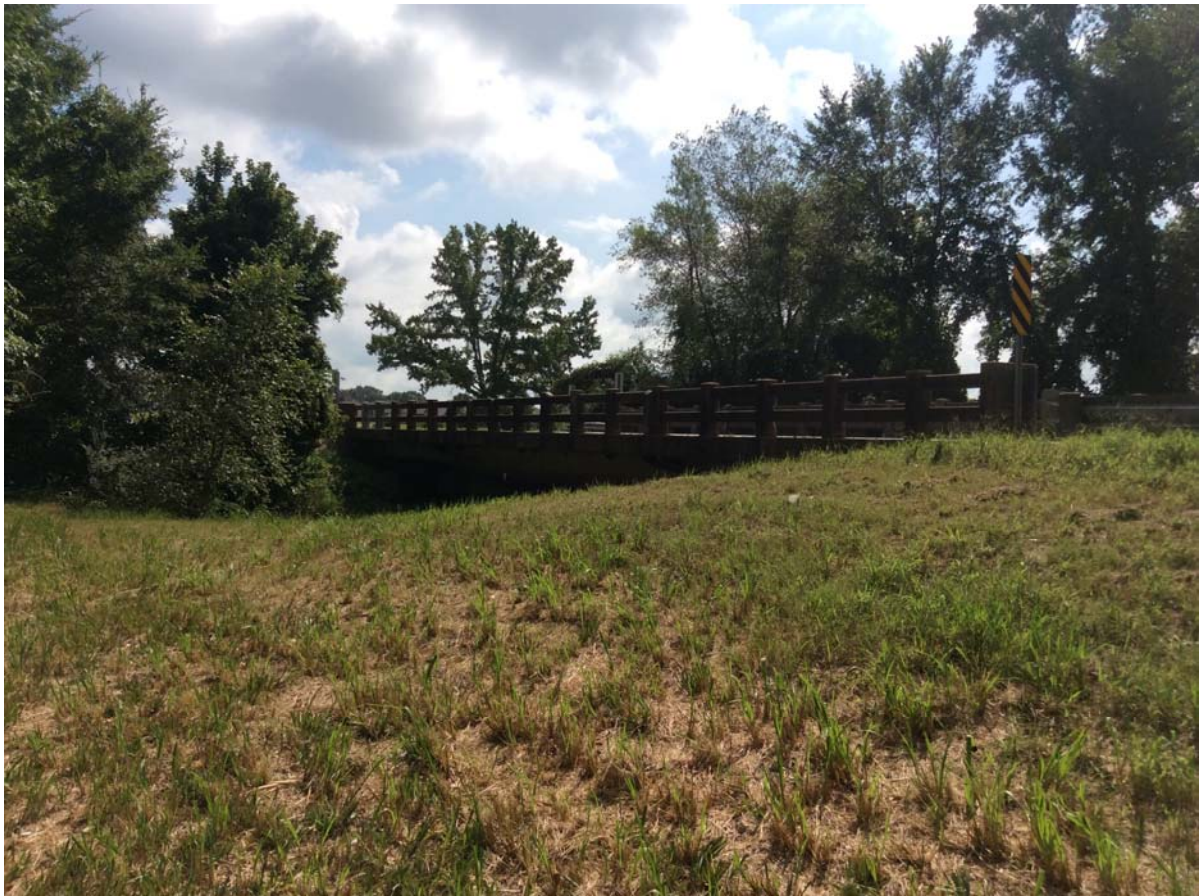
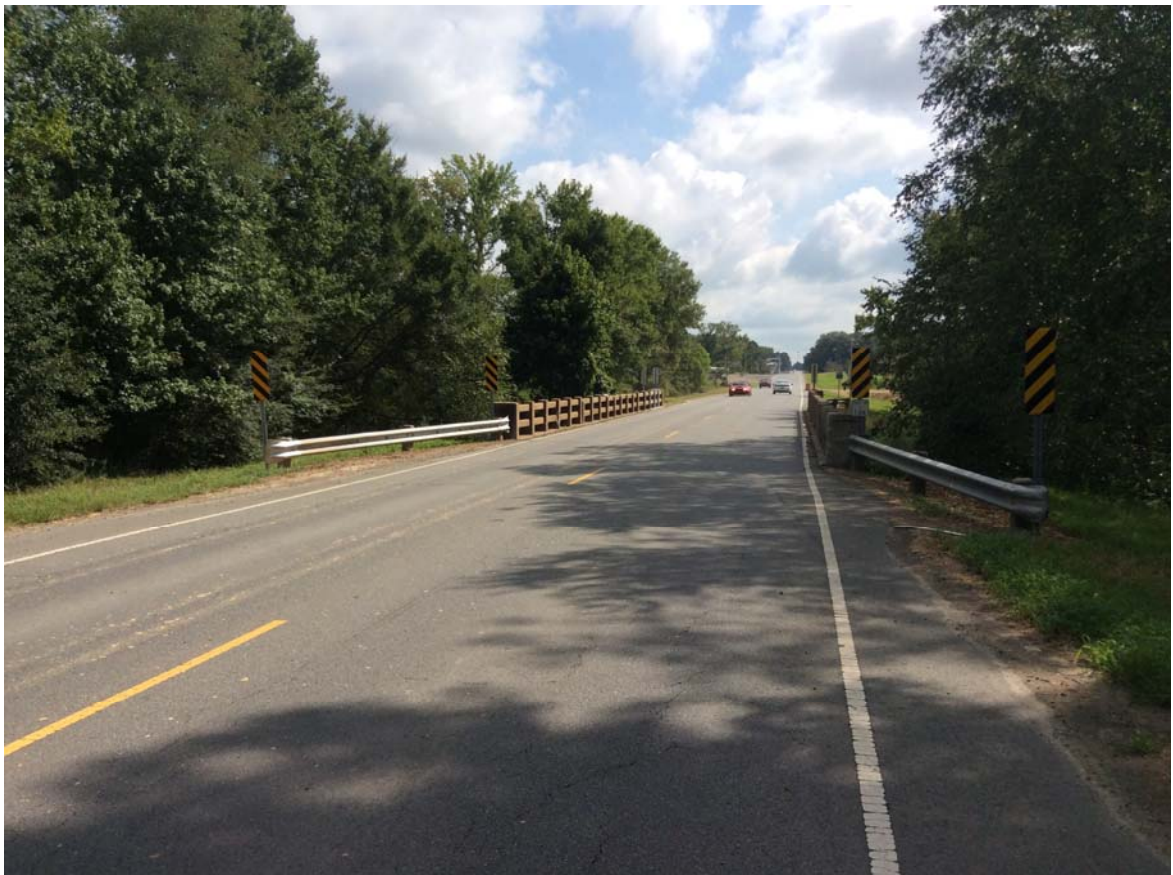
Priority: D - Routine

Both bridge rails have minor traffic damage
