Bridge Inspection Report

01441

SH 367 Log 0.44

WHITE OAK CREEK

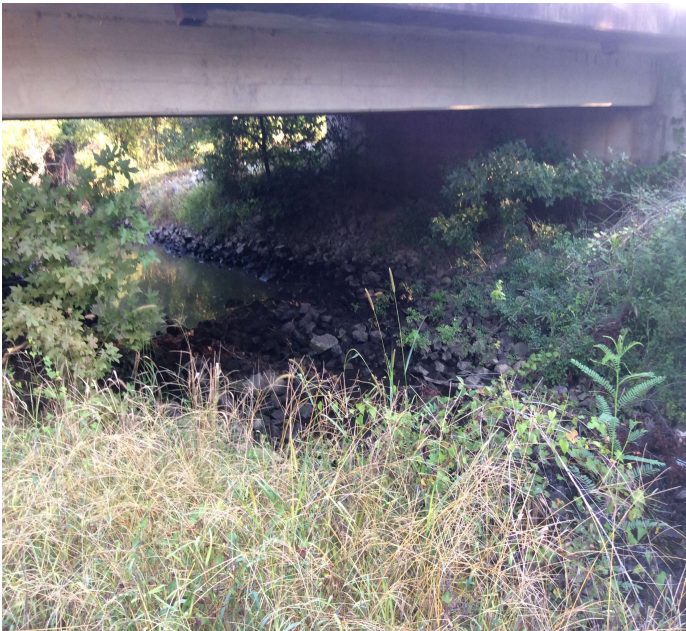
Brush and vines growing under and on the bridge. Photo attached.

PHOTO 1 Description Brush and vines growing under and on the bridge.
