Bridge Inspection Report

01443

SH 367 Log 1.05

BAYOU TWO PRAIRIE

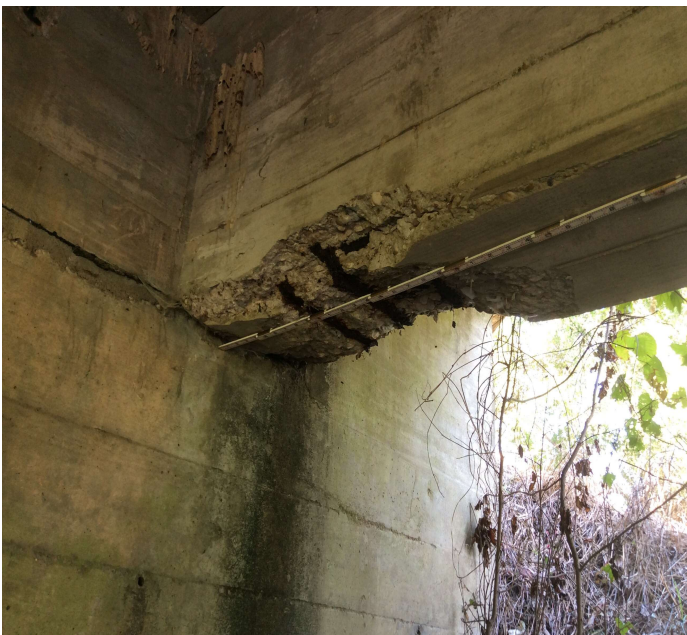
Priority: C - Important

Span 1, girder 1 at bent 1.

The girder has a spall with exposed rebar on the bottom.

PHOTO 1 Description Span 1, girder 1 at bent 1
Spall with exposed rebar.
