Bridge Inspection Report

01453

SH 367 Log 9.36

CYPRESS RELIEF

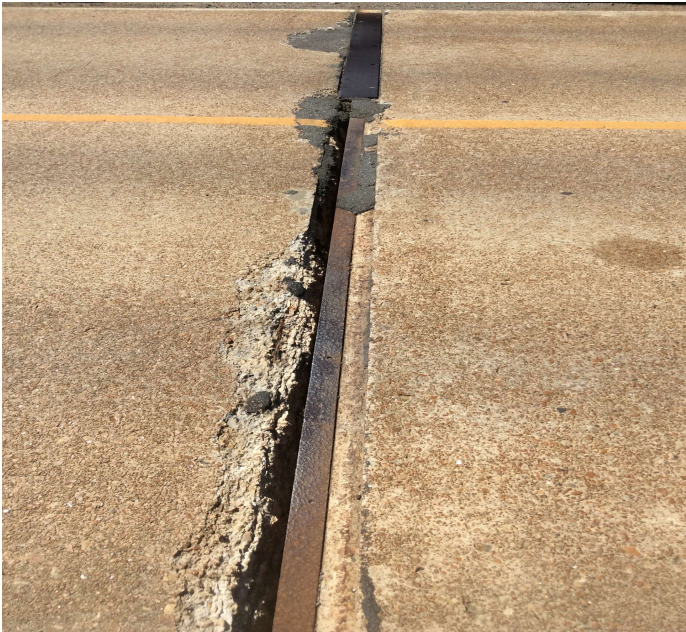
The deck joint at bent 3 has the joint armor missing and spalls with exposed rebar. Previous patching with asphalt material has not work here because this is a double expansion joint. Asphalt patching falls through the joint and piles up on the cap.

PHOTO 1	Description	Bent 3, 14 feet of sliding plate is missing and the deck head steel is missing in span 2. Previous asphalt patching has failed due to joint movement. Do not use a asphalt to repair this joint.
---------	-------------	--

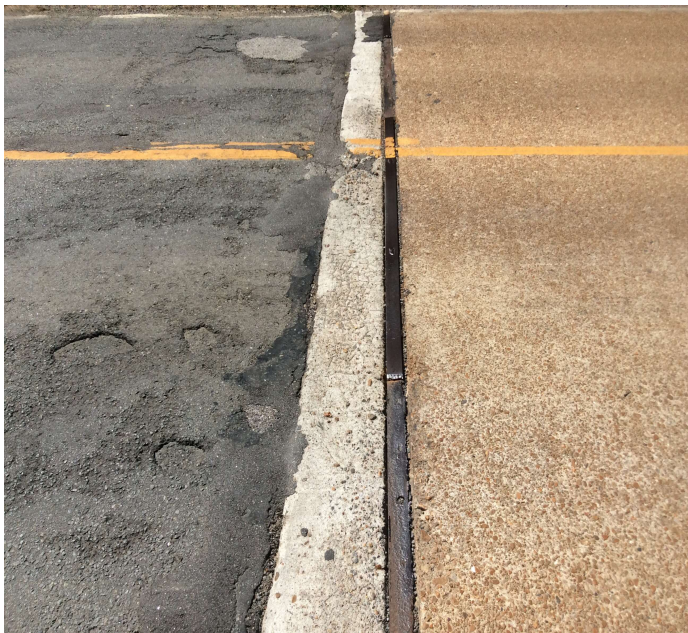
Sections of the sliding plates and joint armor are missing at Bent 1,2,3,4 and 5.

PHOTO 1 Description Bent 1, all of the sliding plate has been removed.

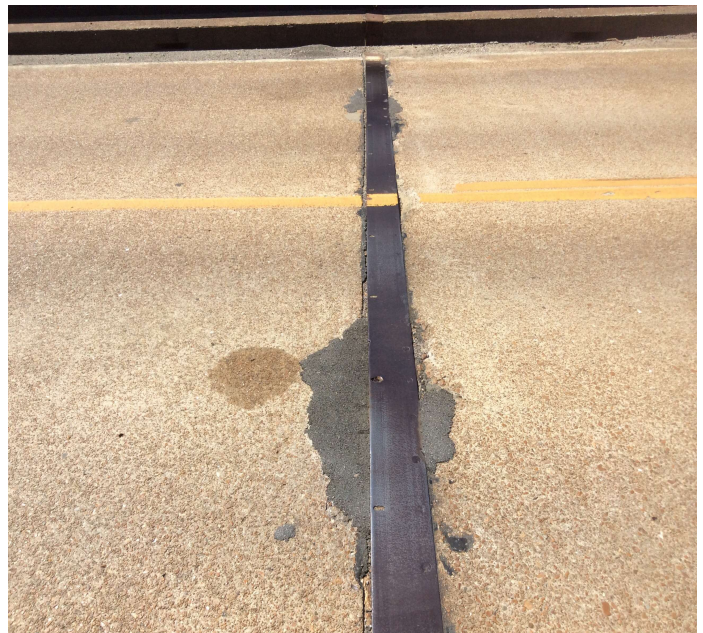
PHOTO 2 Description Bent 2, Spalls in the deck along the joint.

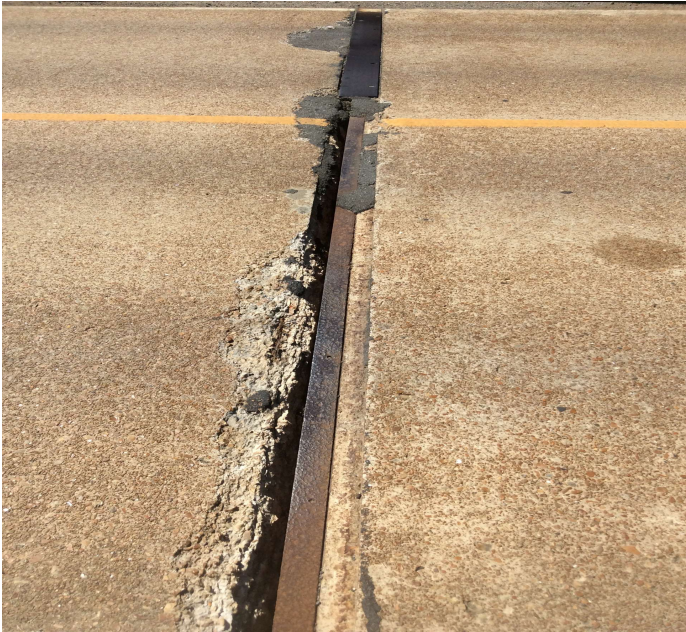
PHOTO 3 Description Bent 3, 14 feet of sliding plate is missing and the deck head steel is missing in span 2. Previous asphalt patching has failed due to joint movement. Do not use a asphalt to repair this joint.

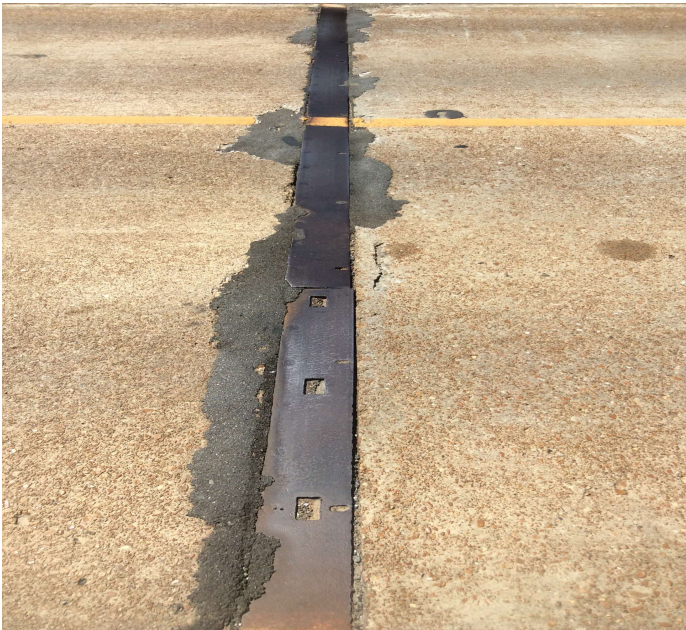
PHOTO 4 Description Assembly joint with repair at bent 4

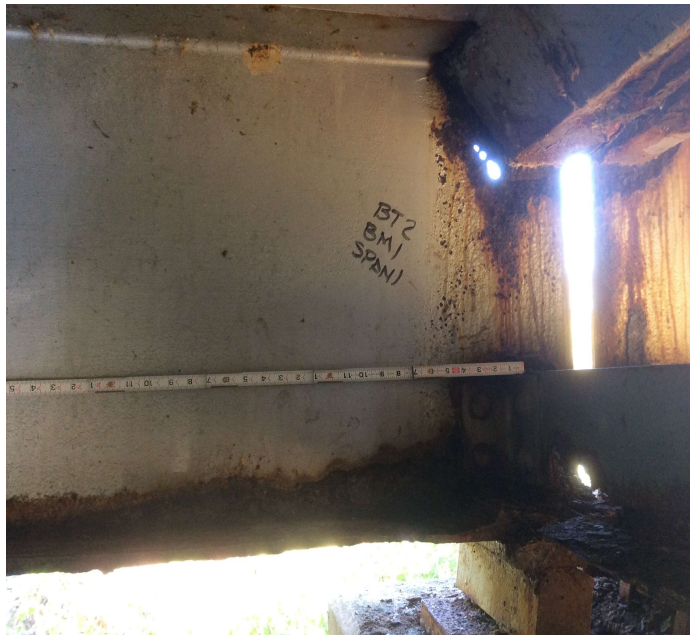
Beam ends have severe section loss to the webs and lower flanges and holes in webs. See photos.

PHOTO 1 Description Span 1, beam 1, at Bent 2.
Holes in the web at the deck haunch.

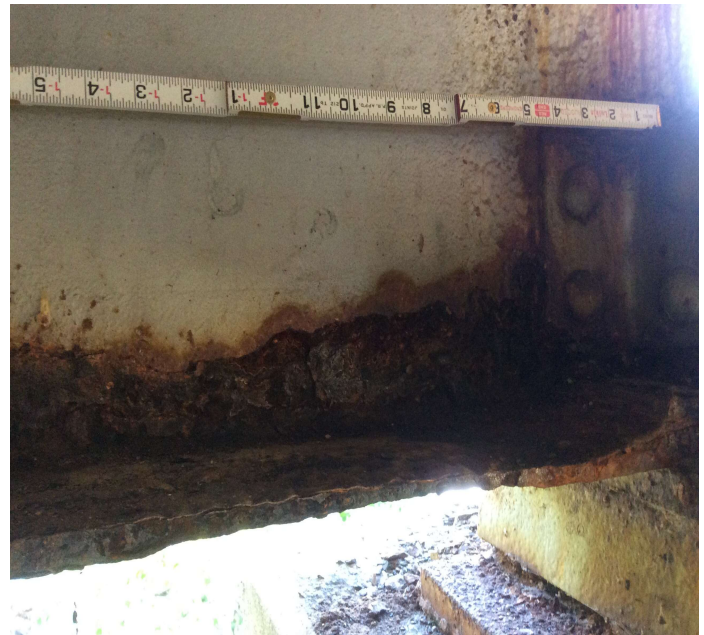
PHOTO 2 Description Span 1, beam 1, bottom flange at bent 2.

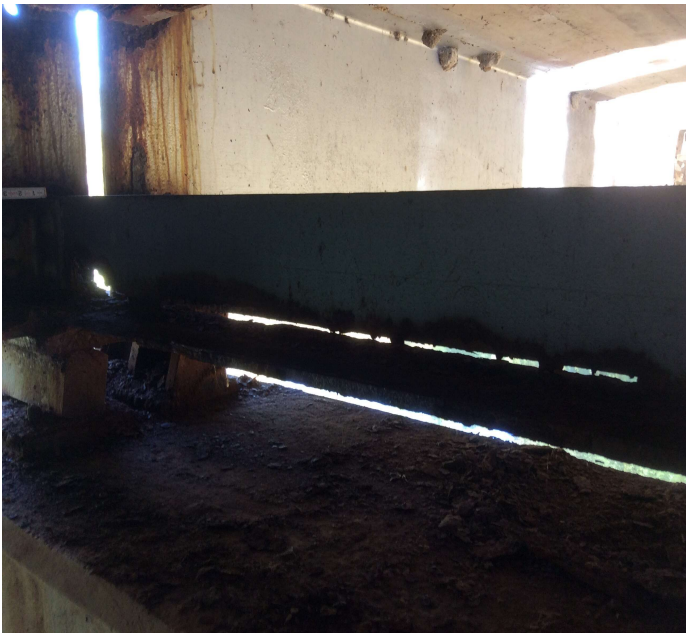
PHOTO 3 Description Span 1, Tee diaphragm between beam 1 & 2, at bent 2

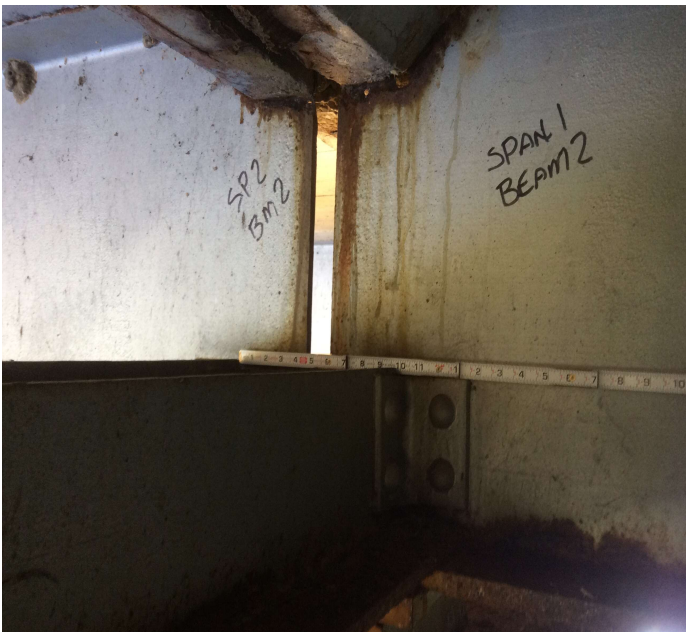
PHOTO 4 Description Spans 1 & 2 at Bent 2
Beam 2 span 1 holes in the web, span 2 beam 2, hole at the edge.

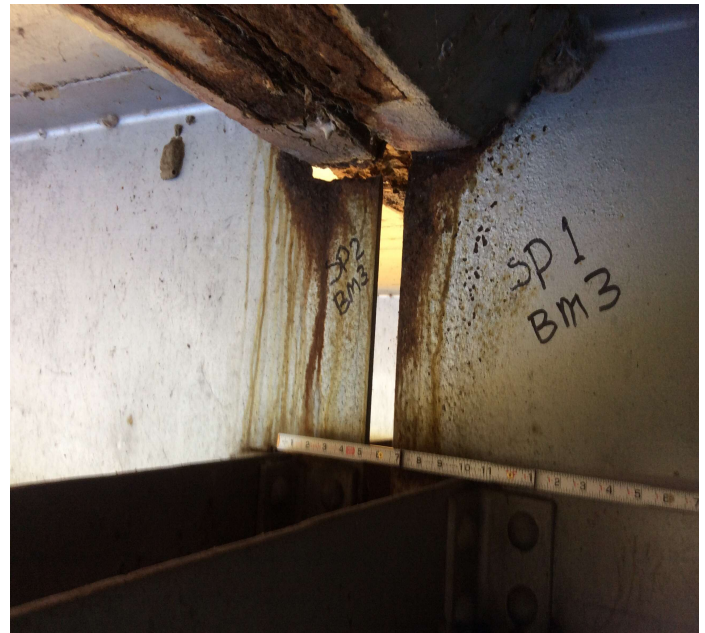
PHOTO 5 Description Spans 1 & 2, beam 3 at Bent 2
Pitting to 3/16" deep on span 1
Hole in the web on span 2.

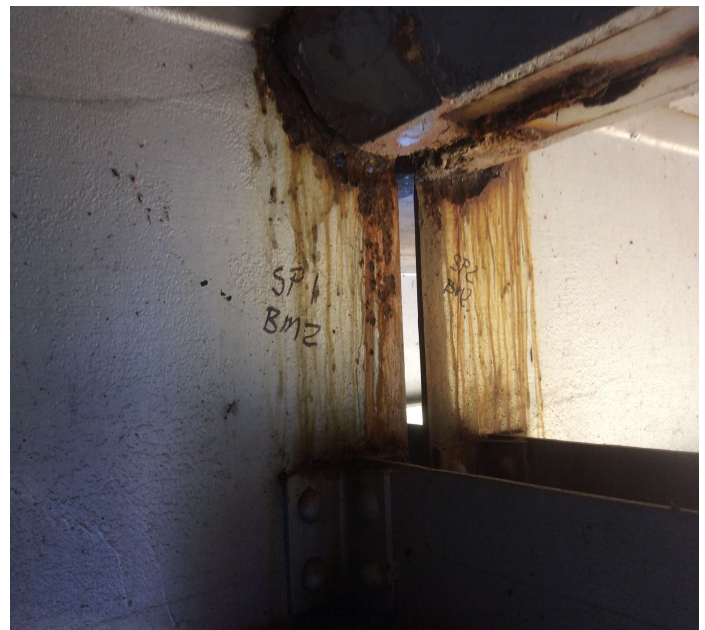
PHOTO 6 Description Spans 1 & 2, beam 2 right side at bent 2.

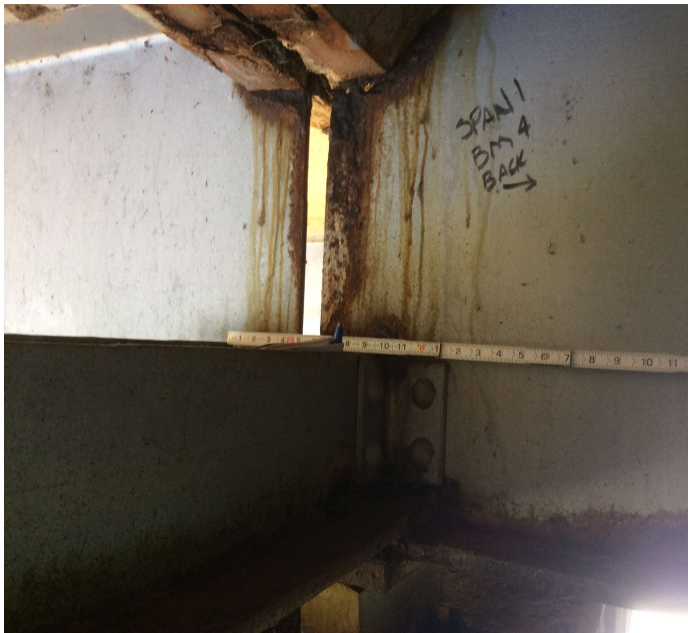
PHOTO 7 Description Span 1, beam 4 at Bent 2
Holes in the web at the haunch.
Span 2, beam 4 pitted to 3/16" at haunch.

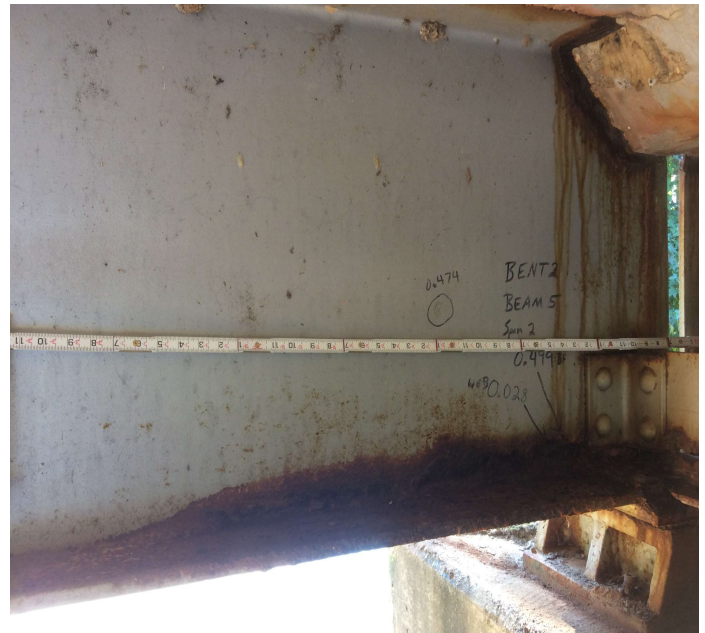
PHOTO 9 Description Span 2, beam 5 at bent 2.
Pitting to 7/16" deep on the lower web, left side.

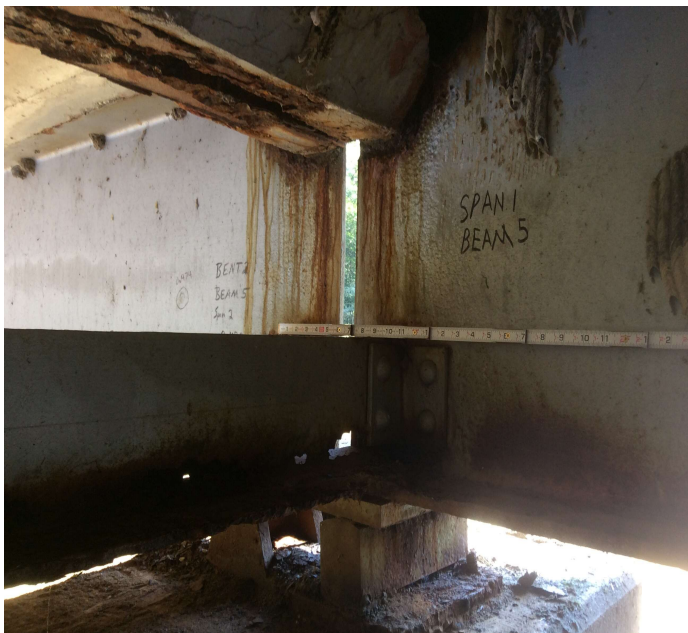
PHOTO 8 Description Span 1, beam 5, left side
Pitting to 3/16" deep at the deck haunch.

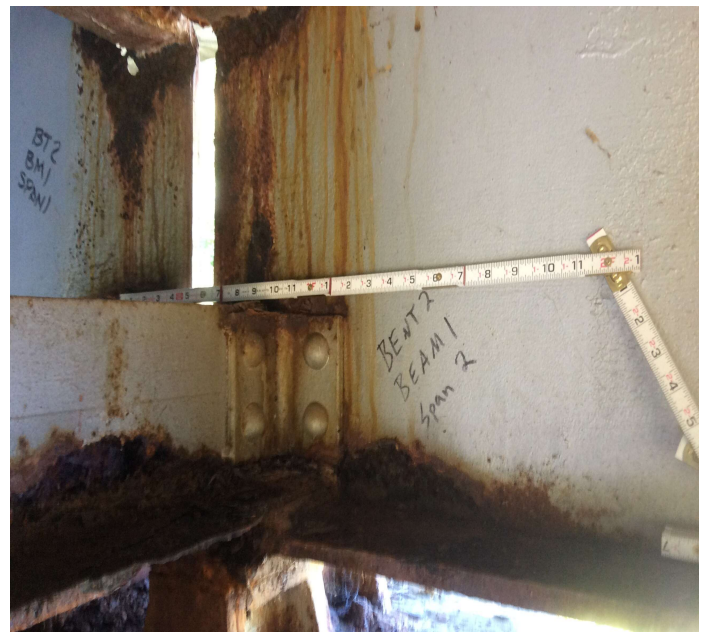
PHOTO 10 Description Span 2, beam 1 at bent 2
Pitting to the lower web 3/16" deep.

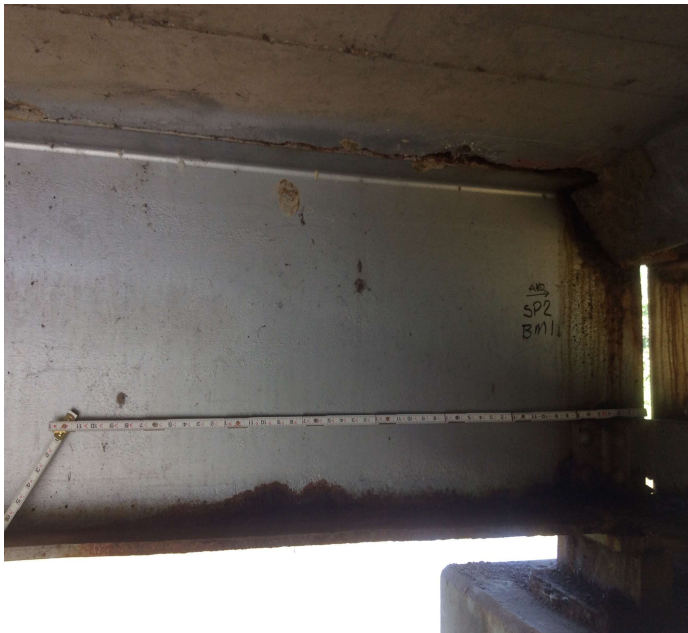
PHOTO 11 Description Span 2, beam 1 at bent 3
Pitting to 3/16" at the deck haunch and
Lower web. Bottom flange pitted to 1/8"
x 4 feet right side.

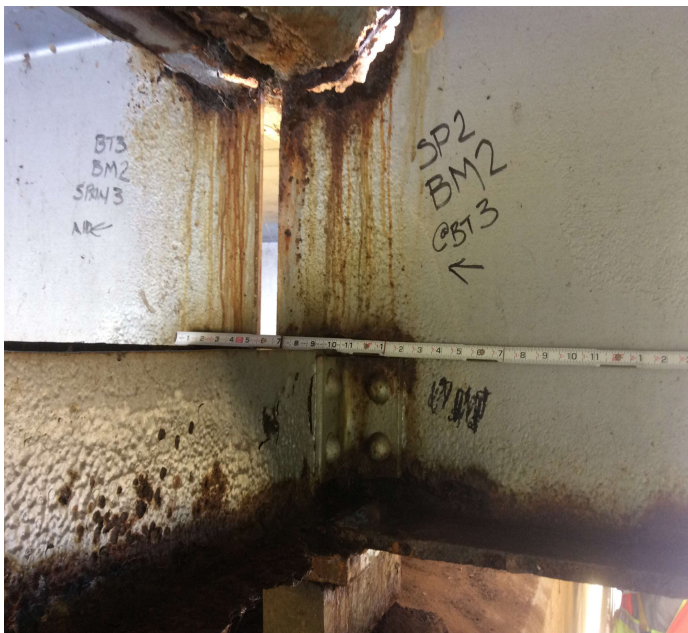
PHOTO 12 Description Span 2, beam 2 at bent 3
Hole in the web at the deck haunch and
pitting to
The lower web to 3/16".
Bottom flange pitted to 1/8" x 1 foot
back and
Narrowed x 3/8" at bearing.

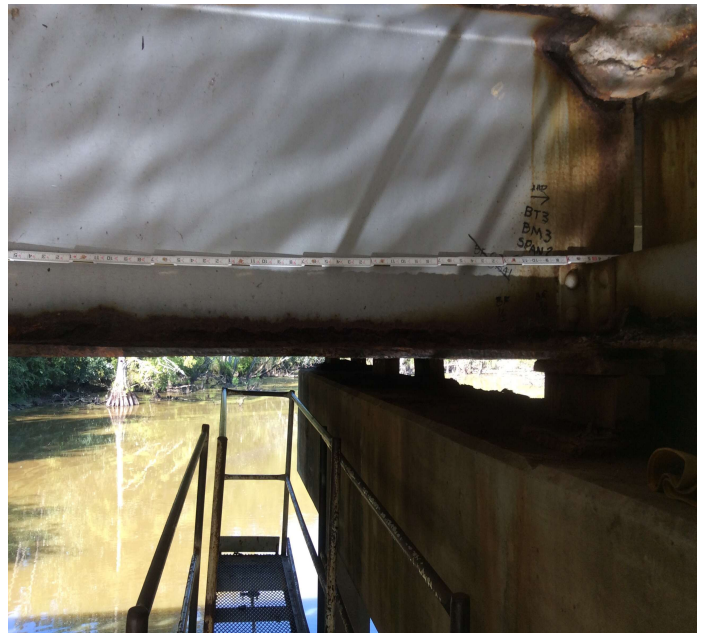
PHOTO 13 Description Span 2, beam 3 at bent 3.
Hole in the upper web at haunch,
Holes in the lower web back from
bearing
Bottom flange down to 1/2" thick x four
feet both sides and
Narrowed 1/2" each edge at bearing.

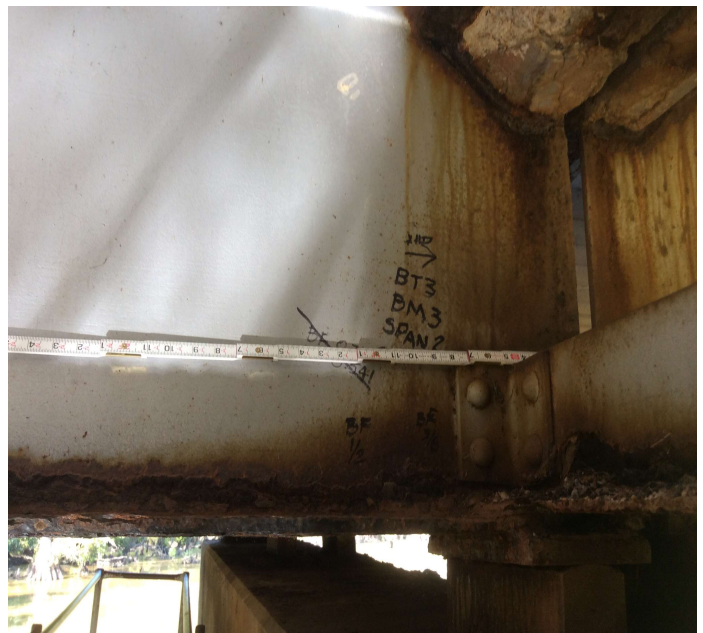
PHOTO 14 Description Span 2, beam 3 right side
Closer view of holes in the web and
bottom flange.

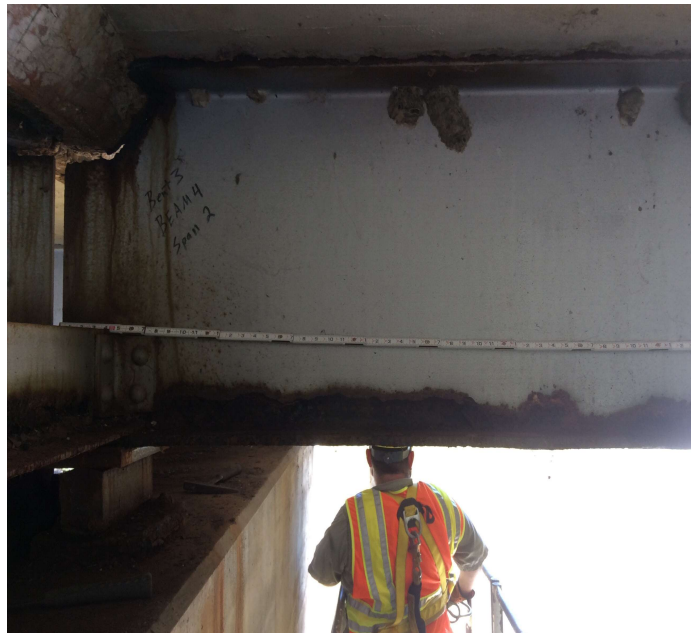
PHOTO 15 Description Span 2, beam 4, left side
Hole in the web at the haunch and
Pitting to the bottom flange 1/8" to 3/16"
Along both sides x five feet long.

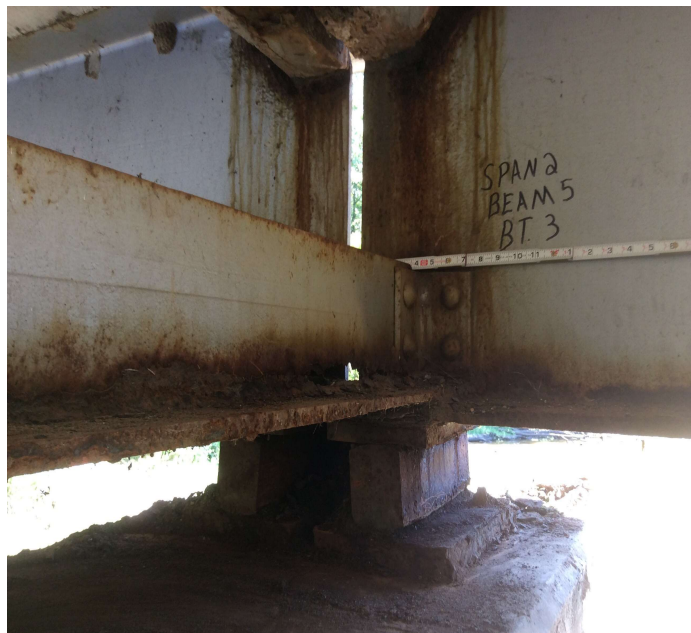
PHOTO 16 Description Span 2, beam 5 at bent 3
Pitting to 3/16" deep at haunch and
The bottom flange has 1/2" remaining
at bearing.

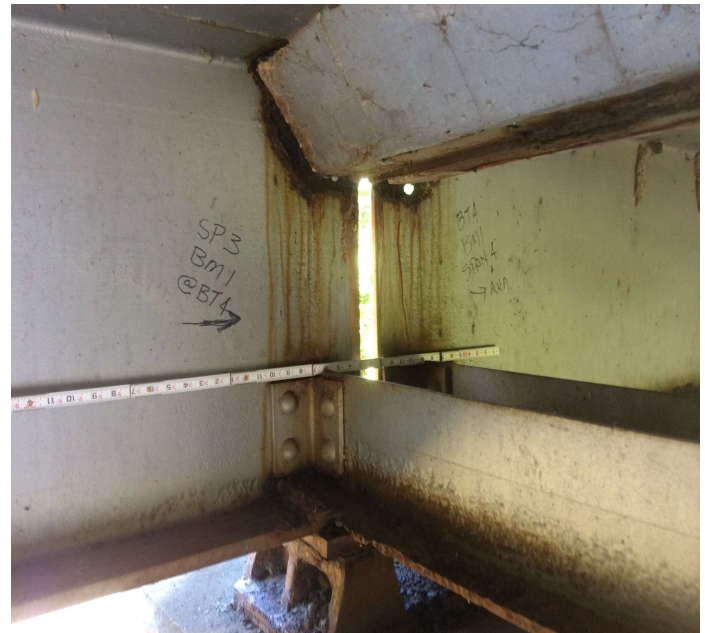
PHOTO 17 Description Spans 3 & 4 at bent 4
Beam 1 span 3 pitted at the deck
haunch
To 3/16" deep and lower web pitted to
1/8".
Beam 1 span 4 has a hole in the web at
the haunch.

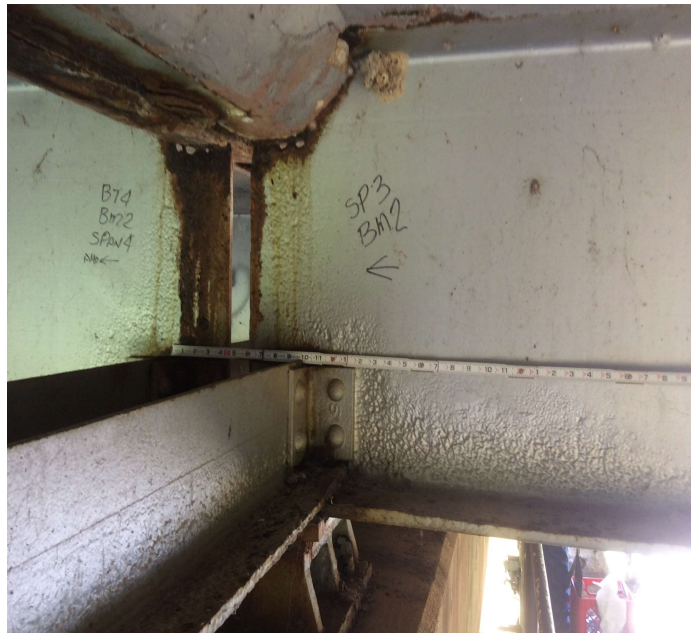
PHOTO 18 Description Spans 3 & 4, at bent 4
Beam 2 span 3 holes in the web at the haunch and
Pitting to the lower web 1/8" deep x 6" tall x 2 feet.
Beam 2 span 4 similar.

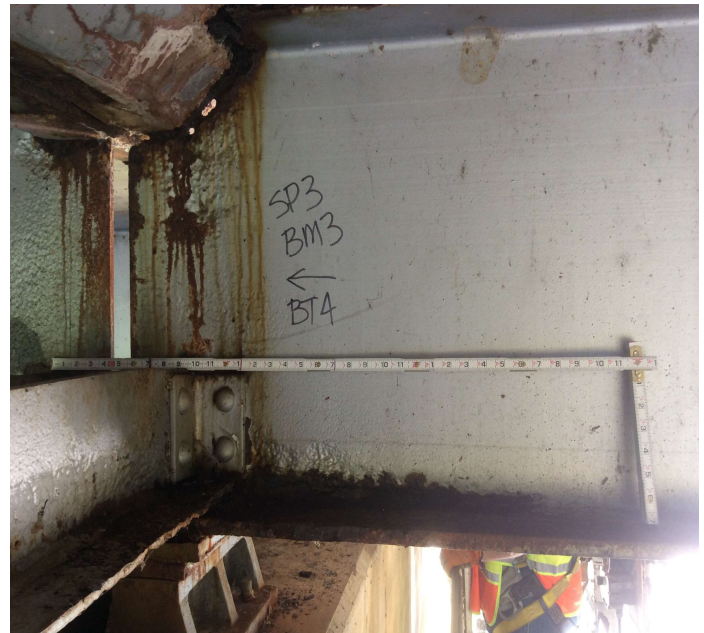
PHOTO 19 Description Span 3, beam 3 at bent 4
Holes in the web at the deck haunch and
Pitting to 1/8" deep x four inches tall x two feet long
to the lower web and bottom flange.

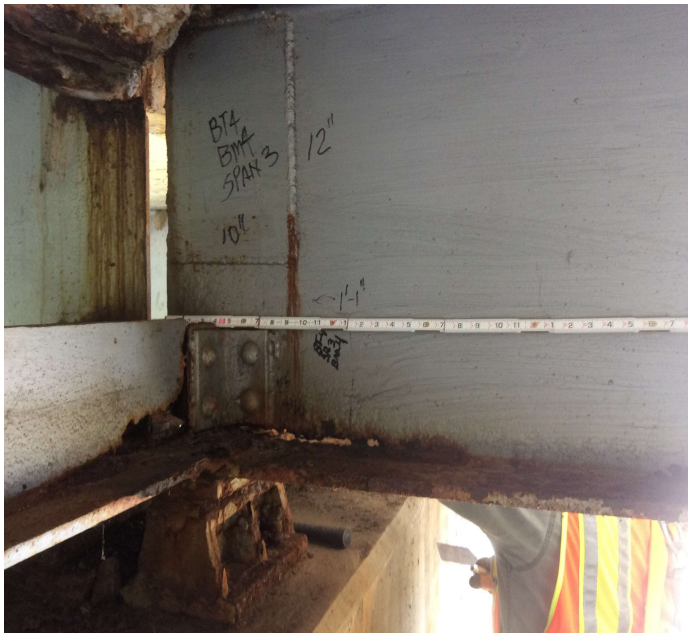
PHOTO 20 Description Span 3, beam 4 at bent 4
15" x 3/4" hole in the web at the bottom flange.
Bottom flange corroded down to 3/8 thick at bearing.
Repair plates at the top of the flange noted on section loss sketch.

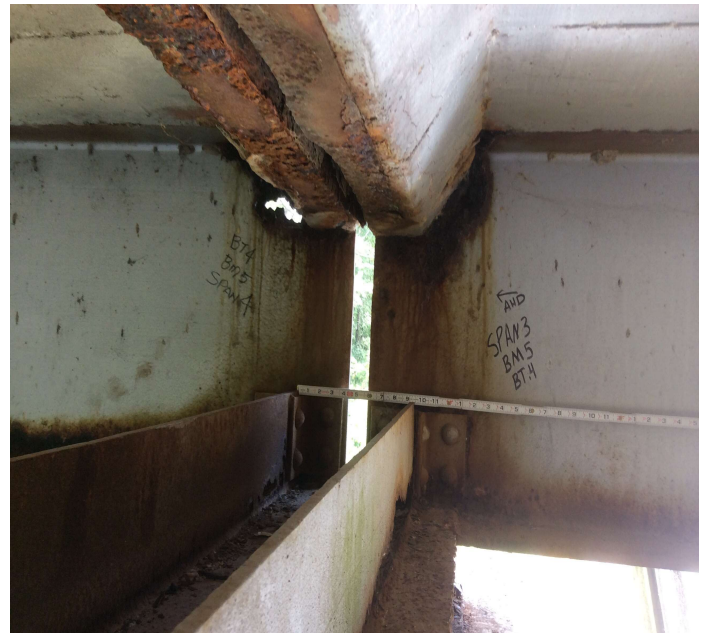
PHOTO 21 Description Spans 3 & 4 at bent 4
Beam 5 span 3 pitted to 1/4" deep at deck haunch and the bottom flange pitted to 3/16" x 1 foot back.
Span 4 beam 5 hole in the web at the deck haunch.

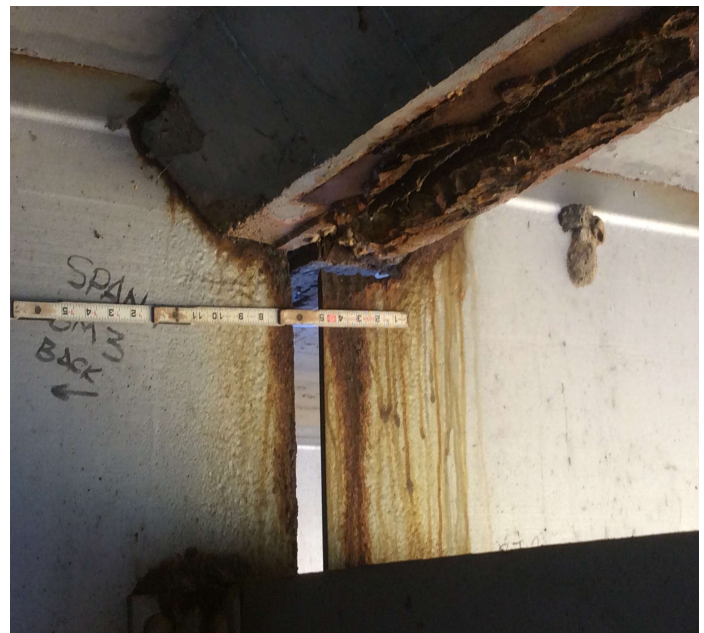
PHOTO 22 Description Bent 2 span 2 beam 3, 4 1/2" x 1" hole in upper web.

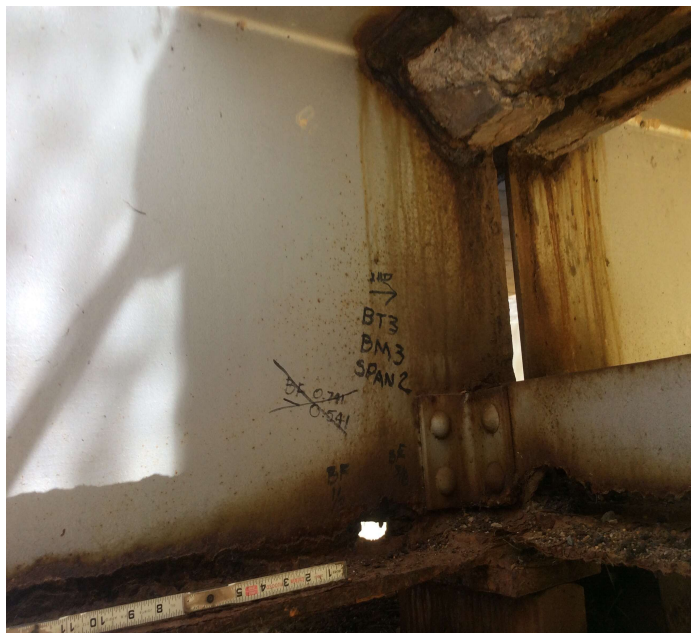
PHOTO 23 Description Span 2 at bent 3 beam 3 holes in the upper and lower webs and pitting to bottom flange up to 3/8 deep.
