# Bridge Inspection Report

**04198**  
**SH 338-1 Log 0.45**  
**over**  
**OTTER CREEK**

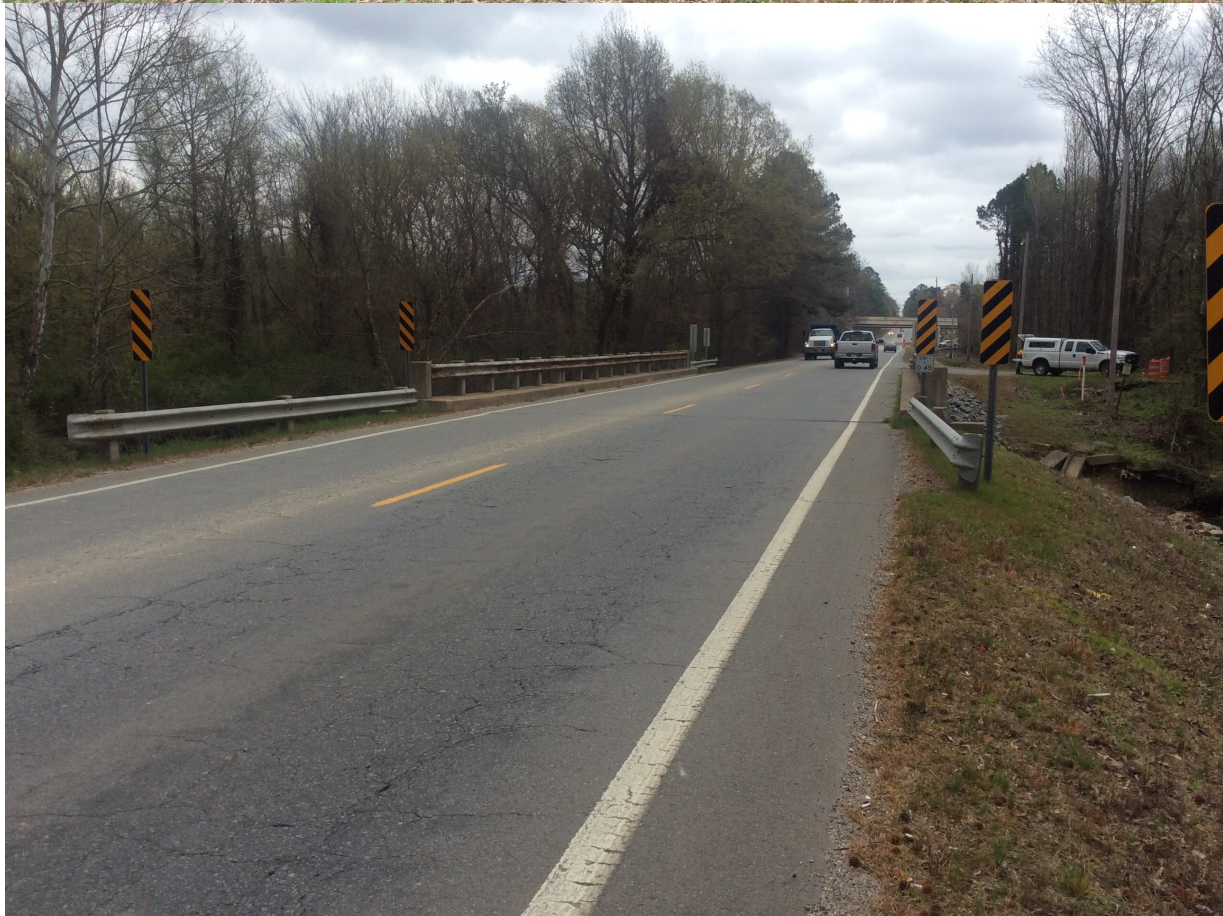
2 inches of asphalt  
overlay on the bridge  
deck.
