Bridge Inspection Report

02943

US 70B WB Log 3.54

Br. GulphaCrk, McClendon

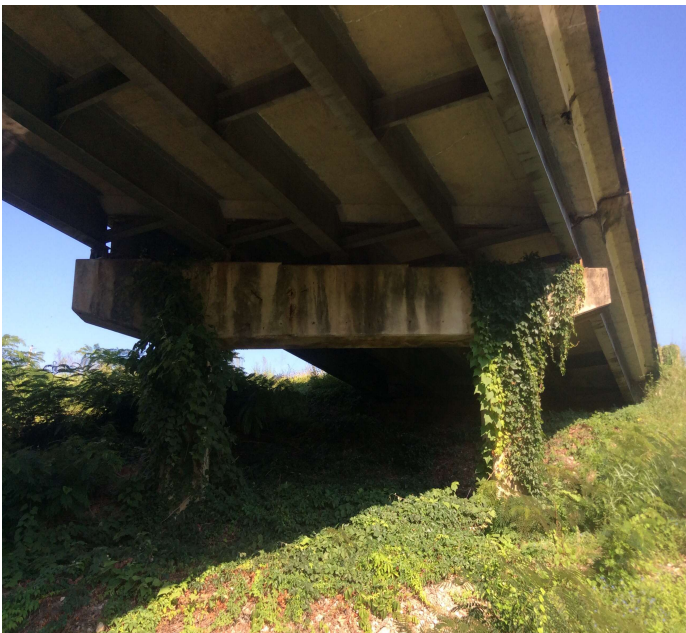
Bent 2 vines growing on columns & cap.

PHOTO 1 Description Bent 2 vines growing on columns & cap.

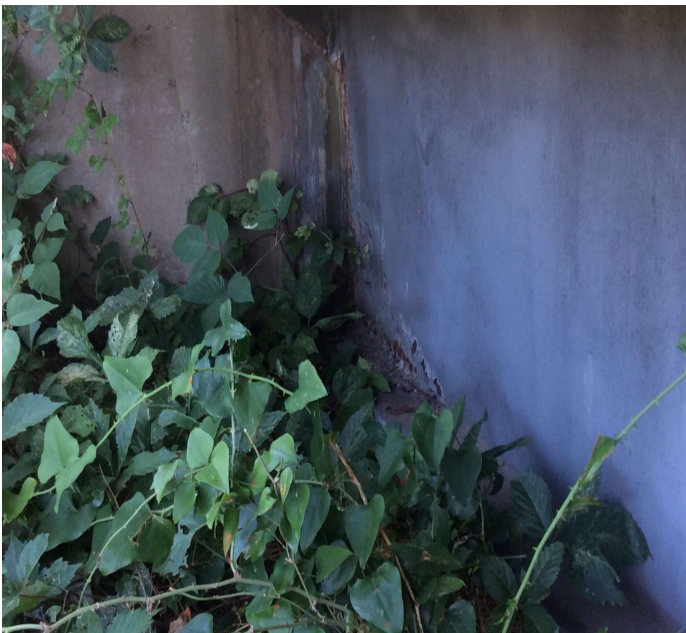
Bent 1 span 1 beam 1 & 5, flaking rust to lower flange web.

PHOTO 1 Description Span 1, beam 5 at bent 1, peeling paint with initiation of active corrosion.

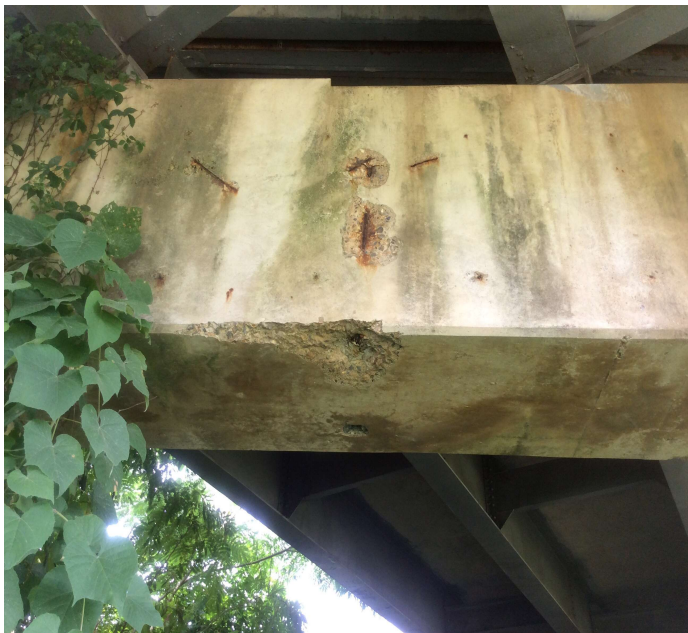
Caps and columns have spalls with rebar exposed

PHOTO 1 Description Caps at bents 2 and 3 have large spalls with rebar exposed

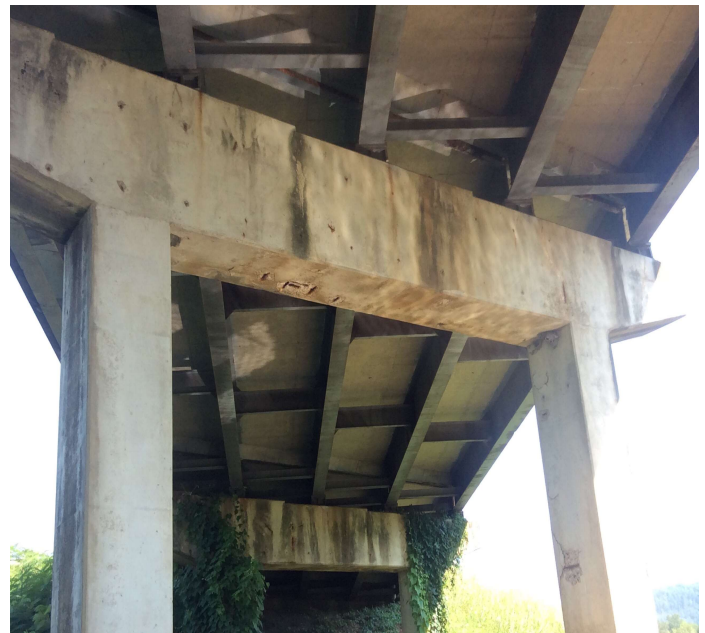
PHOTO 2 Description Bent 3 looking back, spalls with exposed rebar on columns & cap.
