# Bridge Inspection Report

**A2943**

**US 70B EB Log 3.5**

**Br. GulphaCrk, McClendon**

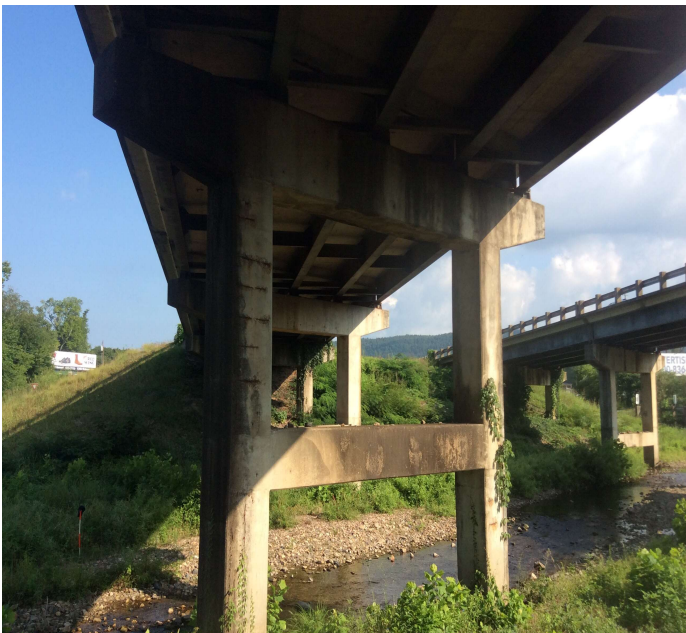
3440 - Effectiveness (Steel Protective Coatings)		257				195	62
205 - Reinforced Concrete Column	1- Ben.	10	each	7	0	3	0
	Bent 2 column 1, bent 4 columns 1 and 2 have rebar exposed.						
1090 - Exposed Rebar		3				3	
215 - Reinforced Concrete Abutment	1- Ben.	90	ft.	84	6		
	Both abutments have cracks.						
234 - Reinforced Concrete Pier Cap	1- Ben.	165	ft.	158	4	3	0
	Bent 2 cap has a spall with rebar exposed Bent 4 cap has exposed rebar.						
1080 - Delamination/Spall/Patched Area		1			1		
1090 - Exposed Rebar		3				3	
1130 - Cracking (RC and Other)		3			3		
311 - Movable Bearing	1- Ben.	30	each	0	10	20	0
1000 - Corrosion		30			10	20	
313 - Fixed Bearing	1- Ben.	30	each	10	20	0	0
1000 - Corrosion		20			20		
330 - Metal Bridge Railing	1- Ben.	528	ft.	528			
515 - Steel Protective Coating		1056	sq. ft.	252	804	0	0
3440 - Effectiveness (Steel Protective Coatings)		804			804

Caps and columns have spalls with rebar exposed

PHOTO 1      Description      Bent 4, ahead side, exposed rebar on columns.
