Bridge Inspection Report

02942

US 70B WB log 1.93

GULPHA CREEK

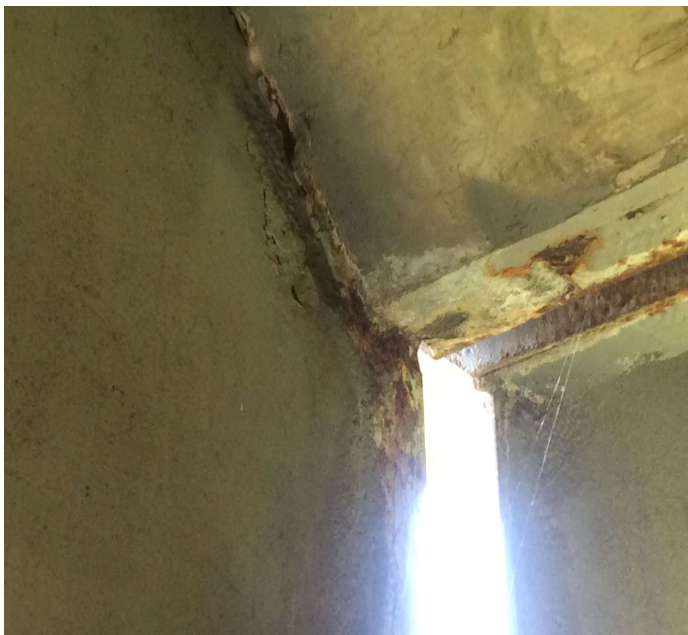
Painted system is falling. Beam ends have pitting to 3/16 inch deep at the ends. Section loss that has been painted over but beginning to rust

PHOTO 1 Description Painted over section loss on beams with minor rust

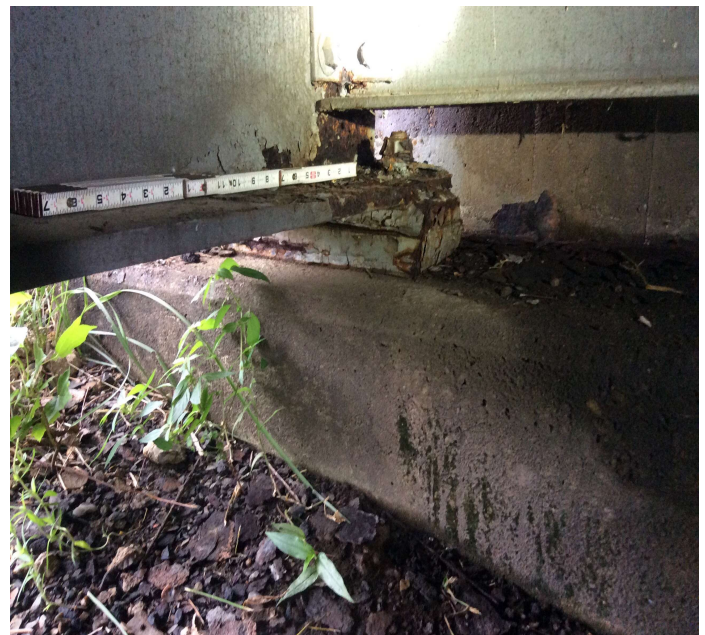
PHOTO 2 Description Span4 beam 1 pitting to web and bottom flange up to 3/16".

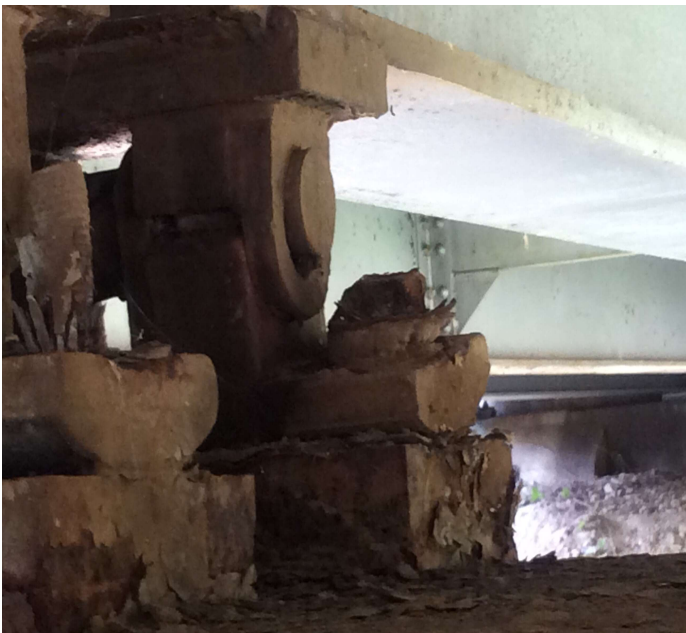
Span 1 bearings under girders 1,2,4 and 5 has up to 3/8 inch gap around bearing pin

PHOTO 1 Description Span 1 bearings under girders 1,2,4 and 5 has up to 3/8 inch gap around bearing pin
