# Bridge Inspection Report

**A2942**  
**US 70B EB Log 1.93**  
**over**  
**GULPHA CREEK**

Structure Number: A2942

Facility Carried: US 70B EB Log  
1.93

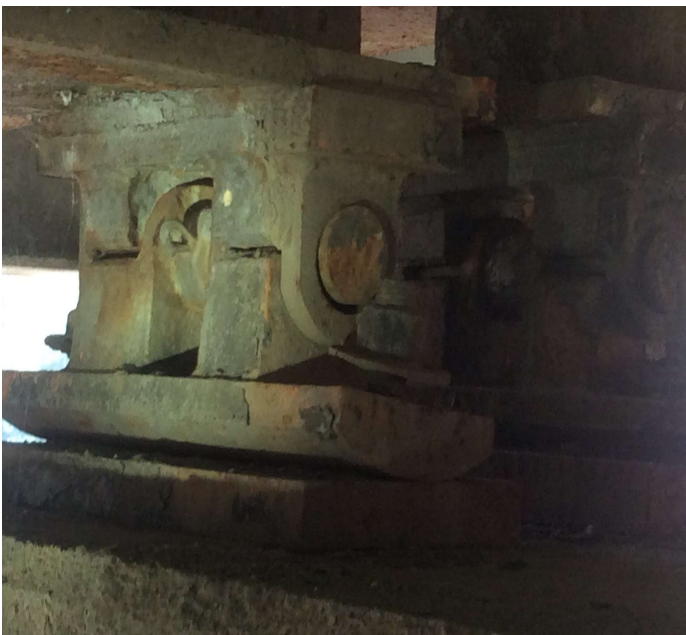
All bearings have rust with rotation. Span 2 at bent 2 bearings under girders 3,4 and 5 have a 1/4 inch gap around pins, same on span 4 under girders 2,3 and 4.

PHOTO 1      Description      Span 2 at bent 2 bearings under girders 3,4 and 5 have a 1/8 inch gap around pins

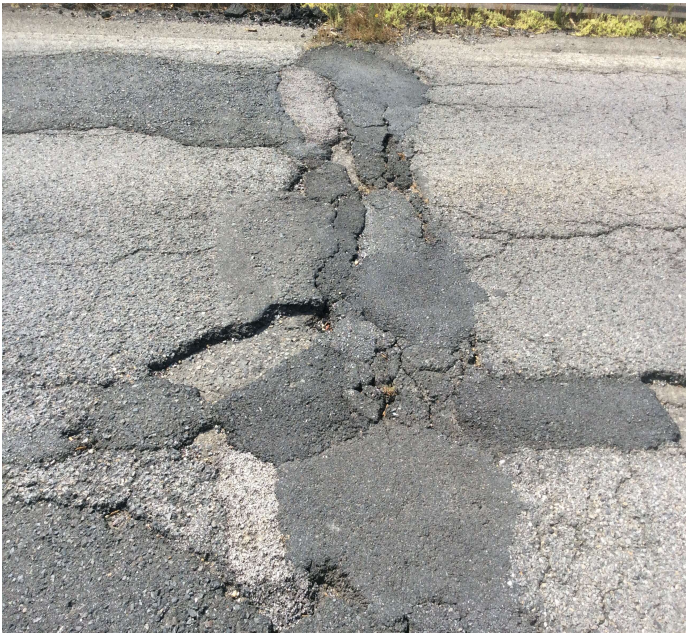
Soffit has small cracks and spalls. Asphalt wearing surface has large unsealed cracks.

PHOTO 1      Description      Asphalt overlay has large spalls and unsealed cracks

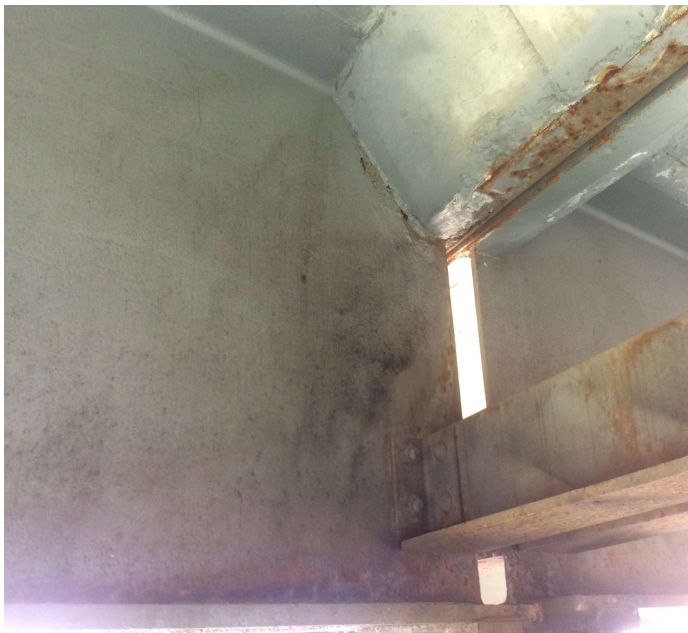
Painted system is failing. The webs and bottom flanges of the beams ends have active rust with pitting to 3/16 inch deep.

PHOTO 1 Description Painted over section loss

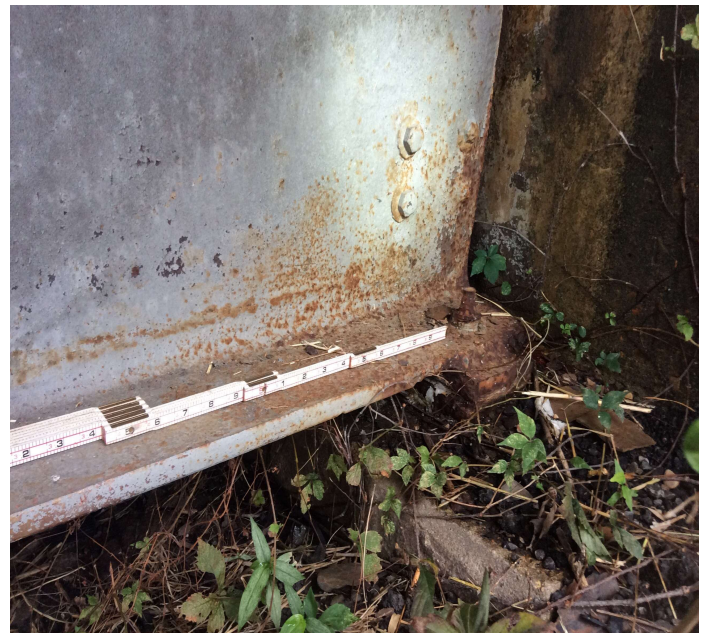
PHOTO 2 Description Span 4 girder 5, pitting up to 3/16" in web and bottom flange
