# Bridge Inspection Report

**06318**  
**US 270 BYPASS**  
**over**  
**US 70B Log 0.04**

Structure Number: 06318

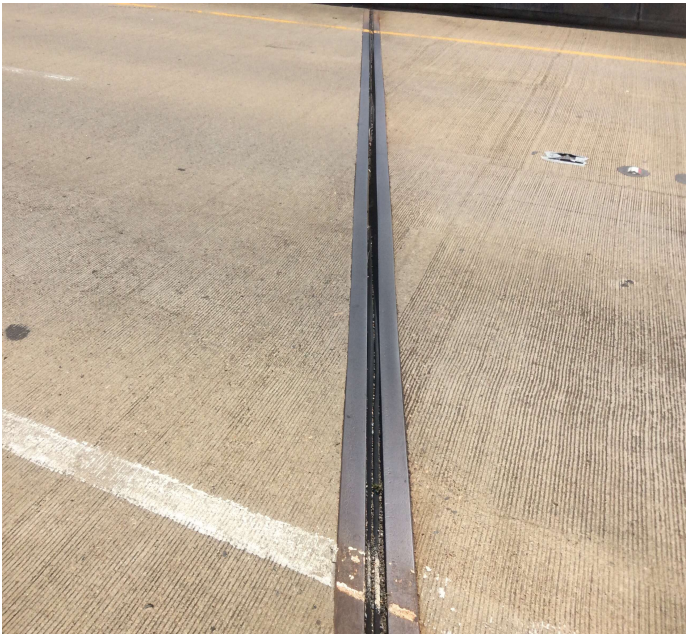
| | Environment | Total Quantity | Units | Condition State 1 | Condition State 2 | Condition State 3 | Condition State 4 |
|---|---|---|---|---|---|---|---|
| All Joint seals are leaking. At Bent 3 20 foot of joint seal has fallen | | | | | | | |

20 feet of joint seal has fallen out over bent 3 eastbound lanes. And all other joint seals are leaking causing debris to build up around bearing areas.

PHOTO 1      Description      20' of joint seal in eastbound lane at bent 3 has fallen out.

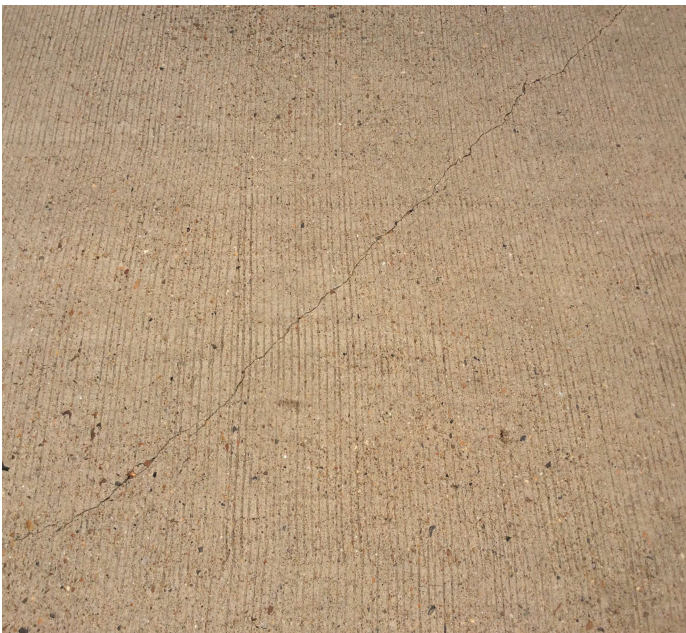
| | Environment | Total Quantity | Units | Condition State 1 | Condition State 2 | Condition State 3 | Condition State 4 |
|---|---|---|---|---|---|---|---|
| Deck has unsealed cracks. | | | | | | | |

Deck has unsealed cracks.

PHOTO 1    Description    Deck cracks
