Bridge Inspection Report

03635
SH 9 -5 Log 4.68
over
ALUM FORK

Structure Number: 03635

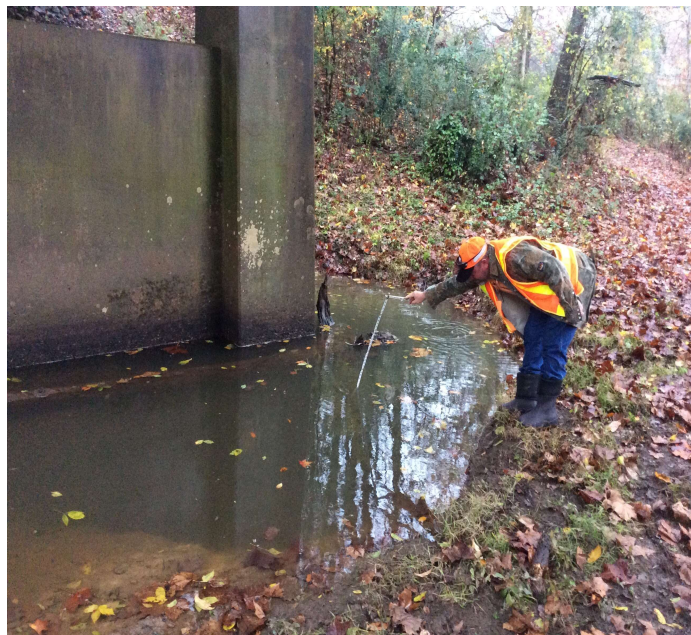
Bent 2 scour hole.

PHOTO 1 Description Looking back at Bent 2: a scour hole near column 2. (28" deep where measurement was taken)

Stage: Monitor

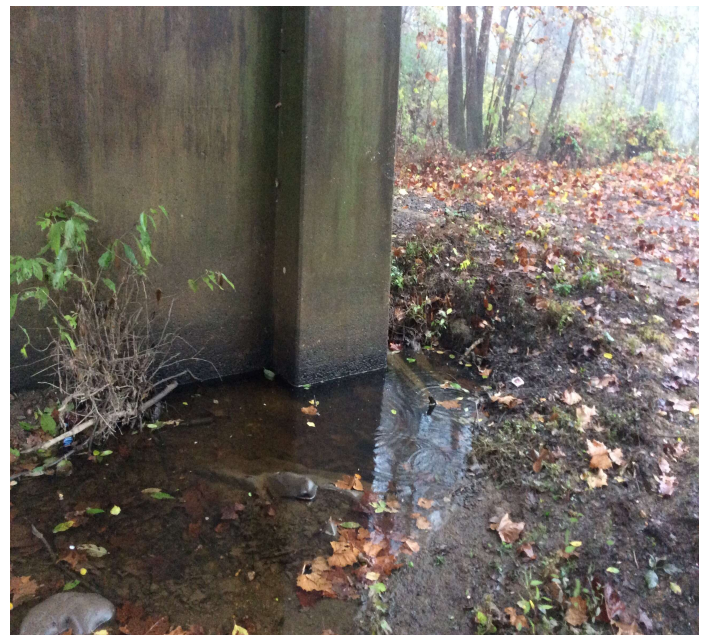
PHOTO 2 Description Looking back at bent 3: local scour at column 1.

Stage: Monitor
