# Bridge Inspection Report

**M0256**  
**SH 9 -5 Log 3.65**  
**over**  
**CREEK**

Structure Number: M0256

Facility Carried: SH 9 -5 Log 3.65

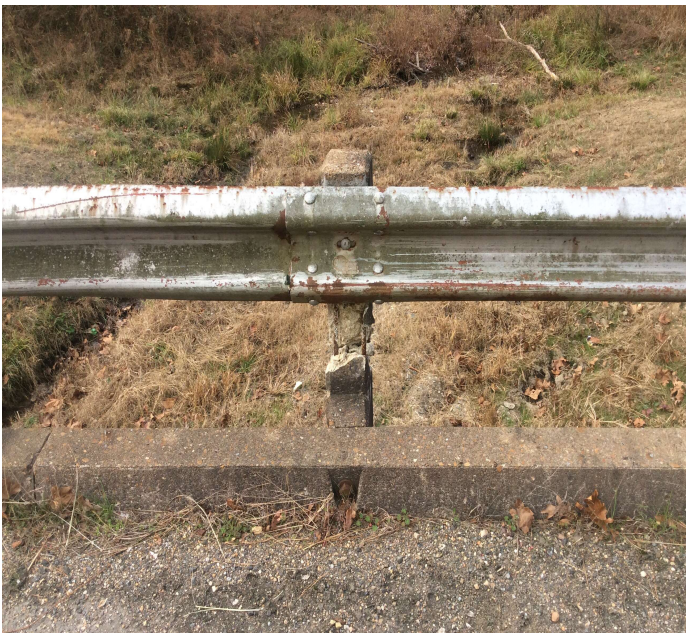
4th rail post on the left side is broken and railing is bent.

PHOTO 1      Description      4th rail post on the left side is broken and rail is bent.
