Bridge #06439(Routine)
SH 107 Log 4.95 over WOODRUFF CREEK

Location: .75 MI N OF KIEHL

Team Lead: Kevin Milligan Inspection Date: February 05, 2018

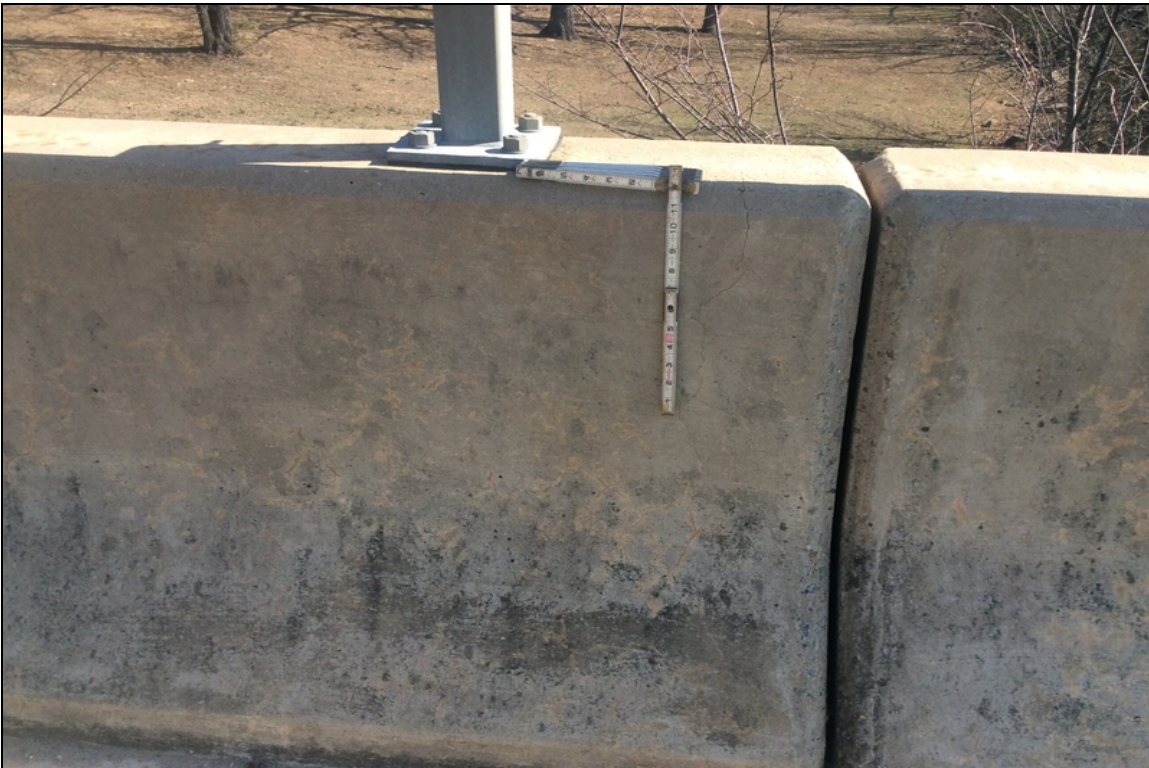
ELEM	DESCRIPTION	UNITS	TOTAL	CS1	CS2	CS3	CS4
(313)							
02/05/2018 - KRM & RLS - No noteworthy defects at this inspection.							
330	Metal Bridge Railing	LF	264	264	0	0	0
515	Steel Protective Coating	SF	264	264	0	0	0
(330)							
02/05/2018 - KRM & RLS - No noteworthy defects at this inspection.							
331	Reinforced Concrete Bridge Railing	LF	264	264	0	0	0
(331)							
02/05/2018 - KRM & RLS - Concrete bridge rail has vertical/diagonal cracking throughout structure.

Vertical and horizontal cracking in concrete bridge rail.

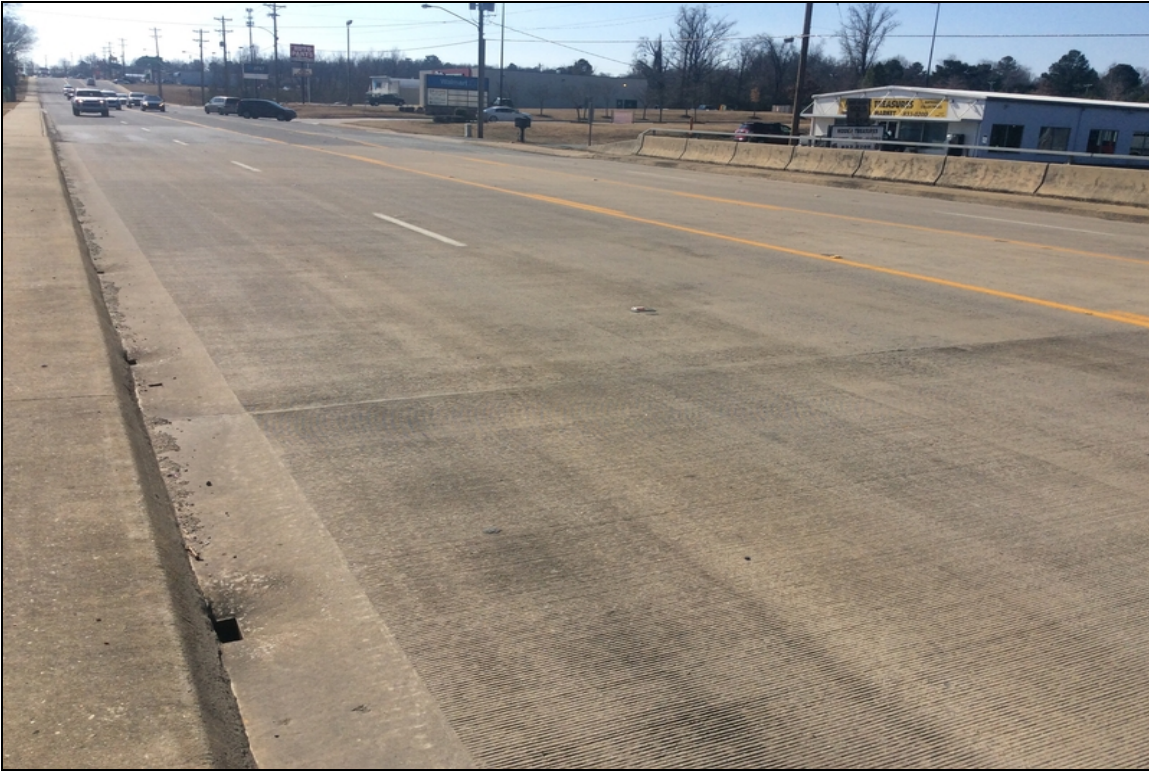
Typical deck.

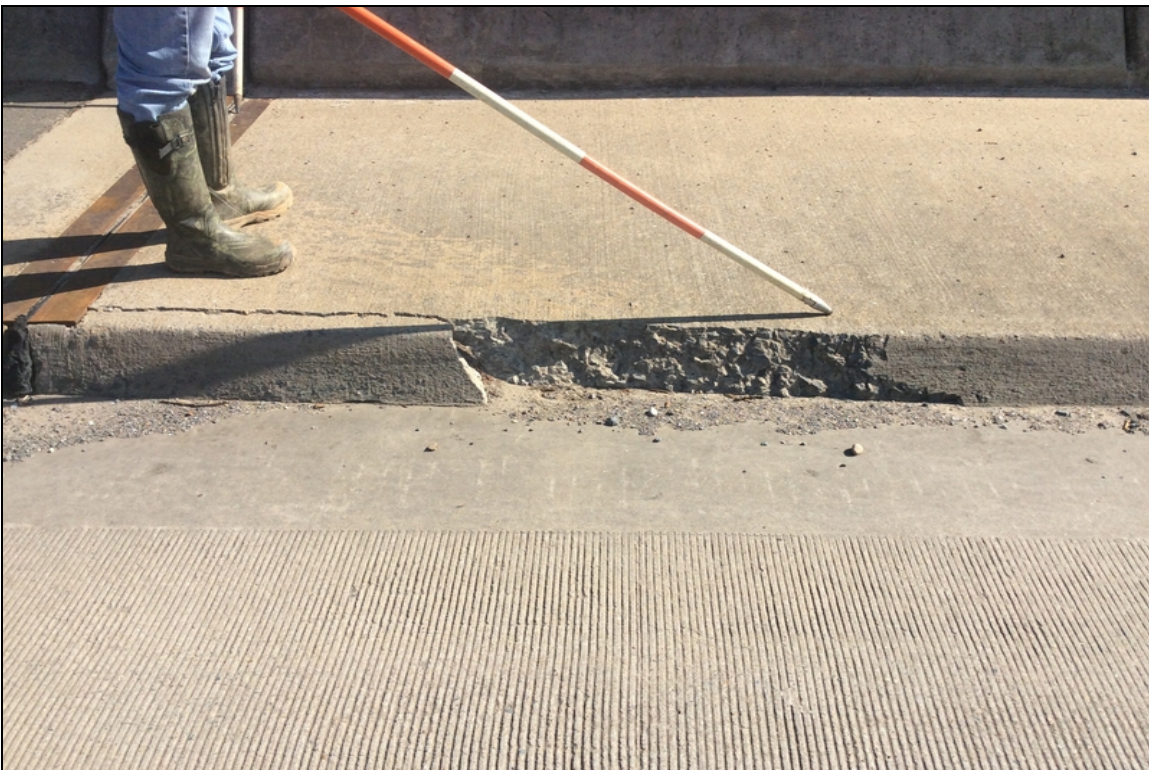
Spall in curb right side.

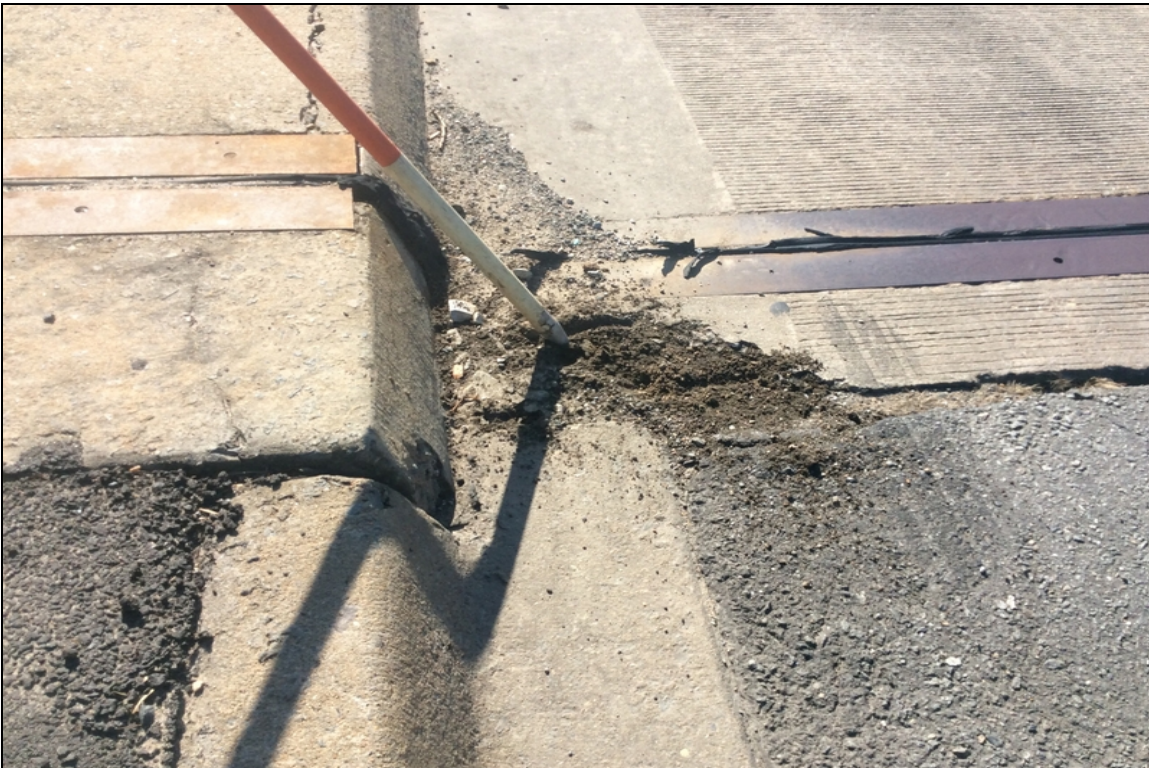
Spall in top of back wall right side north end.

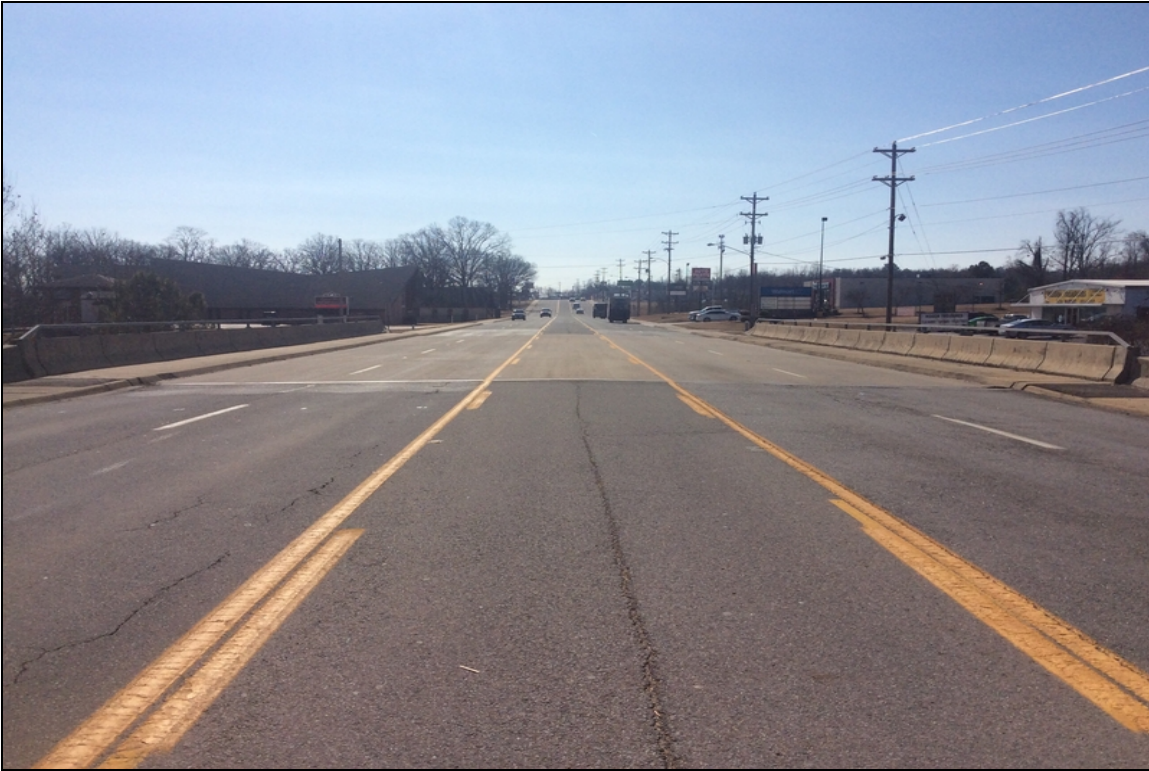
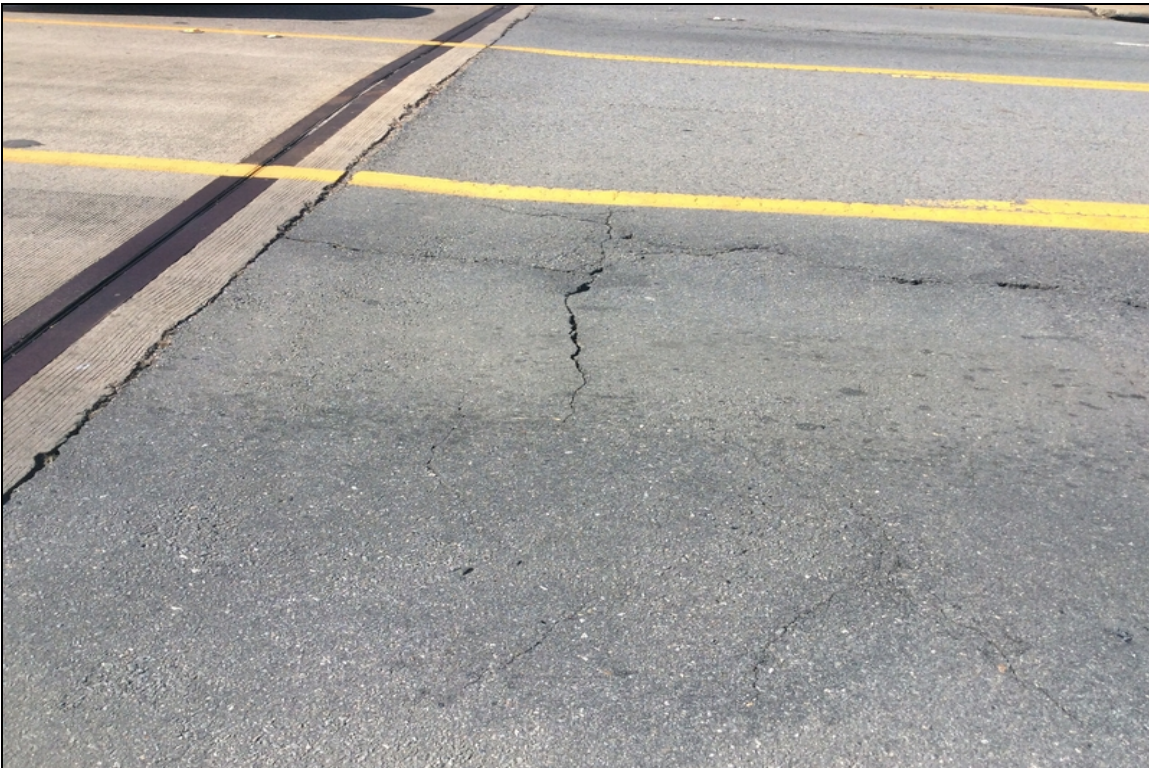
Settlement in asphalt approach north end.

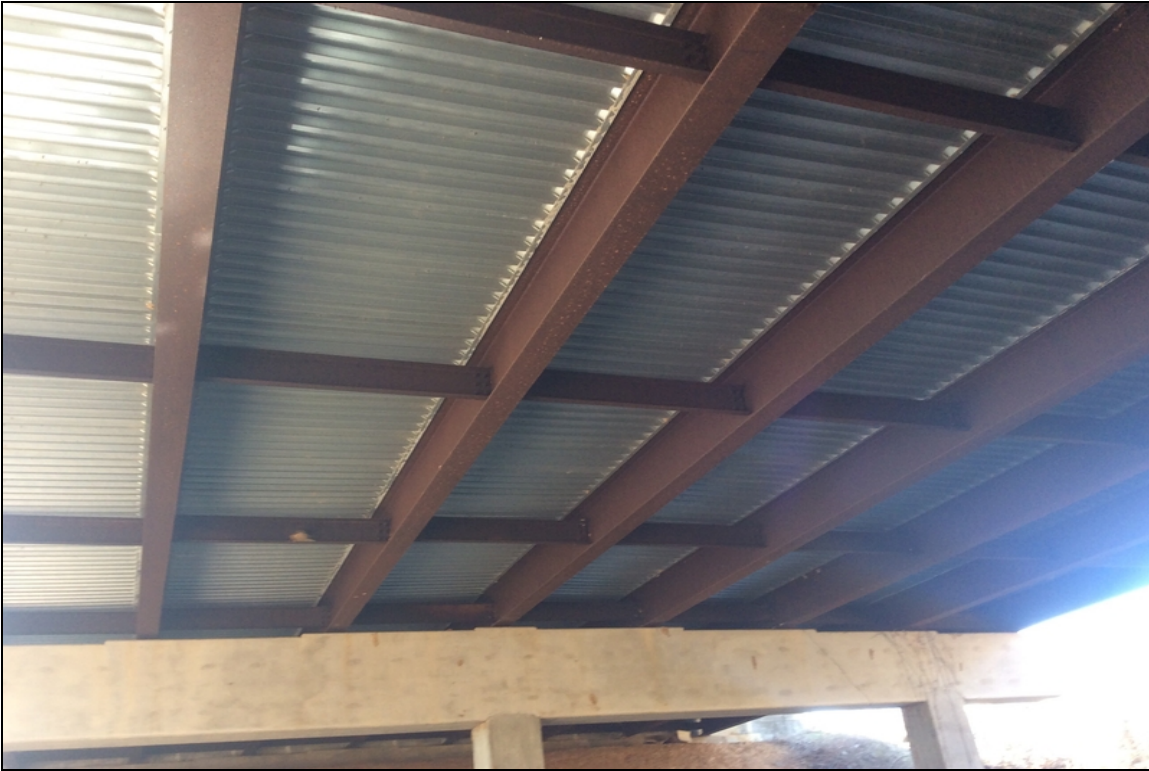
Typical condition of undersurface.

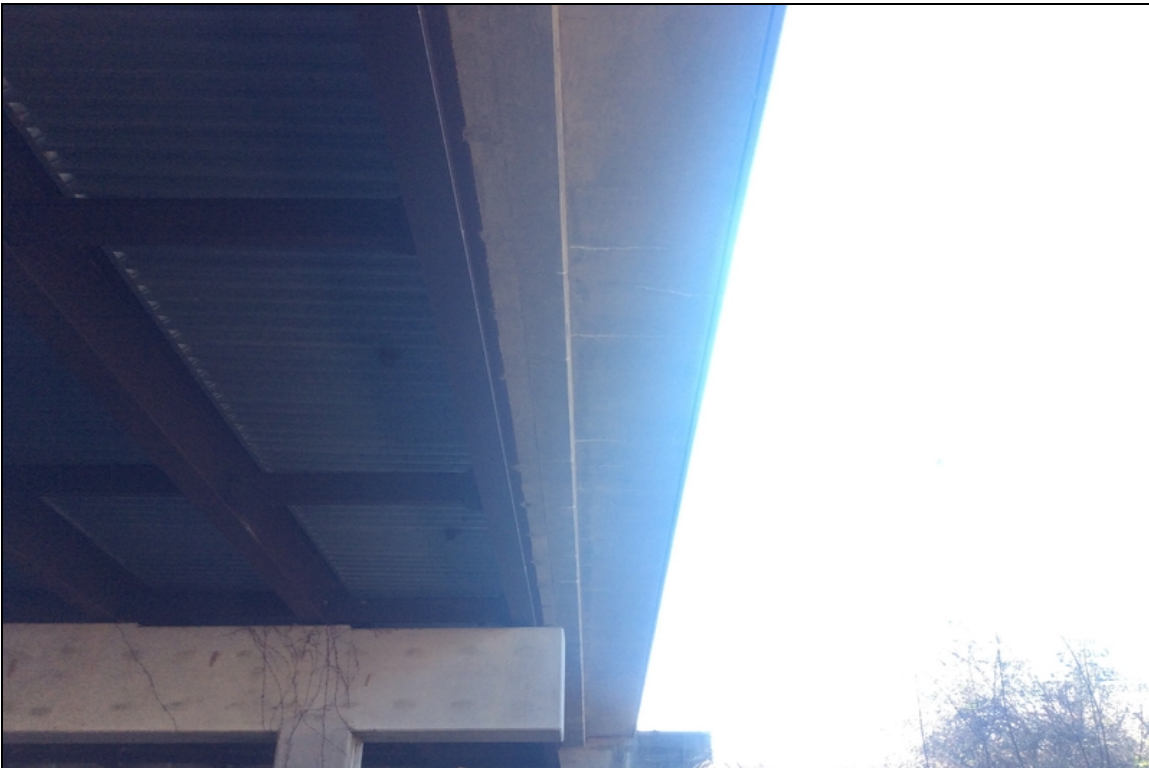
(12)							
02/05/2018 - KRM & RLS - Deck has sealable transverse/longitude cracks scattered throughout structure. Soffits have cracks with efflorescence staining.							
All spans have longitudinal and transverse cracks. 0.030 inch avg.							
107	Steel Open Girder/Beam	LF	1170	1170	0	0	0
515	Steel Protective Coating	SF	7933	7933	0	0	0

Efflorescence cracking on soffits.

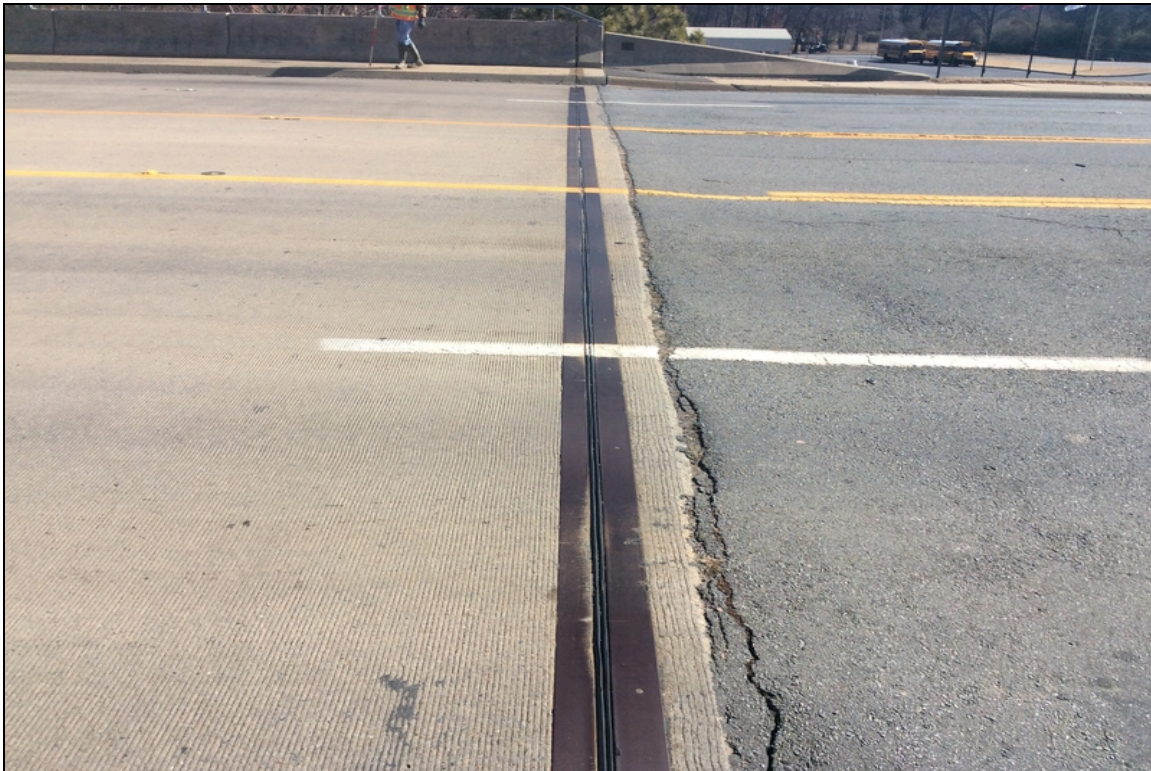
(302)							
02/05/2018 - KRM & RLS - Compression joints have cracks at bent 1 and 4.							
Both of the seals at the abutments are cracked.							
311	Movable Bearing	EA	18	18	0	0	0

Compression seal joints at bent 1.

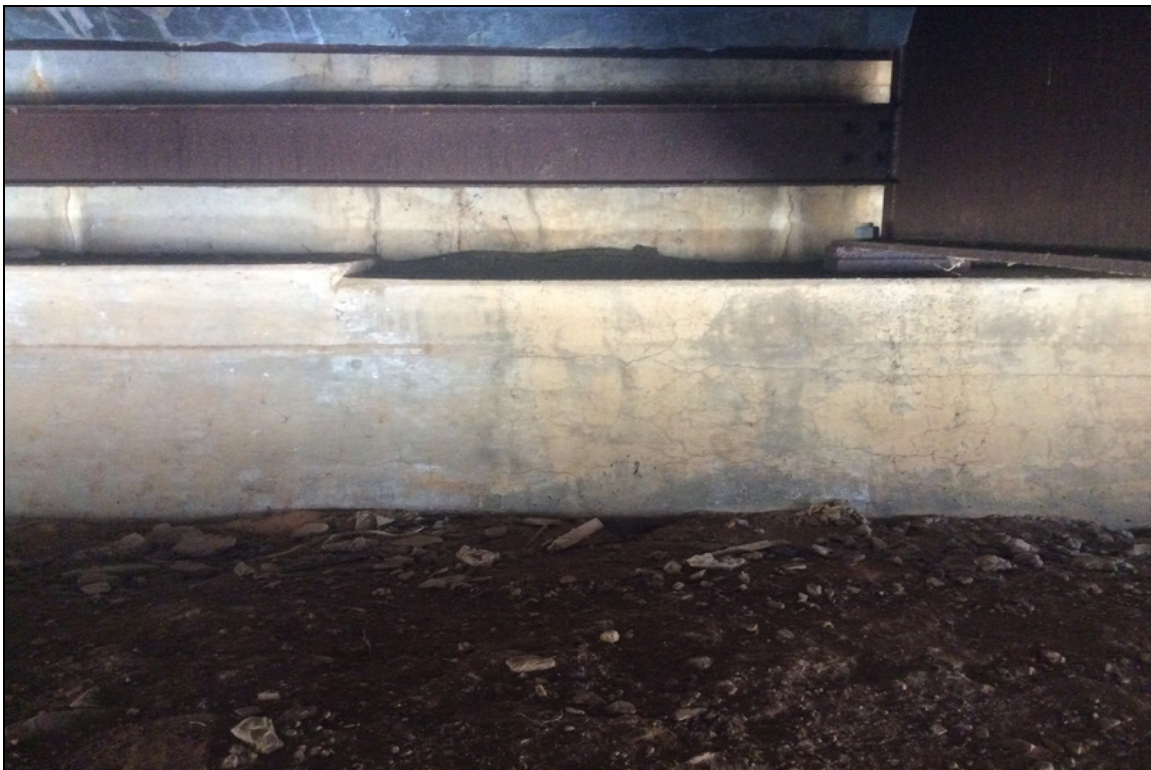
(215)							
02/05/2018 - KRM & RLS - Both abutments have moderate horizontal cracks along entire length. Bent 1 is the worst with cracks measuring up to .05".							
Both abutments have moderate horizontal cracks along their entire length. 0.30 avg. Kevin bent 1 the worst.							
234	Reinforced Concrete Pier Cap	LF	130	130	0	0	0

Bent 4 horizontal cracks full length of abutment.

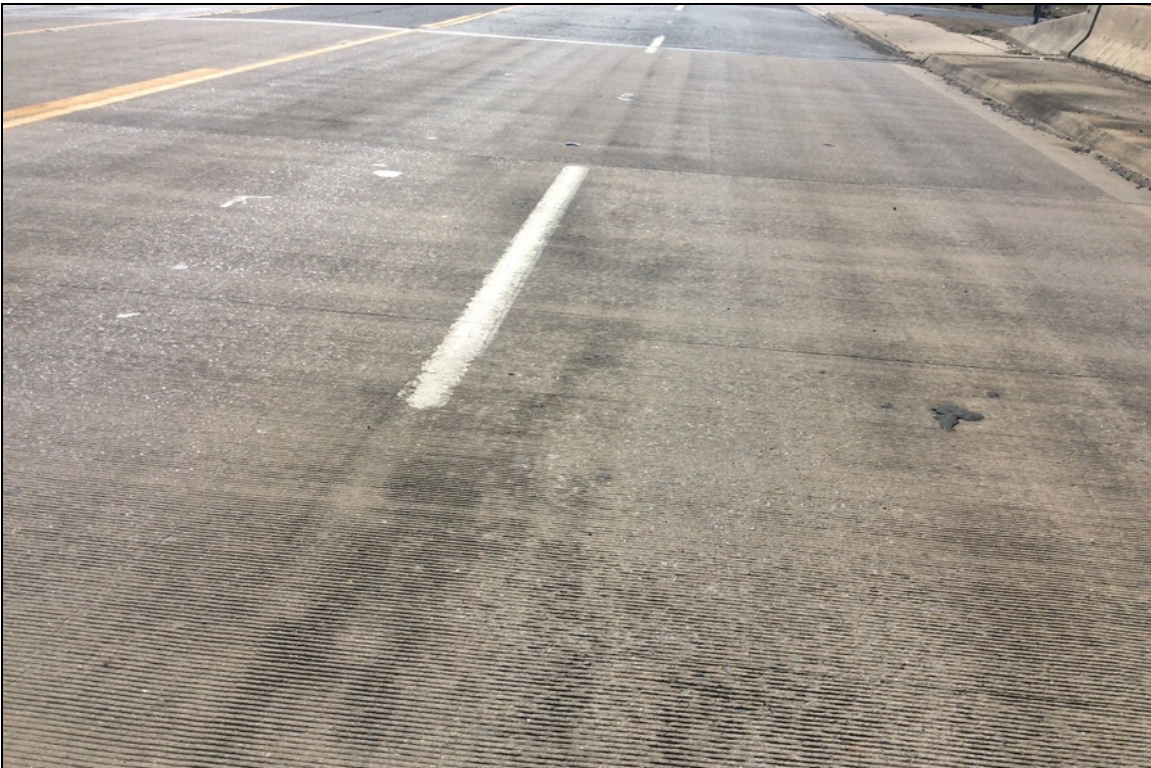
Span 1 longitudinal cracking.

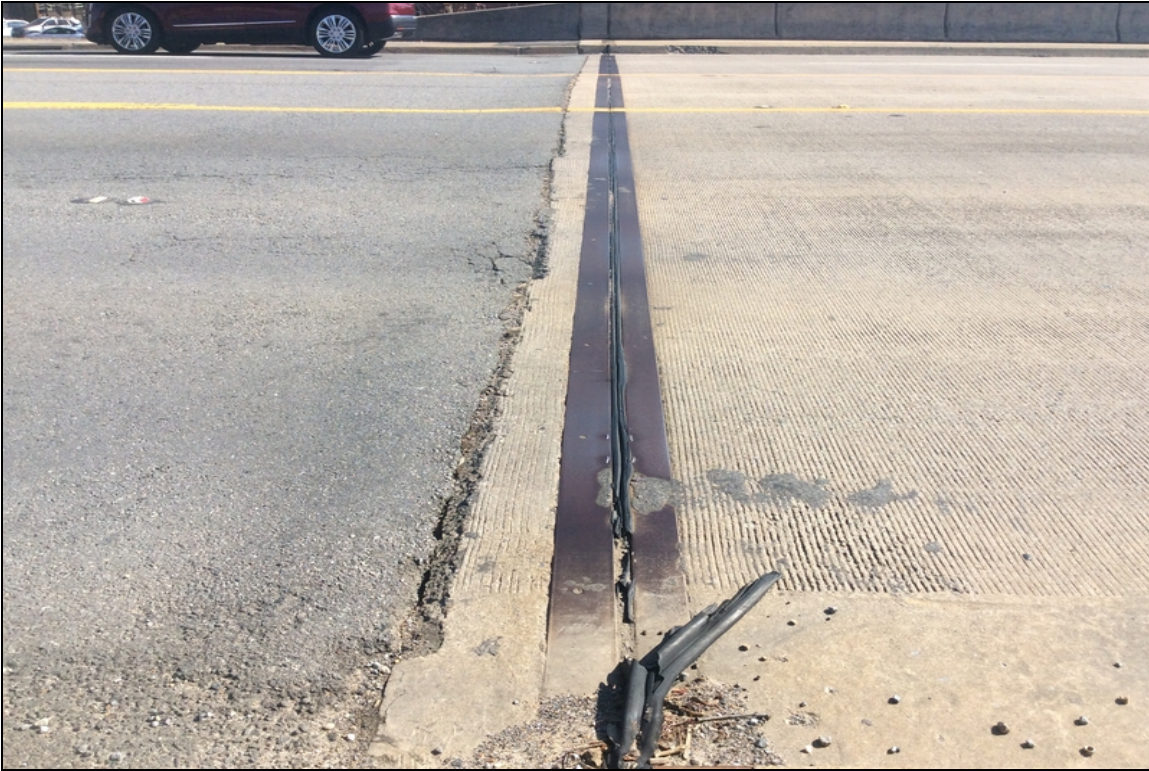
Bent 4 compression joint seal damaged.
