# Bridge Inspection Report

**A5706**  
**I 440 WB Log 7.11**  
**over**  
**US 165-SEC 9, RR**

Structure Number: A5706

Facility Carried: I 440 WB Log 7.11

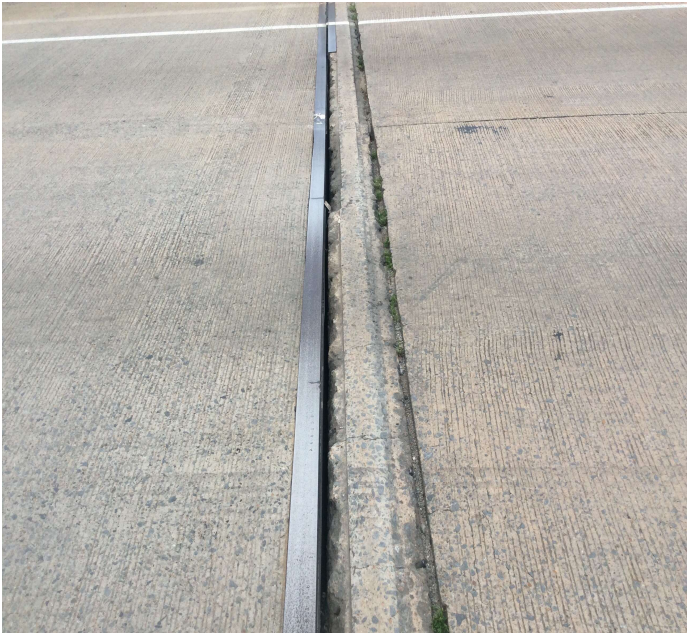
Bent # 3 & 5

Joint armor missing.

PHOTO 1      Description      Joint armor missing at bent 5

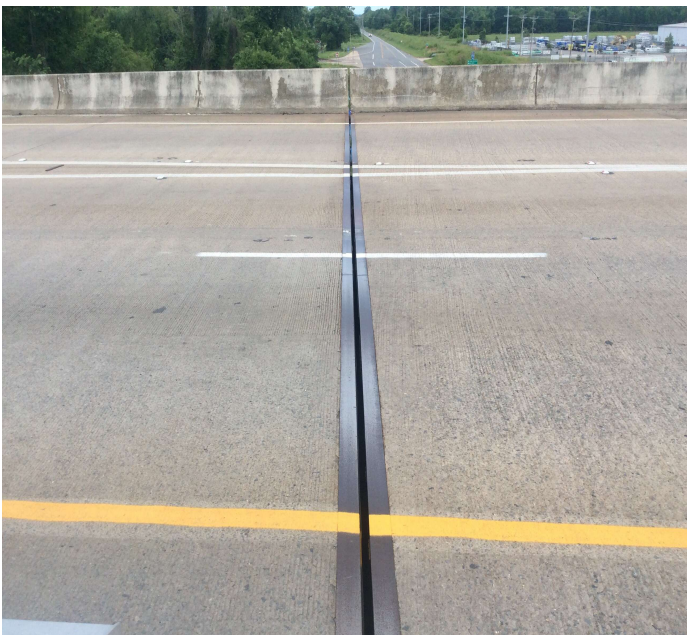
All bents.

Joint seal torn & some have partially fallen out.

PHOTO 1      Description      Bent 2 joint seal has fallen out.
