# Bridge Inspection Report

**B5706**  
**I 440 EB log 7.11**  
**over**  
**US 165-SEC 9,RR**

Structure Number: B5706

Facility Carried: I 440 EB log 7.11

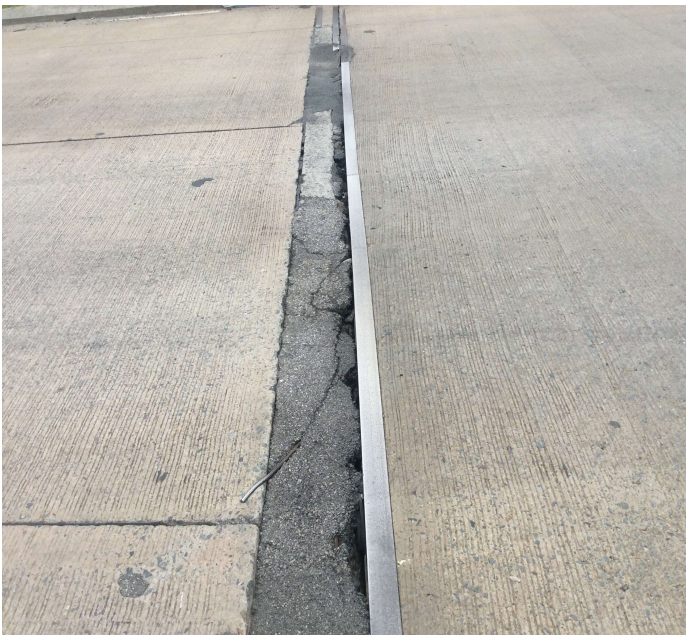
Bent 5 spalls filled with asphalt in the top of backwall. See photo

PHOTO 1      Description      Bent 5 spalls filled with asphalt in the top of backwall
