# Bridge Inspection Report

**A2768**  
**I-30 Log 141.17**  
**over**  
**US 70 Broadway**

Structure Number: A2768

Facility Carried: I-30 Log 141.17

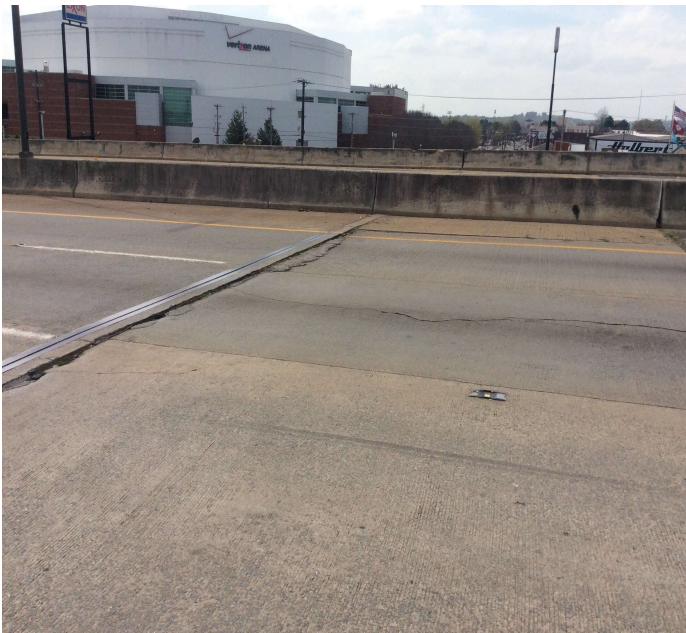
Approach slabs have large unsealed cracks. Eastbound north end of bridge inside lane has up to 2" settlement.

PHOTO 1      Description      Eastbound north approach slab, large unsealed cracks and settlement on the outside lane.

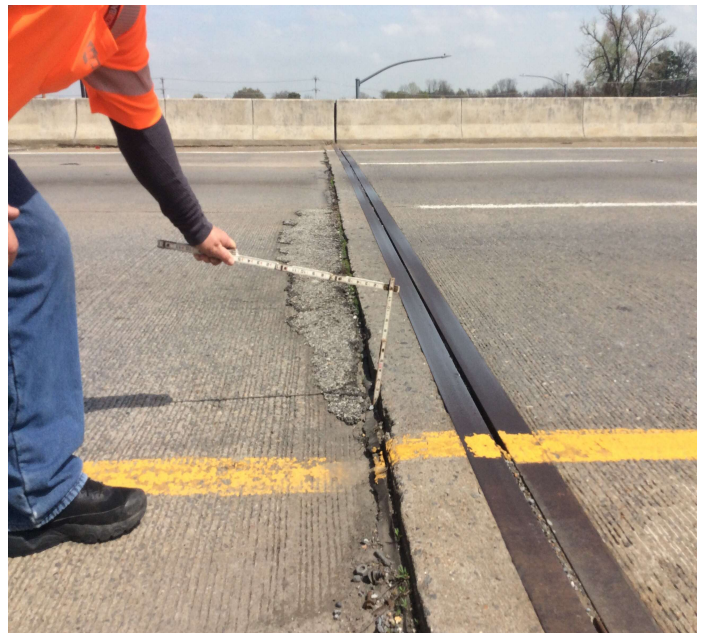
PHOTO 2      Description      Eastbound north end of bridge inside lane has up to 2" settlement.

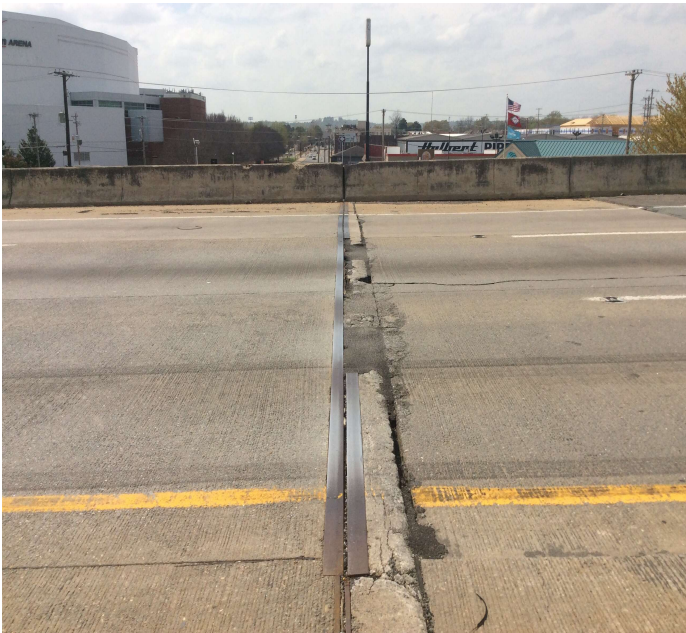
Top of abutment 2 has a large deep spall between joint and approach slab. Photo

PHOTO 1      Description      Bent 2 westbound large spalls filled with asphalt on top of back wall.

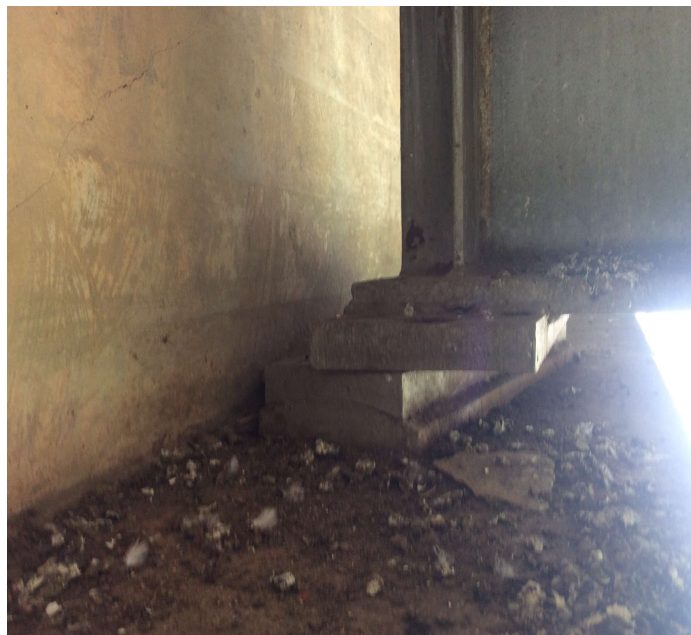
Bearing at bent 2 abutment under girder 14 is working out due to missing anchor bolt. Photo Added on 3/26/2018 KRM & RLS Bent 2 girders 2 and 10 have missing anchorage bolts and bearing are working out.

PHOTO 1      Description      Bent 2 girder 14 bearing has slide half out.

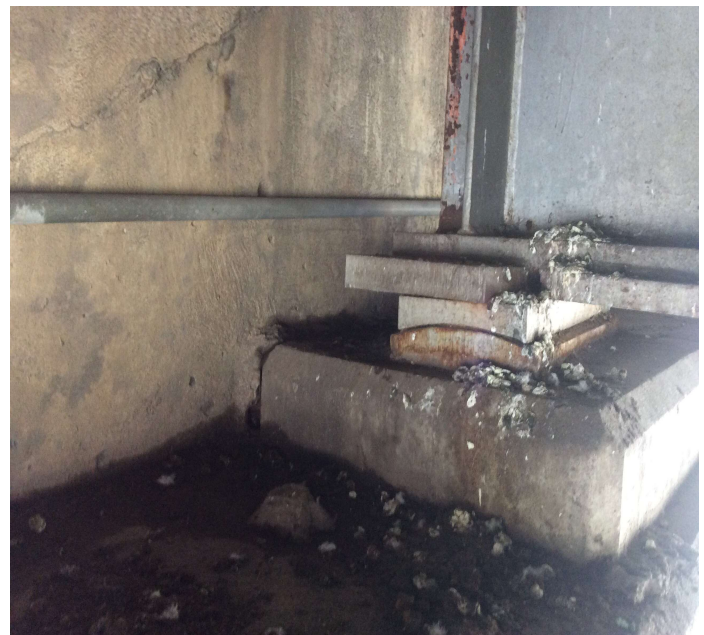
PHOTO 2      Description      Bent 2 girder 10 is sliding out due to broken anchorage bolt.

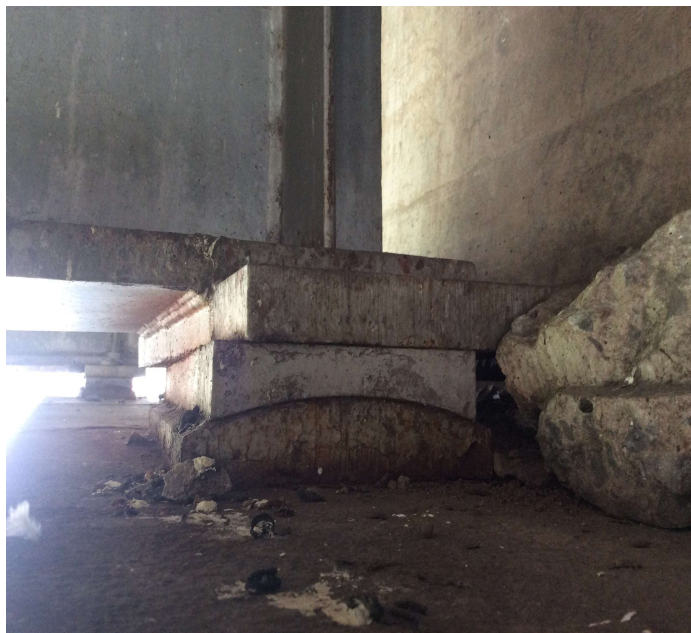
<b>311 - Movable Bearing</b>	1- Ben.	16	each	0	13	3	0
3/26/2018 - KRM & RLS - All bearings have active corrosion, Bent 2 bearings 2 ,10 and 14 have broke anchorage bolts letting bearing rotate.  All bearings have active surface rust.							
1000 - Corrosion		13			13		
1020 - Connection		3				3	
<b>313 - Fixed Bearing</b>	1- Ben.	16	each	0	16	0	0
3/26/2018 - KRM & RLS - All bearings have active corrosion.							
1000 - Corrosion		16			16		
<b>321 - Reinforced Concrete Approach Slab</b>	1- Ben.	2880	sq. ft.	1828	10	1042	0
3/26/2018 - KRM & RLS - All approaches have large longitude cracks. Bent 2 east bound inside lane has settled up to 2".  Bent 1, westbound side, the approach slab has been patched. Bent 2, westbound, the approach slabs have settled and broken.							
1080 - Delamination/Spall/Patched Area		4			4		
1130 - Cracking (RC and Other)		48			6	42	
4000 - Settlement		1000				1000	
<b>331 - Reinforced Concrete Bridge Railing</b>	1- Ben.	356	ft.	321	35	0	0

PHOTO 2      Description      Bent 2 girder 2 bearing sliding out due to broken anchorage bolt.

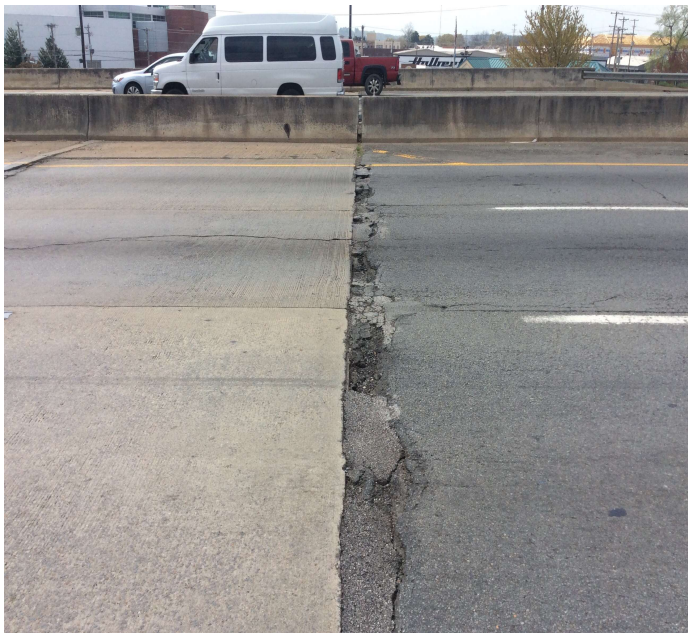
Potholes in roadway at all approach slabs on East and Westbound Lanes. Photo

PHOTO 1      Description      Eastbound north approach, large potholes.

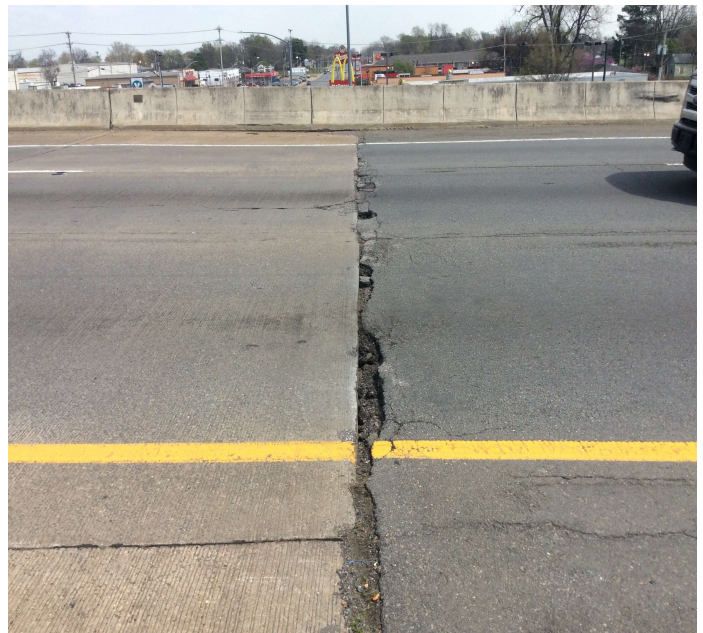
PHOTO 2      Description      Eastbound south approach, potholes in roadway at the approach slab.

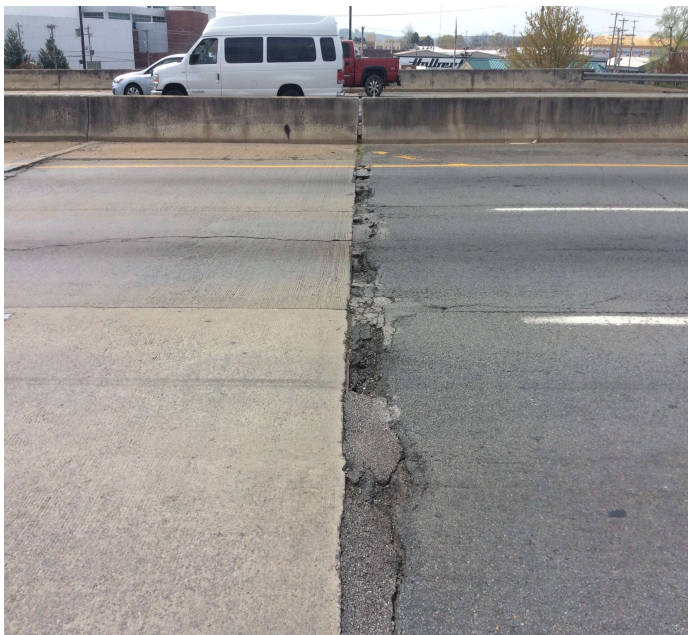
There are potholes on the eastbound and westbound side at the ends of the approach slabs.  
Photos attached.

PHOTO 1 Description Eastbound north approach, large potholes.

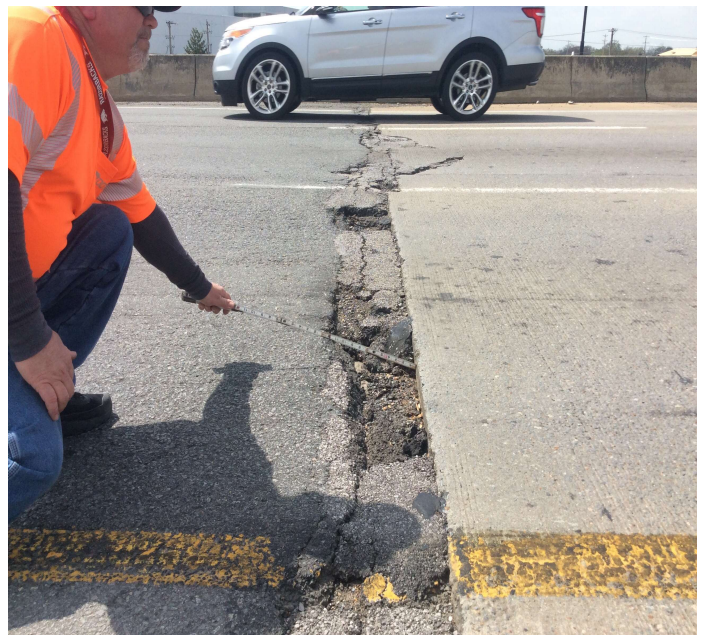
PHOTO 2 Description Bent 1 westbound, potholes in roadway at approach.
