Bridge #A3224(Routine)

SH 15 over I-40 LOG 168.58

Location: 4.5 MI E PULASKI CO LN

Team Lead: Chris Doggett Inspection Date: May 06, 2019

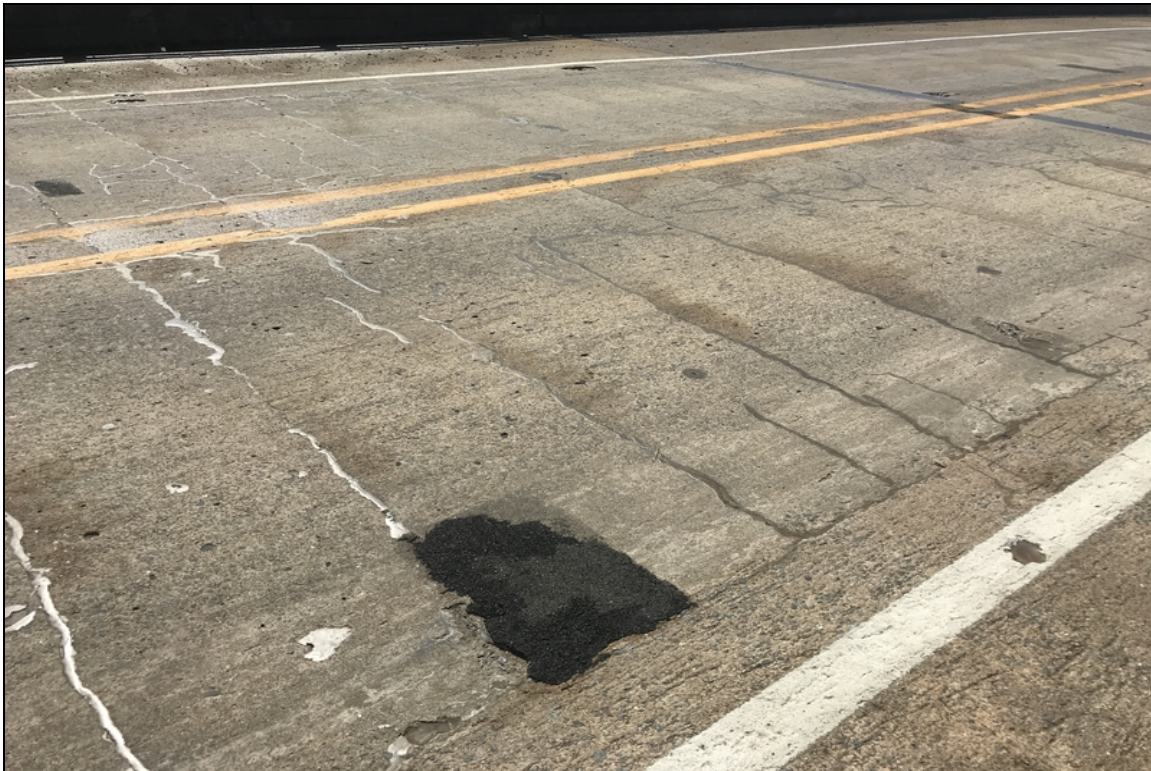
(12)	The deck has approx. 328 sf of concrete patching, 254 foot of spalls, 63 foot of spalls with exposed rebar. See photos. The surface of the deck has unsealed transverse cracks on three foot centers and are up to 1/8 inch wide. See photo Some cracks reflect thru to the soffit with effloresces						
107	Steel Open Girder/Beam	LF	2448	2168	200	80	0
1000	Corrosion	LF	280	0	200	80	0
515	Steel Protective Coating	SF	16694	0	12519	3275	900
3420	Peeling/Bubbling/Cracking	SF	400	0	400	0	0
3440	Effectiveness (Steel Protective Coatings)	SF	16294	0	12119	3275	900

Numerous transverse cracks are sealed

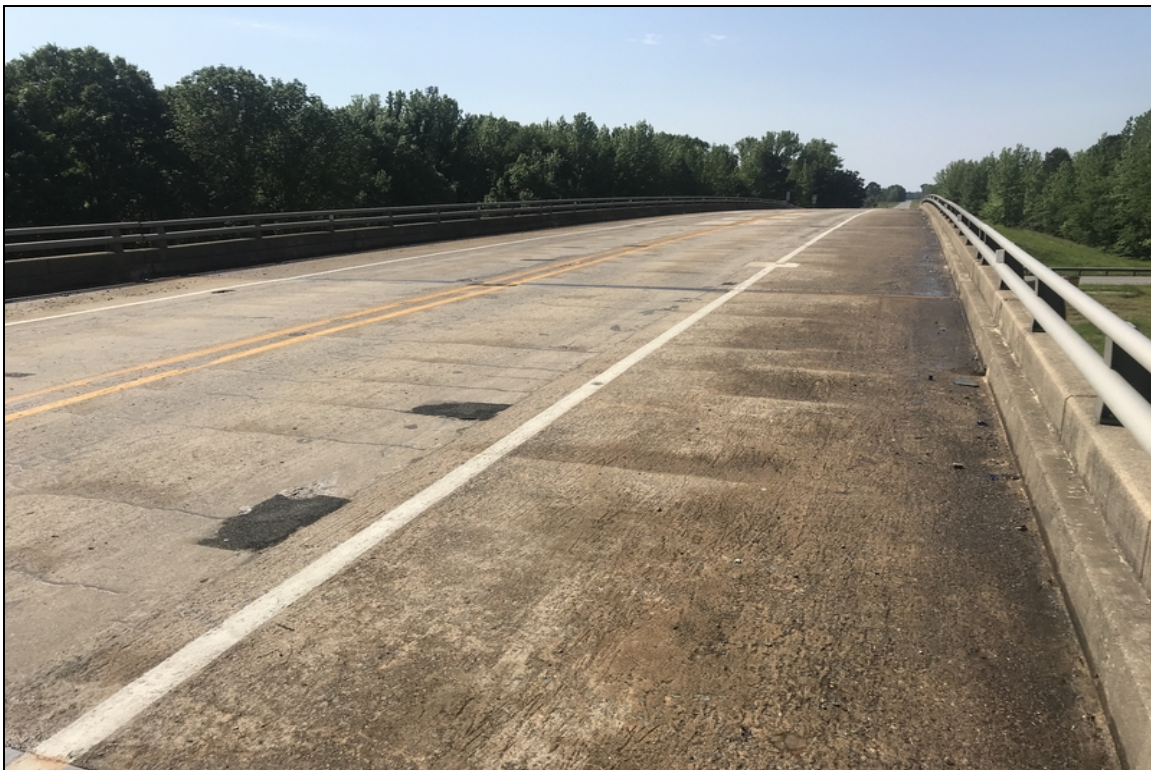
Deck view

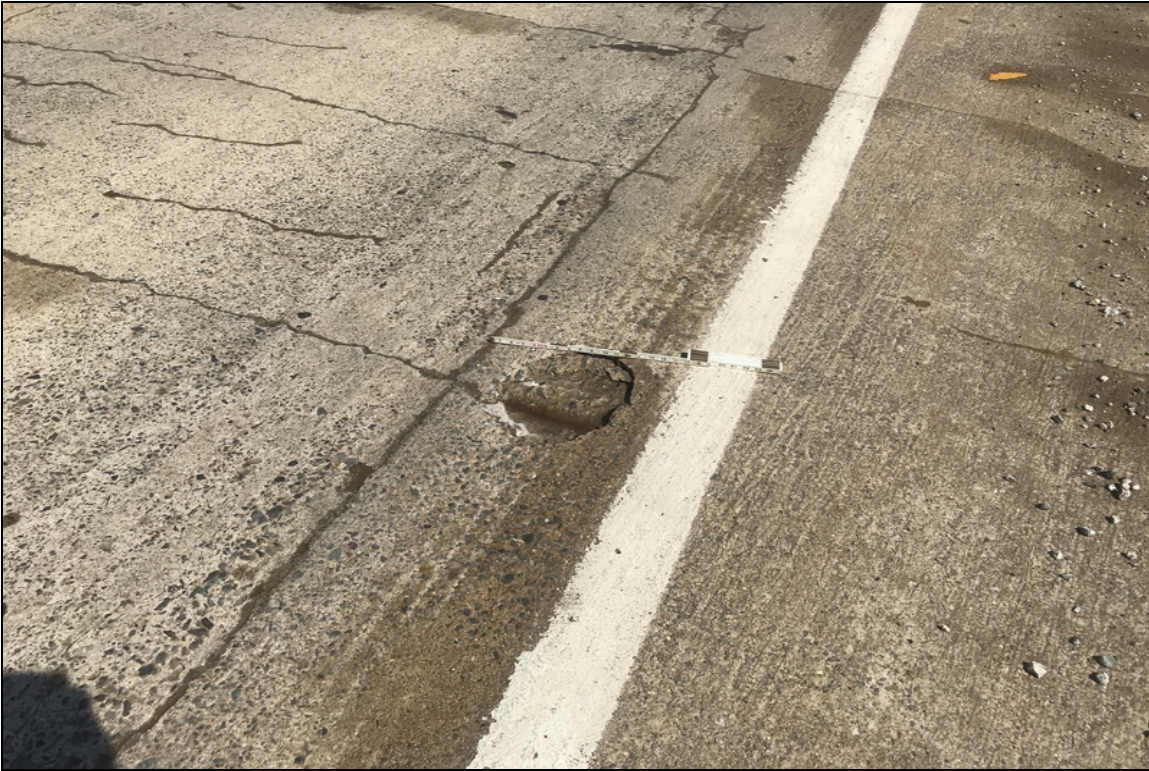
Span 6 with an open spall in northbound lane

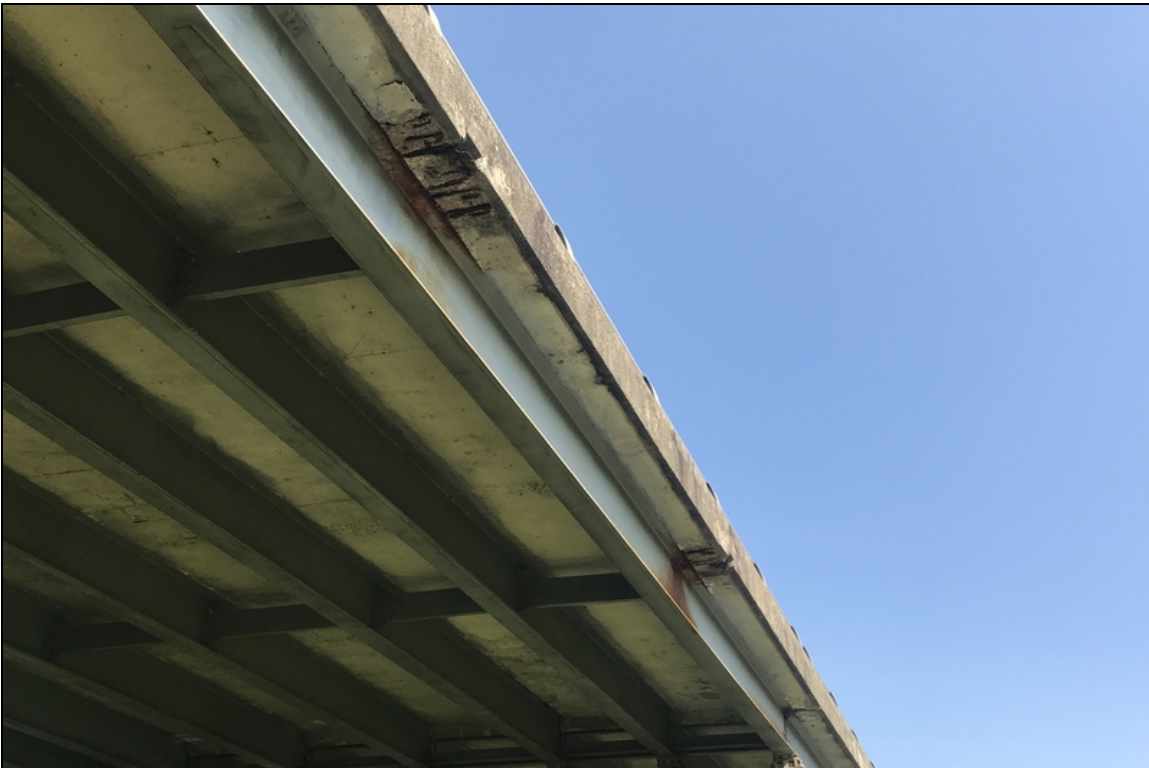
Span 3: right side the soffit has a few spalls with exposed rebar

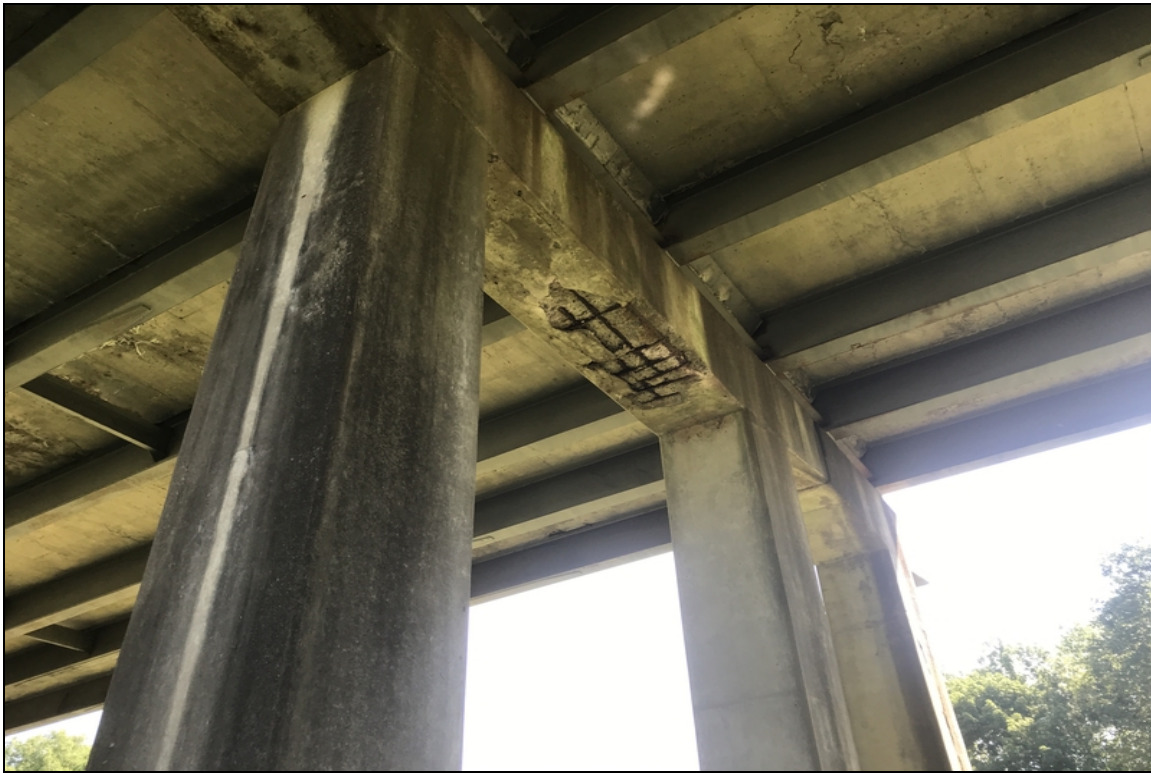
ELEM	DESCRIPTION	UNITS	TOTAL	CS1	CS2	CS3	CS4
1090	Exposed Rebar	LF	20	0	10	10	0
(234)	Small delaminations are present on the faces of all the caps. The caps of bents 2,3,4 & 5 have Spalls with exposed rebar on the sides and bottom. See photo						
305	Assembly Joint without Seal	LF	280	130	150	0	0
2360	Adjacent Deck or Header	LF	150	0	150	0	0
(305)	Several areas of the deck at the joints are cracked, spalled and patched.						
311	Movable Bearing	EA	48	28	20	0	0
1000	Corrosion	EA	20	0	20	0	0
313	Fixed Bearing	EA	48	28	20	0	0
1000	Corrosion	EA	20	0	20	0	0
330	Metal Bridge Railing	LF	612	612	0	0	0
331	Reinforced Concrete Bridge Railing	LF	612	612	0	0	0

Bent 3, between columns 2 & 3: large spall with exposed rebar

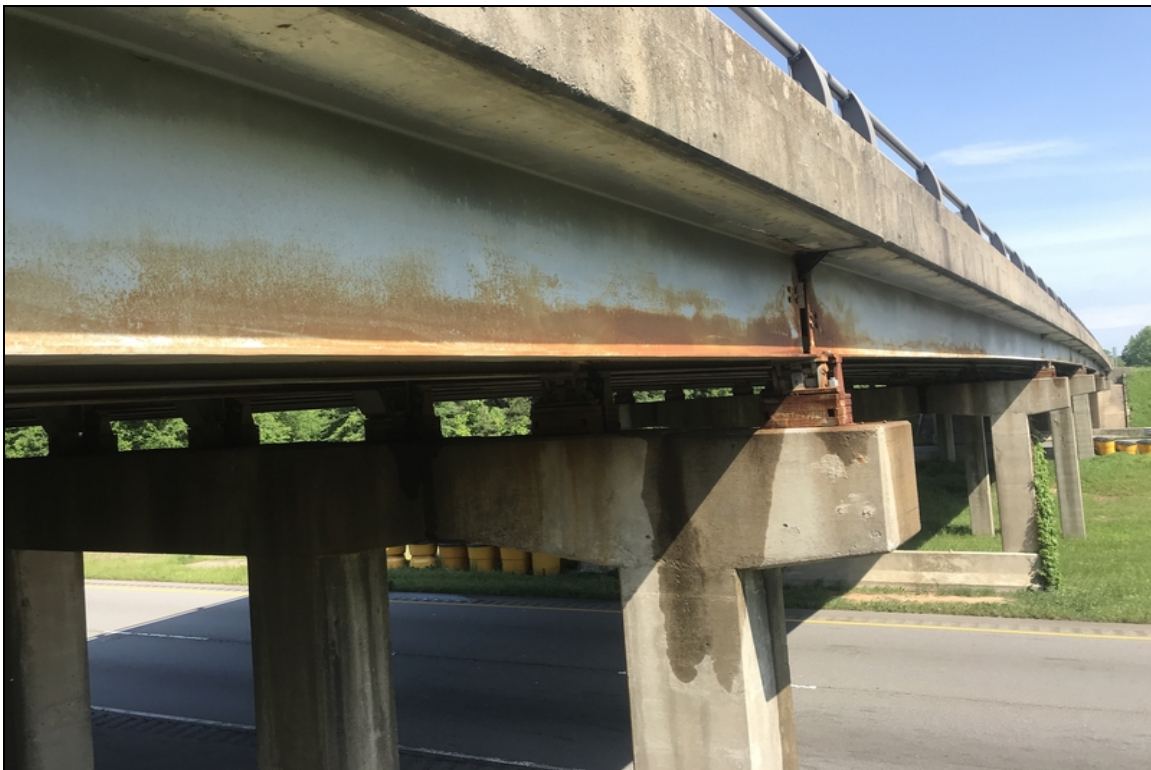
(107)	The beam ends and scattered areas along the top and bottom flanges have active rust with moderate pitting. This is most common on the original beams before the bridge was widened.						
205	Reinforced Concrete Column	EA	20	15	5	0	0
1080	Delamination/Spall/Patched Area	EA	0	0	0	0	0
1130	Cracking (RC and Other)	EA	5	0	5	0	0

Span 1, girder 8: the lower web and bottom flange with active corrosion mean the beam end

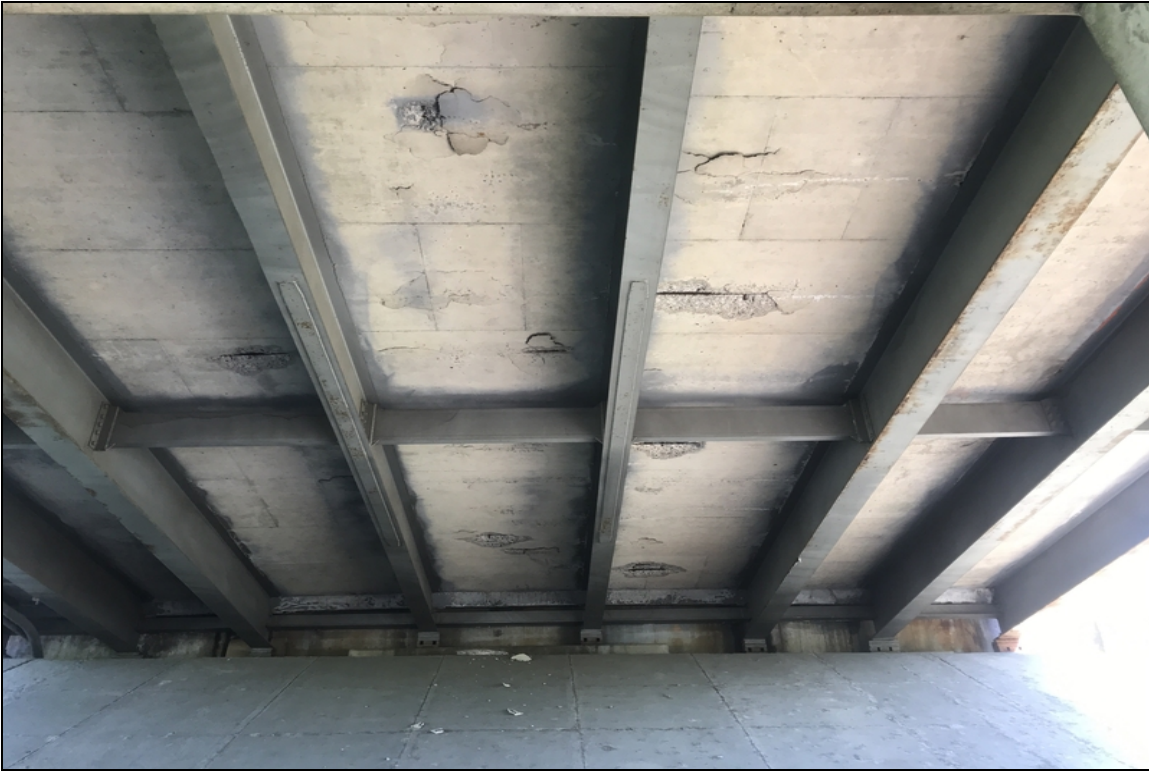
Soffit view of span 6: (worst case)
