Asset #03228(Routine)

SH 31 Overpass over I-40 LOG 174.58

Location: 1.64 MI N US 70

Team Lead: Bryan Saunders, Inspection Date: 03/23/2023

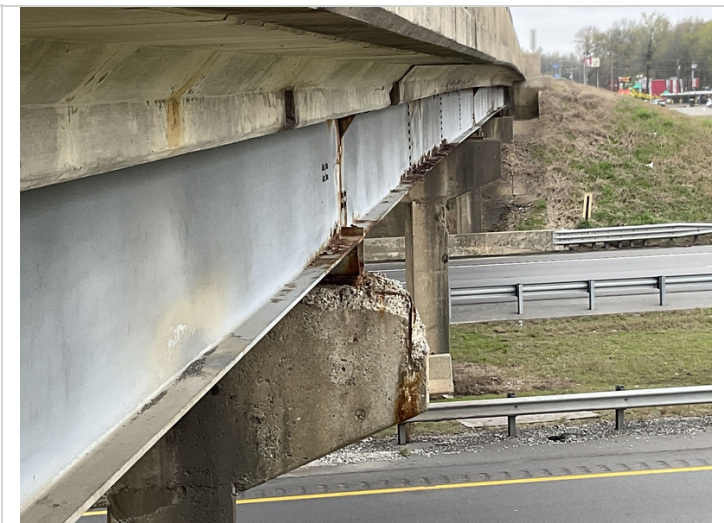
(107) Scattered areas of freckled rust on beams 1 and 5. All of the beam ends have some active rust with pitting up to 1/8 inch deep. Span 3 beam 1 thru 5 have active rust with moderate pitting. (515-107) Span 3 coating has failed allowing corrosion Other spans have scattered areas of peeling and bubbling							
205	Reinforced Concrete Column	EA	6	0	4	2	0
1080	Delamination/Spall/Patched Area	EA	4	0	4	0	0
1090	Exposed Rebar	EA	2	0	0	2	0

Span 3 beam 1 corrosion

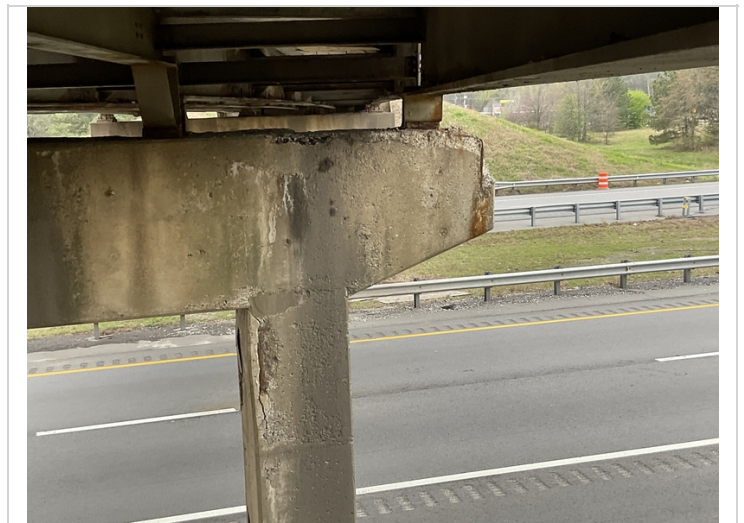
Bent 4 backside spall exposing hoop bars

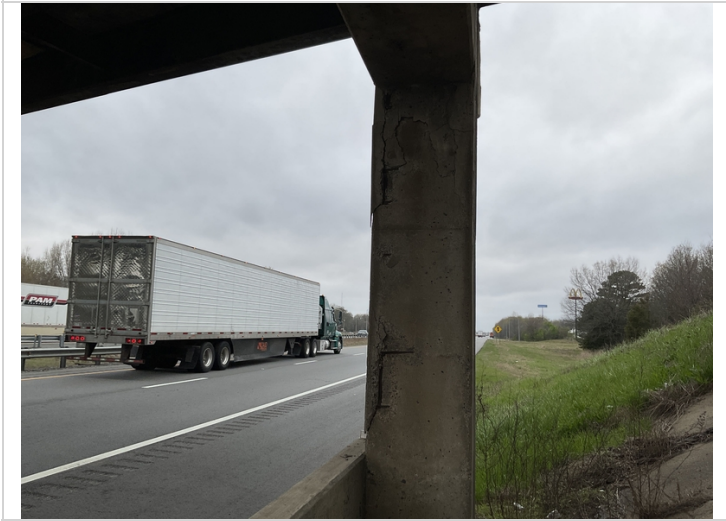
(205) Bent 2 column 1 and 2 large crack and delams at tops Bent 3 column 1 large vertical crack and spall with rebar Bent 3 column 2 large vertical cracks rebar exposed bottom right delam top left Bent 4 column 1 large delam at the top and exposed rebar Bent 4 column 2 vertical cracks							
215	Reinforced Concrete Abutment	LF	58	50	8	0	0
1080	Delamination/Spall/Patched Area	LF	2	0	2	0	0
1130	Cracking (RC and Other)	LF	6	0	6	0	0

Column 1 at bent 4 has large spall delams and exposed rebar

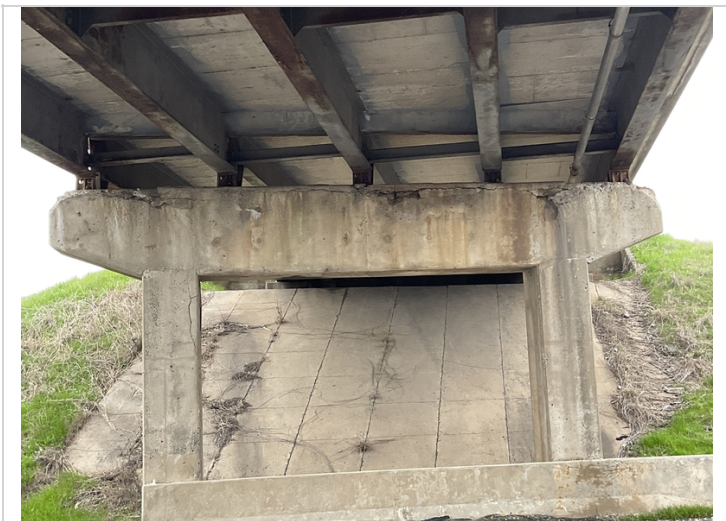
ELEMENTS	DESCRIPTION	UNITS	TOTAL	CS1	CS2	CS3	CS4
1120	Efflorescence/Rust Staining	LF	27	0	27	0	0
1130	Cracking (RC and Other)	LF	18	0	18	0	0
(234) All of the caps have Spalls with exposed rebar, cracking and efflorescence. Bent 4: top of cap is spalled and delaminated at the top. Approximately 15'. Across the length							
303	Assembly Joint with Seal	LF	146	0	0	146	0
2310	Leakage	LF	146	0	0	146	0

Bent 4 cap has large horizontal cracks spalls and rebar exposed

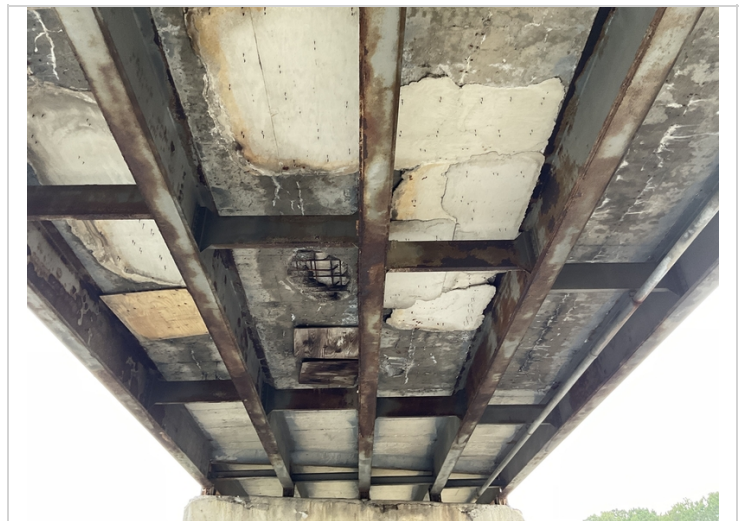
Span 3 paint has failed and corrosion has begun

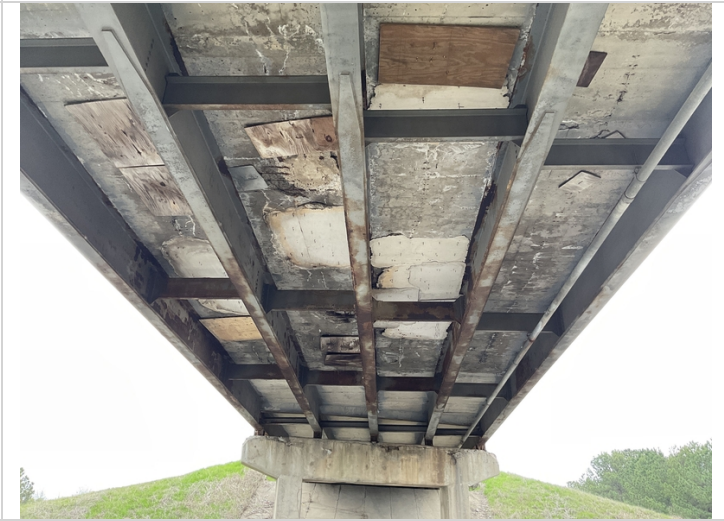
Span 3 soffit has large patches spalls and spalls with rebar

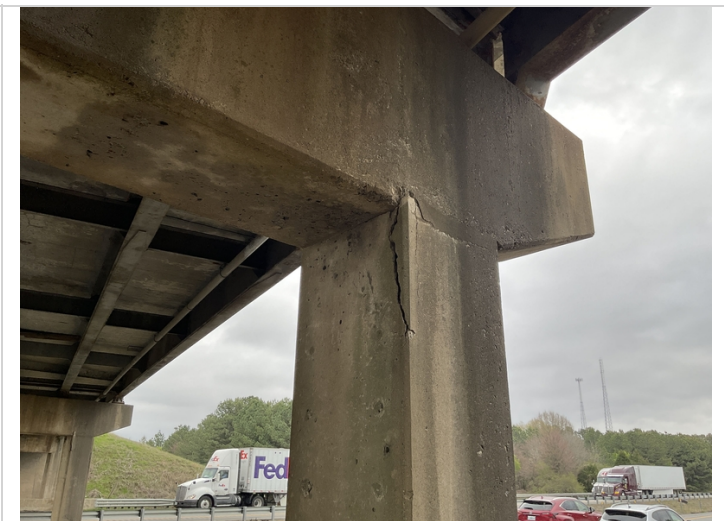
Delam bent 2 column 2

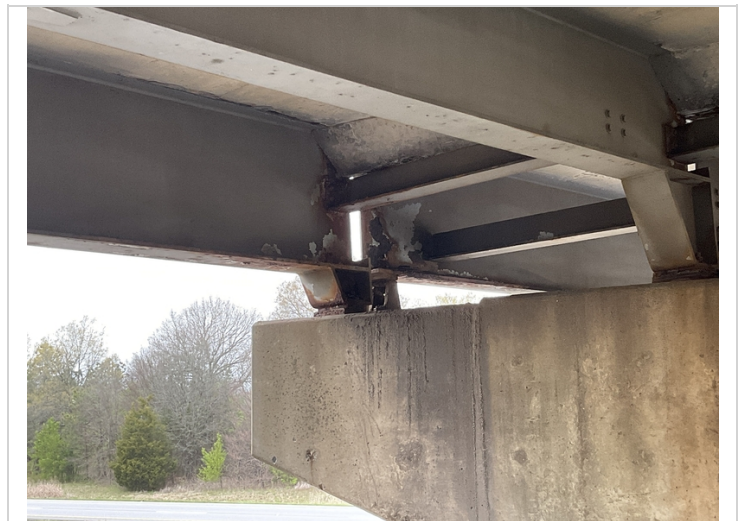
Bent 2 beam 1 corrosion with deep pitting up to 1/8"

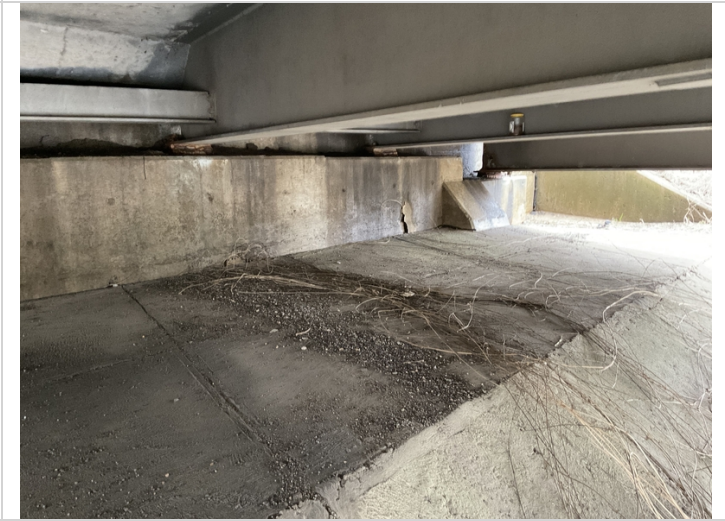
(215) Two small delaminations on the face of bent 1 left side small cracks in bent 5							
234	Reinforced Concrete Pier Cap	LF	87	25	45	17	0
1080	Delamination/Spall/Patched Area	LF	10	0	0	10	0
1090	Exposed Rebar	LF	7	0	0	7	0

Delamination bent 1

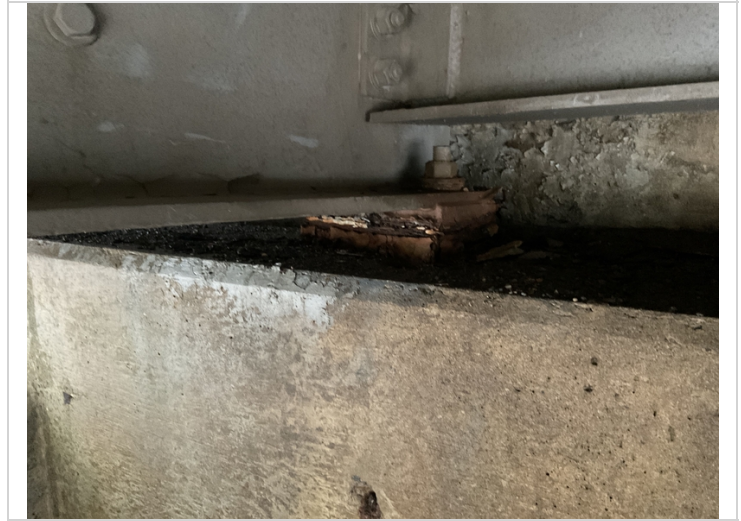
(303) All joints are leaking causing corrosion to beam ends and bearings							
311	Movable Bearing	EA	20	0	0	20	0
1000	Corrosion	EA	20	0	0	20	0
(311) All of the bearings have laminated rust.							
313	Fixed Bearing	EA	20	0	14	6	0
1000	Corrosion	EA	20	0	14	6	0

Beam 4 bent 1 bearings typical all bearings

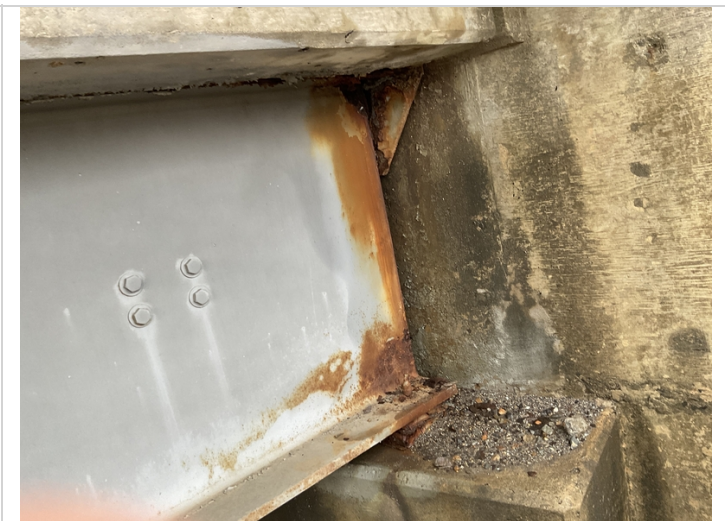
Beam 1 bent 1 corrosion at the bearing and haunches

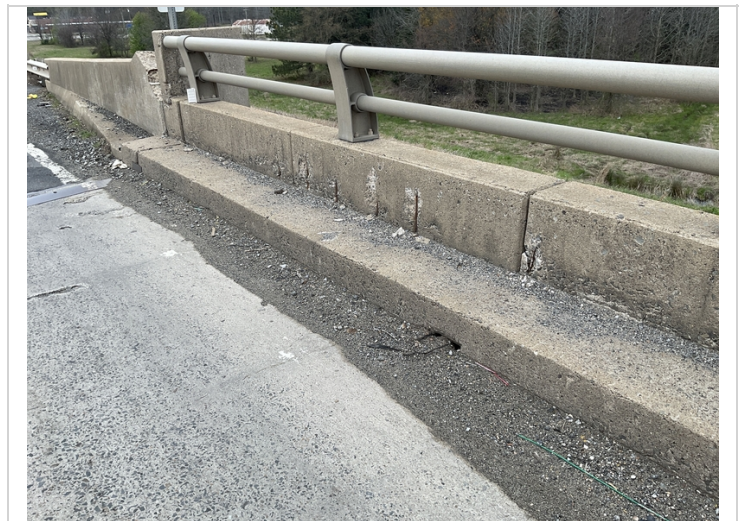
(331) Scattered Spalls with exposed rebar along both rails.

Exposed rebar in the concrete bridge rail left side span 1

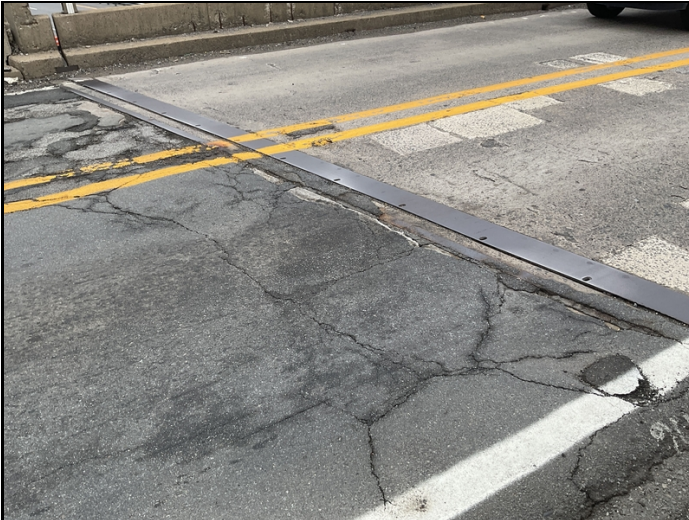
Spalls in the approach roadway bent 1

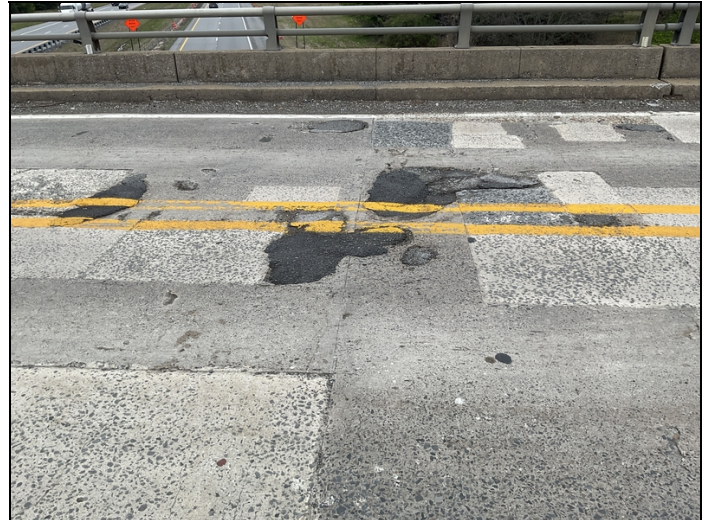
Top of deck on all spans have numerous patches, spalls, spalls filled with asphalt, rebar exposed and cracks that reflect through to bottom of the deck.

Asphalt patches span 2

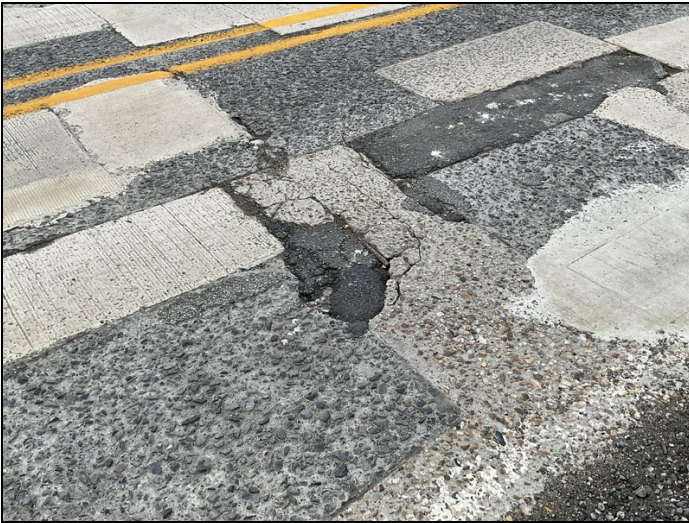
Exposed rebar left side span 3

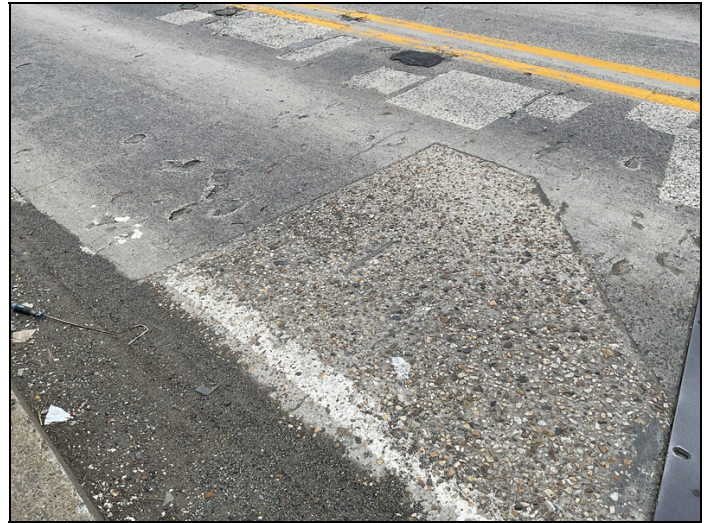
Exposed rebar left side span 4

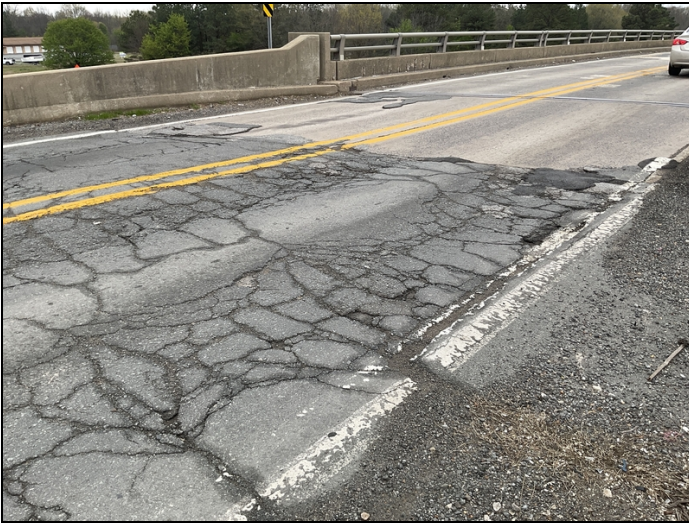
potholes in the Approach wearing surface at north end

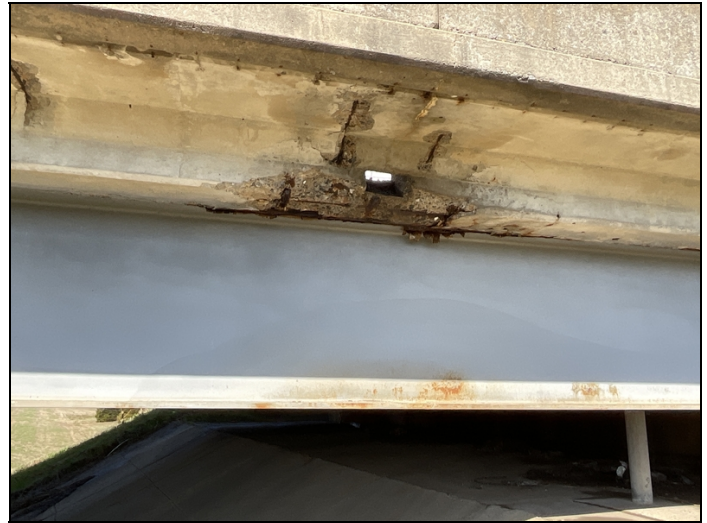
Span 4 right side spall with exposed rebar

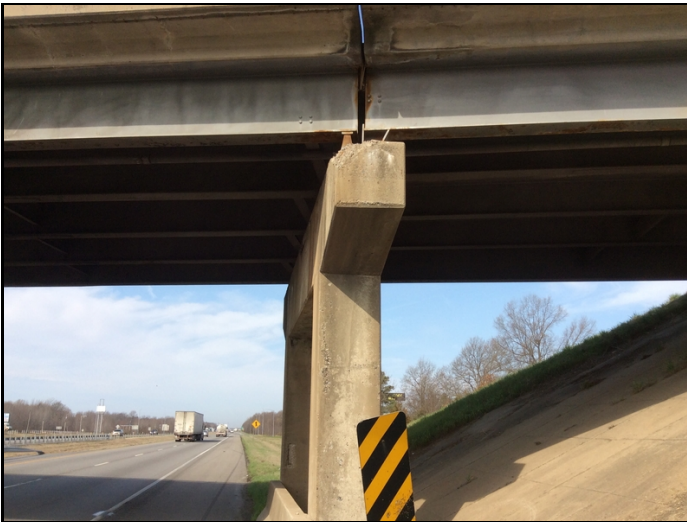
The right end of the cap of bent 4 has a large spall.

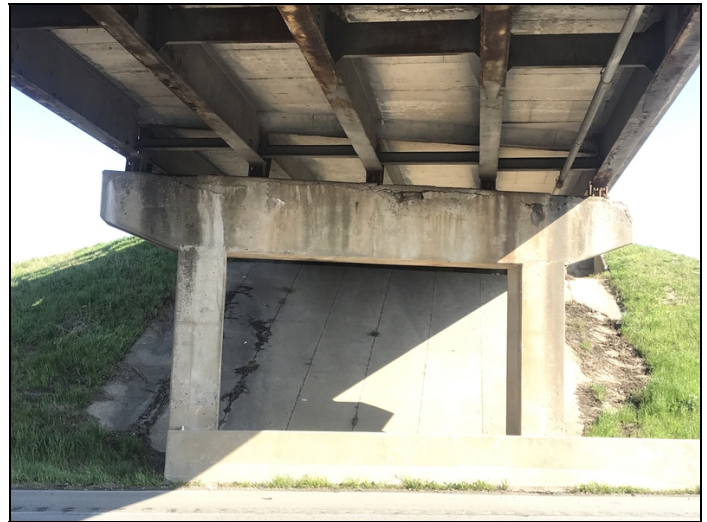
Bent 4, backside of cap is spalled and delaminated at the top.

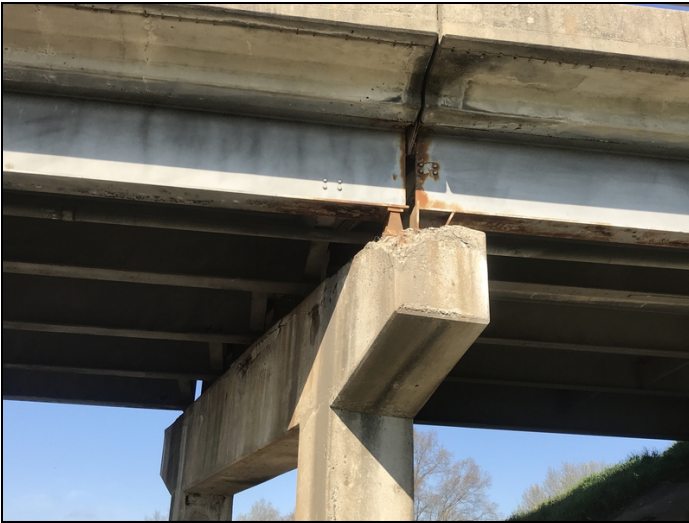
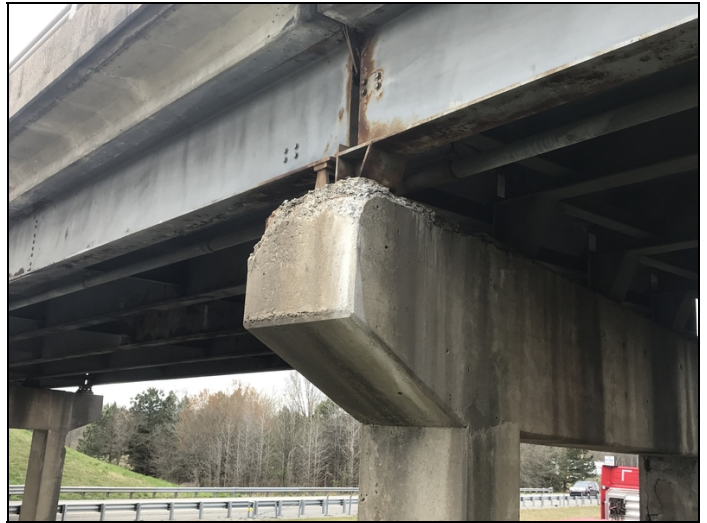
Caps of bents 3 and 4 have spalls with exposed rebar and delamination.
Bent 4: right end of cap with a large spall that is adjacent to girder 5 bearing.

Bent 4: right end of cap with a large spall that is adjacent to girder 5 bearing.

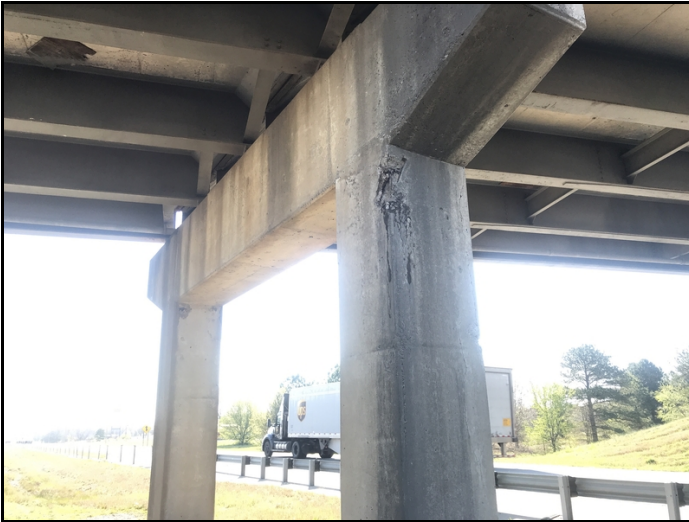
Columns of bents 2, 3 and 4 have spalls with exposed rebar and delamination.

Bent 3, column 1: large spall with exposed rebar.

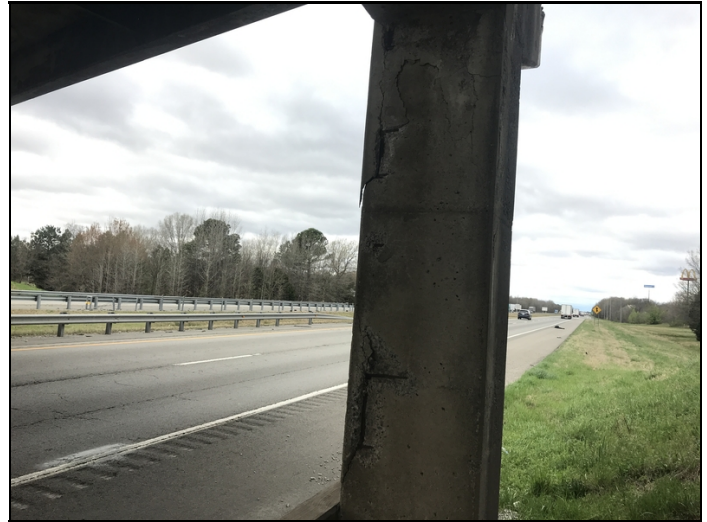
Bent 4 column 1 large spalls with exposed rebar

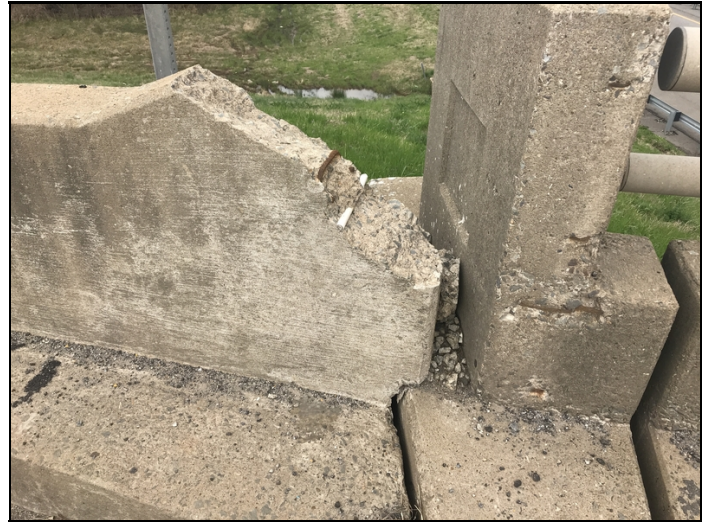
Left approach rail at bent 1 has a large spall.
