Asset #03655(Routine)

SH 13-SEC 10 over I 40-SEC 41 LOG 182.51

Location: 1.41 MI N JCT US 70

Team Lead: Bryan Saunders, Inspection Date: 07/31/2023

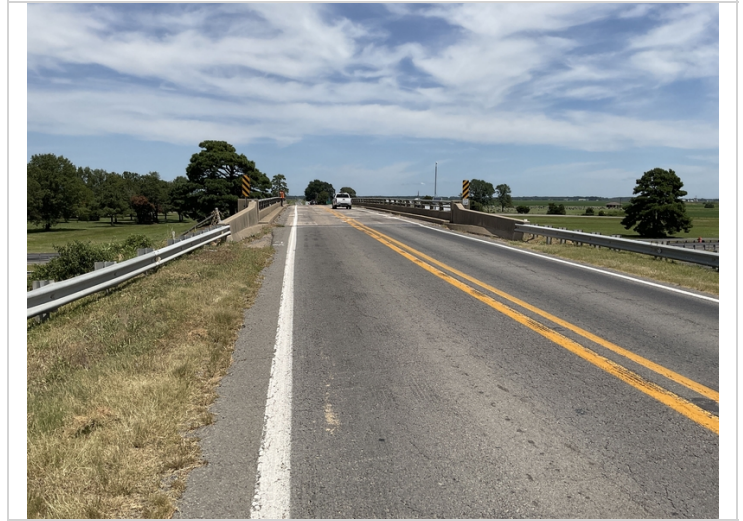
Approach looking north

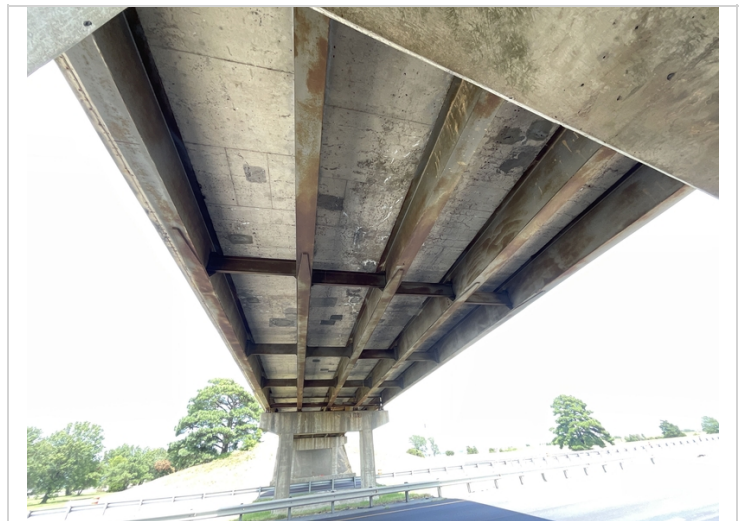
Soffit span 2 has cracking with efflorescence

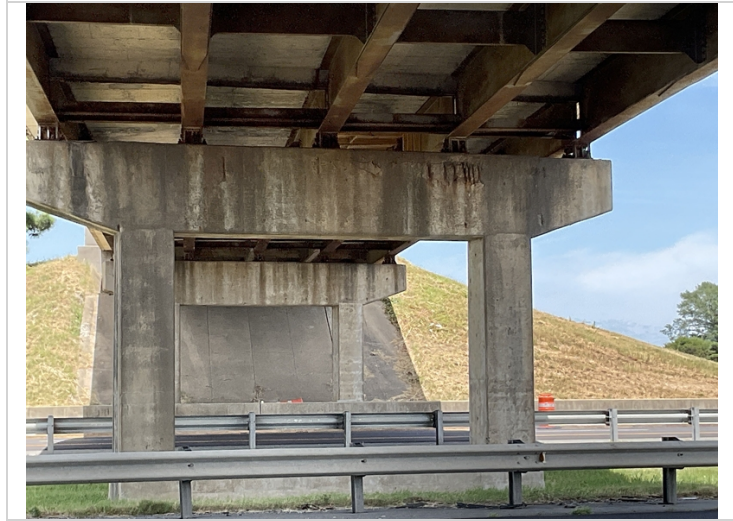
Cracks and spalls with rebar bent 3

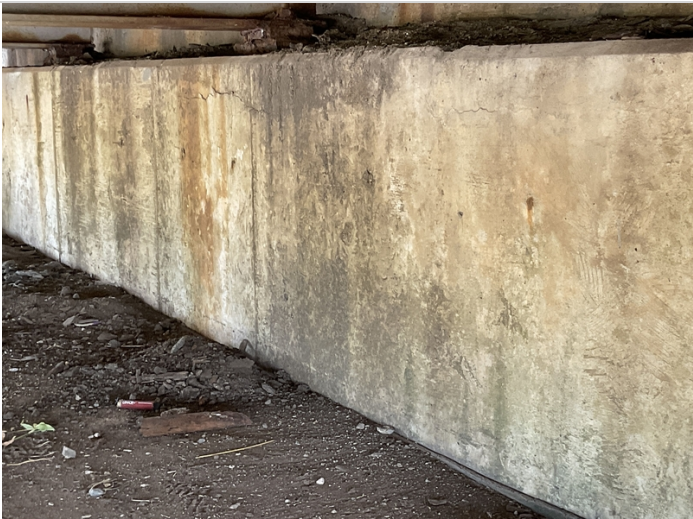
Horizontal cracks in the abutment at bent 1

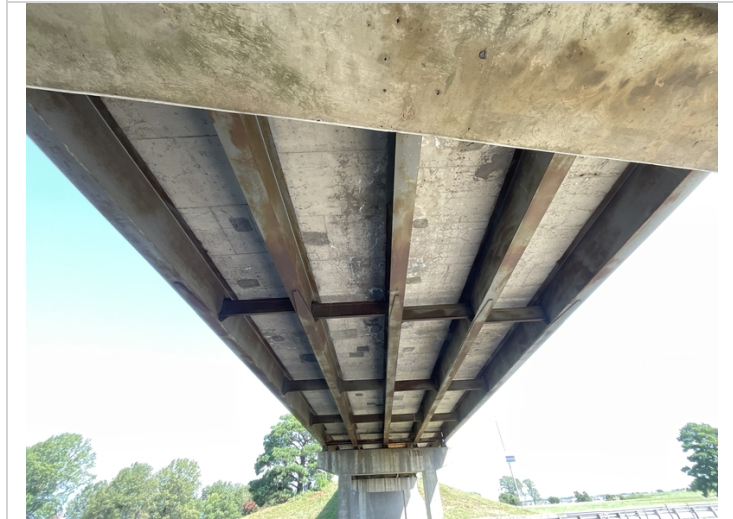
span 2 soffit delams removed

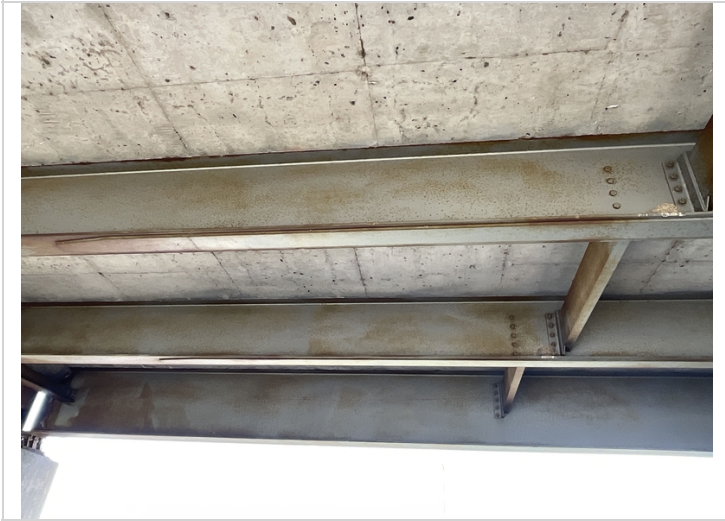
paint system has failed allowing corrosion to initiate on the beam end and the haunch areas

Typical paint condition

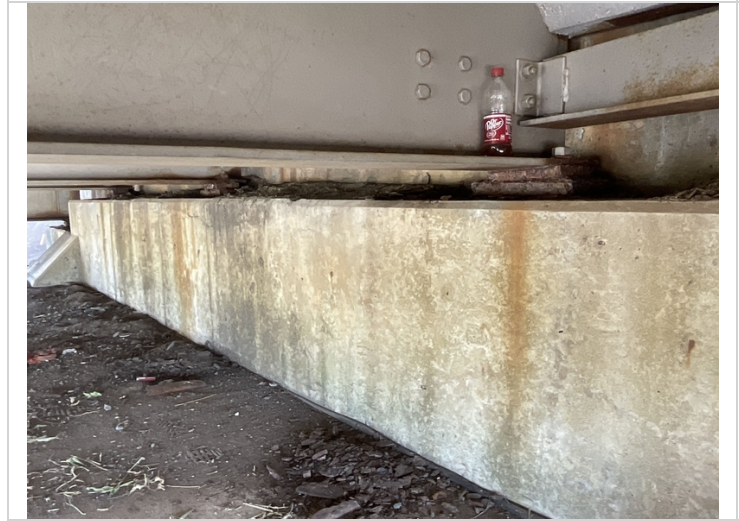
Bent 1 typical bearing condition

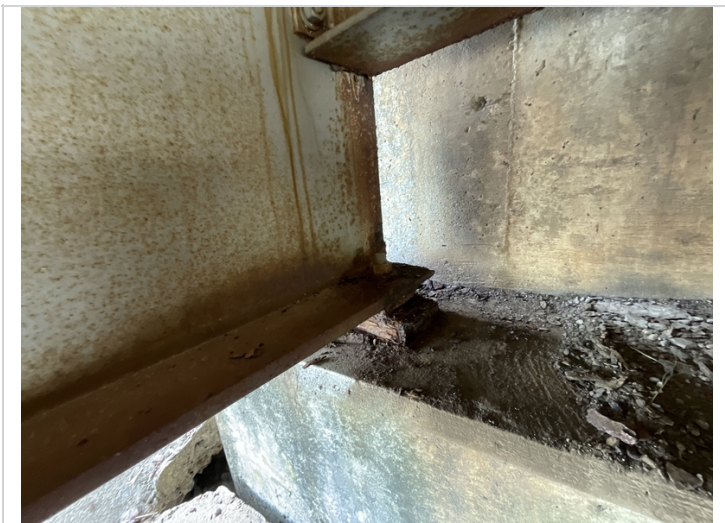
Bent 1 beam 5. Has 1/2 remaining section at bearing area.
Flanges 7/8" thick

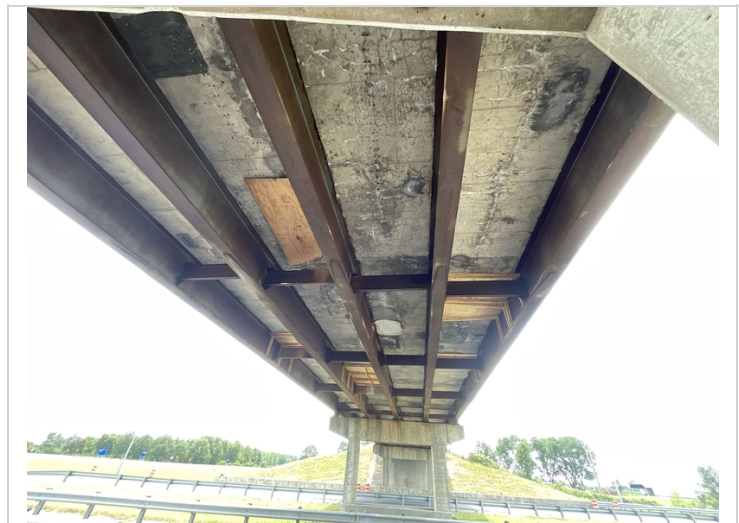
Span 4 repair forms still in place

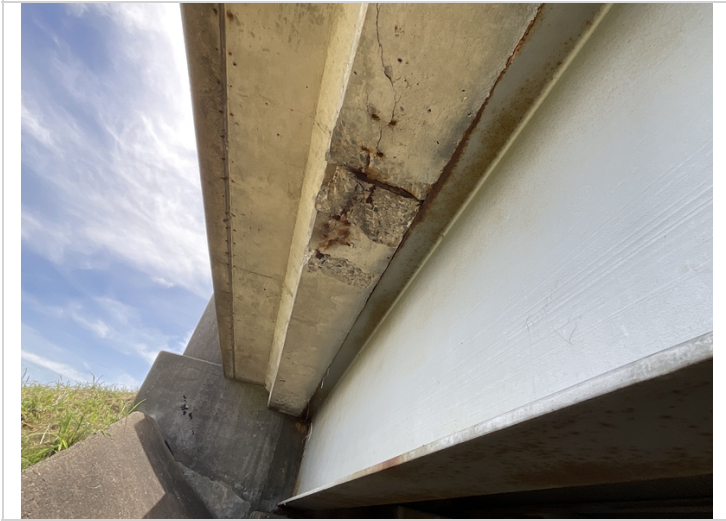
Span 1 right side of beam 5 spall with rebar

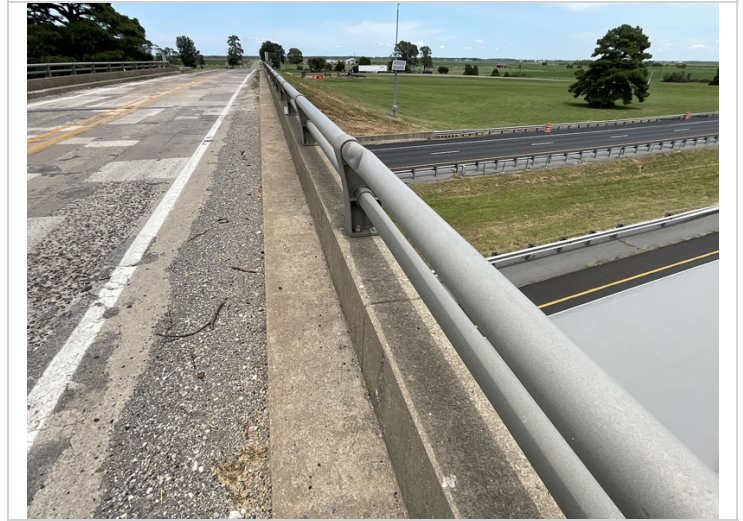
Guardrail damage span 2 east side

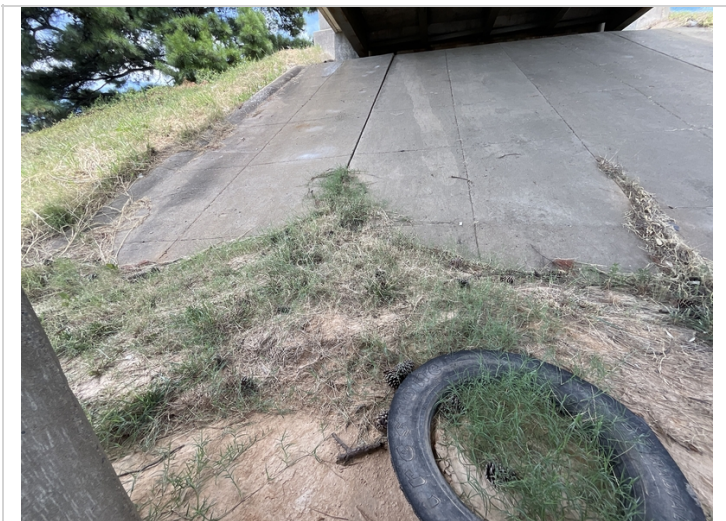
Spillage from erosion at bent 5 accumulation around bent 4 columns

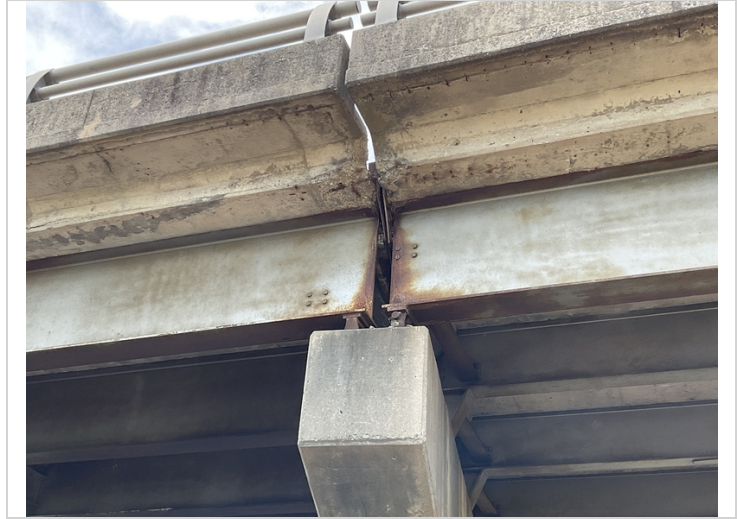
Spall with rebar bent 4 at beam 5

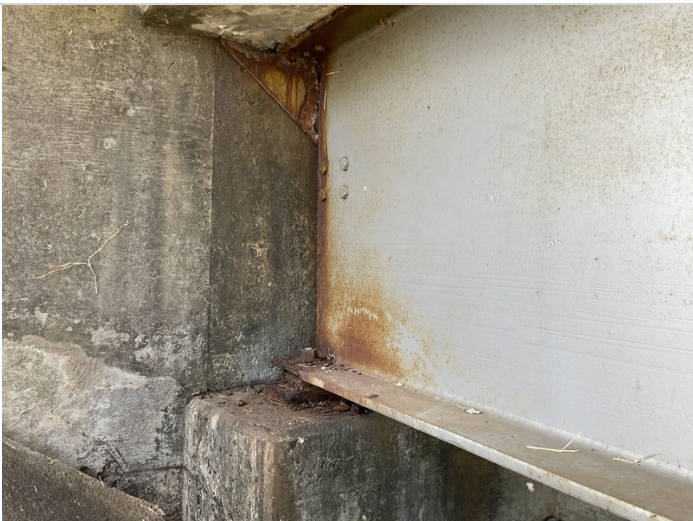
Bent 1 beam 1 corrosion at beam end and bearing

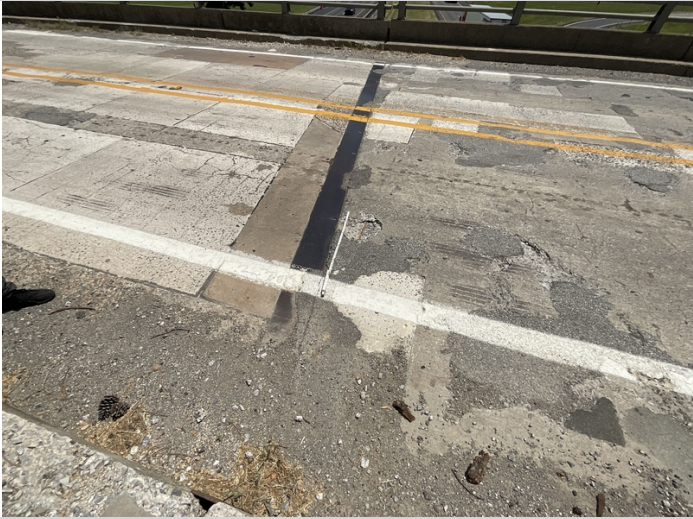
Spall at bent 3 joint

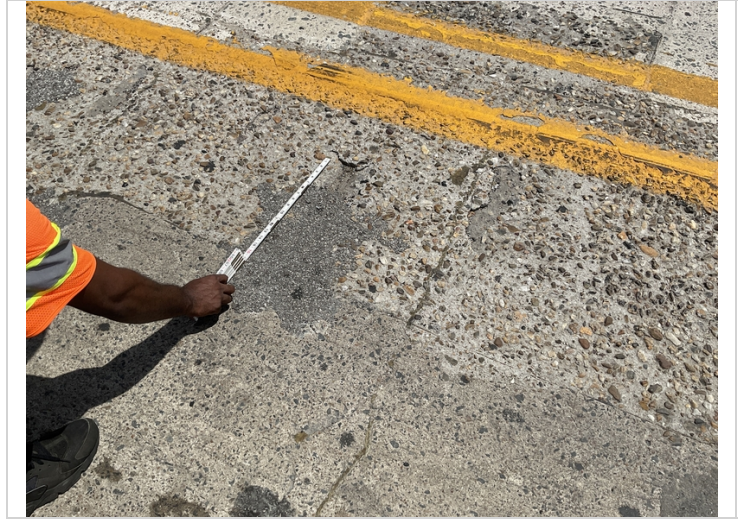
Spalls with exposed rebar in the deck span 2,3 and 4

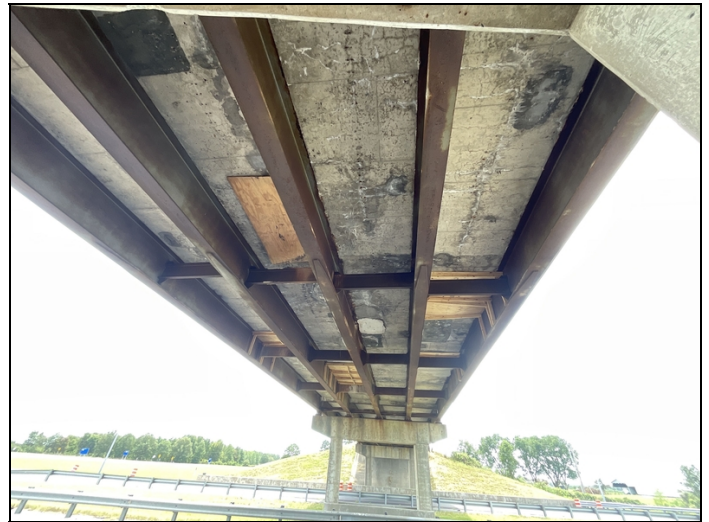
Span 4 repair forms still in place

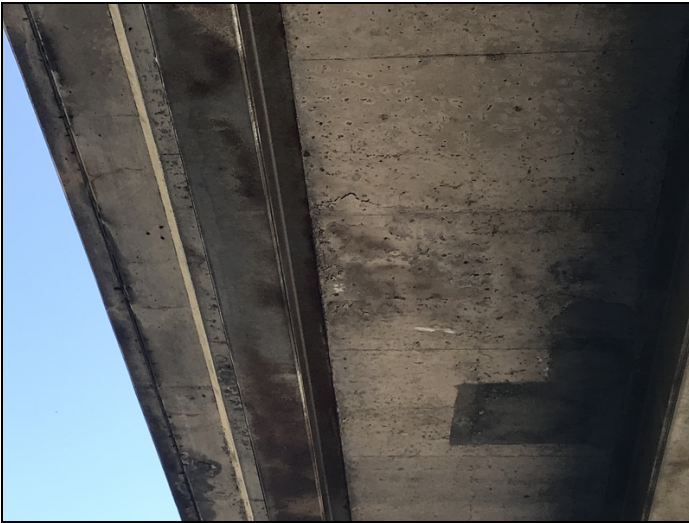
Span 2 delam between beams 1&2 over eastbound traffic right lane.

delams have been removed

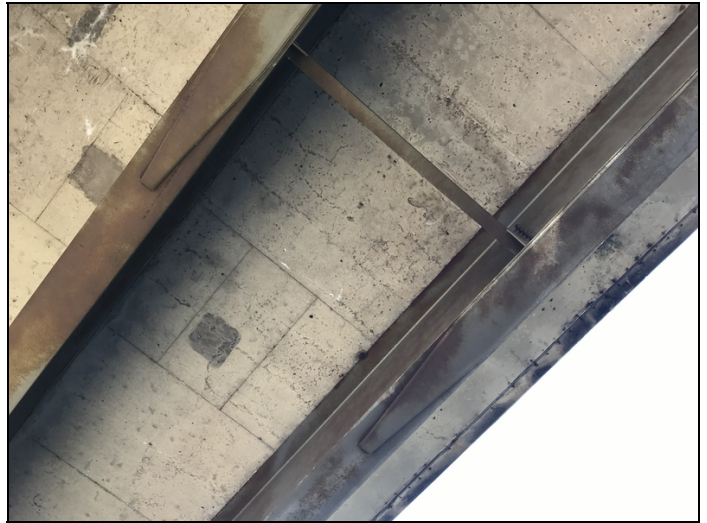
Span 2 delam between beams 1&2 over eastbound traffic off ramp.

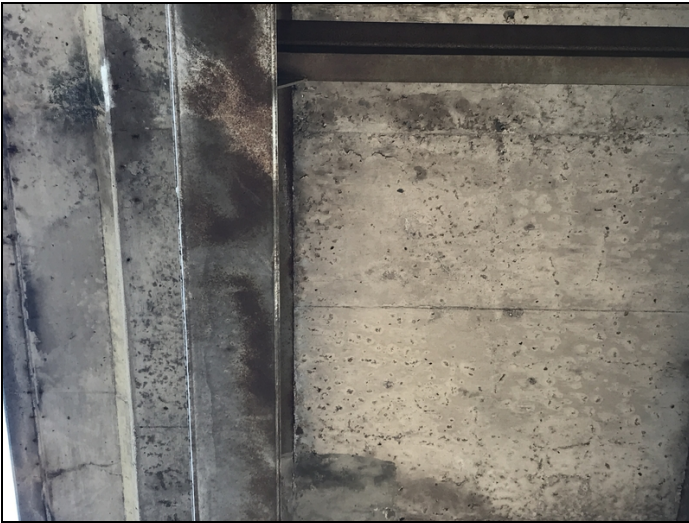
Span 2 small delam between beams 1&2 over eastbound traffic right lane and off ramp.

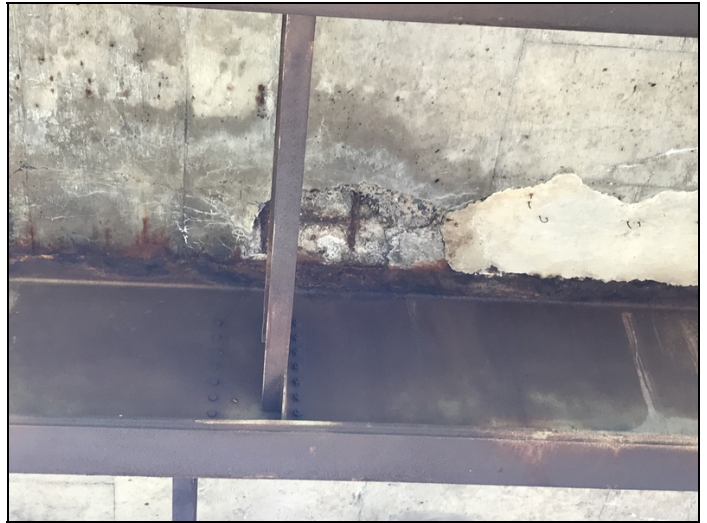
Delams over traffic in westbound fast lane between beams 3&4.

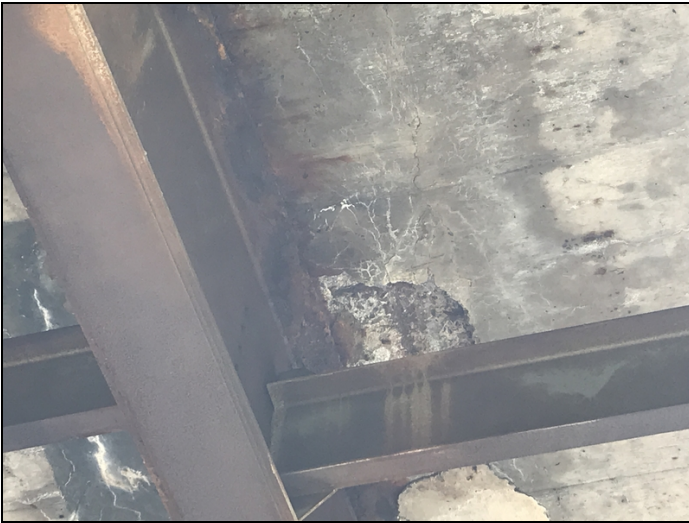
Delams over traffic in westbound fast lane between
beams 3&4

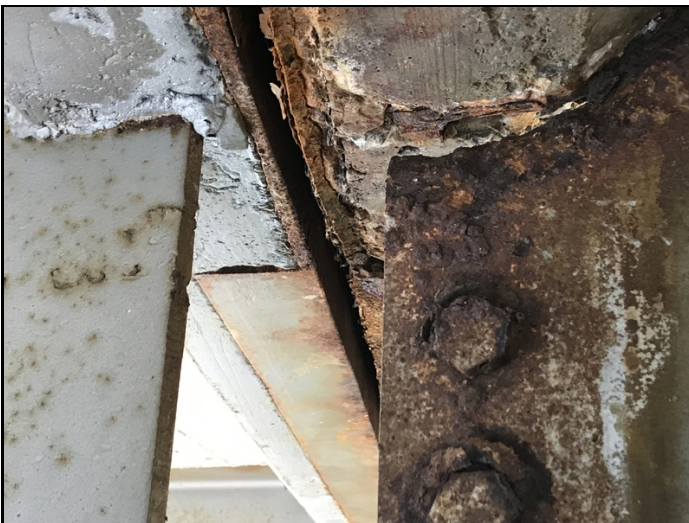
Span 1 beam 2 at bent 2 has a 5" by 1" hole in web under haunch

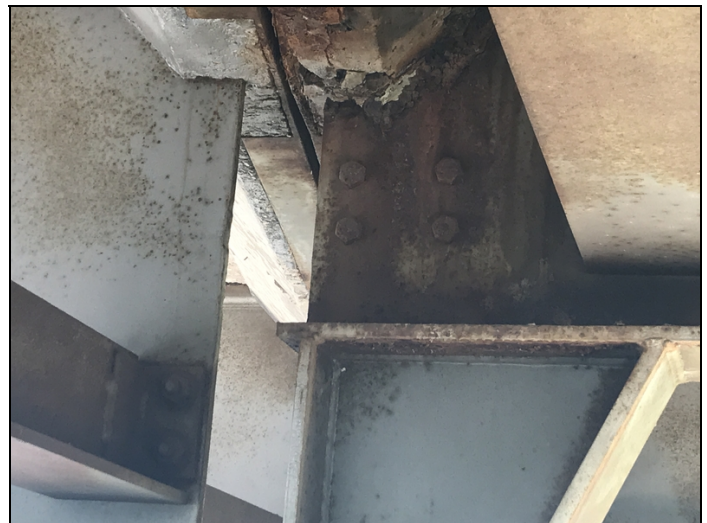
Span 1 beam 3 at bent 2 has a 6" by 1-1/2" hole in web under haunch

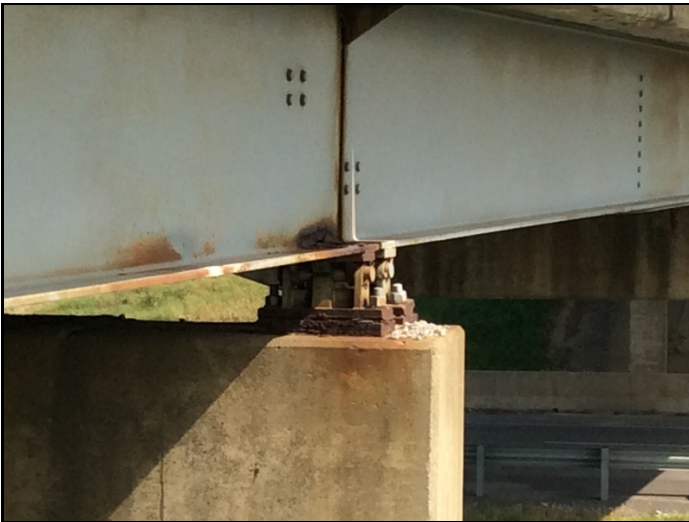
Span 1, beam 5, pitting to 3/16 inch deep on the web and bottom flange.

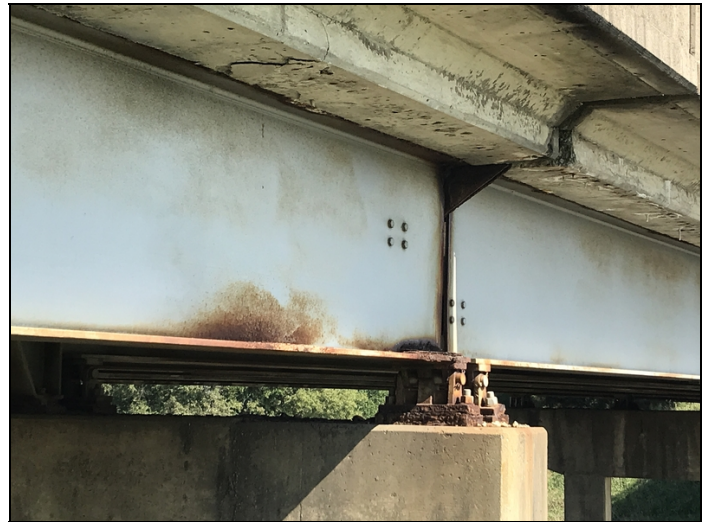
Span1 at bent 2, beam 5 has deep pitting to upper web and lower flange.

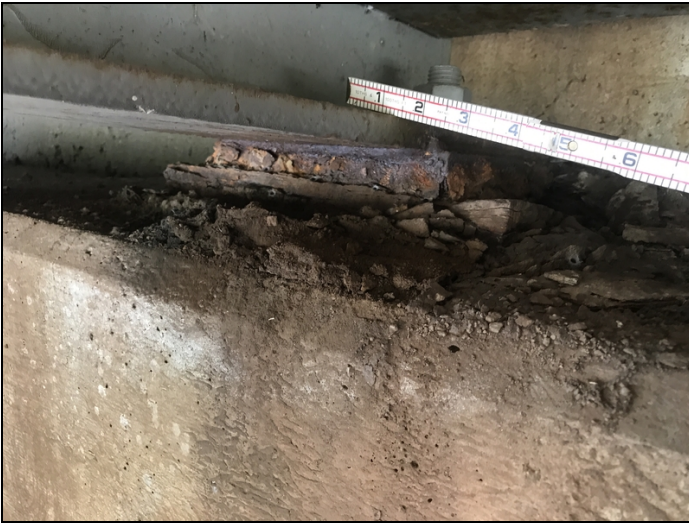
Bent 5, girder 4: typical condition of bearings throughout the bridge

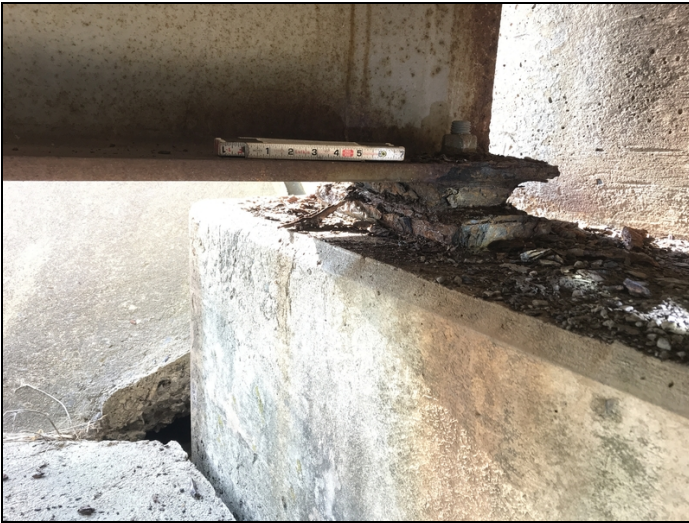
At bents 1 and 5 the bearings have heavy laminating rust to bearings and masonry plates.

Bent 1 bearing 5 laminating rust on bearing and masonry plate.

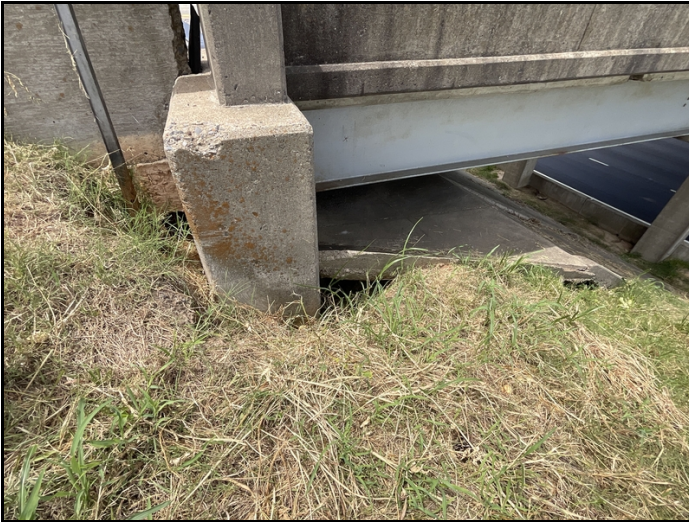
Erosion at bent 1 right side

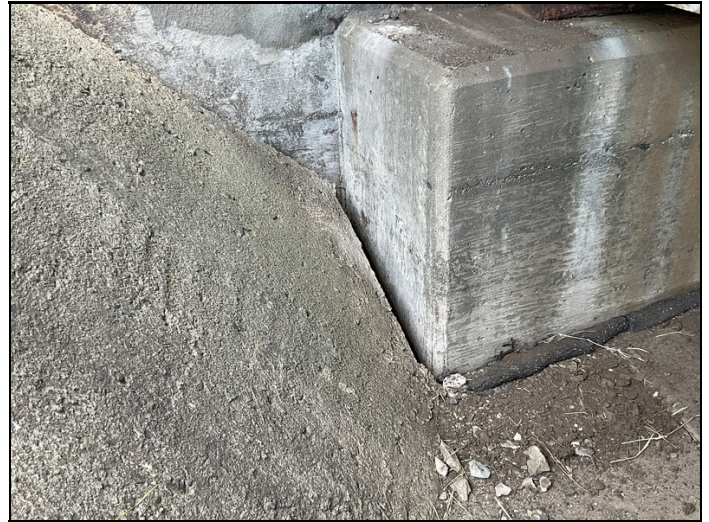
Bent 5 abutment has erosion hole under slope paving
6' deep at point of measurement

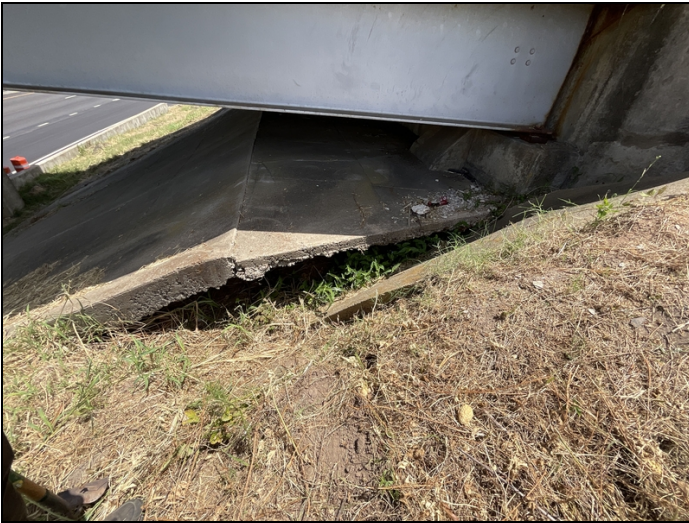
Bent 1 left side erosion hole

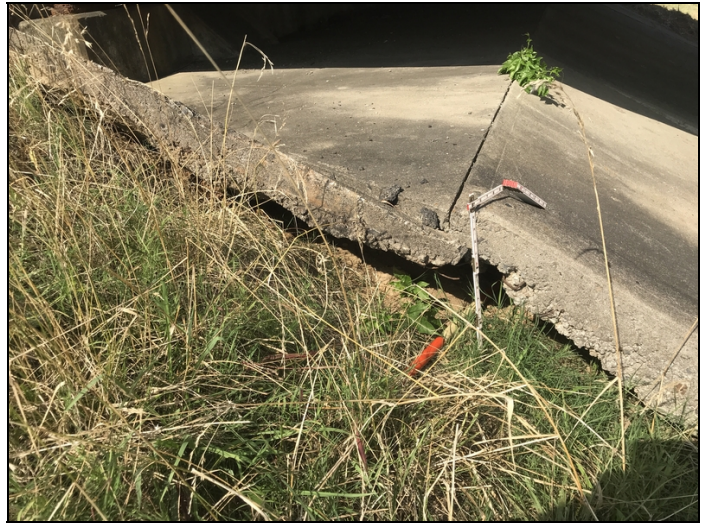
Slope paving undermined on the south end

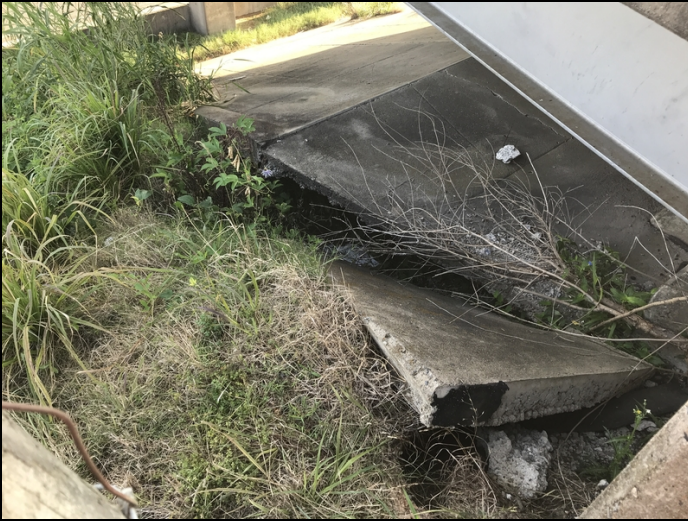
Southeast corner of bridge.
Slope paving has a 10' wide by 2' deep void w

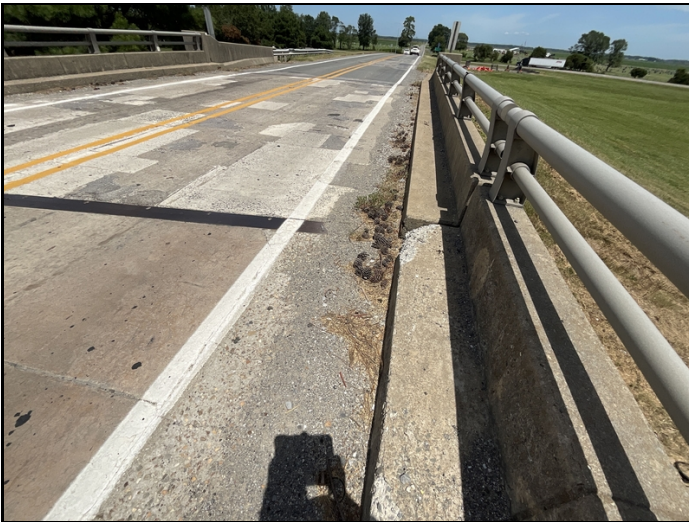
Spall at the curb bent 4

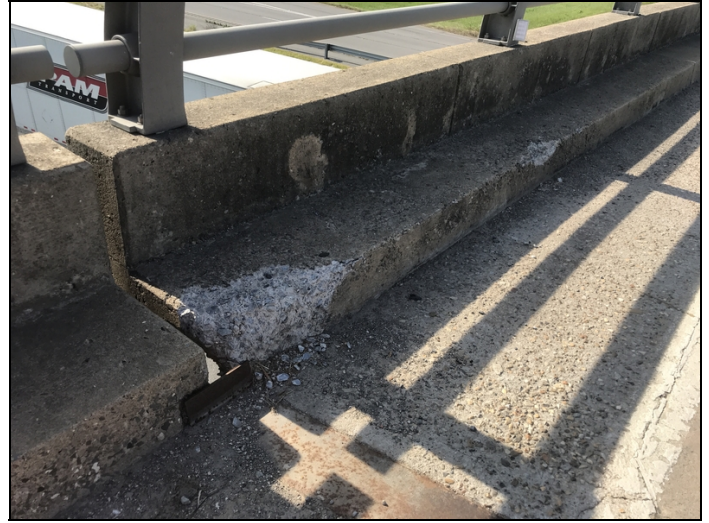
Span 3, right curb with a large spall near bent 4 joint

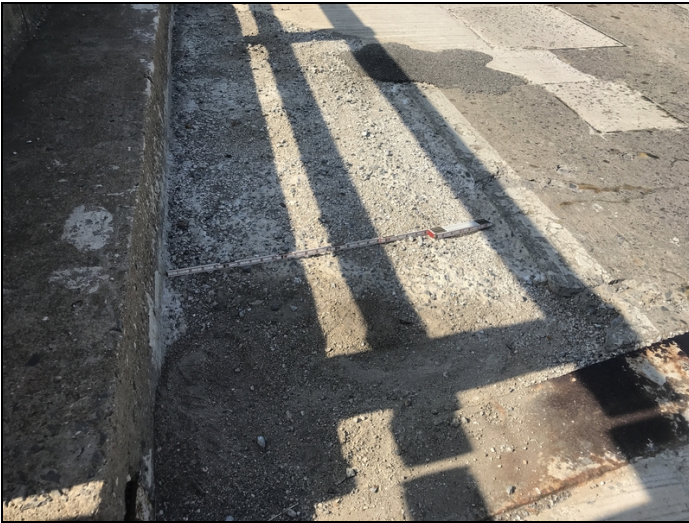
Span 1, right shoulder: previous patch is deteriorating

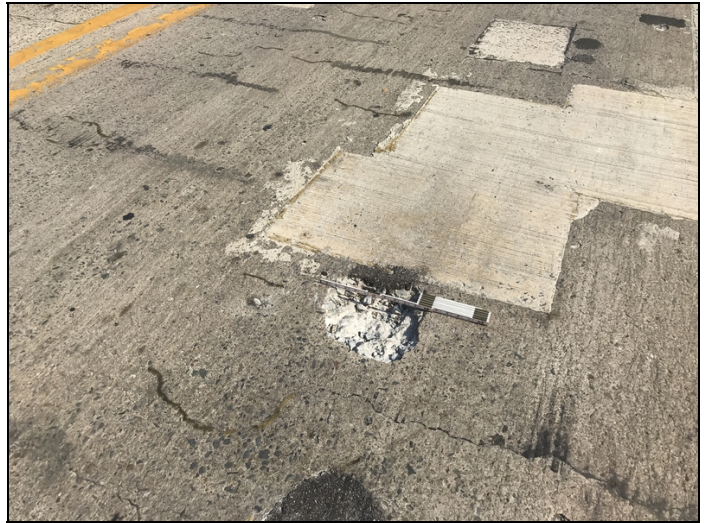
Span 4, right lane: open spall

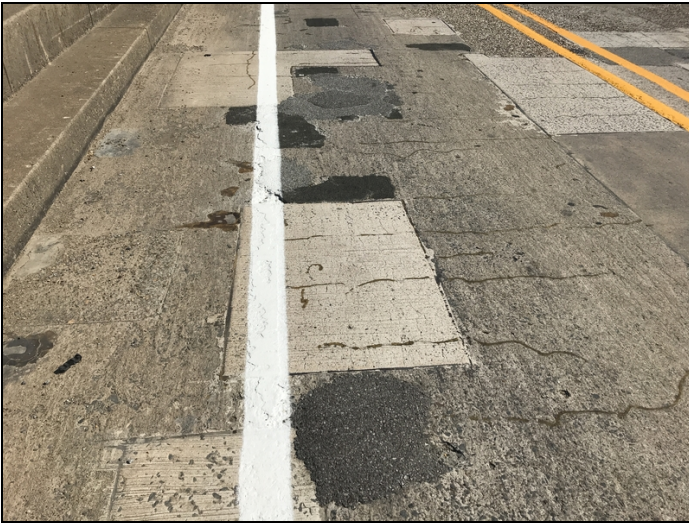
Span 2 spalls and spalls filled with asphalt

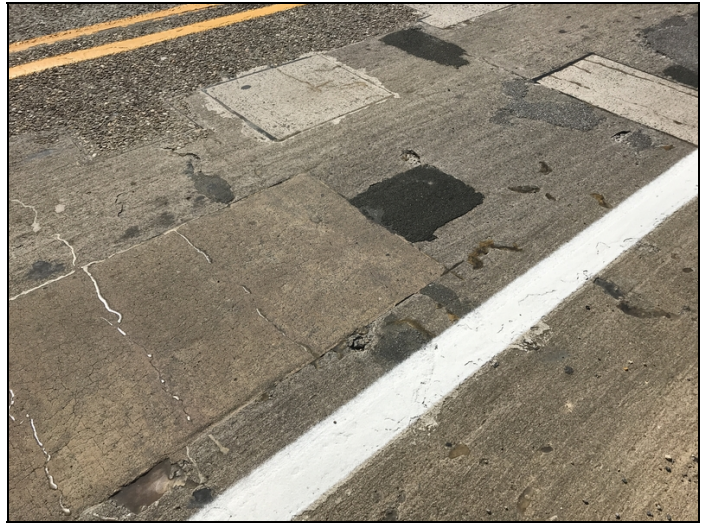
Span 2 spalls in deck

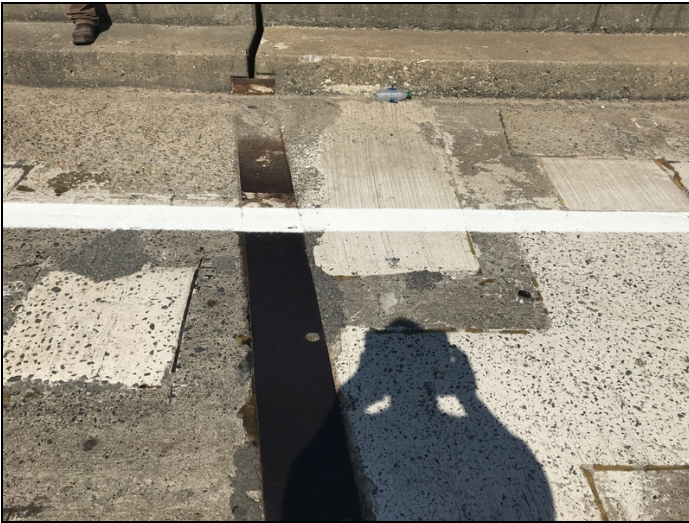
Span 4, left curb with a large spall near bent 4 joint

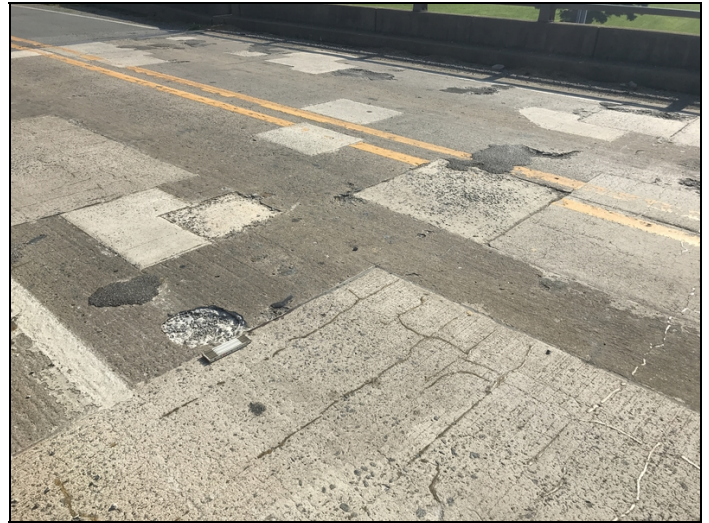
Span 4 spalls and spalls filled with asphalt

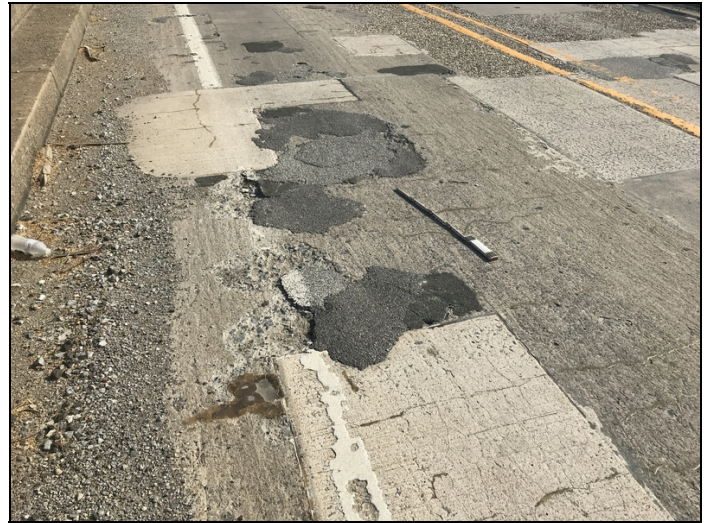
Span 2 large spalls filled with asphalt

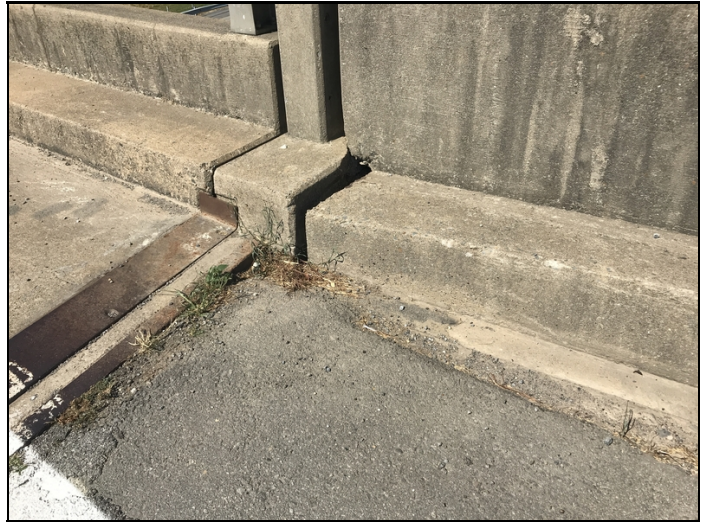
South approach has settled over 4". The north approach has also settled approx. 2.5".

North approach settlement

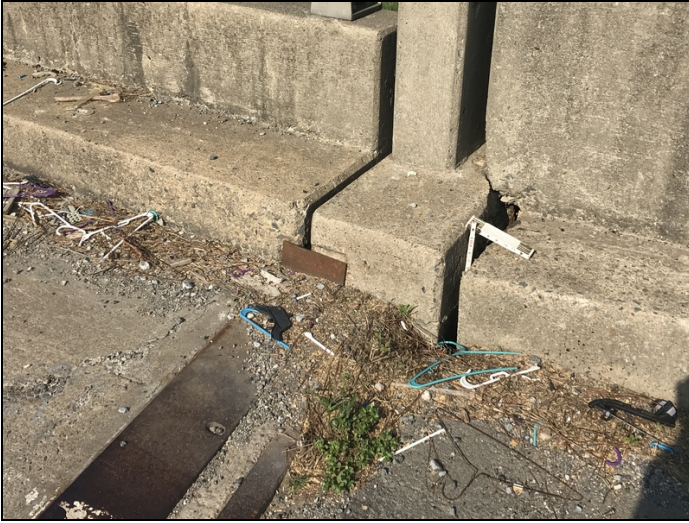
North approach settlement

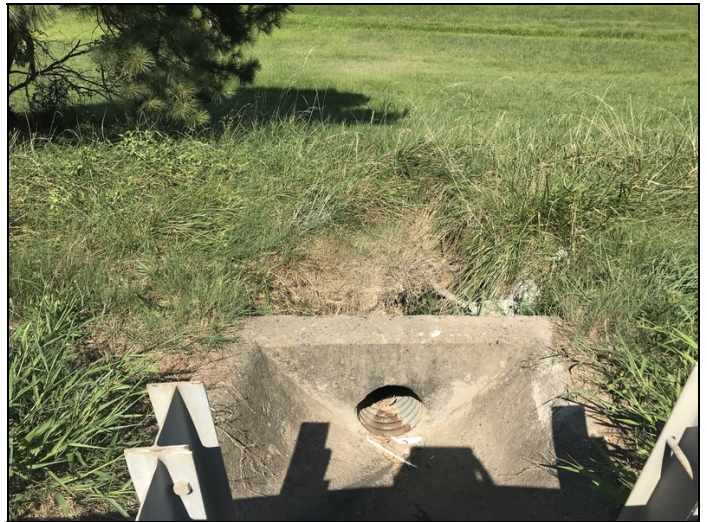
Northwest end of bridge has 5' hole at approach slab drain.

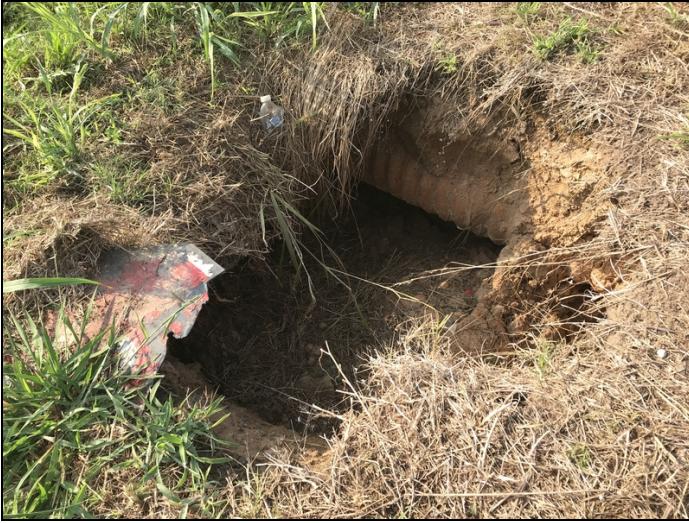
Southwest end of bridge has 3' hole at approach slab drain.

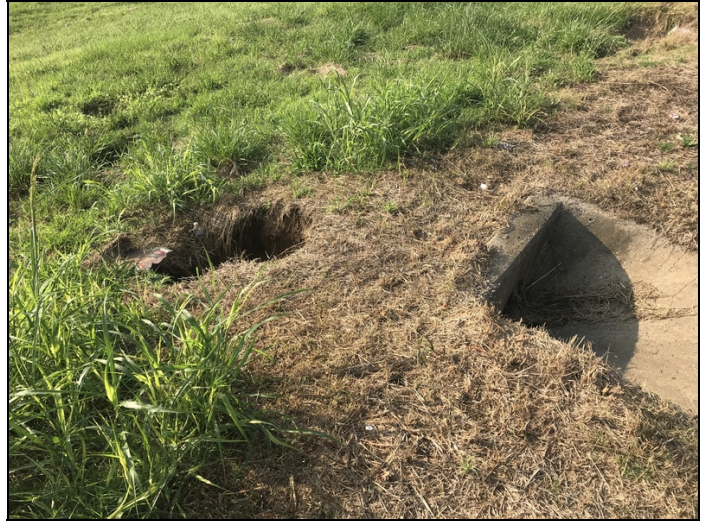
Southwest end of bridge has 3' hole at approach slab drain.

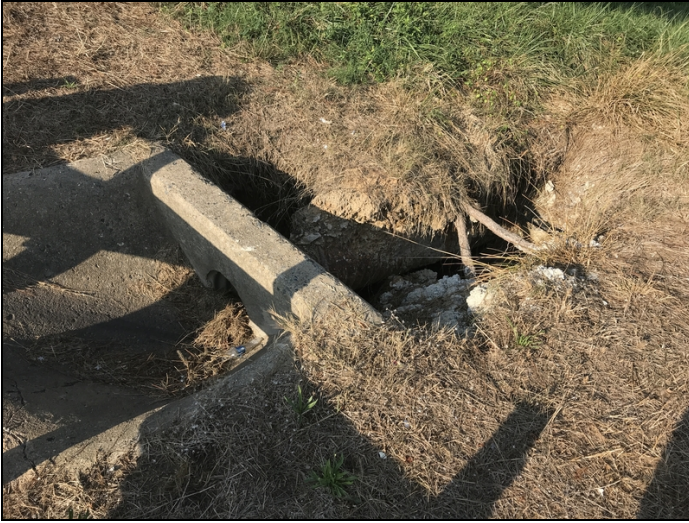
Northwest end of bridge has 5' hole at approach slab drain.

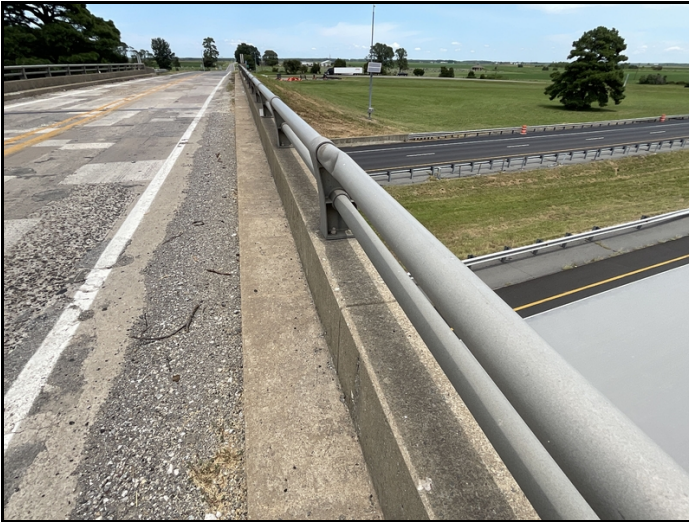
Metal bridge railing has damage in span 2 east side due to vehicle impact

Guardrail damage span 2 east side
