Asset #M1581 (Routine)

SH 86 Log 3.79 over WATTENSAW BAYOU

Team Lead: Bryan Saunders, Inspection Date: 07/31/2023

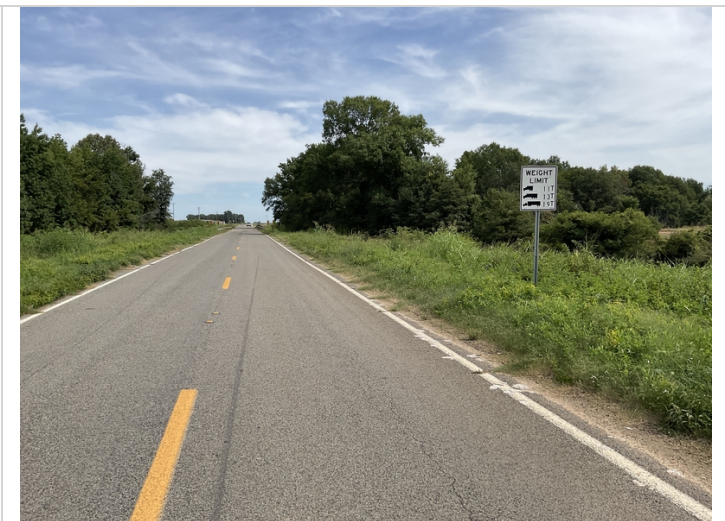
Load posting looking north

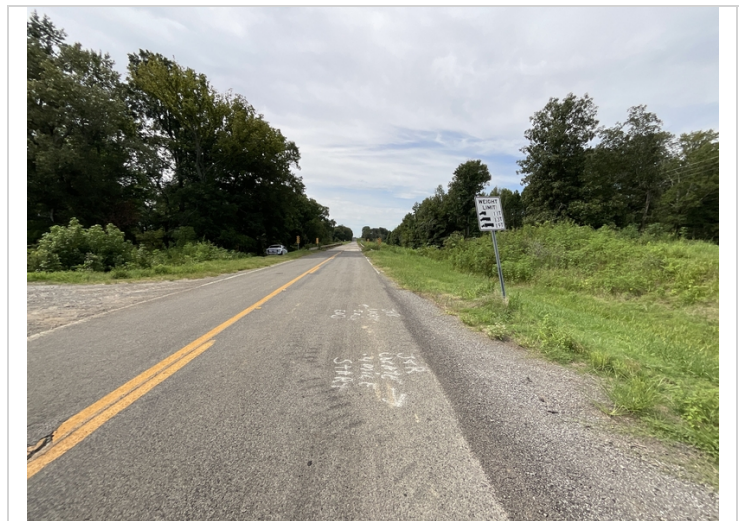
Load posting looking south

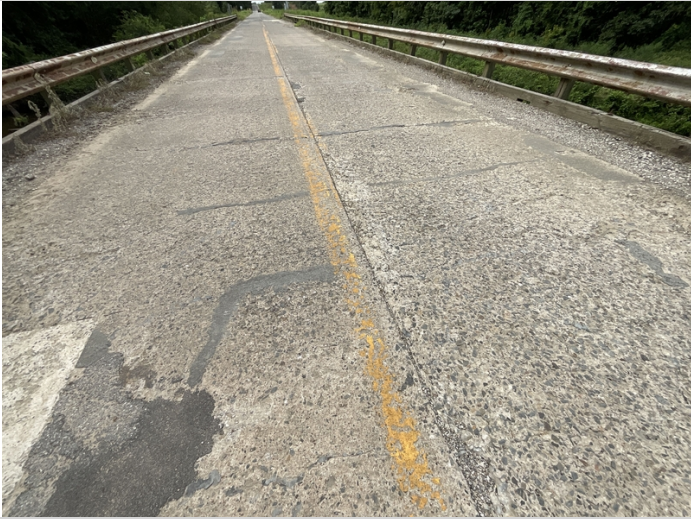
(12) All of the deck surface has abrasion and pop outs with aggregate loss. State forces have patched spalled areas and sealed cracks. Some of the older patches have cracks that have been sealed by state forces. Span 16: Patched areas cracking and beginning to spall.							
111	Timber Open Girder/Beam	LF	4503	3690	300	498	15
1140	Decay/Section Loss	LF	476	0	0	461	15
1150	Check/Shake	LF	13	0	3	10	0
1160	Crack (Timber)	LF	167	0	152	15	0
1170	Split/Delamination (Timber)	LF	157	0	145	12	0

Spalls and abrasion in the deck in multiple locations some cracks have been sealed

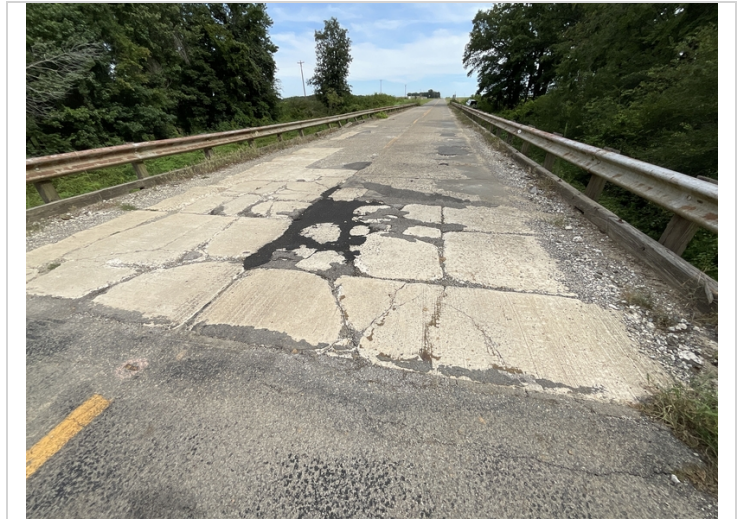
Concrete patches filled with asphalt

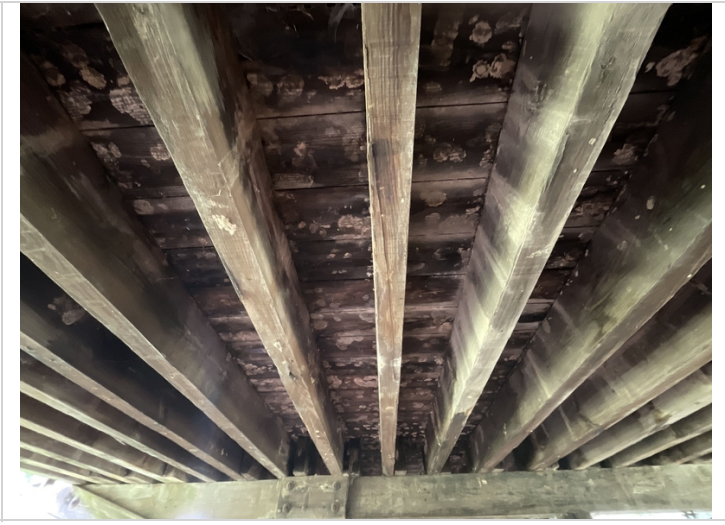
Span 15 girder 10 has split mid span

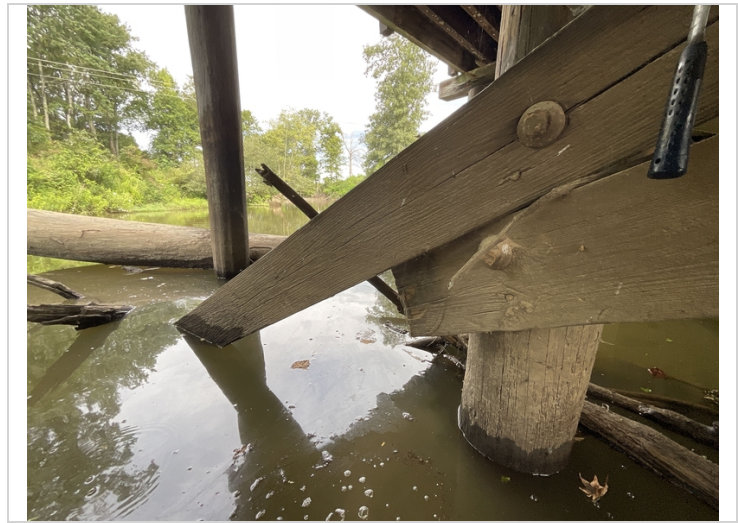
X brace at bent 5 has broken loose from pile 4 at bottom

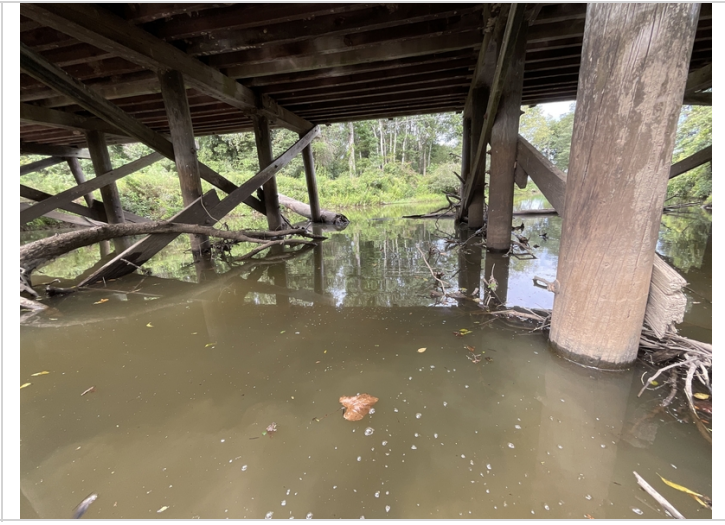
Logs and drift bents 3,4,5

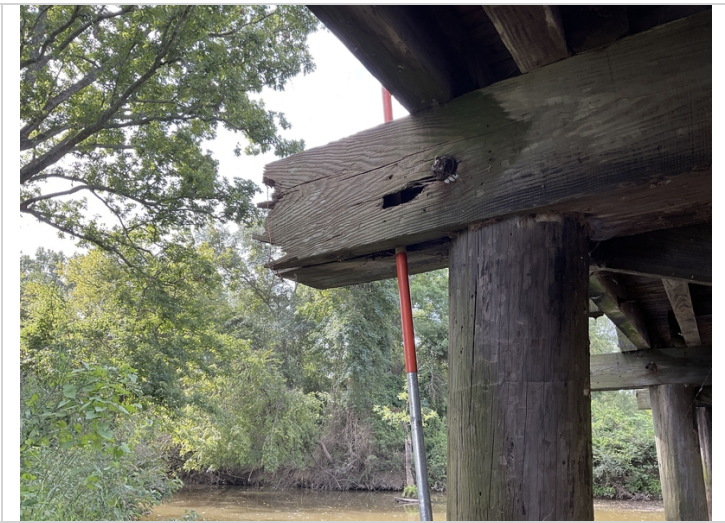
Bent 3 cap decayed and split at left end

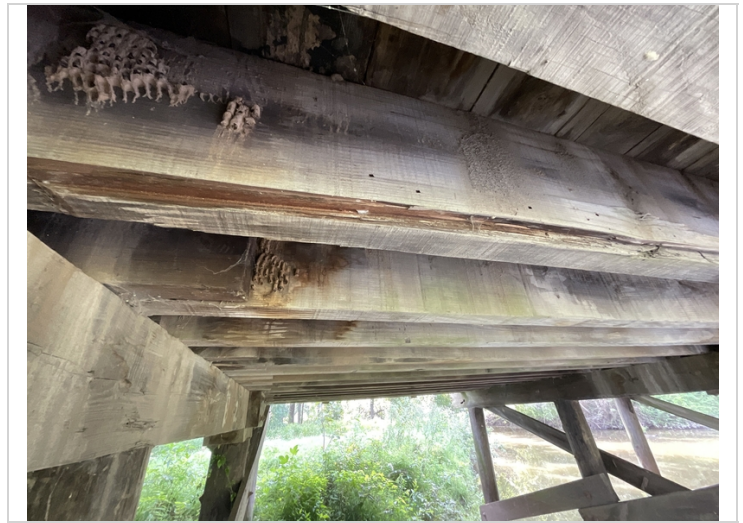
Span 2 girder 15 split at bent 2

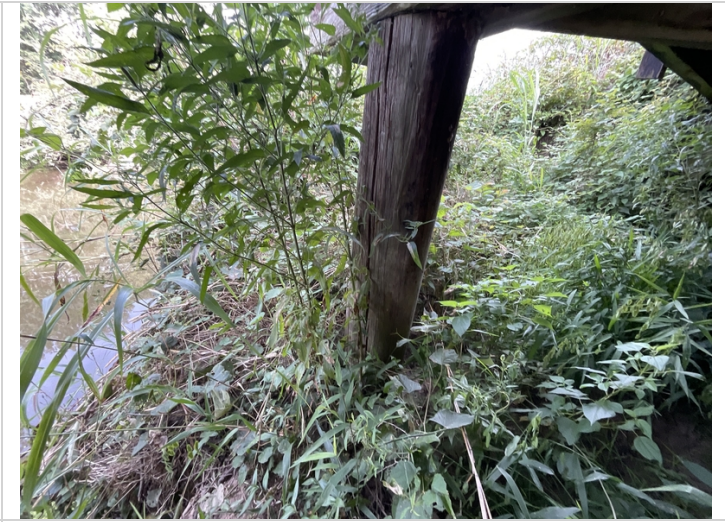
Bent 2 column 4 split

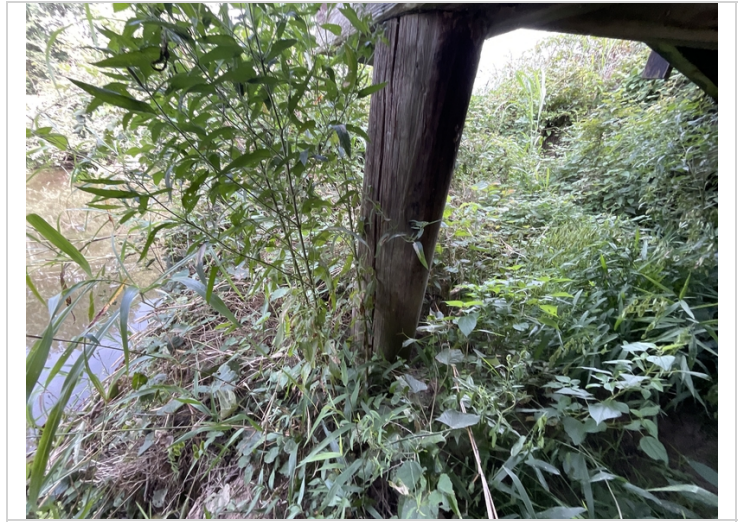
Bent 2 column 4 split

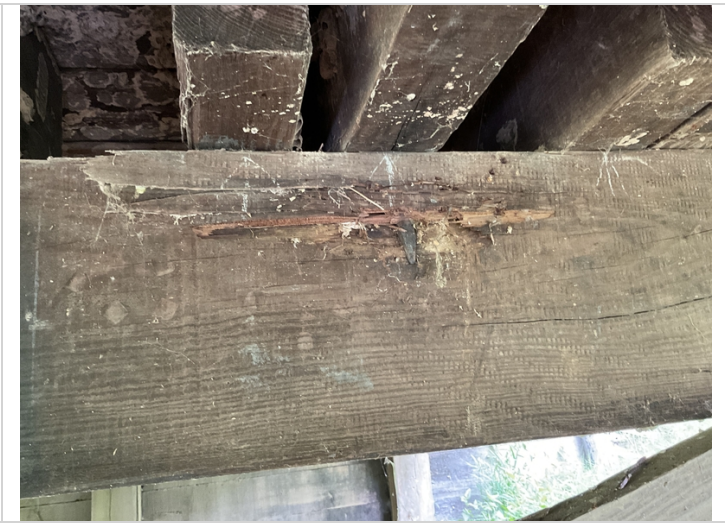
Bent 2 cap under girder 5 has a split where spike has been nailed

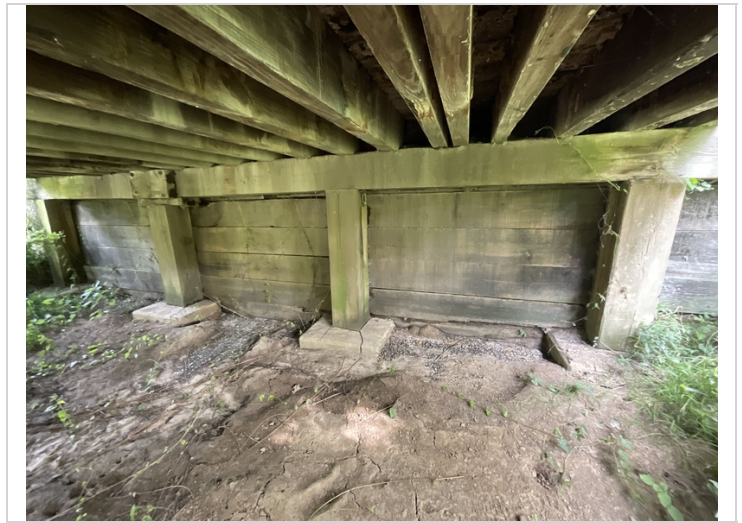
Bent 1 abutment

(216) Sections of the cribbing at bent 1 and 17 are decayed. Most planks have horizontal cracks.							
228	Timber Pile	EA	68	0	58	10	0
1140	Decay/Section Loss	EA	10	0	4	6	0
1160	Crack (Timber)	EA	58	0	54	4	0

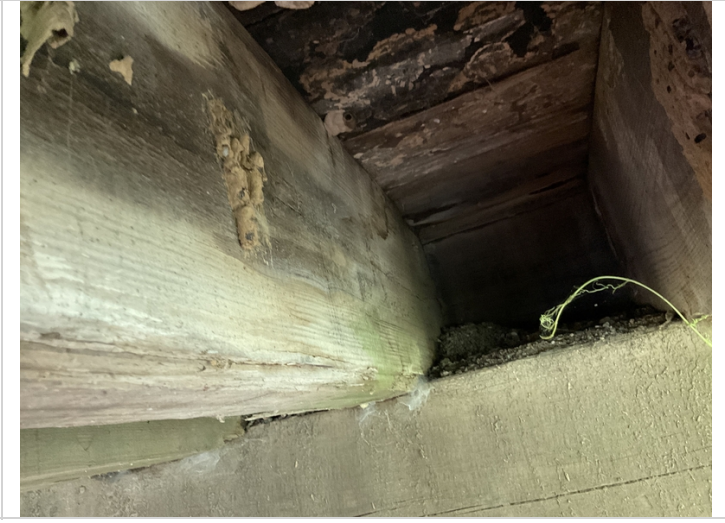
Bent 1 timber girders decayed at ends

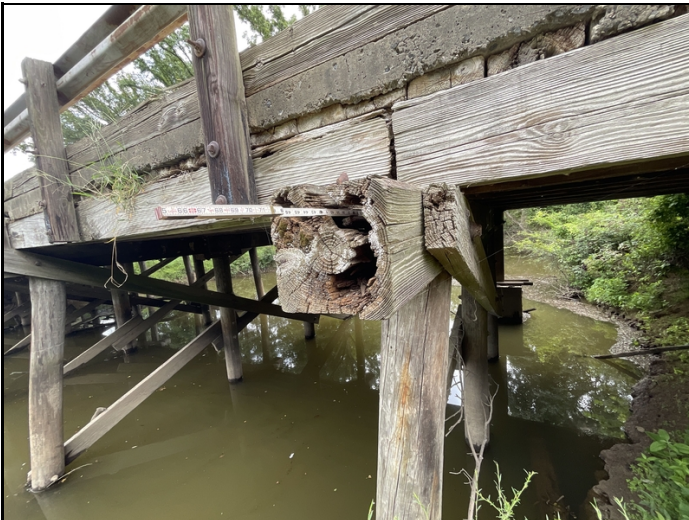
Bent 8 above pile 4 the timber cap has decayed and is hollow 5' deep

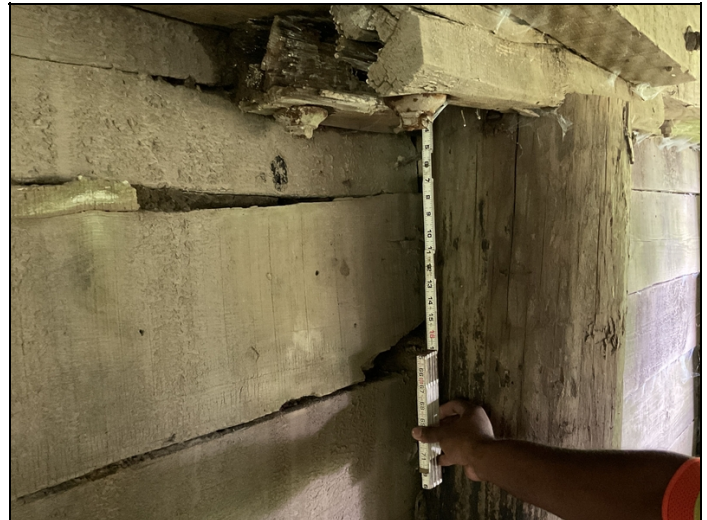
Bent 17 the splice on the cap above pile 3 is crushing and hollow allowing the cap to sag 1 1/2"

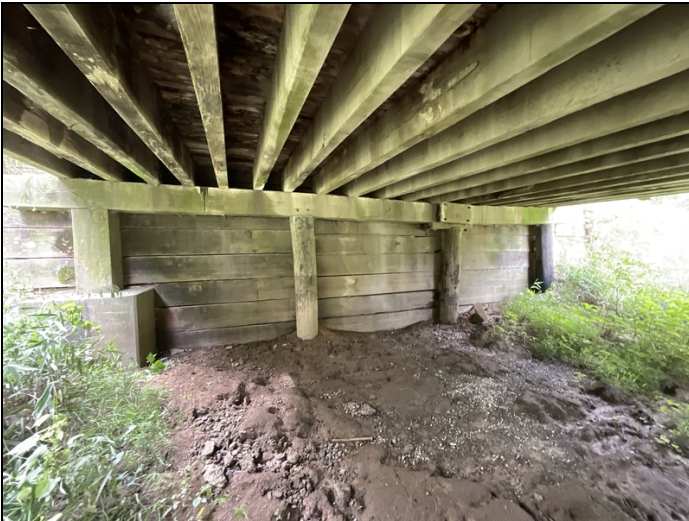
Bent 17 abutment the timber cap has settled 1 1/2 due to decay at the cap splice over pile 3

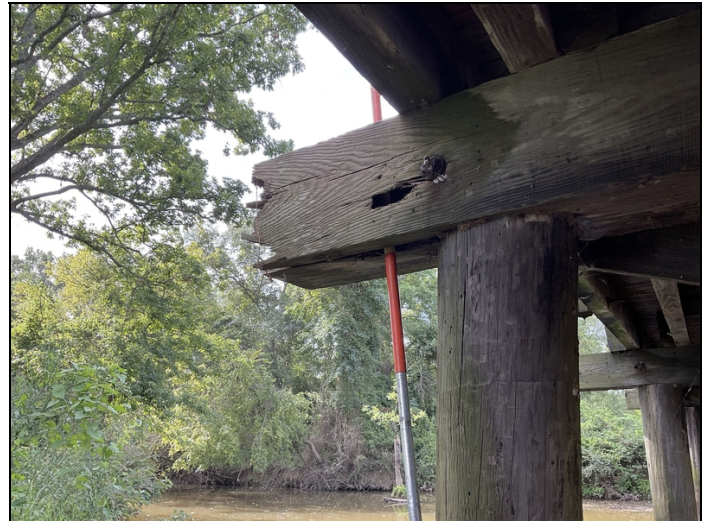
Bent 3 cap decayed and split at left end

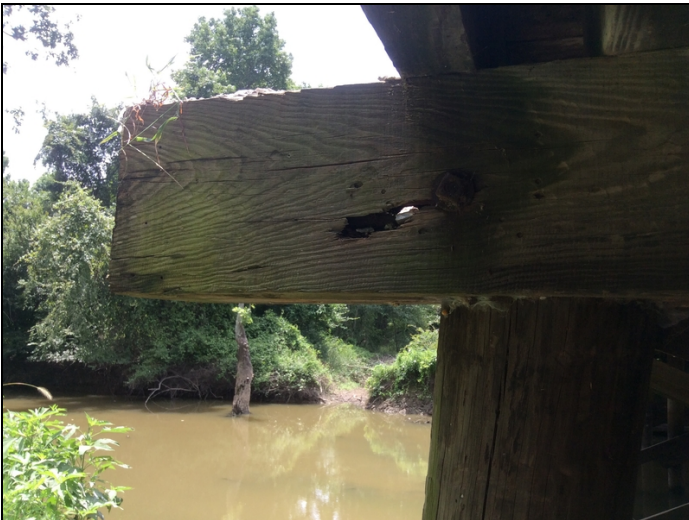
Bent 3, left end of the cap, decayed and hollow.

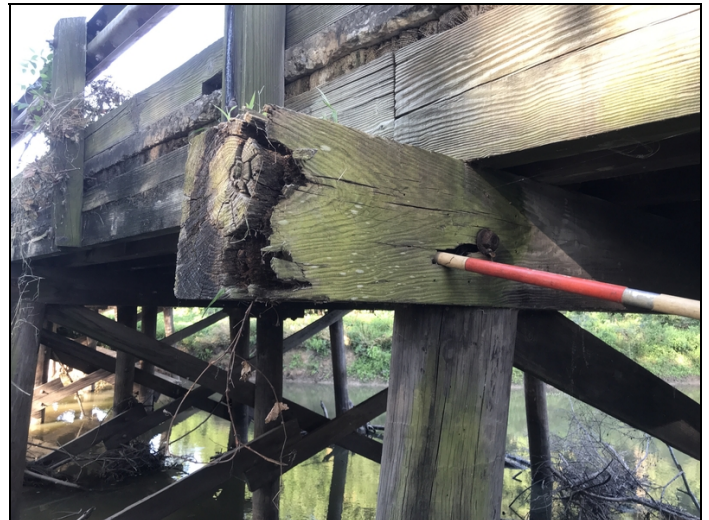
Bent 3: left end of cap hollow. It's hollow 3' from the end of the cap past pile 1.

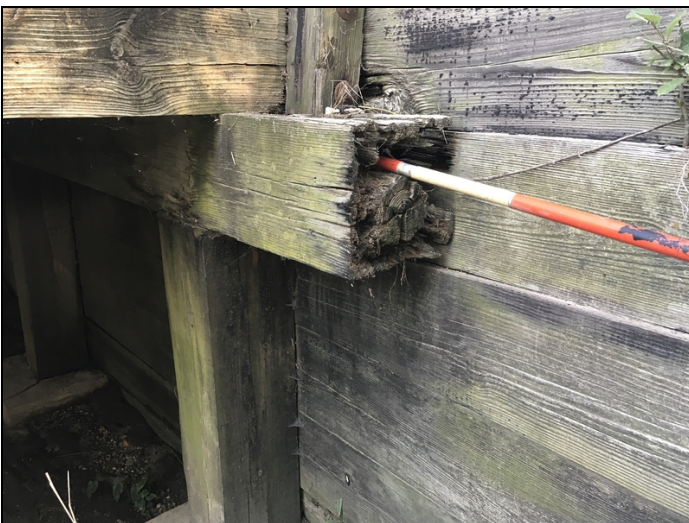
Bent 1: left end of cap hollow up to 2'

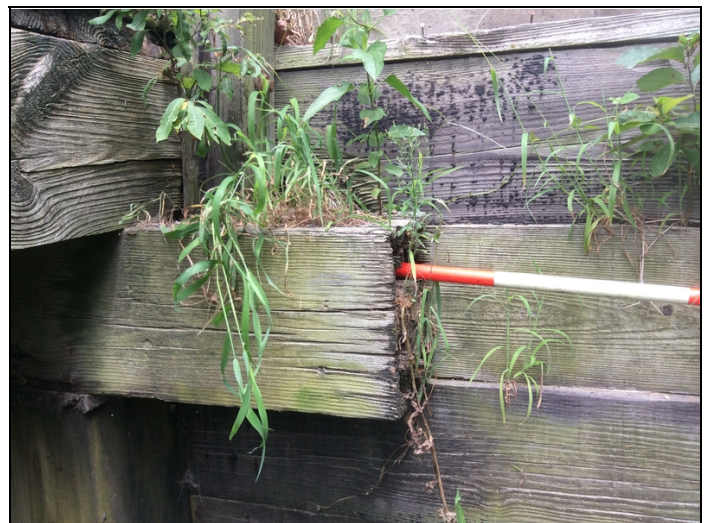
Bent 1, left end of cap, decayed and hollow 1 1/2 feet.

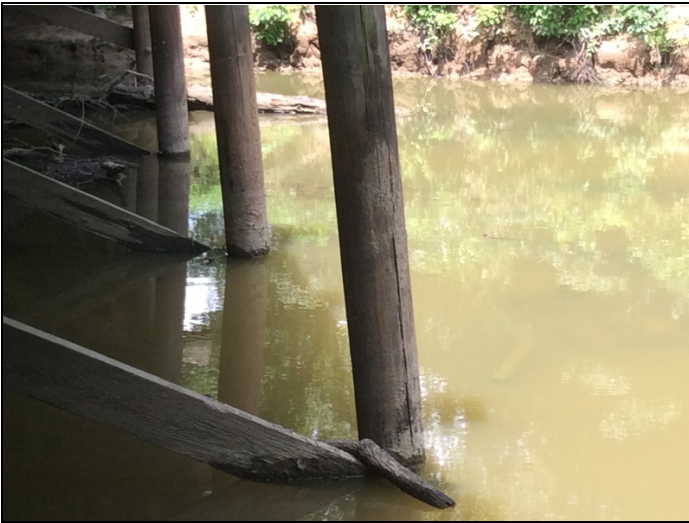
Bent 7, pile 1, large cracks.

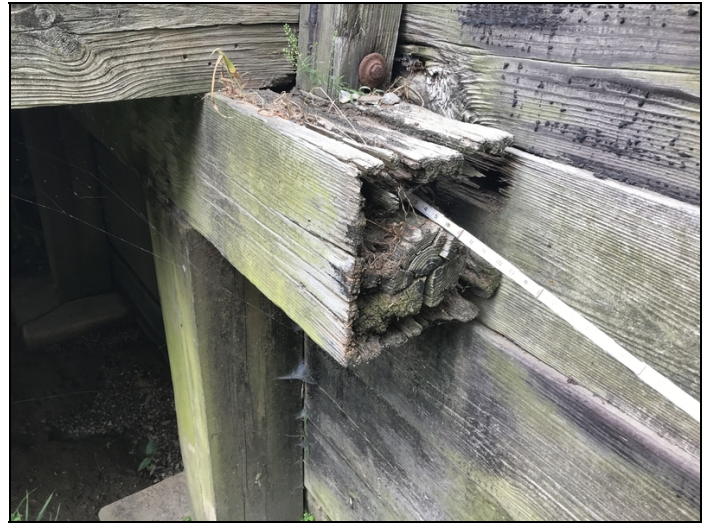
Bent 1: left end of cap hollow up to 2'-6"

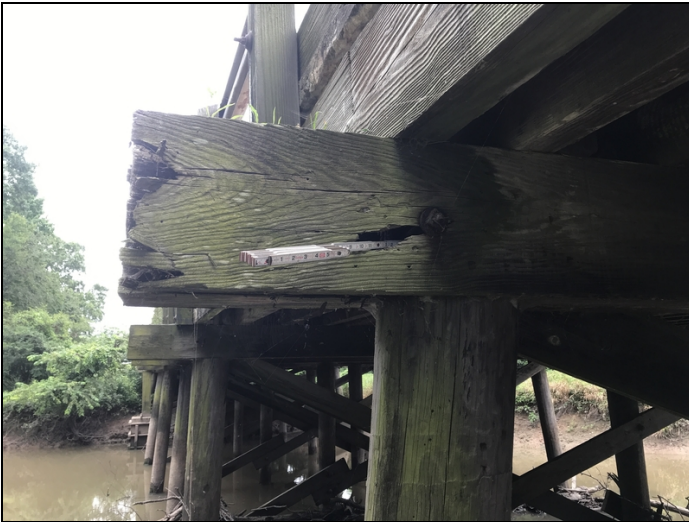
Bent 3 left end of cap is hollow past pile 1.

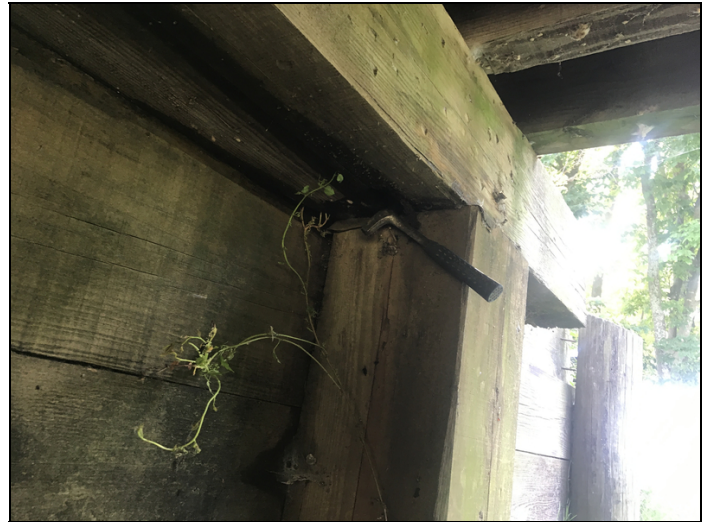
7 foot of the left end of bent 1 cap is split and hollow over pile 1.

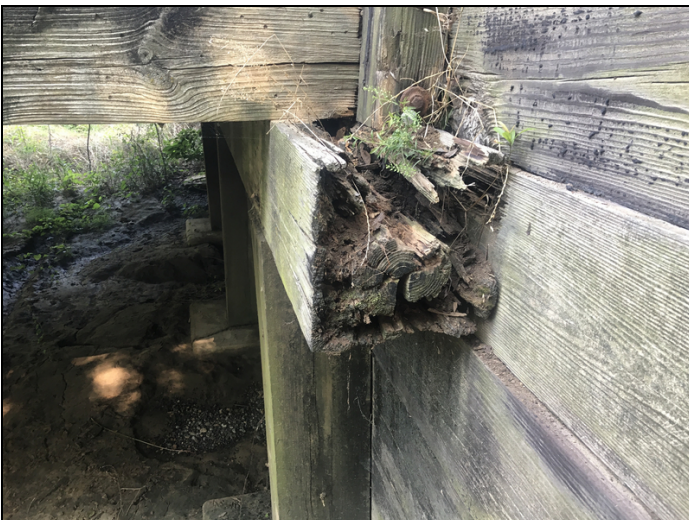
Bent 1 left end of cap is split and hollow over pile 1

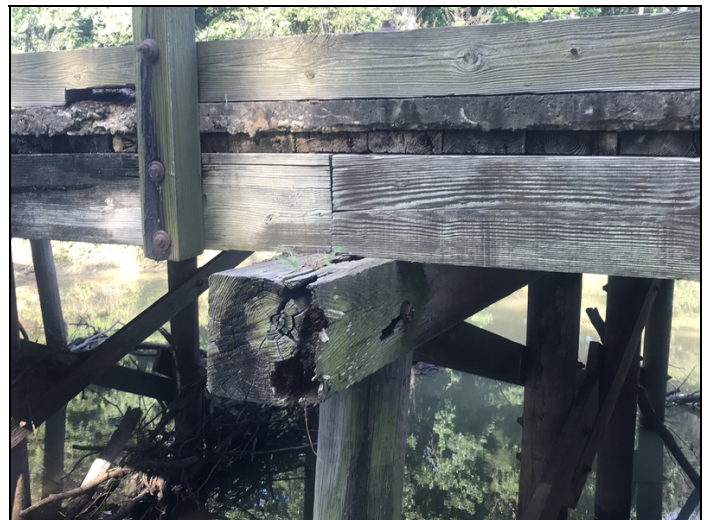
Bent 3, left end is decayed and hollow past pile 1.

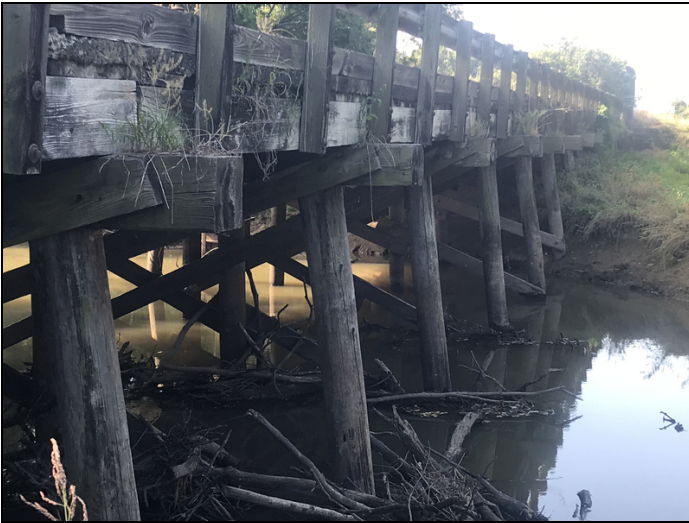
Vegetation growing out of caps

**A-64 - Vegetation Removal Requested (Yes)**

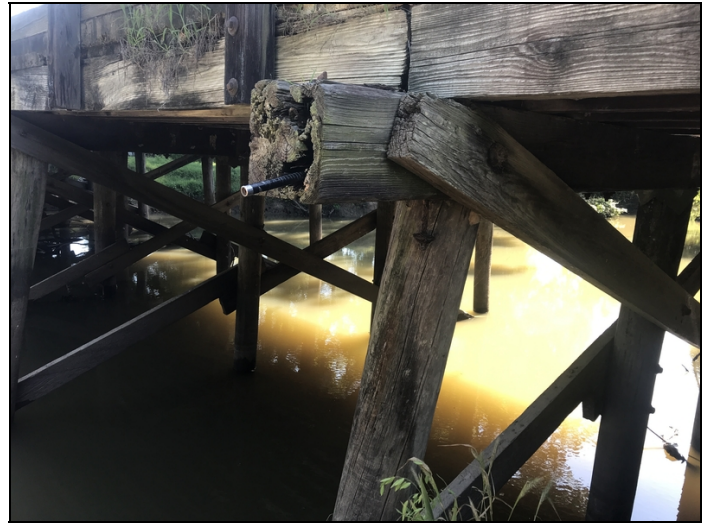
bent 8 right end of cap is decayed and hollow the 3 1/2' over pile 4

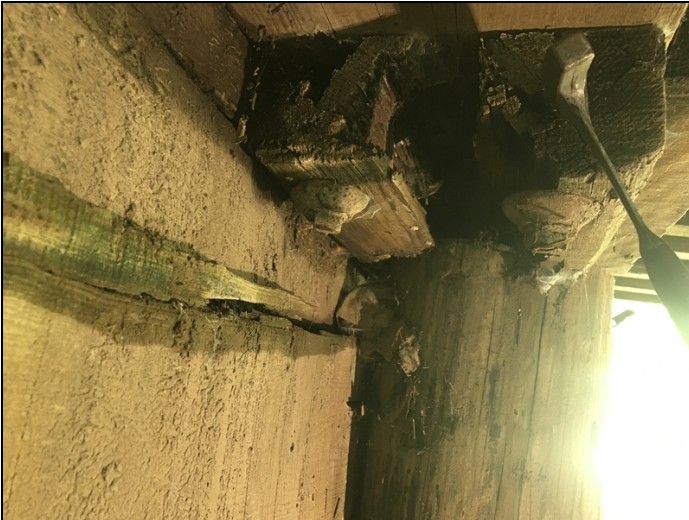
bent 17 the cap splice connection is decayed and crushing over pile 3

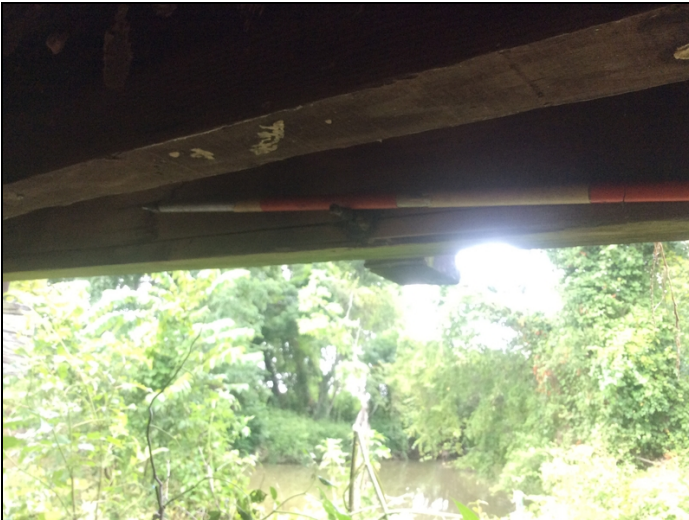
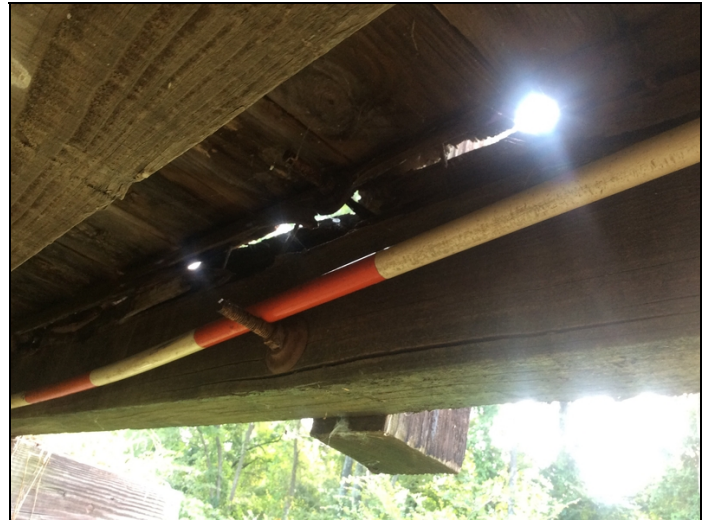
Span 16 girder 1 hollow and crushing the entire length.

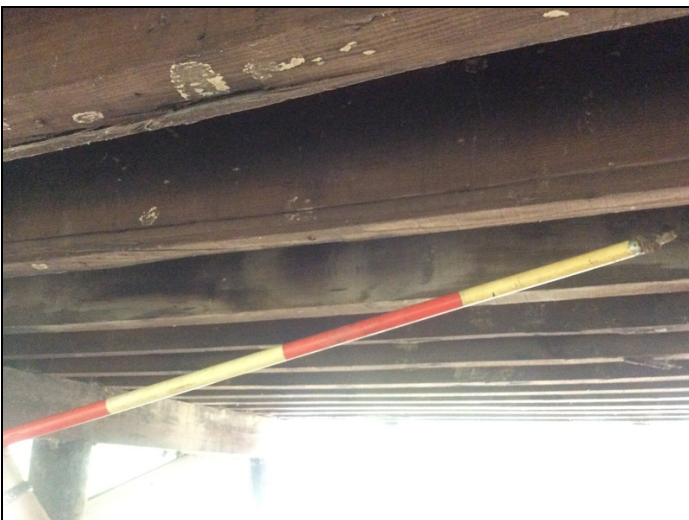
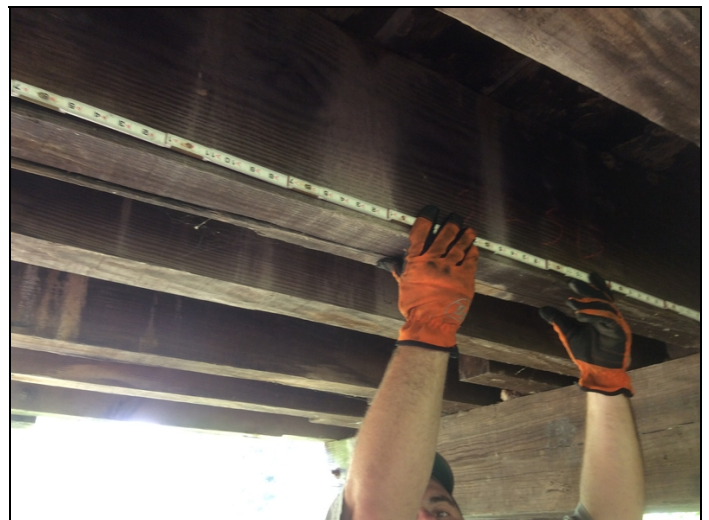
Spain 2, girder 15, cracked.

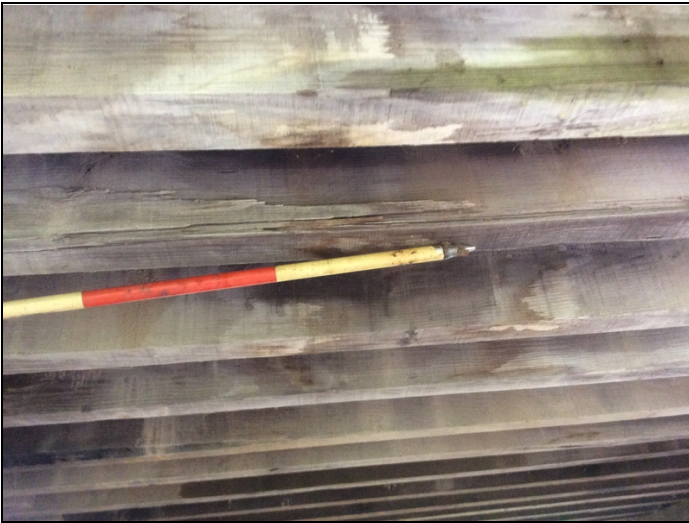
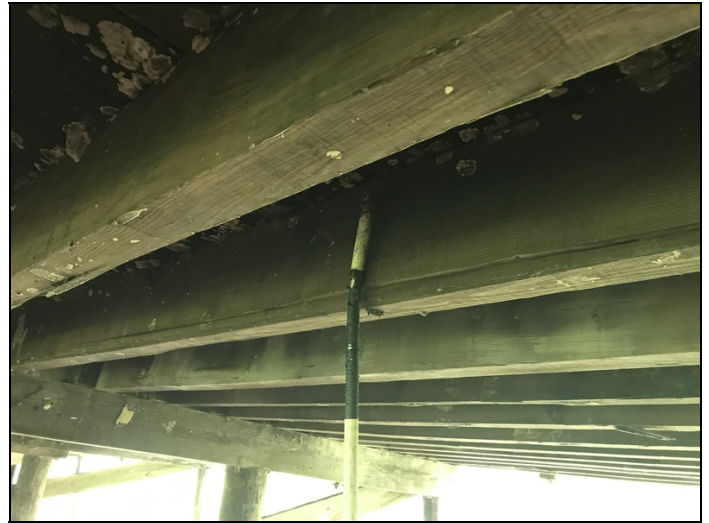
Span 13 girder 9 is cracked along 10' of bottom.

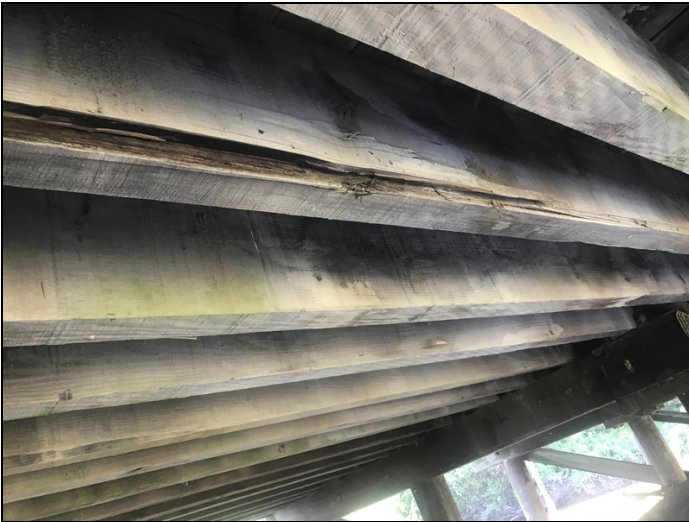
Span 2 girder 15

Span 2, girder 15 is cracked

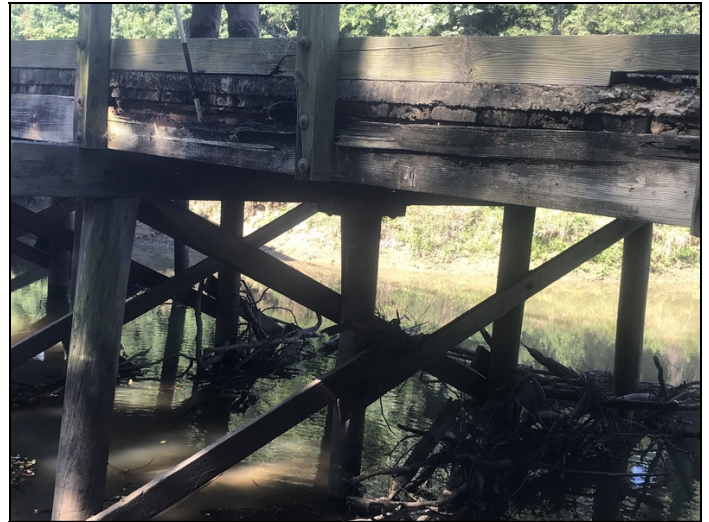
span 3 girder 1 is rotted the whole length

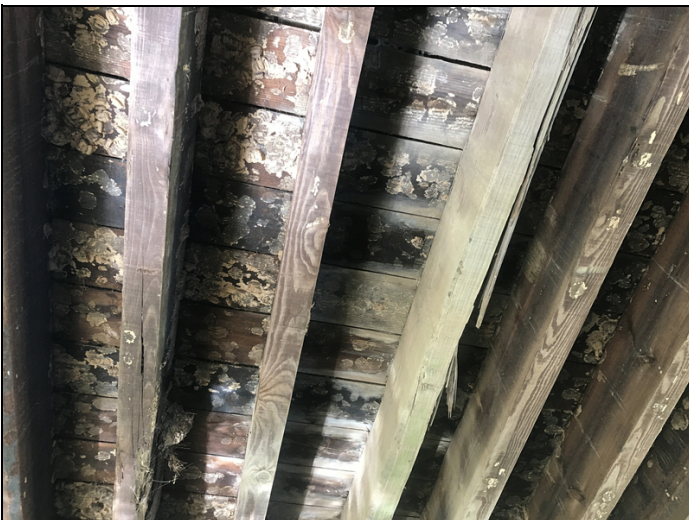
Span 4 girders 8&10 have splits and checks

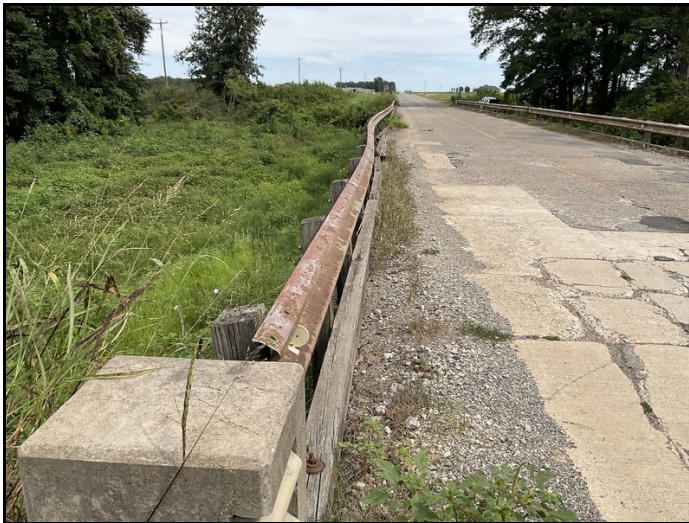
Guardrail damage on west side

Assigned to Bridge Crew 7/17/2020

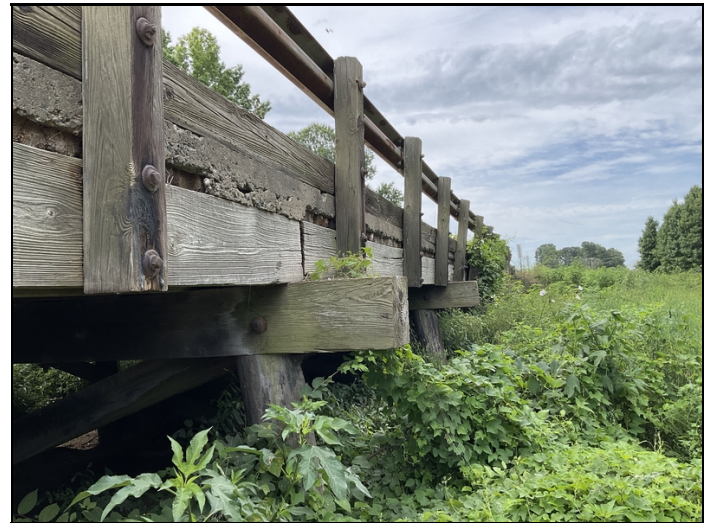
Outside girders on west side are no longer supporting the guardrail post allowing free movement

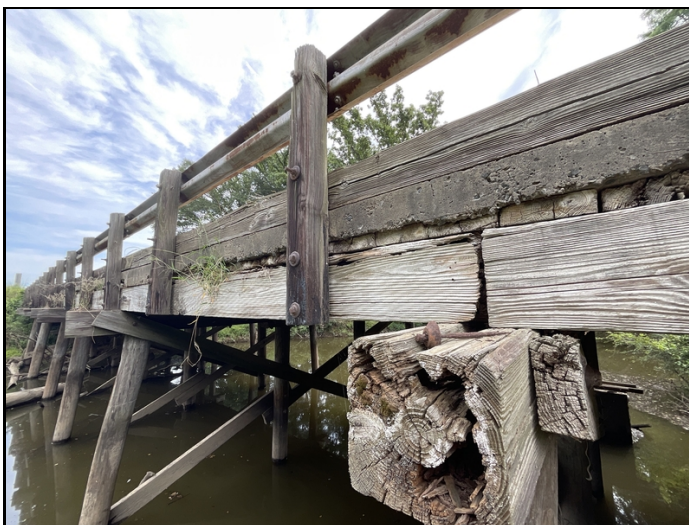
Span 7 outside girder 18 is decayed and split

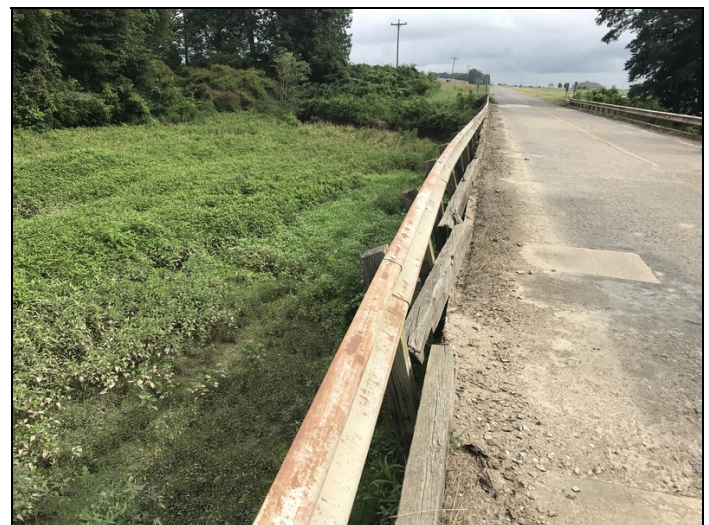
60' of bridge rail is damaged from traffic impact on right side of bridge

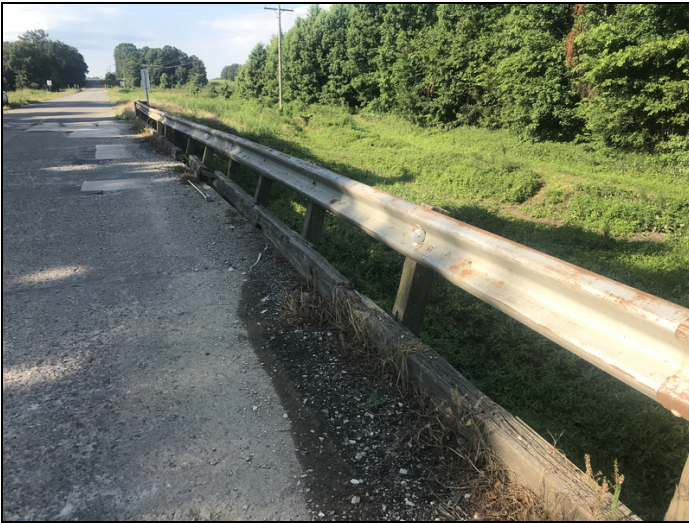
60' of bridge rail is damaged from traffic impact on right side of bridge

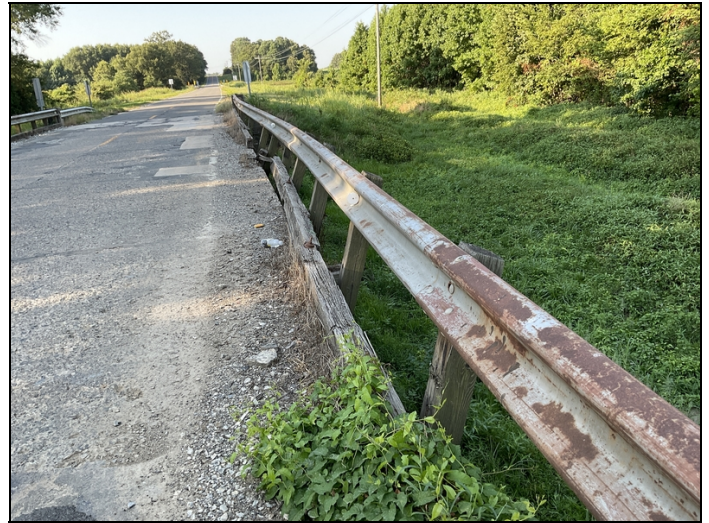
Right side bridge rail damage

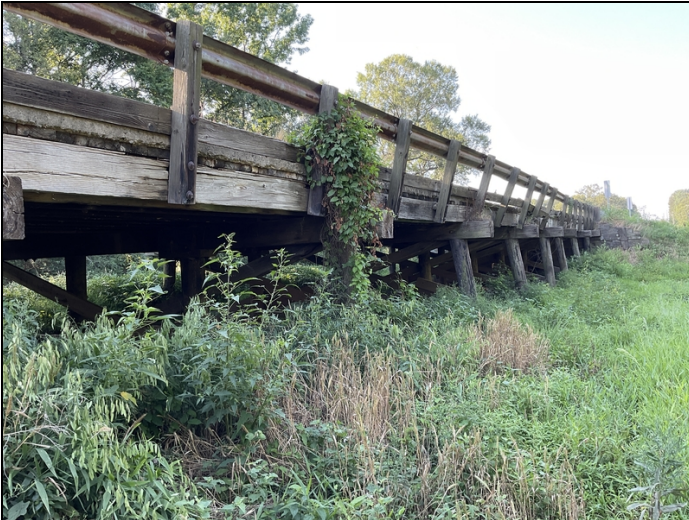
Right bridge rail damage

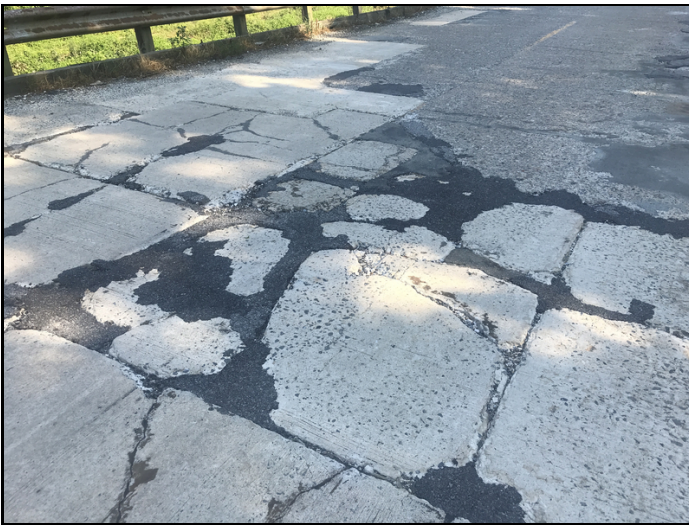
Span 16 spalls and spall filled with asphalt

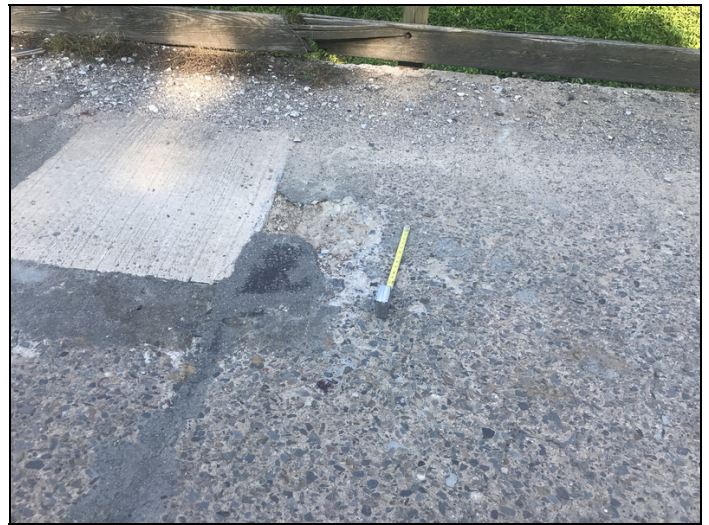
Span 12 spall

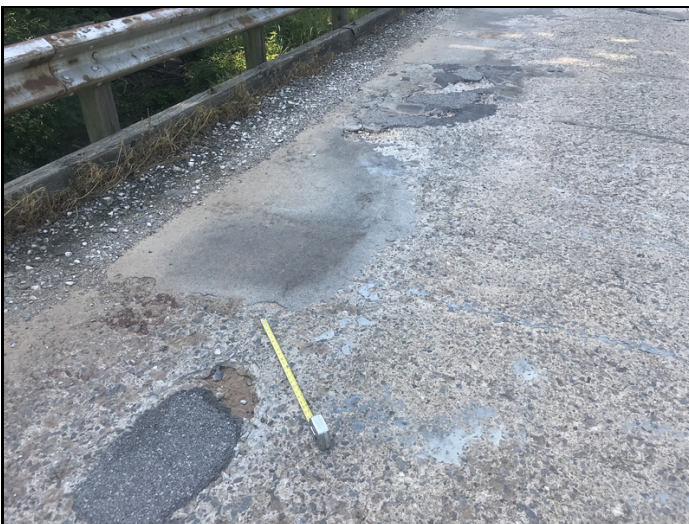
Span 14 spalls with exposed rebar

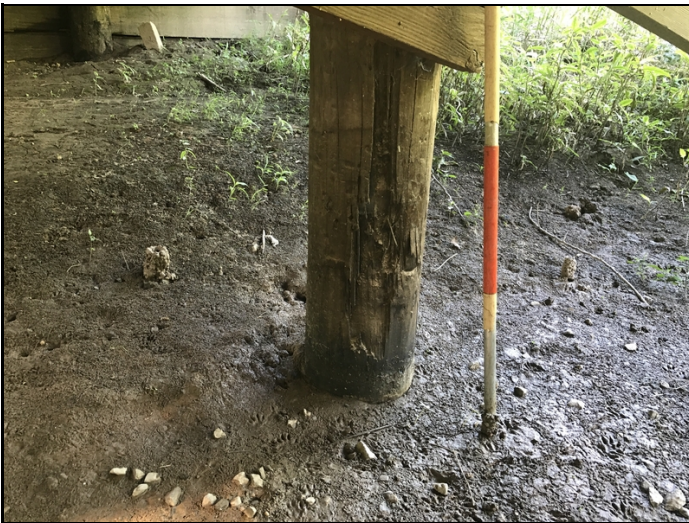
Bent 16, pile 3 with a large shake

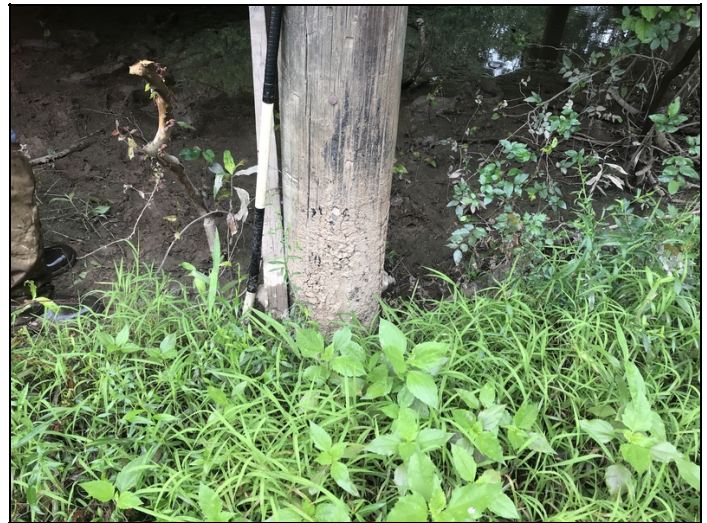
Bent 14 pile 4 is decayed on bottom 2'

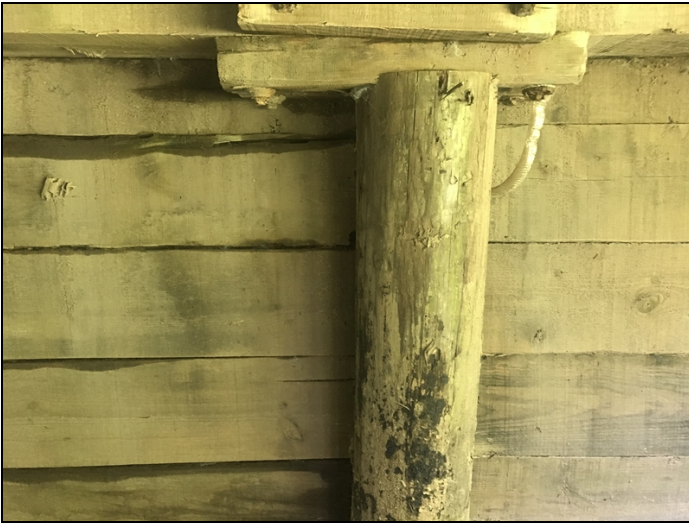
Bent 17 pile 3 is hollow at the top

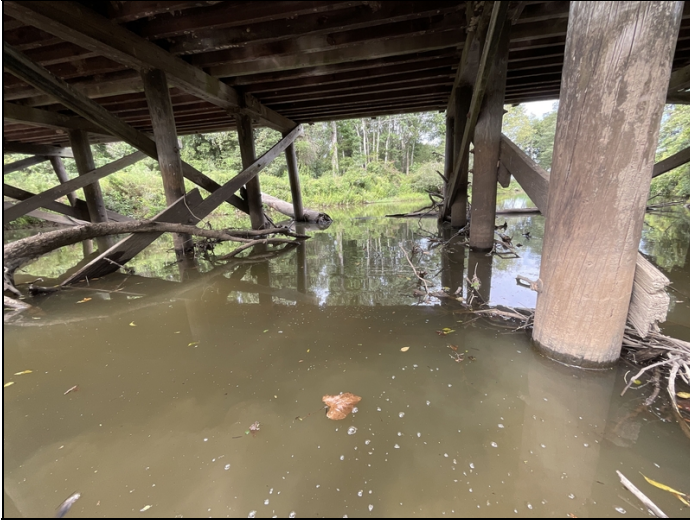
Logs and drift bents 3,4,5
