**Asset #M1582(Routine)**  
**SH 86 Log 3.92 over WATTENSAW BAYOU REL**

**Location: 3.9 MI S JCT SH 38**

**Team Lead: Bryan Saunders, Inspection Date: 10/23/2023**

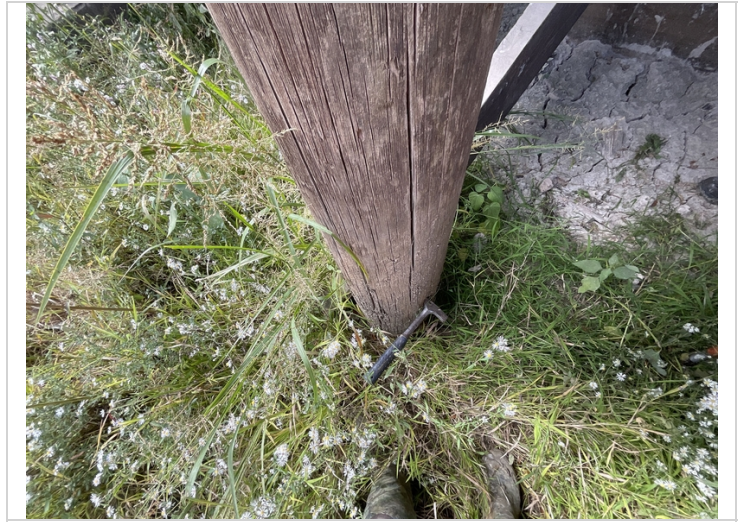
Bent 4 pile 1 is hollow at ground level

Bent 4 pile 1 is hollow

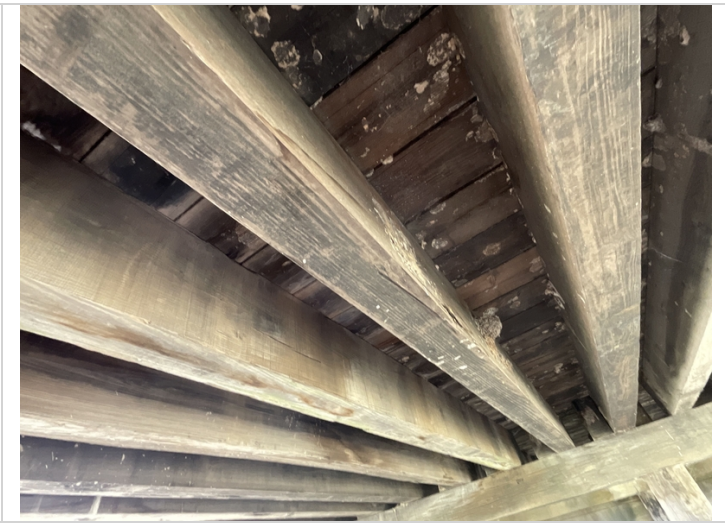
(111) Span 1 girder 15 has been replaced by state forces. Span 1 girders 8,12,13 at bent 1 are hollow on the end at bent 1. Span 2 girder 7 is split girder 15 checked and decayed. Span 3 girder 2,4,7&14 have checks girder 8 has a split Span 6 girder 7 has a check full length on the right side. Span 7 girders 2,3,4,5,6,7,8 are decayed and crushing at bent 8. Girders 9 thru 14 are beginning to decay and have fungi on the sides. All of the exterior girders in all spans are weathered and have large checks							
216	Timber Abutment	LF	92	27	22	43	0
1140	Decay/Section Loss	LF	65	0	22	43	0

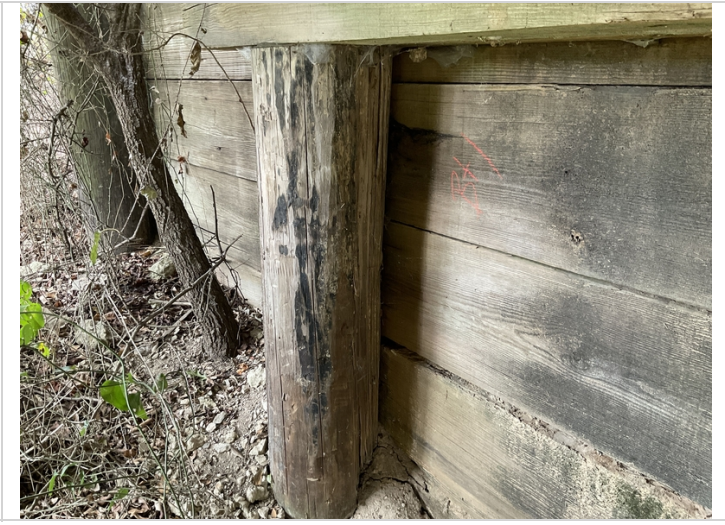
(228) Bent 1 all pile have small cracks. Pile 1 is hollow at top. And pile 4 is split whole length Bent 2 all pile have small to medium cracks. All piles have minor decay at ground line. Pile 2 is hollow at top.pile 4 is hollow in lower 3' Bent 3 all piles have cracks. Piles 2,3,& 4 have minor decay at ground line. Bent 4 pile 1 has small splits and is hollow at ground line and pile 2,3 & 4 have been replaced by state forces. See photos and update plain sketch for repairs. Update 2019: the newly placed pile 4 has a large split adjacent to the cap. Bent 5 piles 1 and 3 have been replaced by state forces pile 2 has cracks, pile 4 has cracks and decayed at ground line. Bent 6 piles 1,2,3,&4 have been replaced by state forces. The concrete collars around pile have large cracks in them. Bent 7 pile 1 is hollow,pile 2&3 are cracked, state forces have poured concrete collar around the base of pile 4. Bent 8 pile 1 has decay to outer shell at ground line, pile 2 is decayed and hollow and starting to crush pile 3&4 have small cracks.

Bent 1 pile 4 split whole length

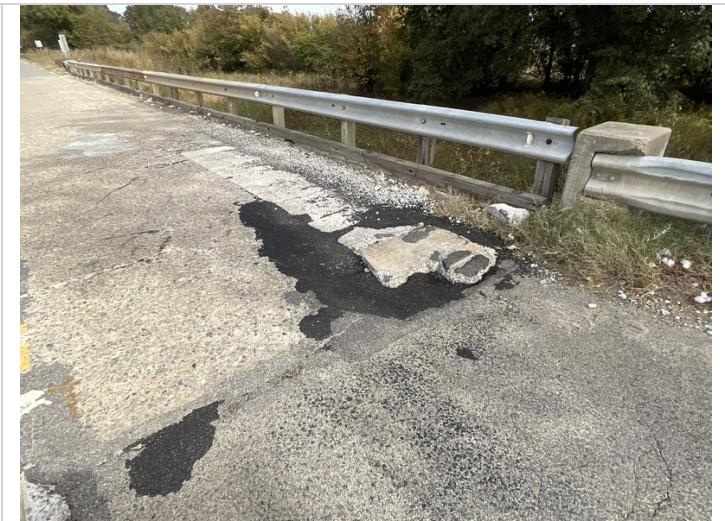
concrete patches have failed.

Patch in north bound lane has failed

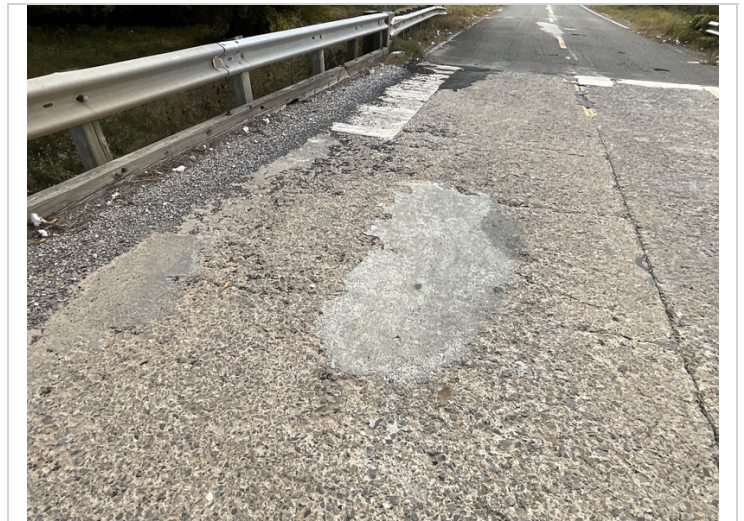
Heavy scaling in north bound lanes

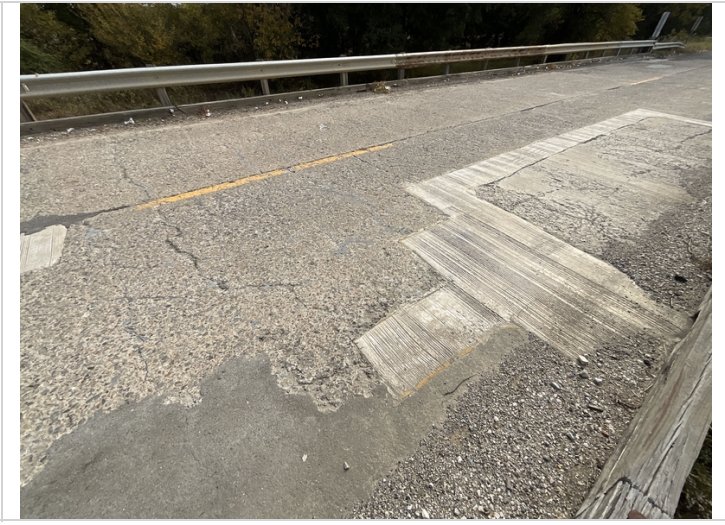
Comment: concrete deck has large cracks, large spalls and heavy scaling

Large cracks and patch areas

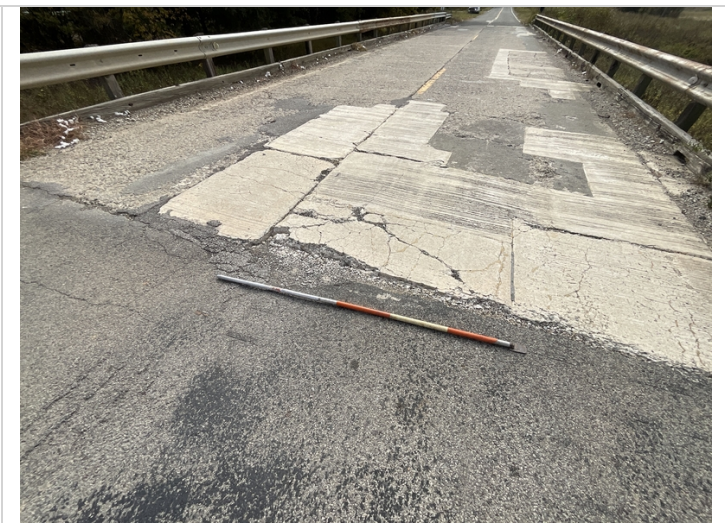
Large spall in the concrete at north end of the bridge

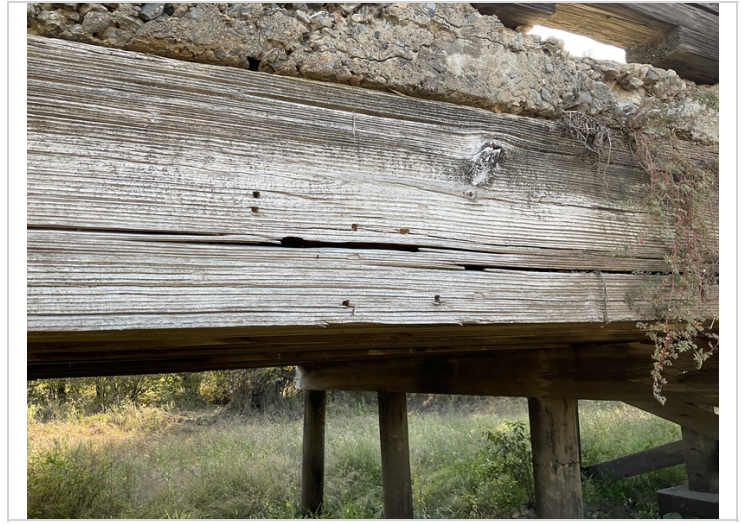
Span 2 girder 15 is hollow

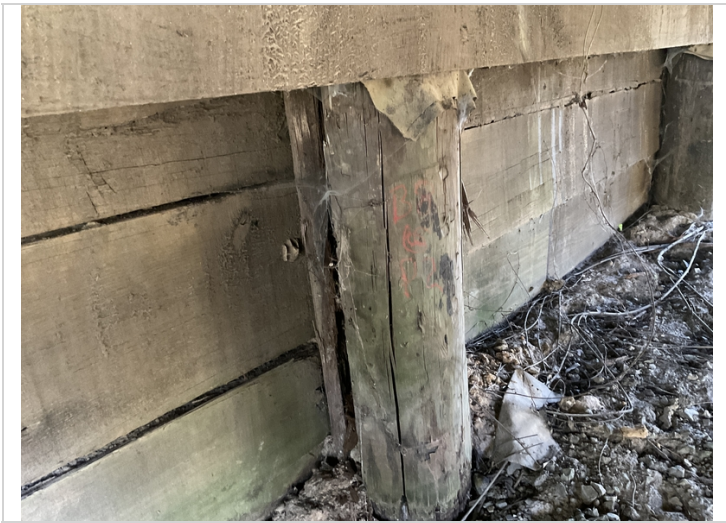
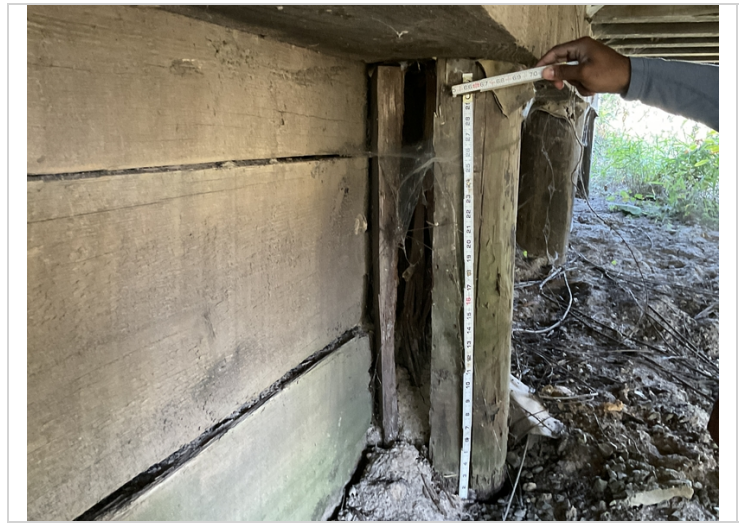
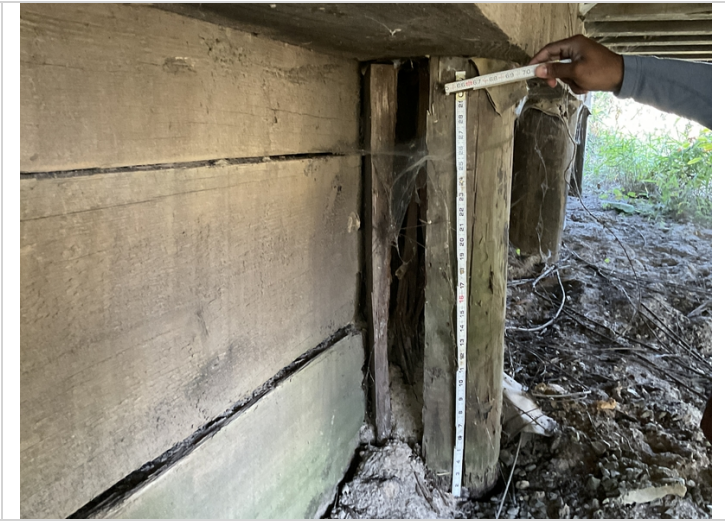
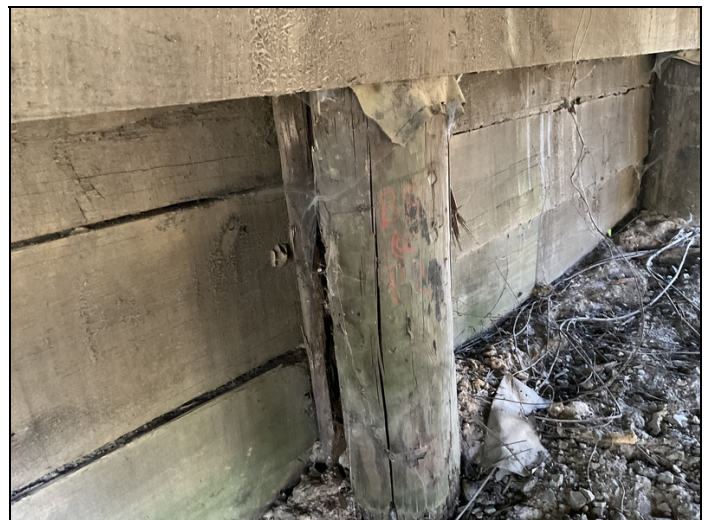
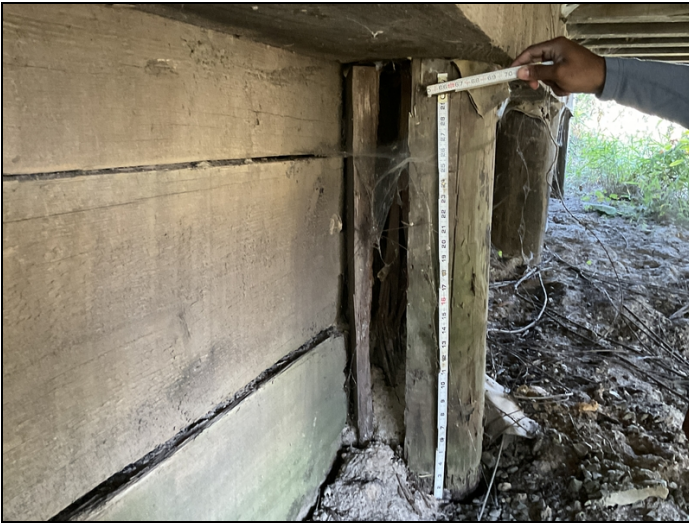
Bent 8 pile 2 has crushed and is no longer supporting the timber cap

Bent 8 pile 2 is hollow and split 2022 picture

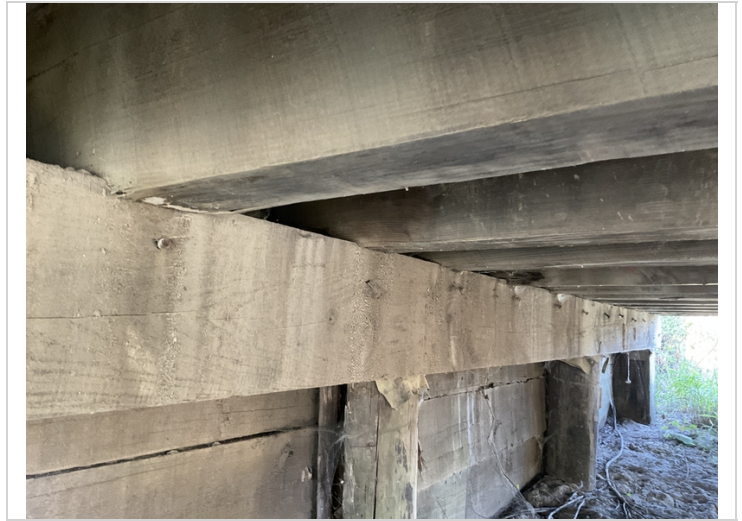
Bent 8 girder ends 2,3,4,5,6,7 and 8 are decayed

Span 7, girders 2,3,4,5,6,7 and 8 are decayed at the ends and beginning to crush.

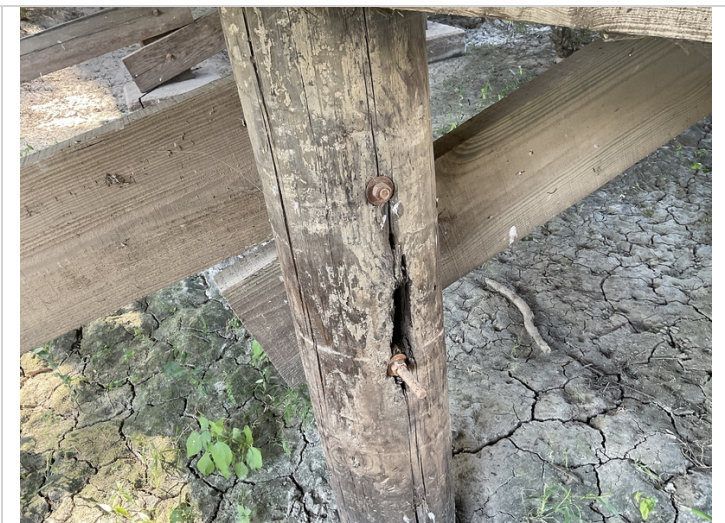
Bent 5 pile 2 backside is hollow around bolts

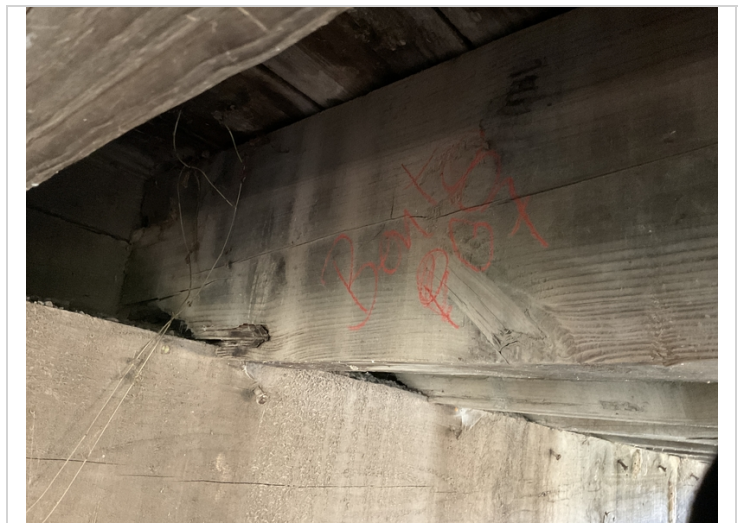
Bent 8 g7. bent 8 girders are decayed on the end

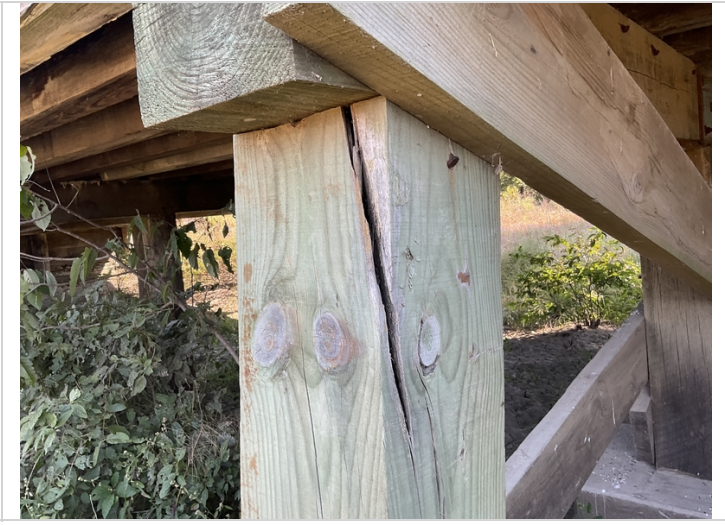
Bent 4 pile 4

Bent 4, pile 4: this is a newly placed wooden spliced pile that has a large split adjacent to the cap

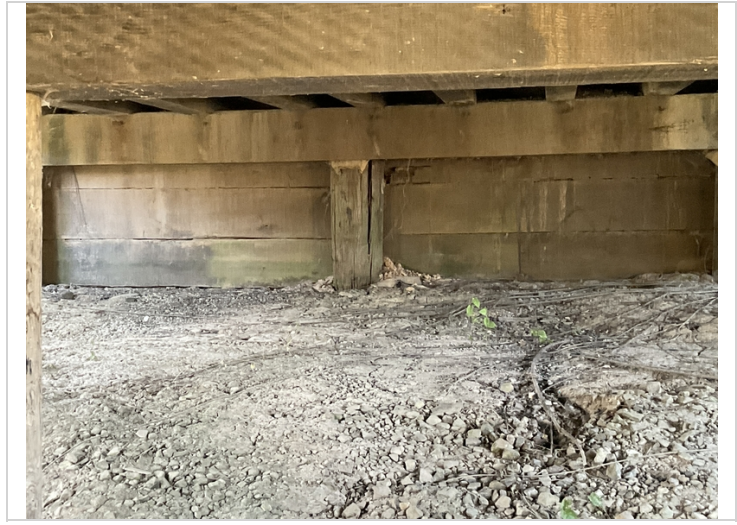
Bent 8 abutment pile 2 is split at the top and hollow

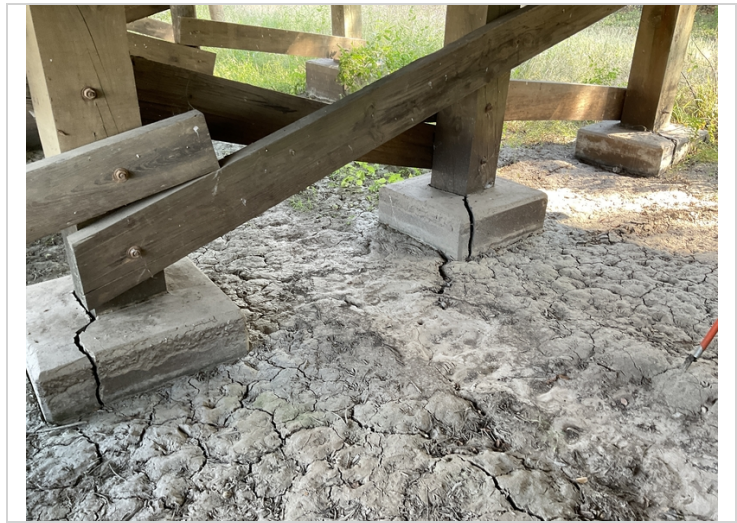
Concrete collars around the bottom of the pile at bent 6 have cracked and split

Bent 6, all concrete collars have large cracks.

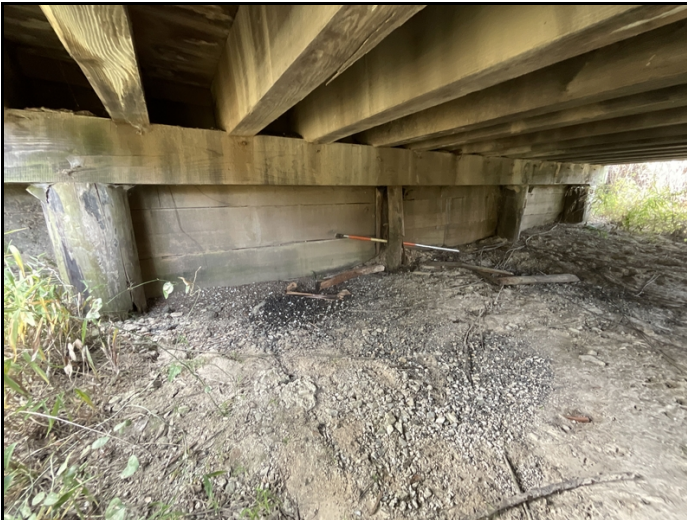
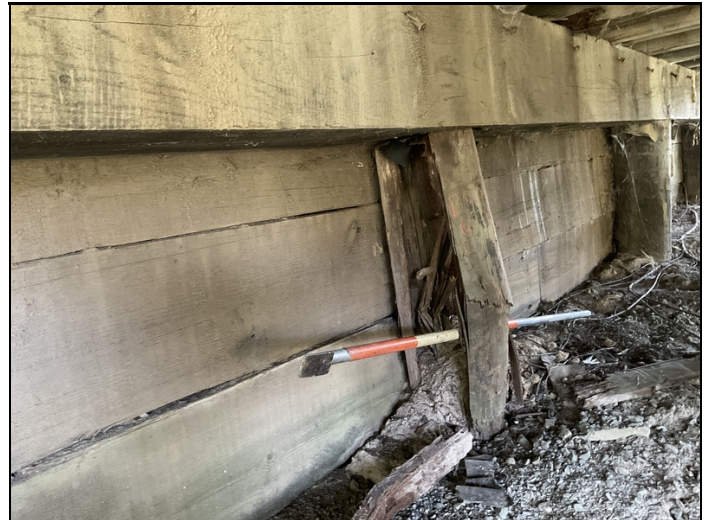
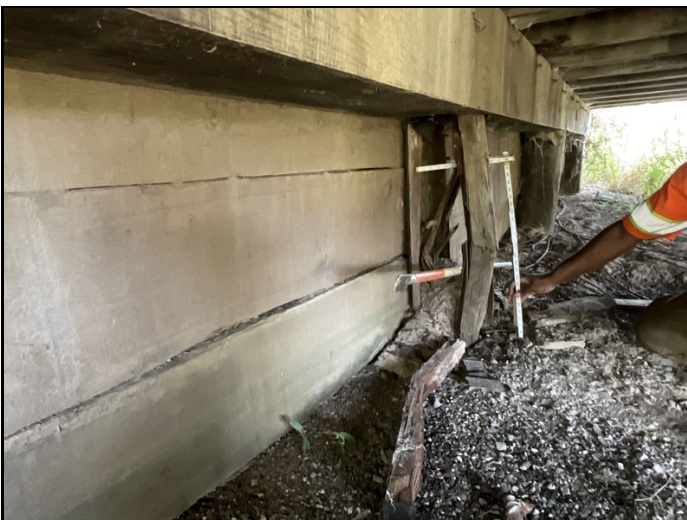
Bent 8 abutment timber pile 2 has crushed and failed and no longer supports the timber cap above the pile this is an interior pile in a 4 pile system

Bent 8 pile 2 has failed and is crushed

**Type of Work:** Piling Repair/Replace

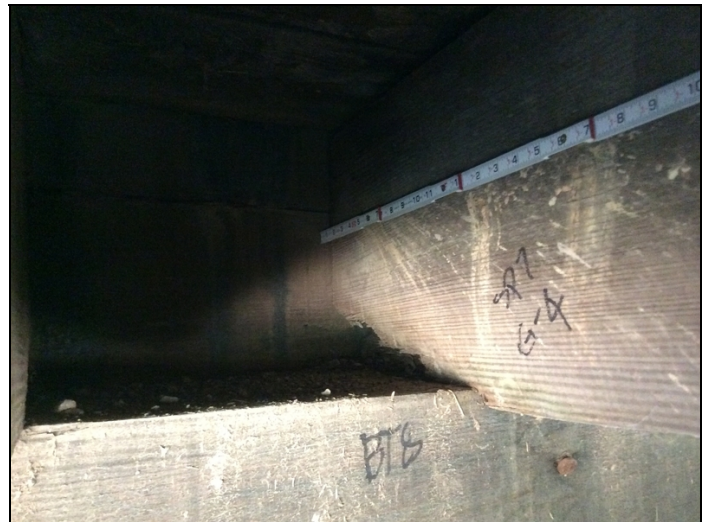
Span 7 girder 4, crushing at bent 8

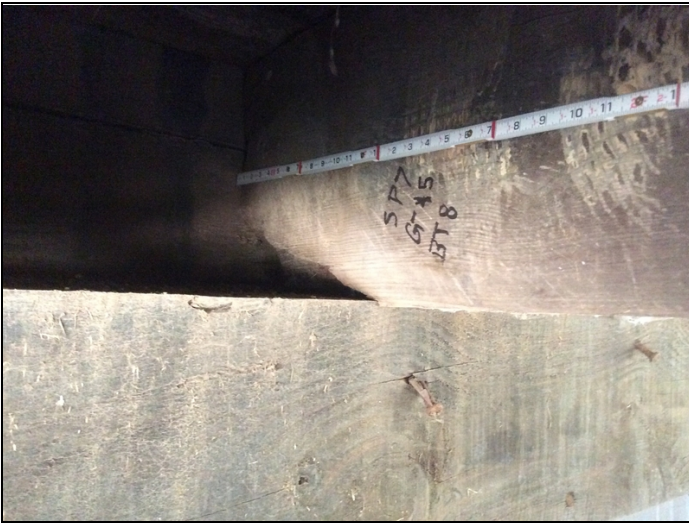
Span 7 girder 5 at bent 8, crushing.

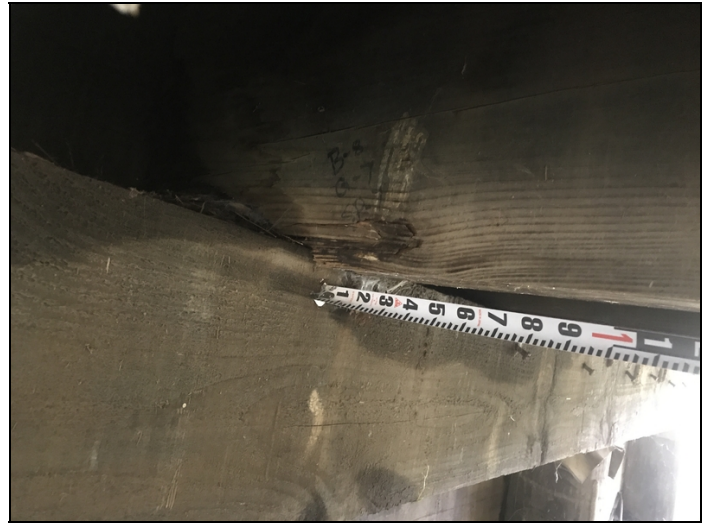
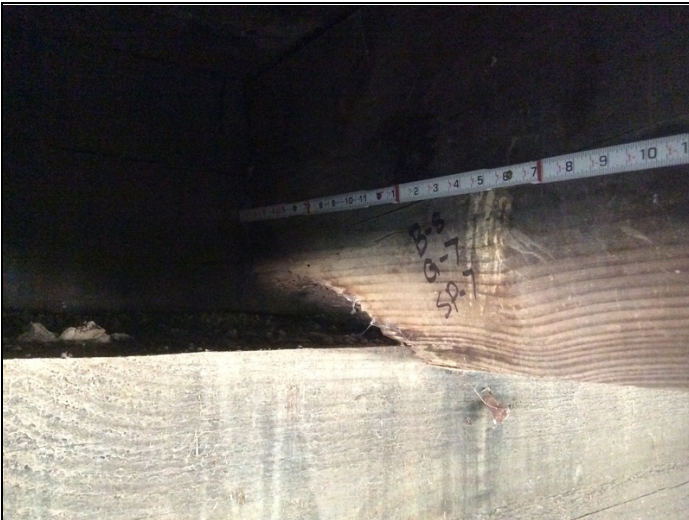
Span 7, girder 7 at bent 8, crushing.

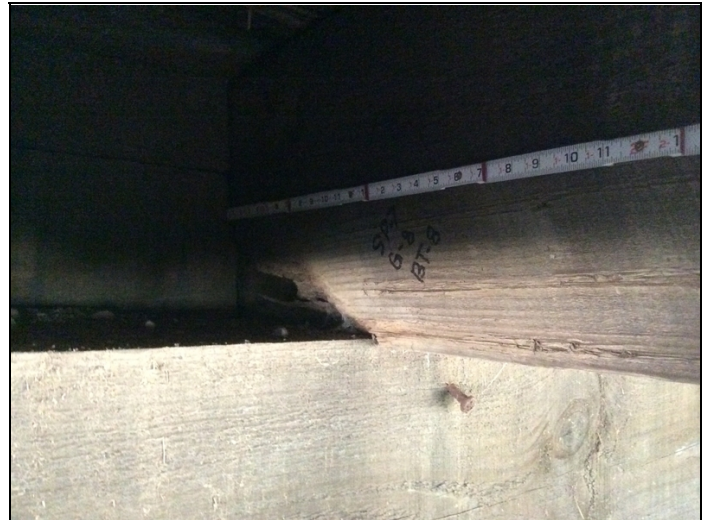
Span 7, girder 8 at bent 8, crushing.

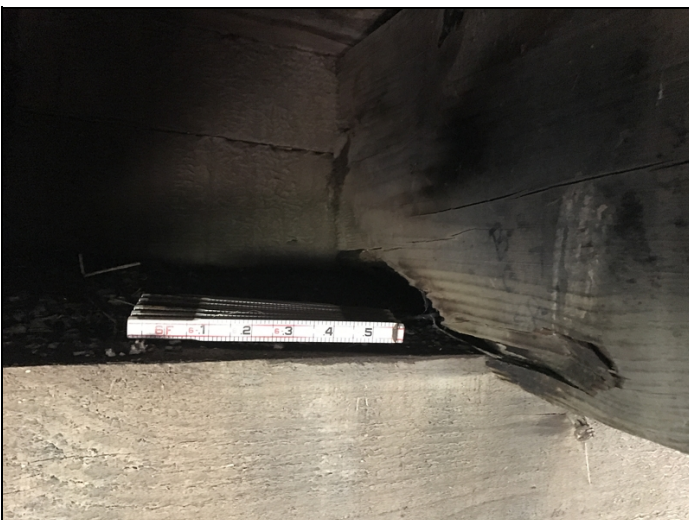
Girder 7 is decayed and crushing

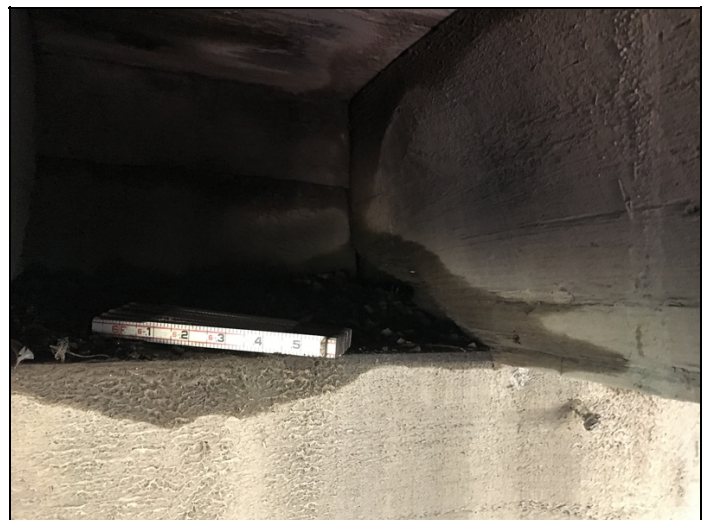
Girder 8 is decayed and crushing

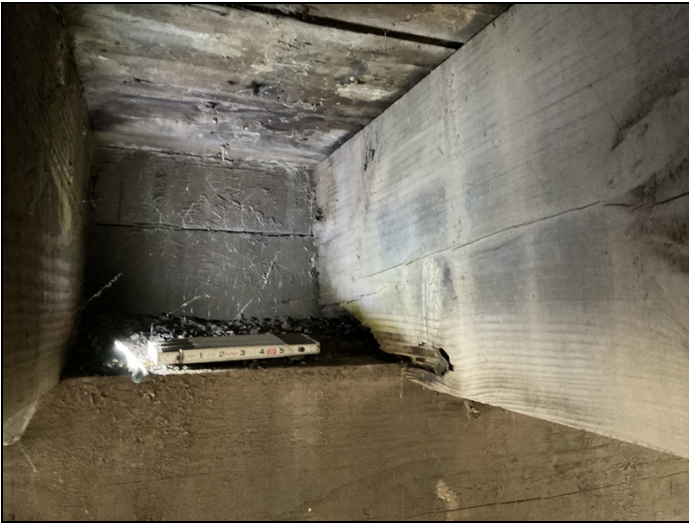
Span 7 girder 8 at bent 8, decayed and crushing

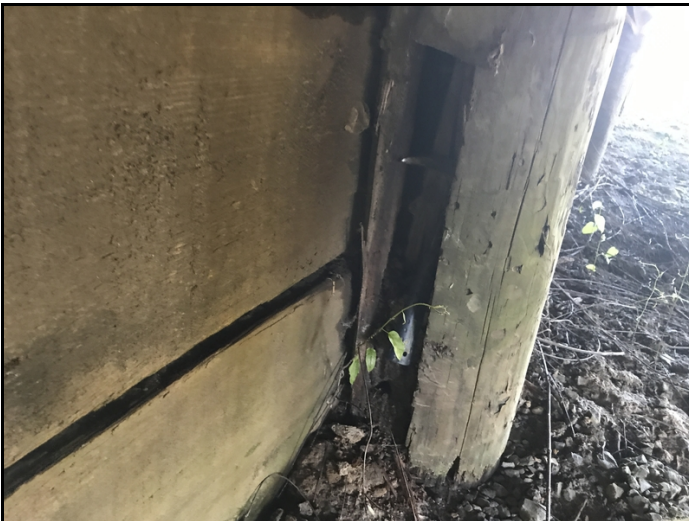
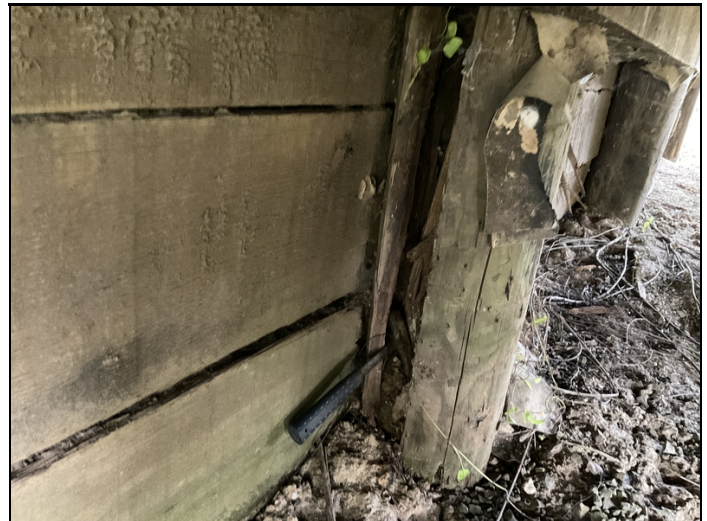
Bent 8 pile 1 is hollow, pile 2 is hollow and decayed (worst case this bridge)

Bent 8 pile 2 hollow and decayed. Worst case this bridge.

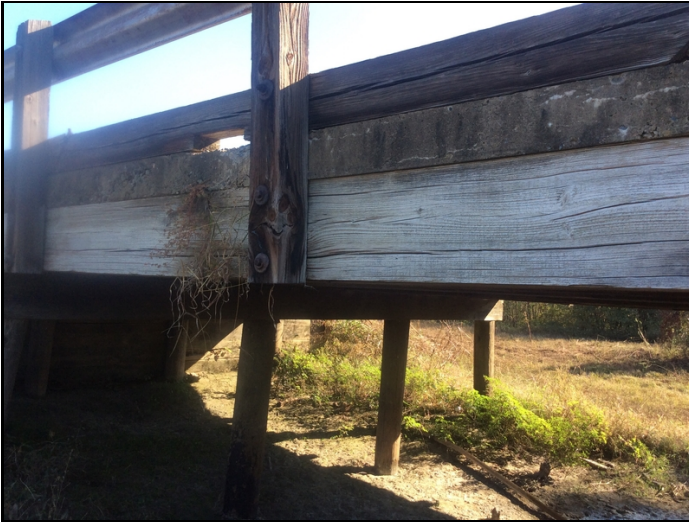
Span 1 girder 1, span 2,3,4,5,6 & 7 girders 1 and 15 are split and decayed.

Span 2 girder 15 decayed and split.

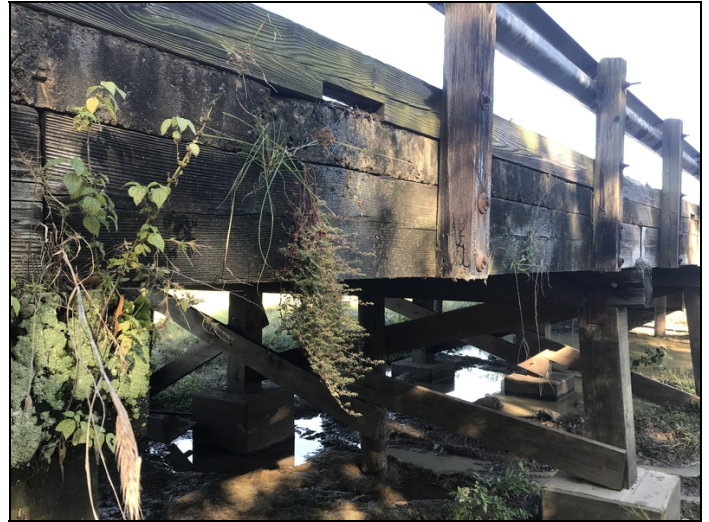
Span 5 girder 1, Typical outside girder condition

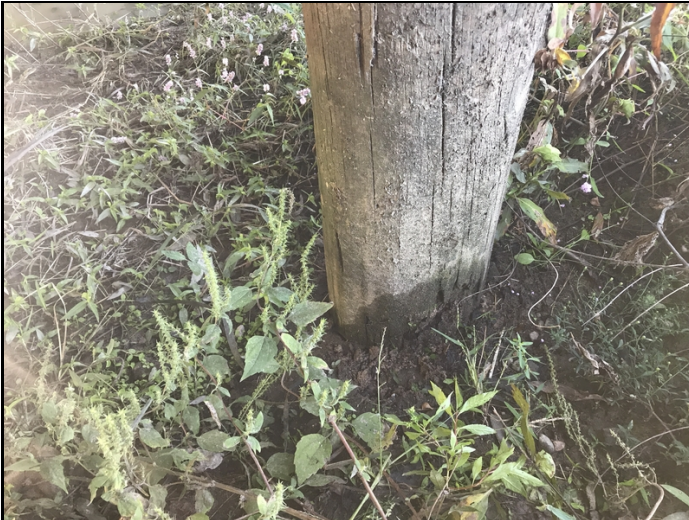
Bent 2 all piles have minor decay at ground line

Bent 2 pile 4 minor decay at ground line.

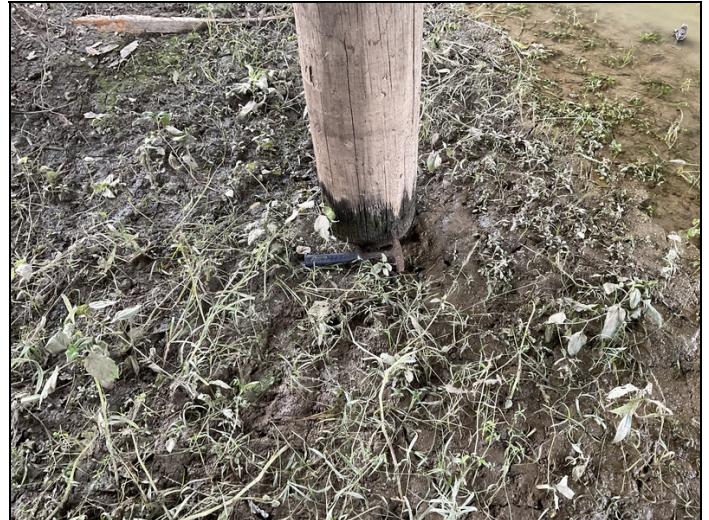
Bent 2 pile 2 has minor decay at ground line

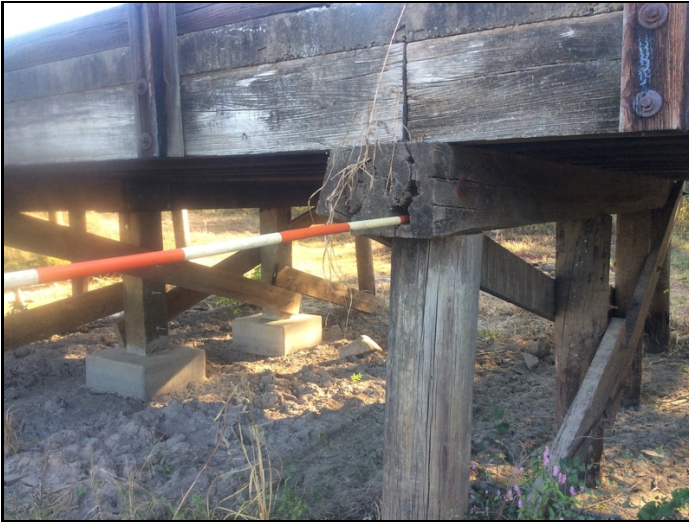
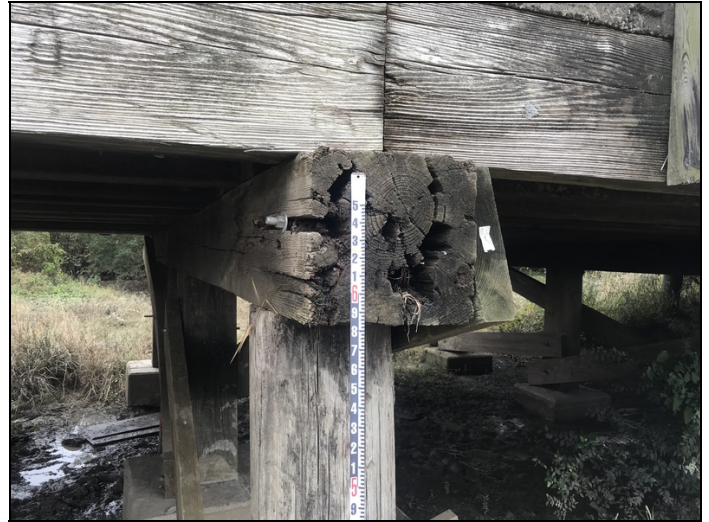
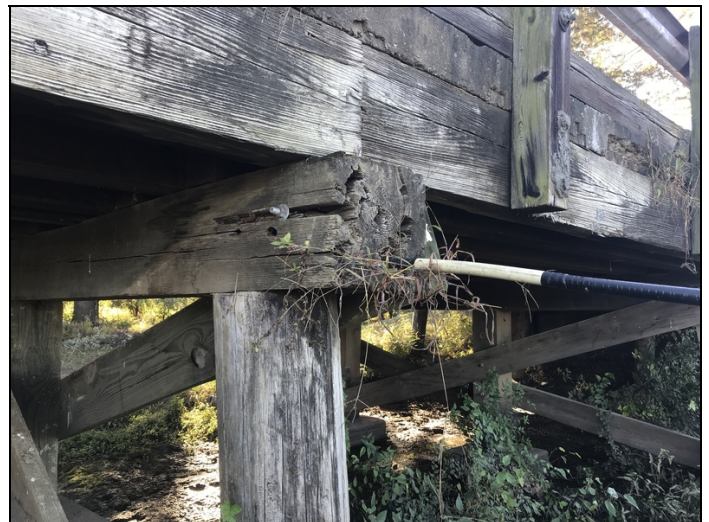
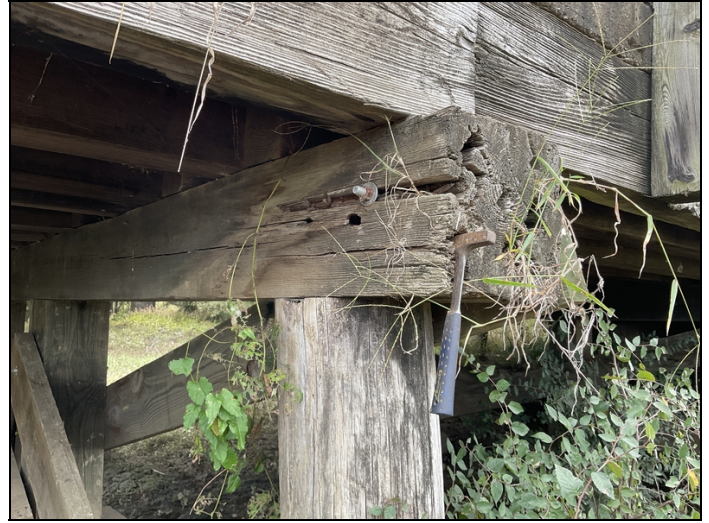
The end of caps at bents 1,2,3,4,5,6,7 & 8 are decay on the ends up to one foot.

Bent 5 right end of cap decayed and hollow up to one foot.

Bent 5: right end of cap is hollow

Bent 5 right end of cap is decayed and hollow up to 20"

Bent 5 right end of cap is decayed up to 20"

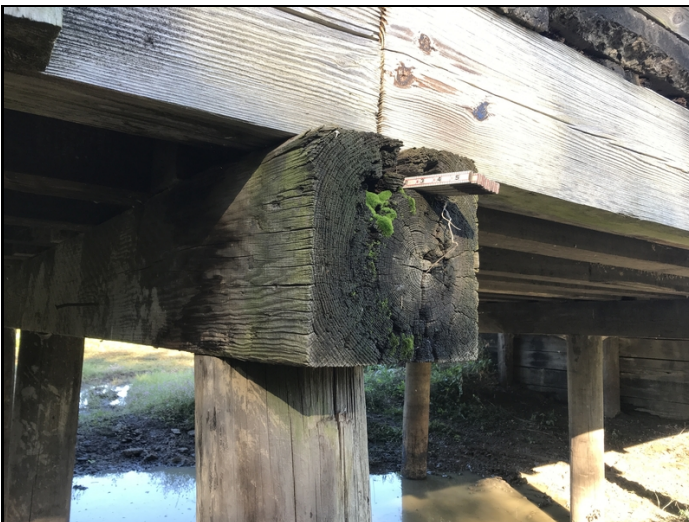
Bent 3 left side of cap is decayed.

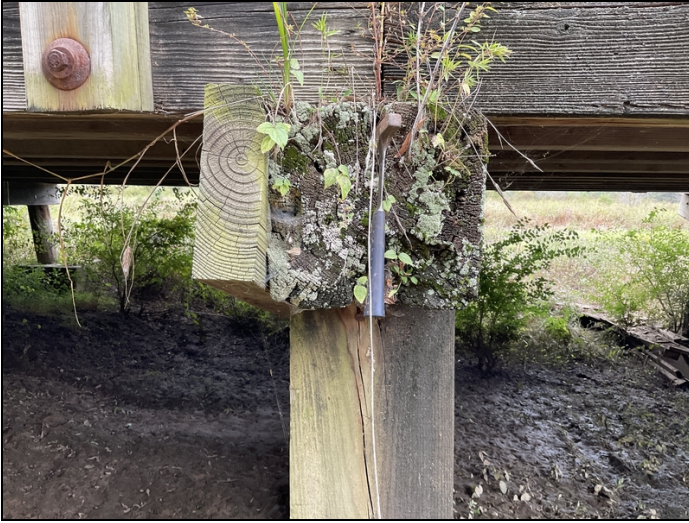
Bent 6 left end of cap is decayed 1'

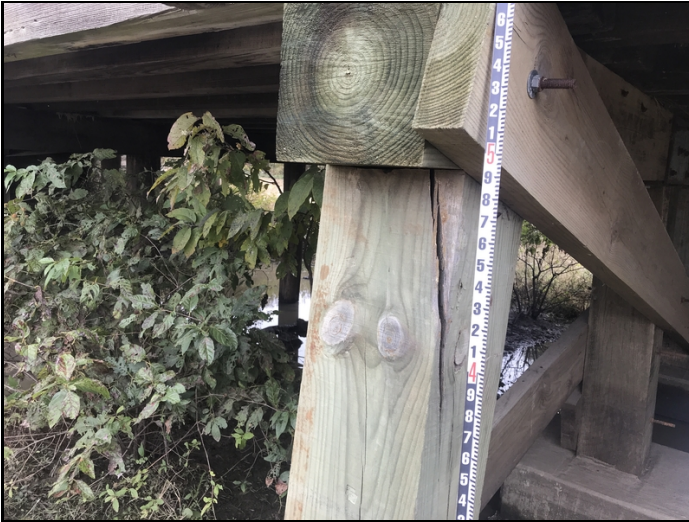
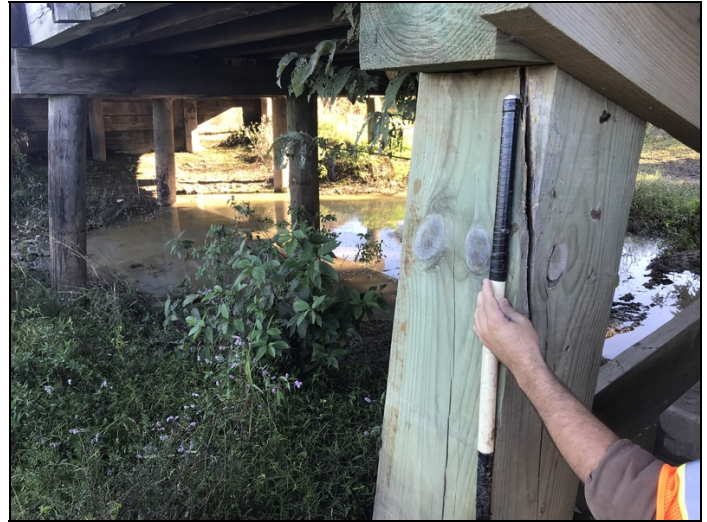
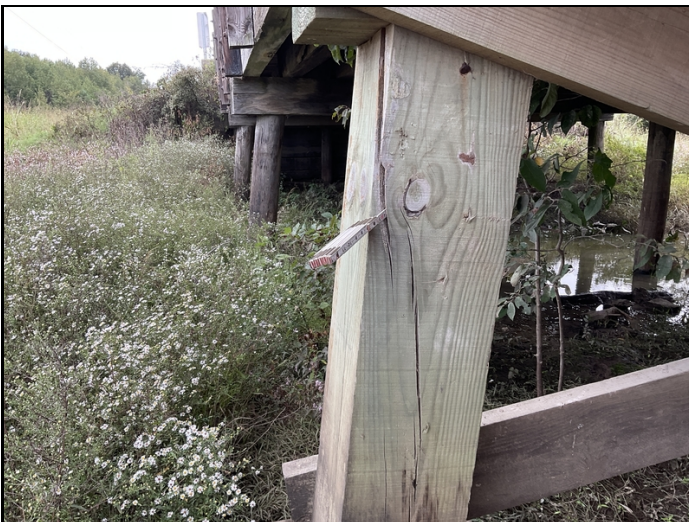
Bent 4, pile 4: this is a newly placed wooden spliced pile that has a large split adjacent to the cap

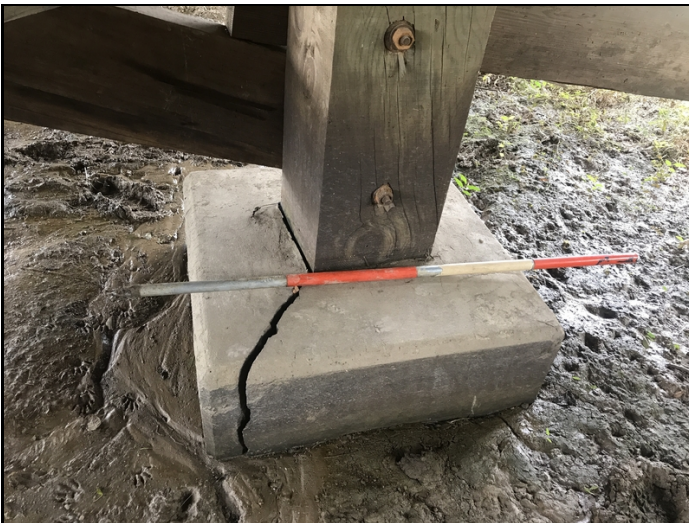
Bent 6, pile 2: concrete collar with large crack. Similar condition at pile 1 at this bent

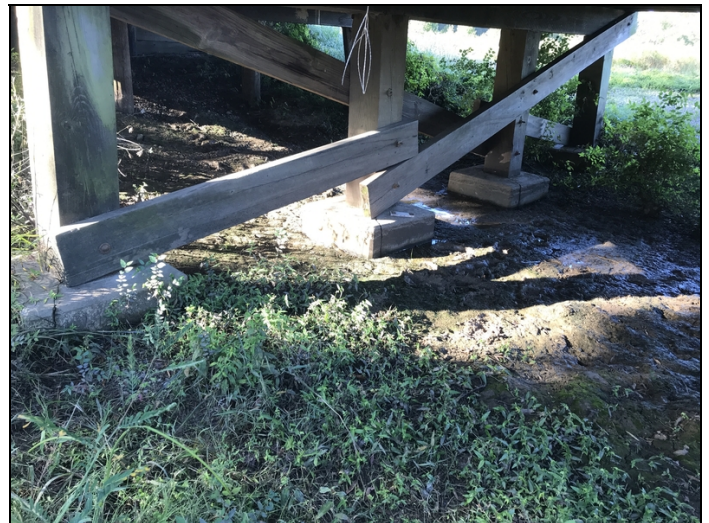
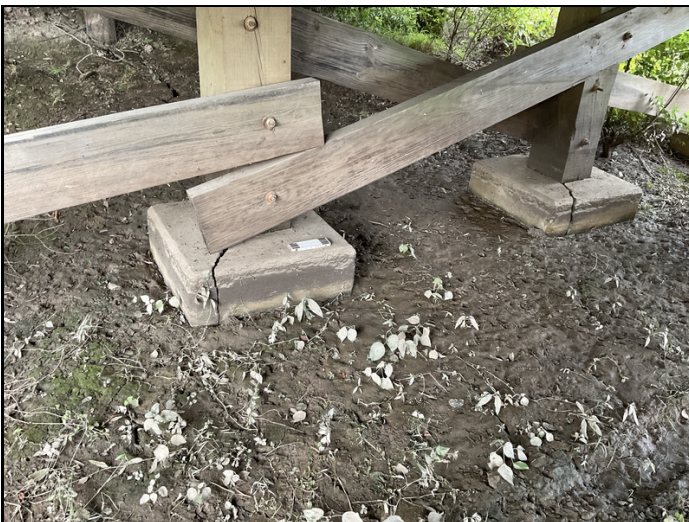
Bent 6, all concrete collars have large cracks.

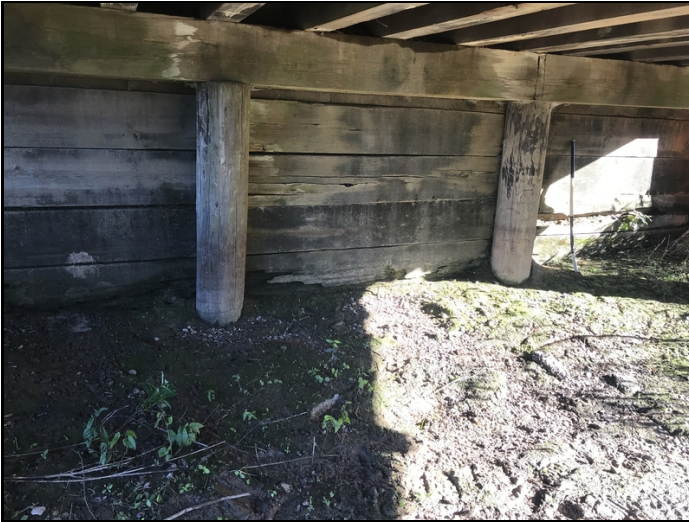
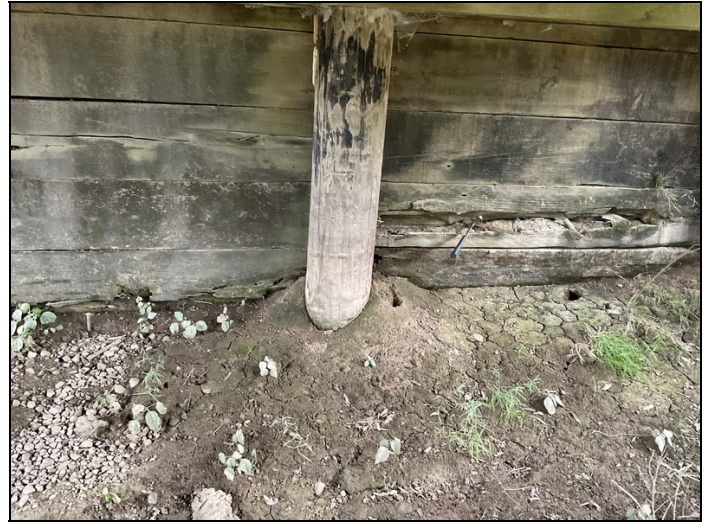
Timber cribbing at bents 1 & 8 have scattered areas of decay.

Timber cribbing at bent 1 is decayed.
