Asset #01858(Routine)

US 63 Log 10.07 over WOLF BAYOU

Location: 2.5 M N OF SH 86 WEST

Team Lead: Bryan Saunders, Inspection Date: 06/07/2023

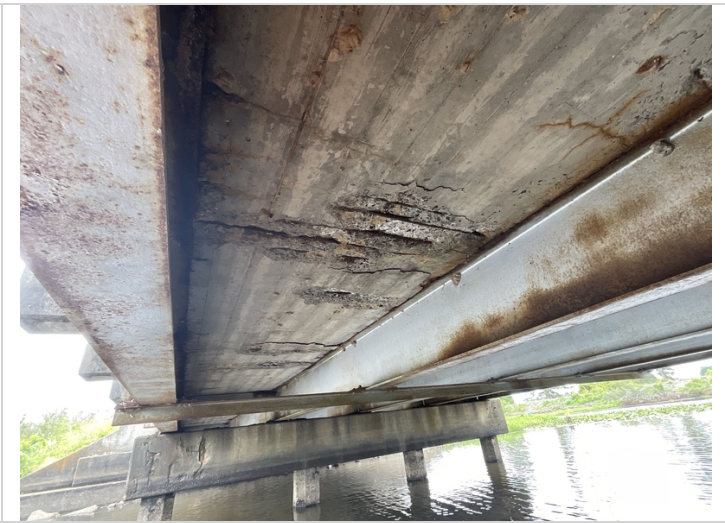
Span 2 between beam 1 and 2

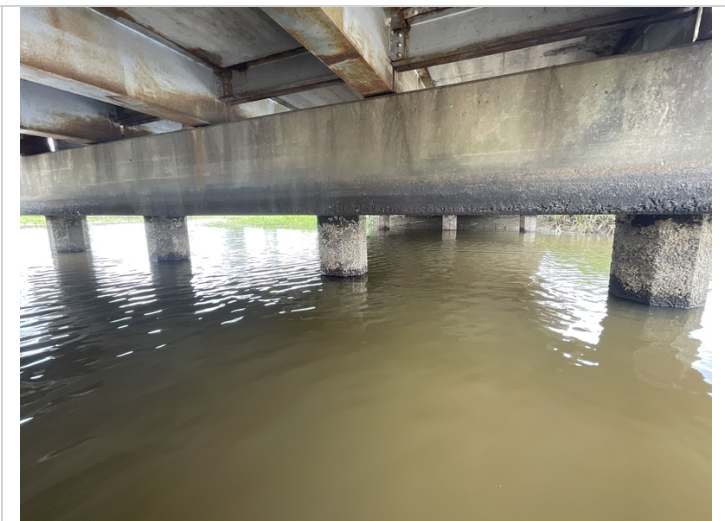
(215) Both abutments have random cracks..							
227	Reinforced Concrete Pile	EA	8	0	0	8	0
1190	Abrasion/Wear (PSC/RC)	EA	8	0	0	8	0
(227) all pile have abrasion (1190-227) All pile have heavy coarse abrasion							
234	Reinforced Concrete Pier Cap	LF	48	0	44	4	0
1080	Delamination/Spall/Patched Area	LF	34	0	34	0	0
1090	Exposed Rebar	LF	4	0	0	4	0
1130	Cracking (RC and Other)	LF	10	0	10	0	0

Heavy abrasion to piles at bents 2 and 3

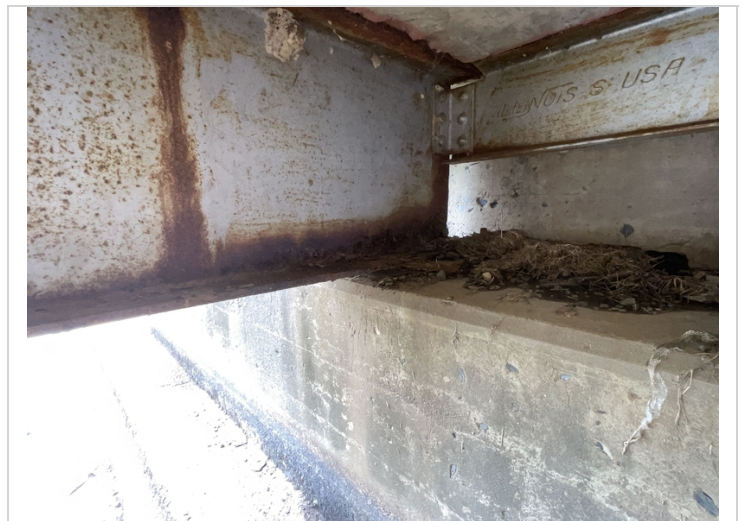
Bent 4 beam 1 lower flange and bottom of the web has pitting up to 3/16"

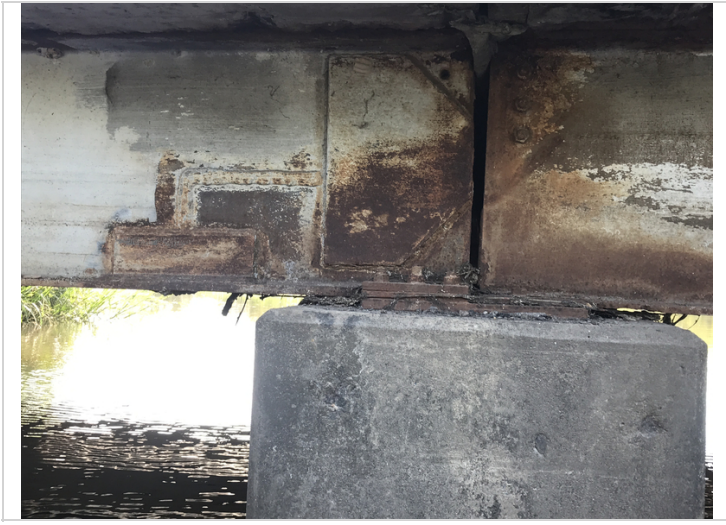
T-splice repair span 2 beam 5

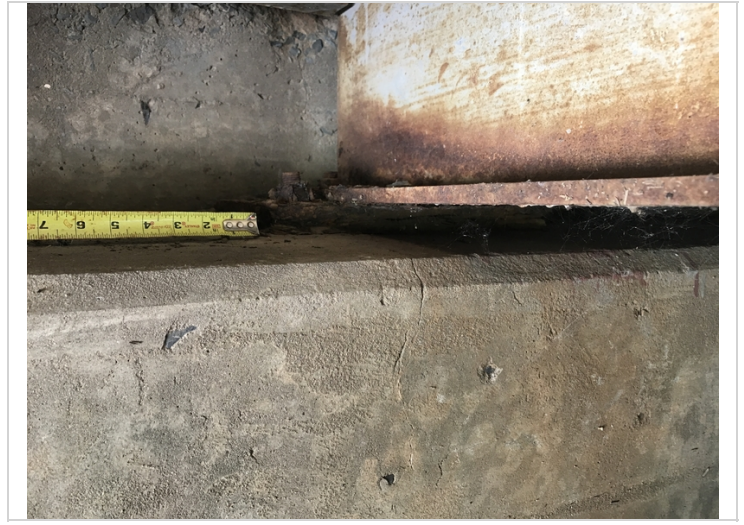
bearing at Beam 4 at bent 4 laminating rust

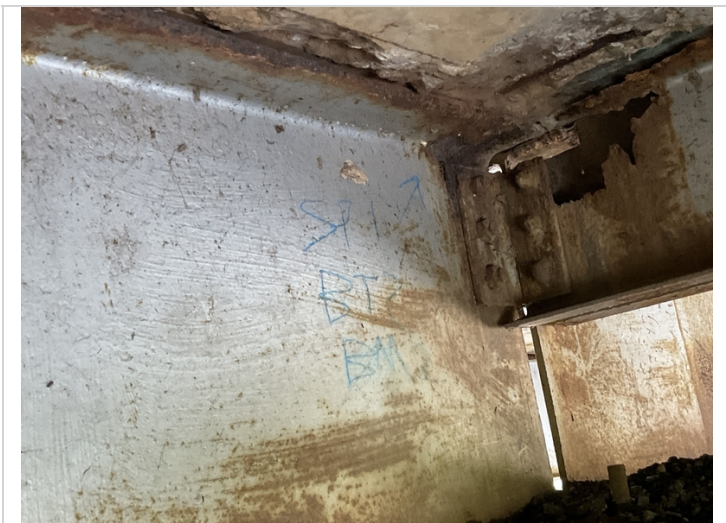
Bent 2 sp1 bm 2 hole in upper web

Bent 2 span 1 beam 2 hole in the upper web.

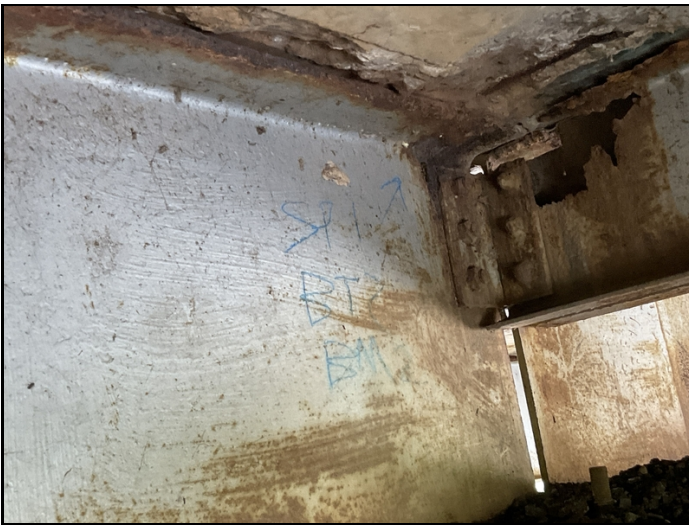
Bent 2 sp1 bm 2 hole in upper web

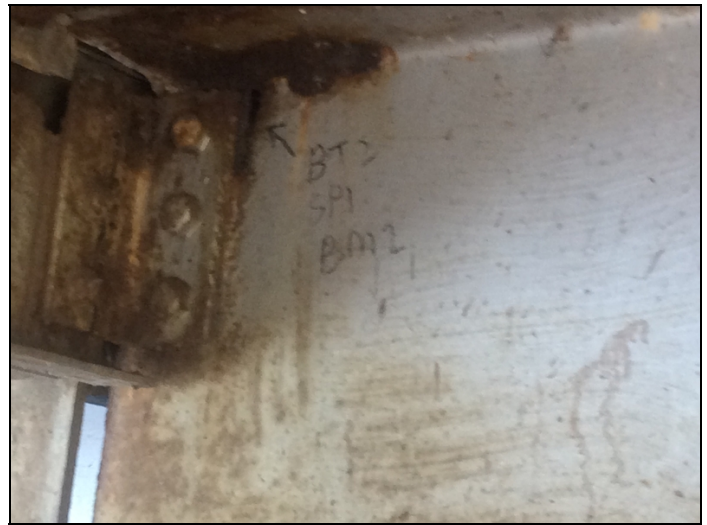
Bent 2 span 1 beam 2 hole in the upper web.

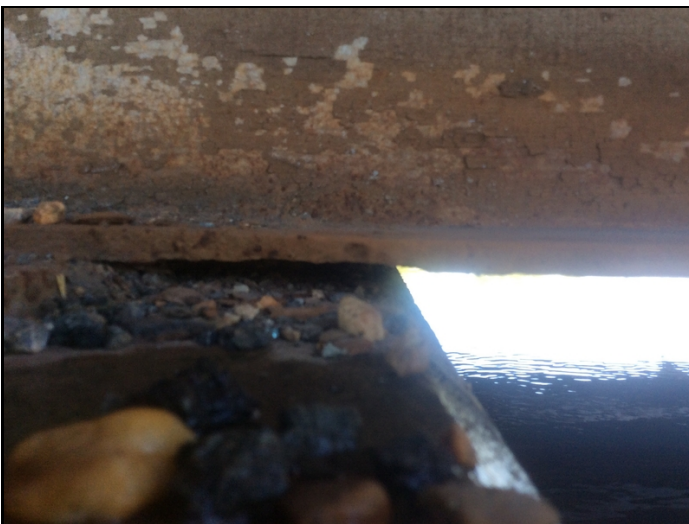
Bent 3 span 3 beam 5 1/4" pitting to lower flange.

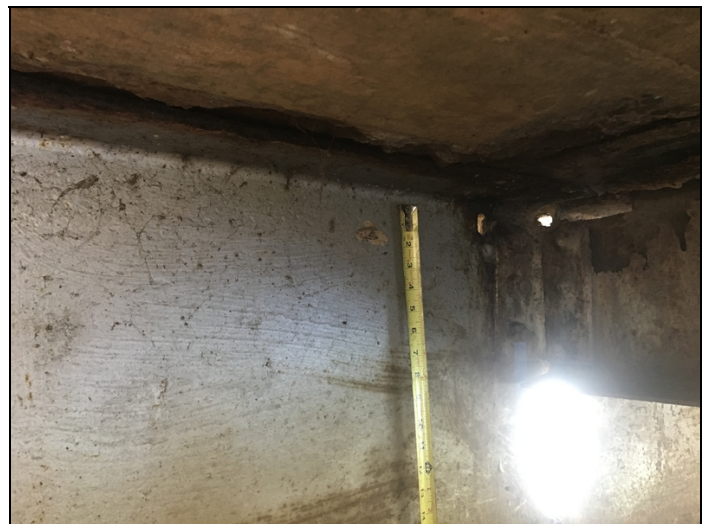
Bent 2 span 1 beam 2 hole in the upper web.

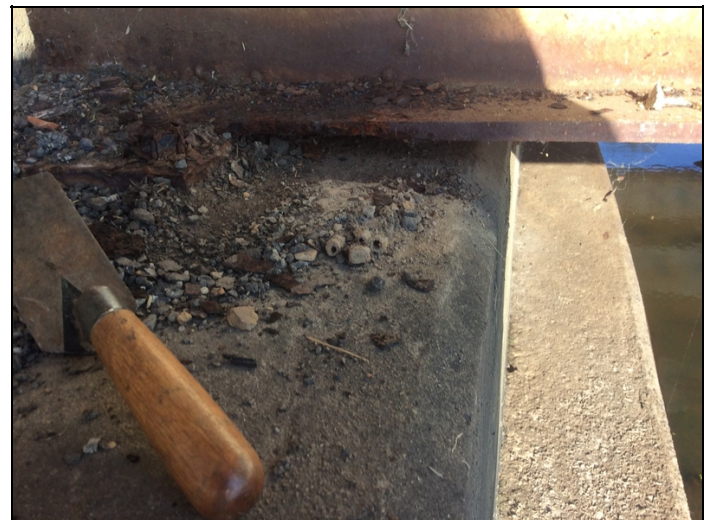
Bent 4 span 3 beam 1, 3/16" pitting to bottom flange.

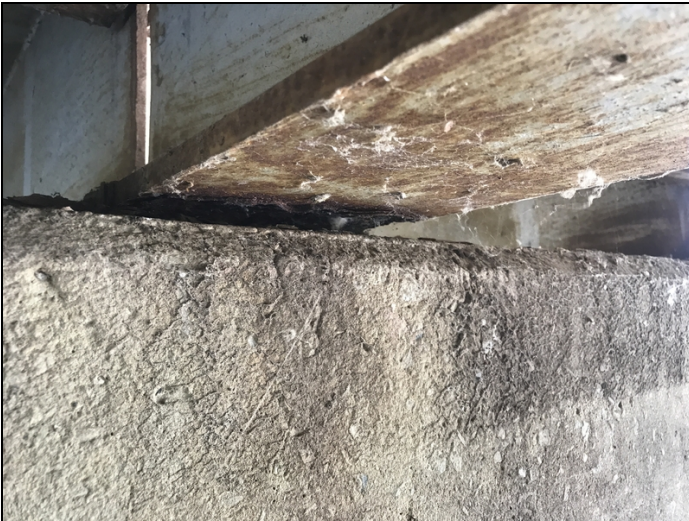
Span 3 girder 1: common condition to majority of beams with section loss to the bottom of the lower flange

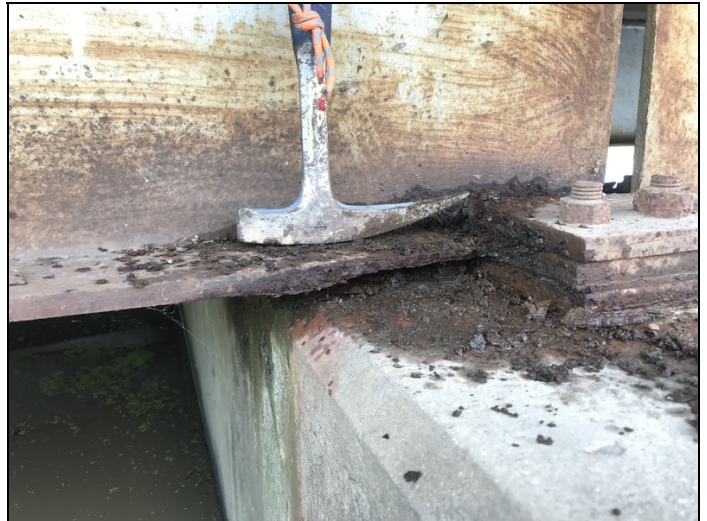
Span 1 at bent 2, beam 5: bottom flange has lost half it's section due to corrosion at the bearing area

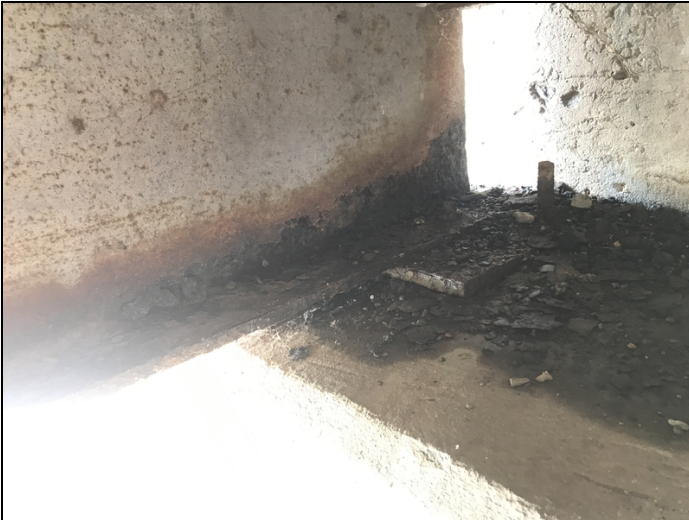
Span 4, girder 1: Section loss to the lower web and bottom flange.

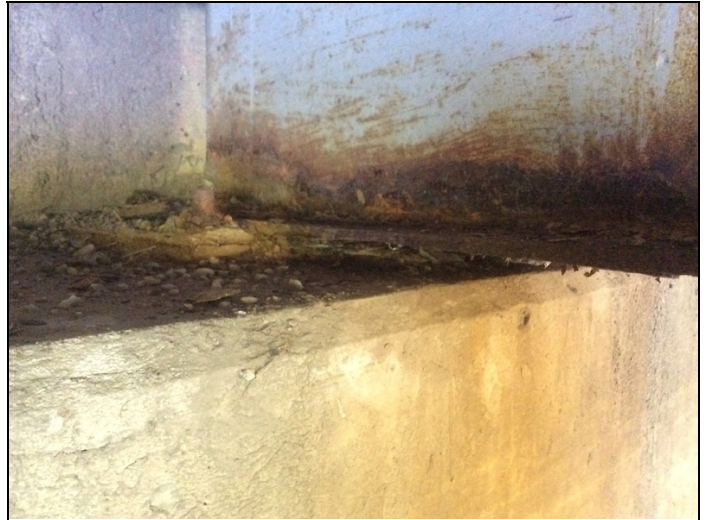
Bent 1 span 1 beam 2. 3/16" pitting to bottom flange.

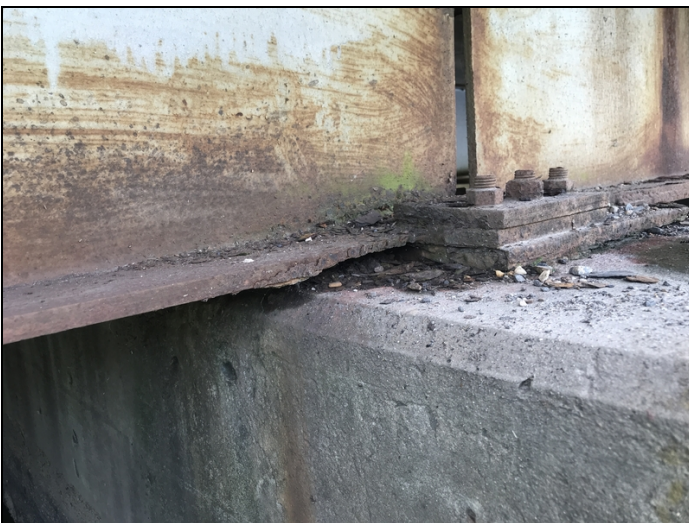
Span 1, bent 2, beam 5: Bottom flange with measurable section loss near bearing.

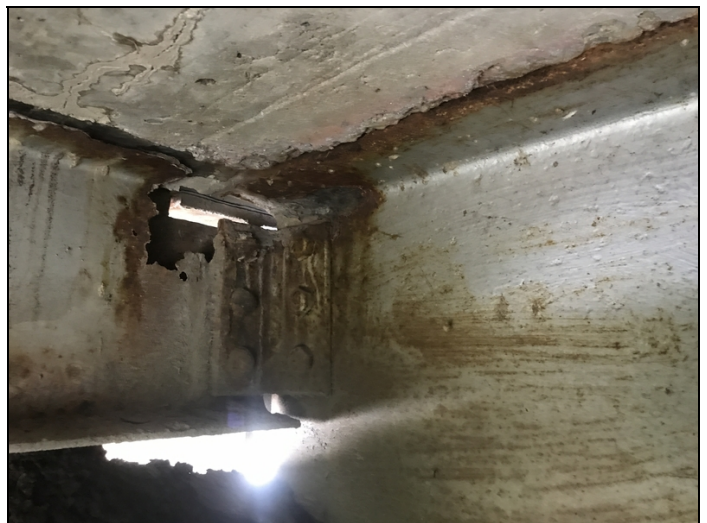
Span 1, bent 2, beam 2: upper web with deep pitting and diaphragm with large hole due to corrosion action.

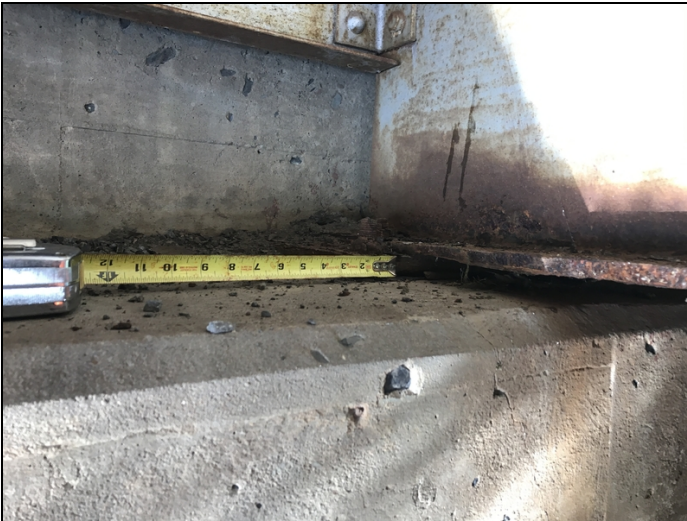
Beam 2 Span 3 at bent 4. 3/16" section loss to bottom flange

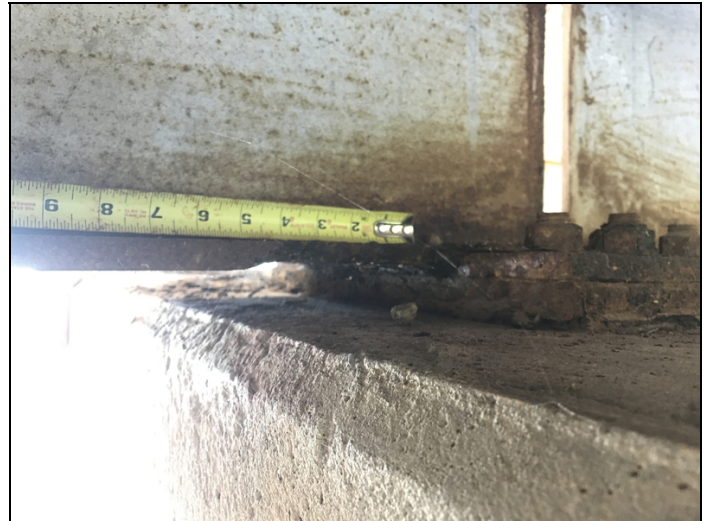
Span 2 beam 2 at bent 3, 3/16" section loss to bottom flange

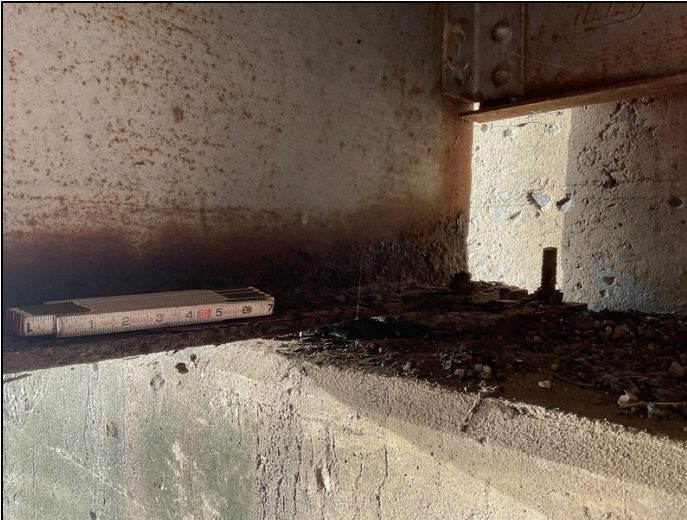
Bent 4 span 3 beam 1, 1/4" section loss to bottom flange.

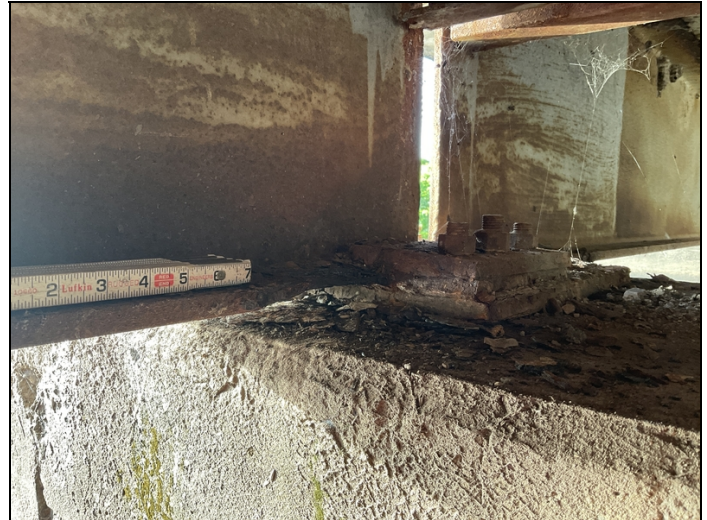
Bent 3 span 2 beam 1 bottom flange is down to a knives edge.

Bent 3 span 2 beam 1 bottom flange on right side is down to knives edge. Worse case.

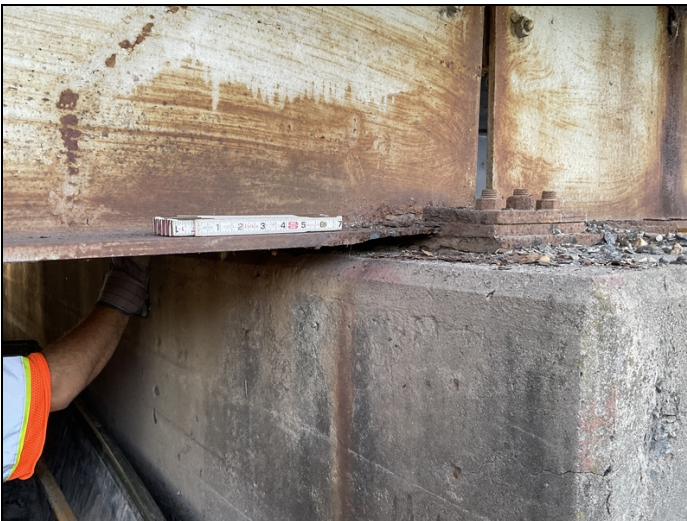
Bent 2 span 1 beam 5, 1/4" section loss to bottom flange at bearing area.

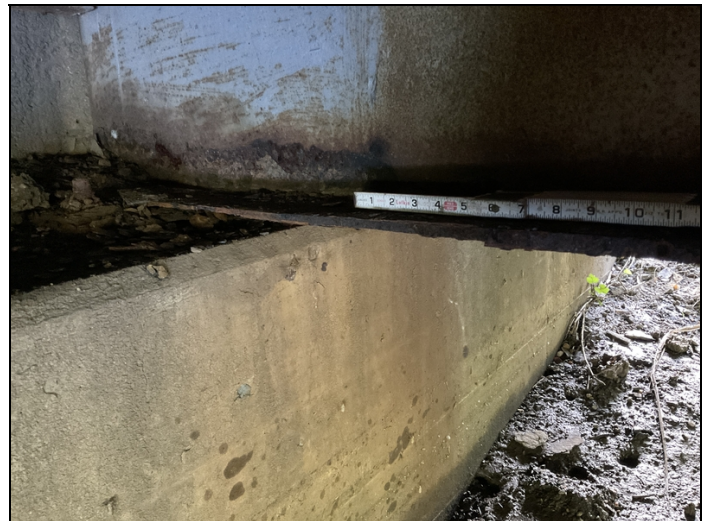
Bent 1 beam 2 1/4" section loss to bottom flange. 1/8 in lower web

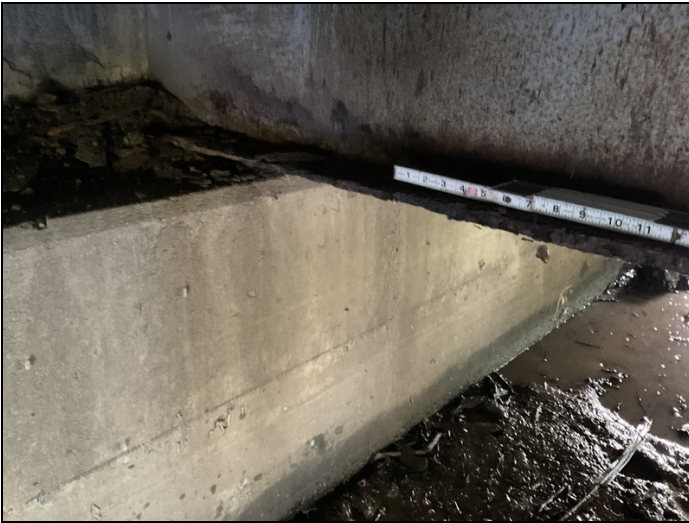
Span 1 bent 1 beam 3, 1/4" section loss to bottom flange

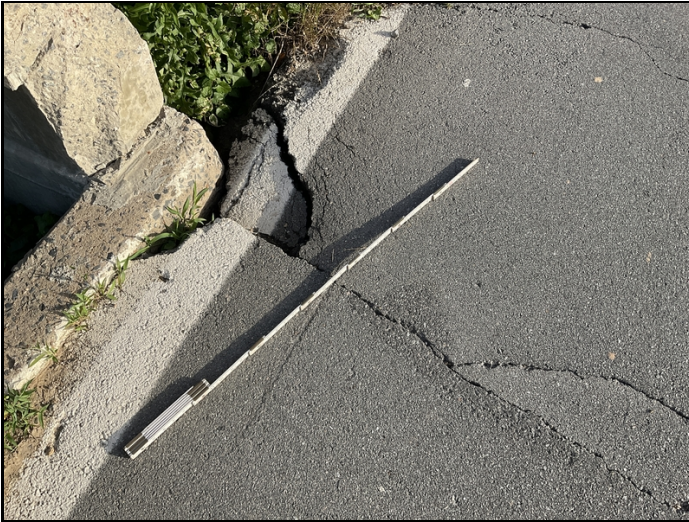
Void under approach roadway at bent 1. Asphalt is cracked and settling.

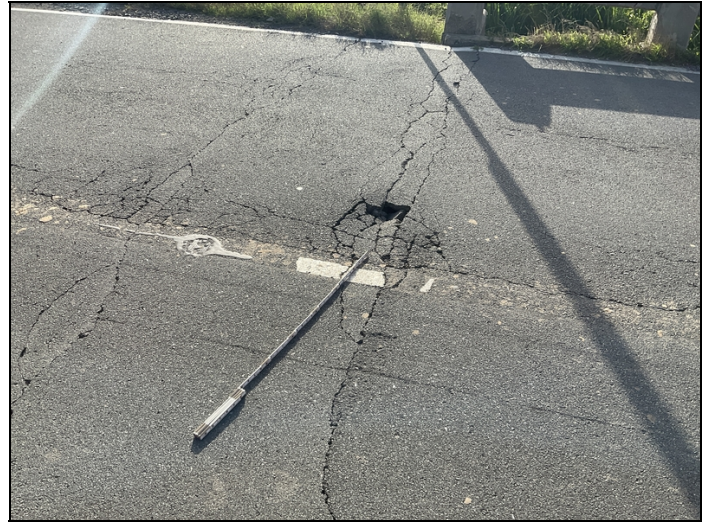
Void under approach roadway at bent 1. Asphalt is cracked and settling.

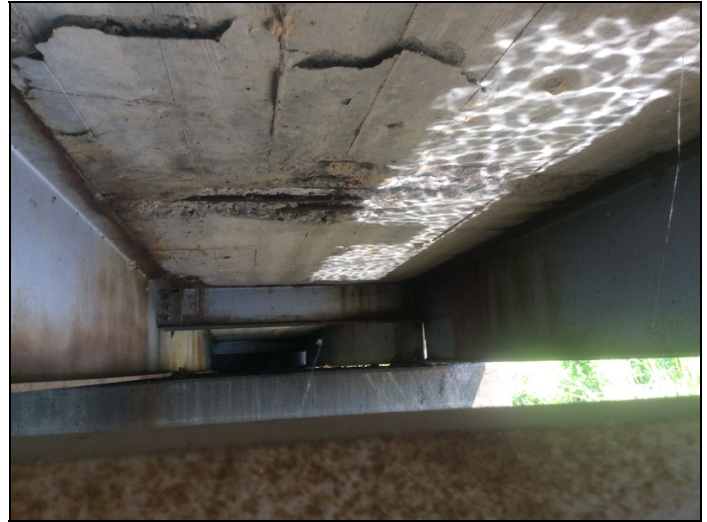
Span 2 soffit spalls with exposed rebar. Common all spans.

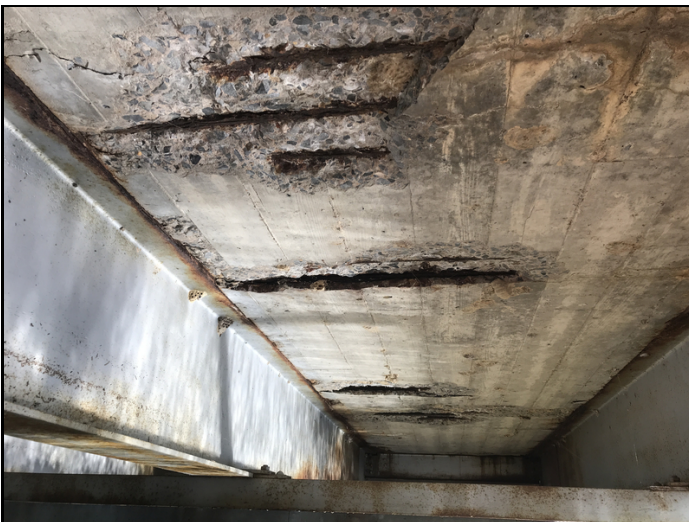
Span 2 soffit between beams 1&2, large spalls with section loss to exposed reinforcing steel.

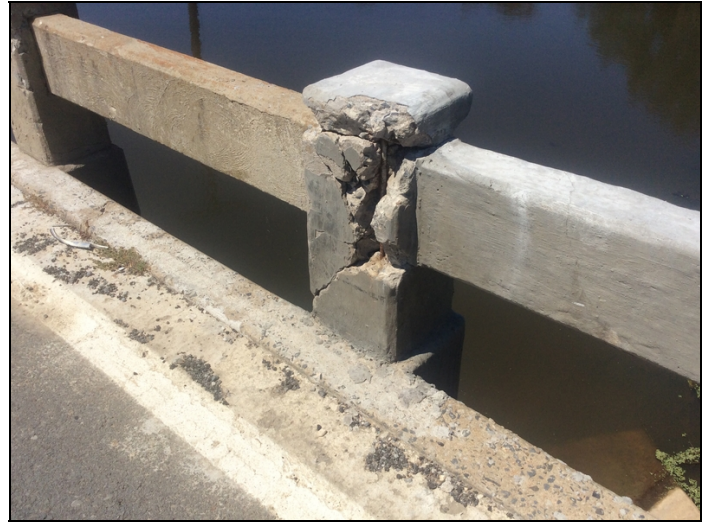
Span1 right bridge rail damaged.

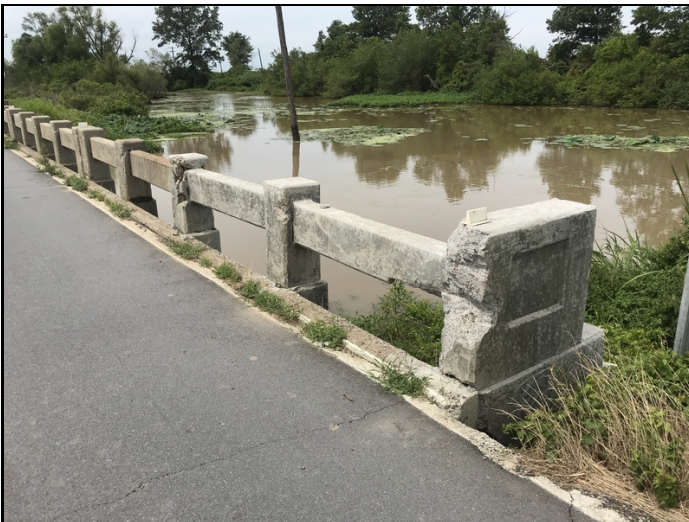
Right rail: the first 3 posts have been damaged due to traffic impact

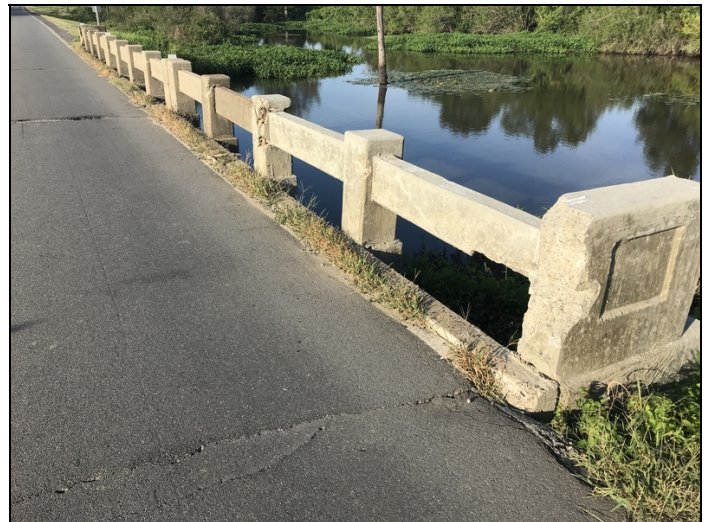
Span 1 right bridge rail has traffic damage

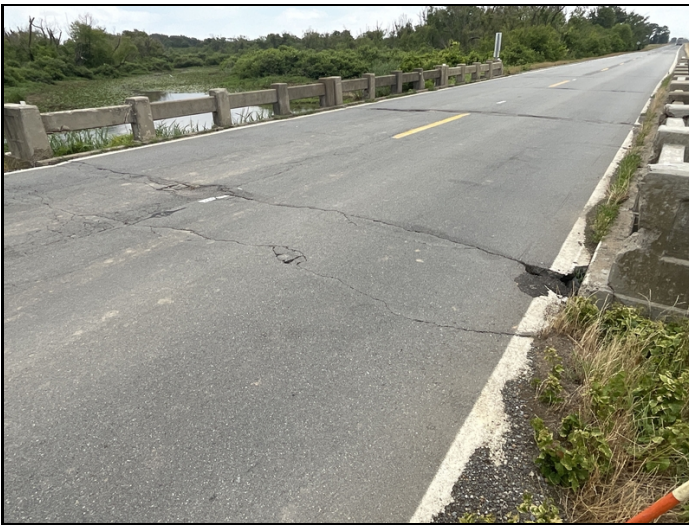
Potholes at joints

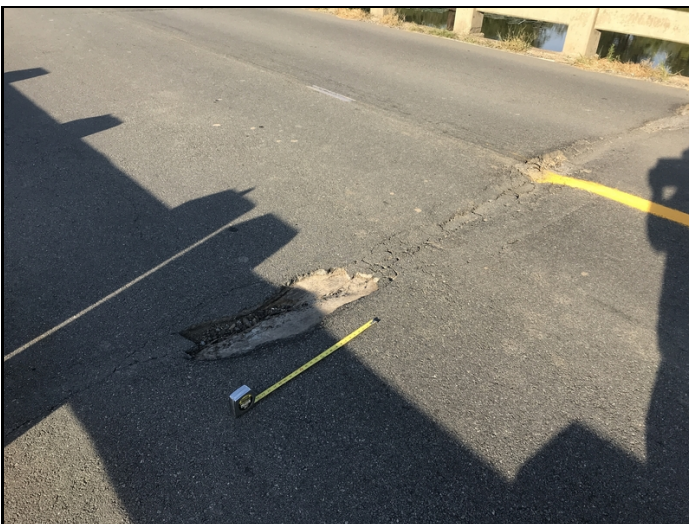
Spalls in asphalt overlay at bent 2

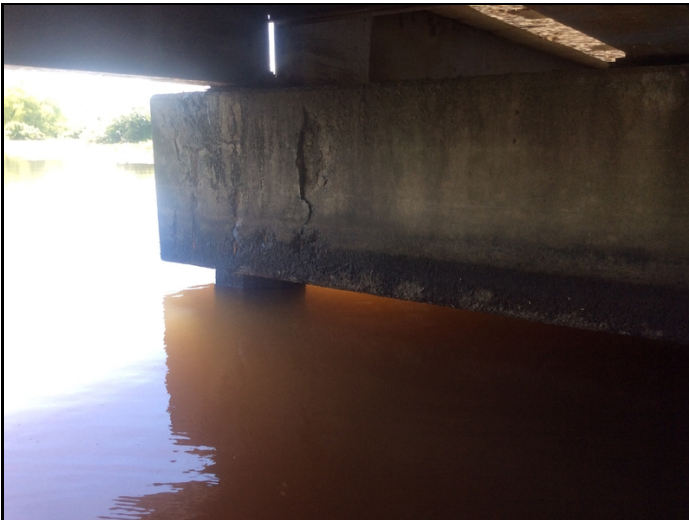
Bent 3 cap back left side spalls with rebar.

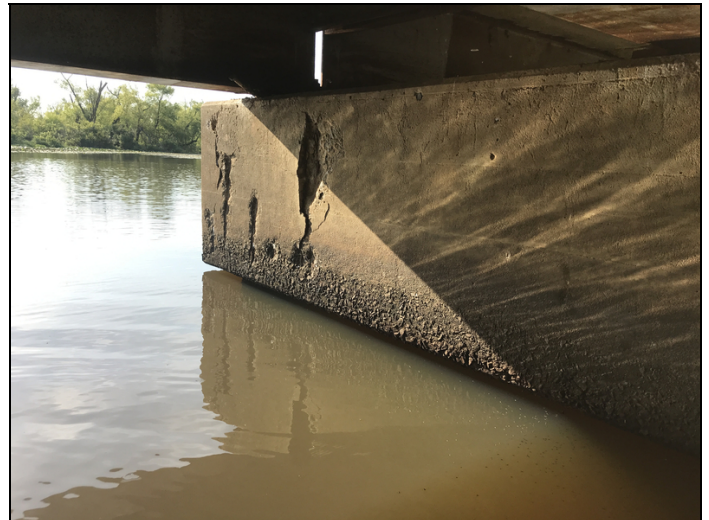
Bent 3 cap spalls with exposed rebar

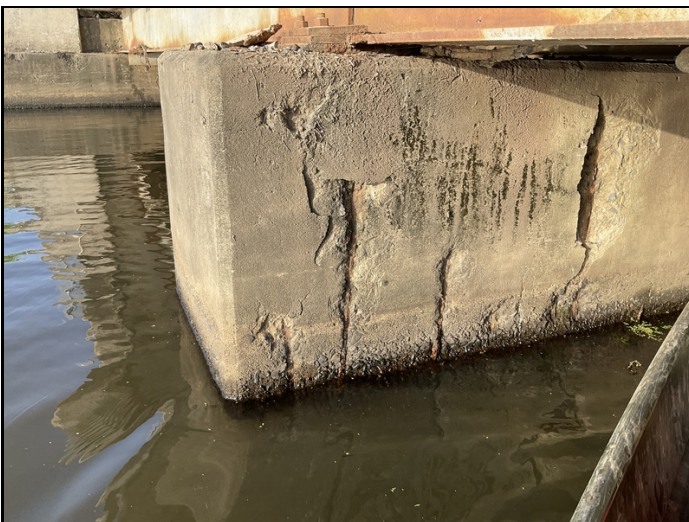
Bent 3 cap back left side spalls with rebar.
