Asset #01859(Routine)

## US 63 Log 8.69 over LAGRUE CREEK RELIEF

Location: 1.9 M S OF SH 86 EAST

Team Lead: Bryan Saunders, Inspection Date: 05/23/2023

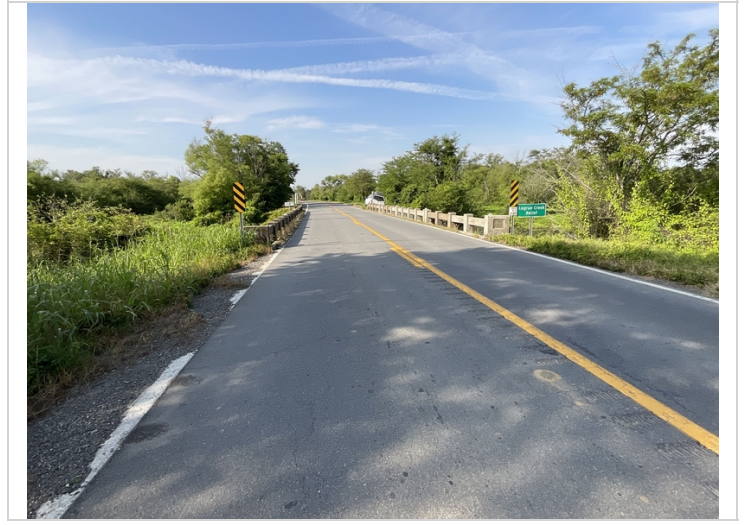
Approach looking south

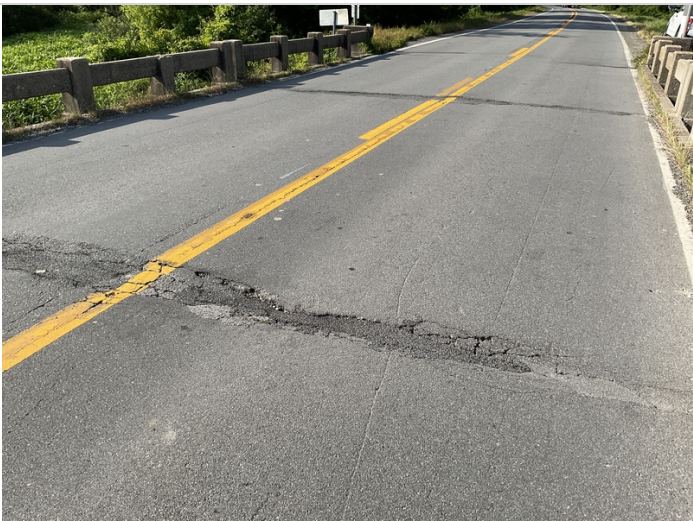
patched areas over joints have spalls

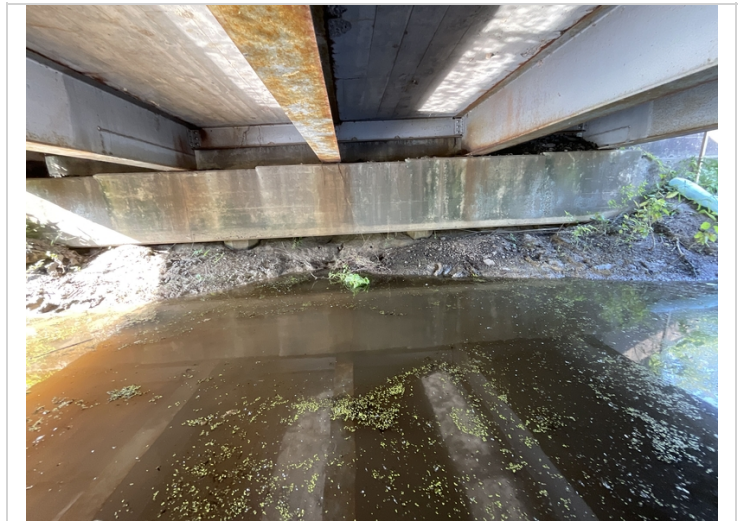
(227) 3 pile added from erosion action exposing pile at bent 5

Bent 5 erosion

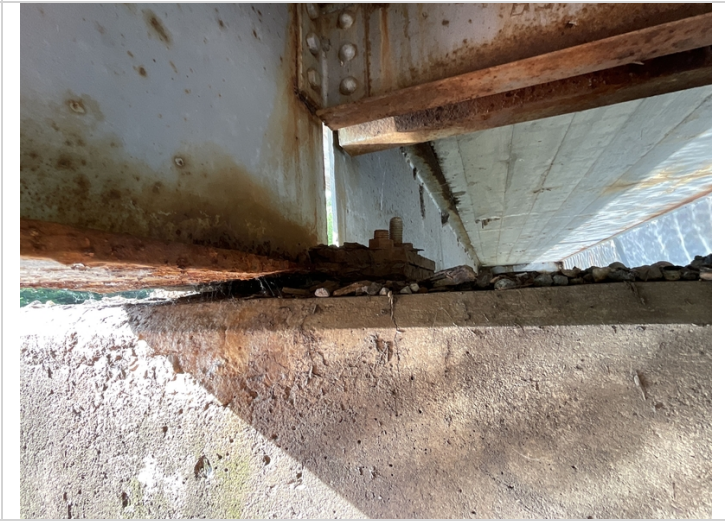
Bent 3 span 2 beam 1 right side lower flange to knife edge

Bent 3 span 2 beam 1 has section loss on the right bottom flange is down to a knives edge.

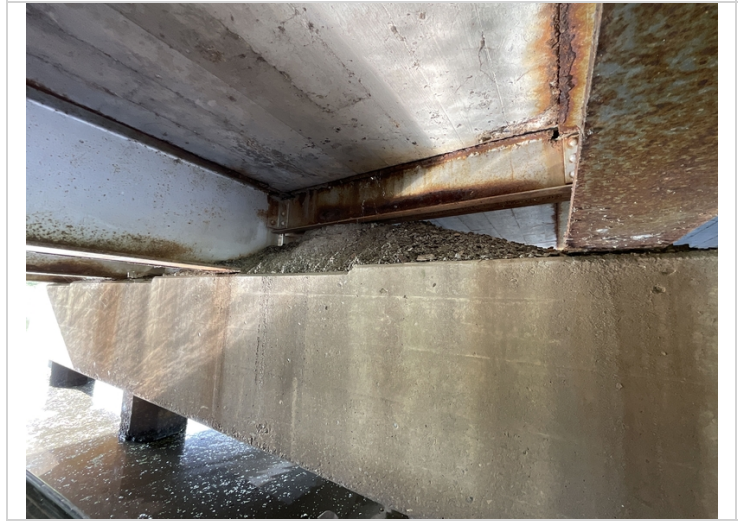
Bent 3 cap

Caps have dirt and debris around bearings

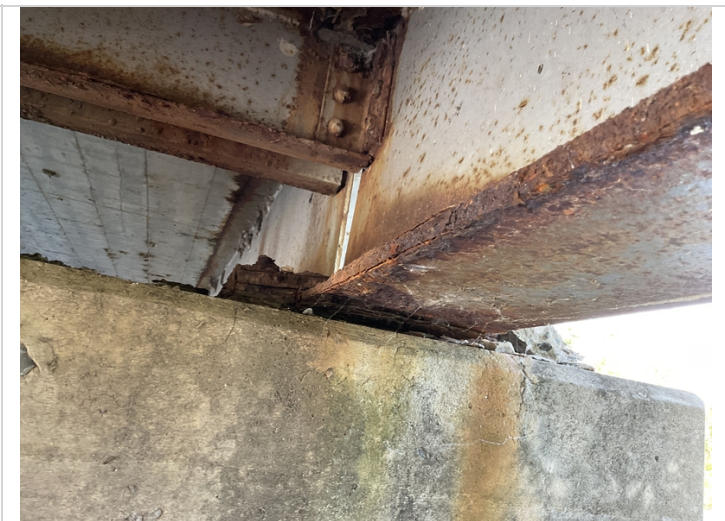
Bent 3 span 2 beam 5 has section loss on the left bottom flange only 1/4" remains

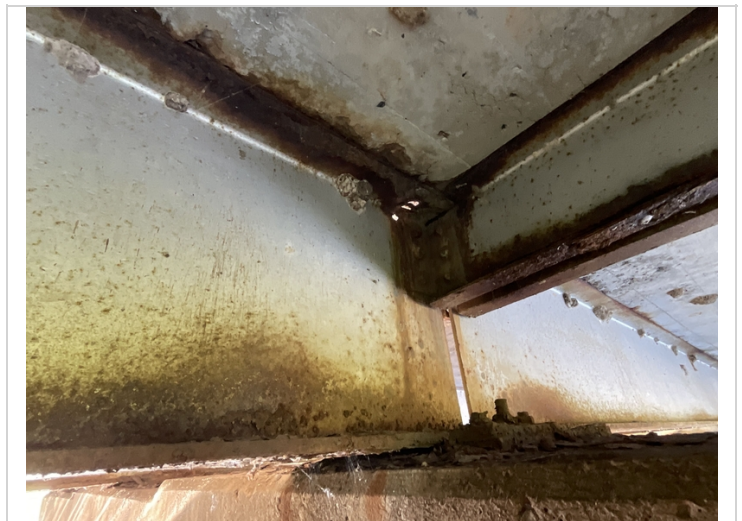
Bent 2 beam 4 1" hole at upper web laminated rust at lower web and flange

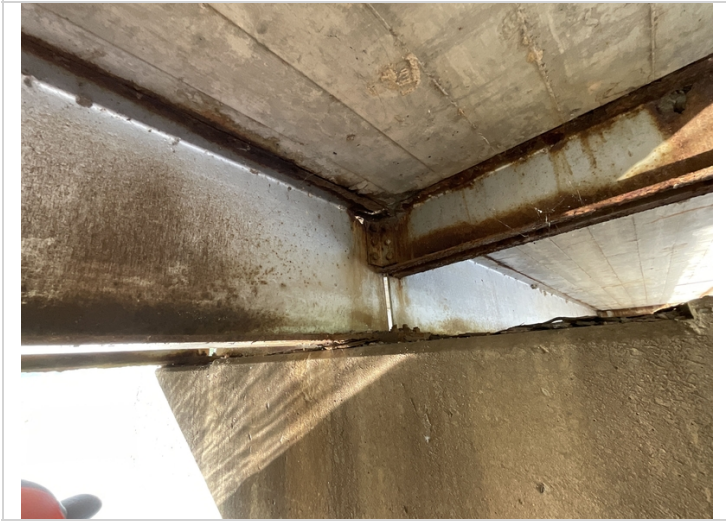
Bent 2 beam 2 3"x2" hole at top web and laminated rust at lower web and flange

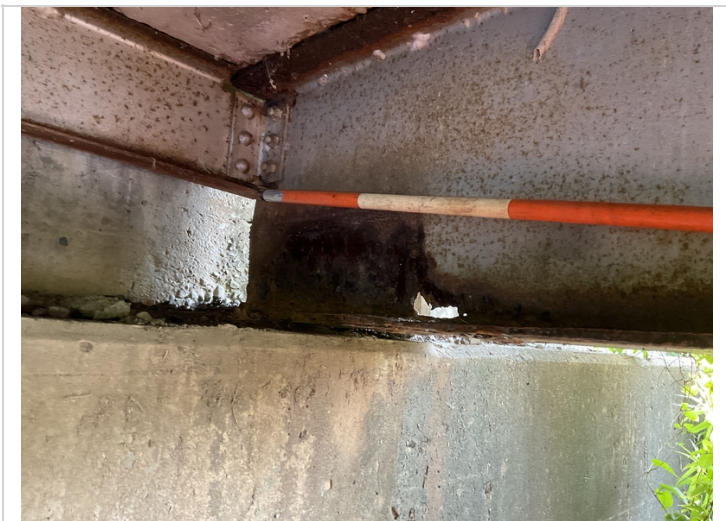
Bent 1 beam 1 has a 3"x6" hole and the lower web is a knife edge

Bent 1 beam 1 has a 3" hole in bottom of web. Bottom flange on right side is down to a knives edge.

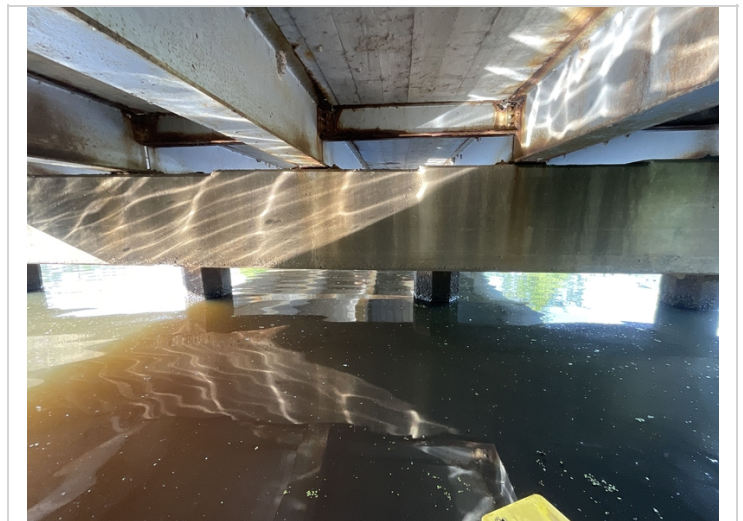
Columns have heavy abrasion starting 1' from bottom of cap down

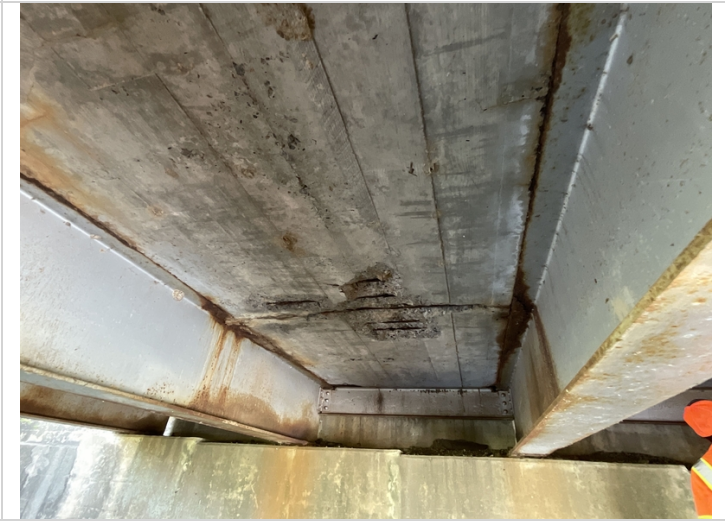
Large spalls with rebar in the soffit  
Span 1 between beam 3 and 4 large spall with rebar

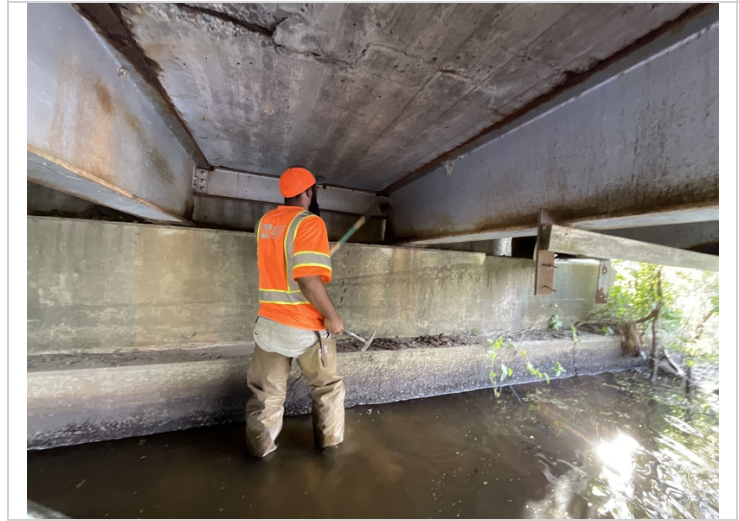
Bent 1 beam ends have deep pitting and laminated rust

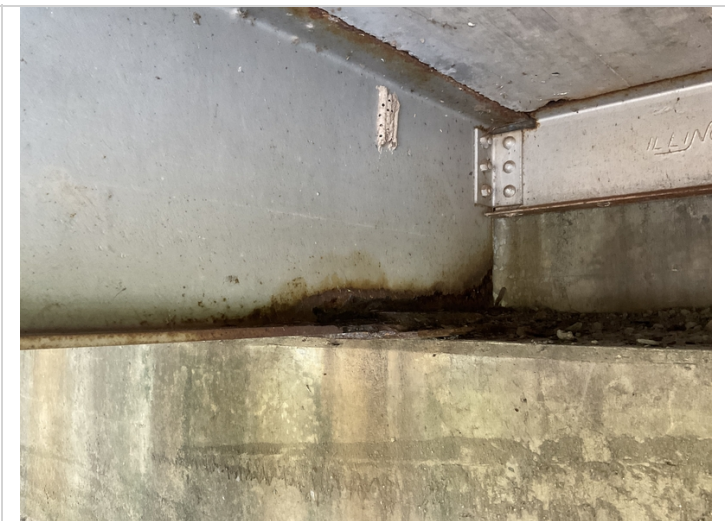
Bent 1 beam 2 has up to 1/8" pitting to the lower web

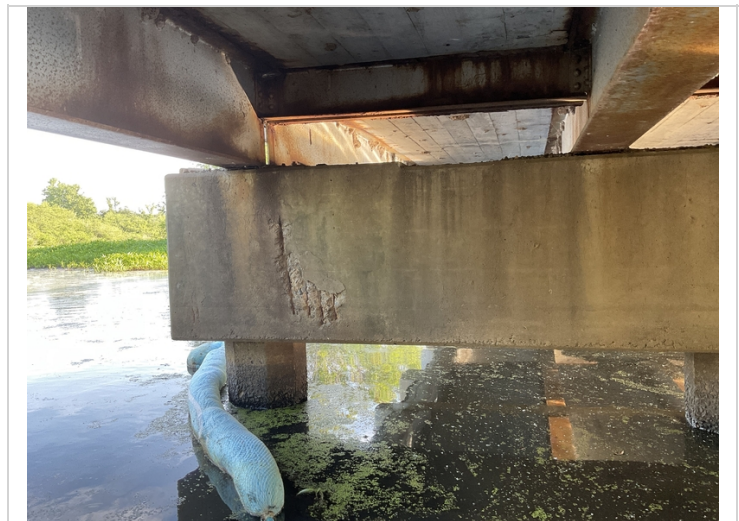
Bent 4 ahead right spall with rebar

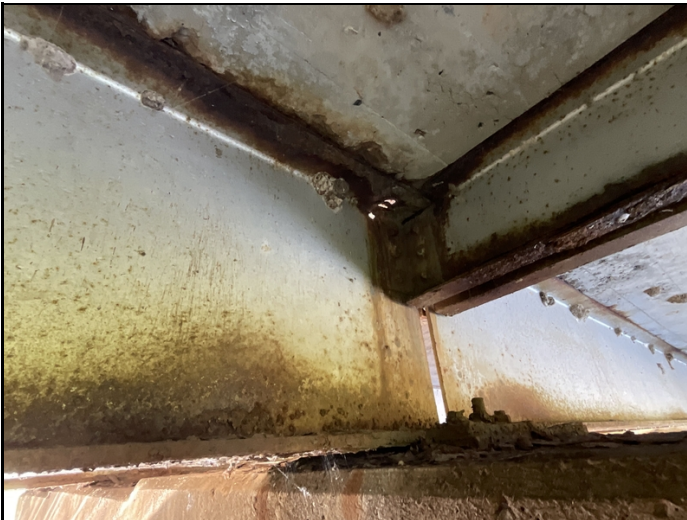
Bent 2 beam 4 1" hole at upper web laminated rust at lower web and flange

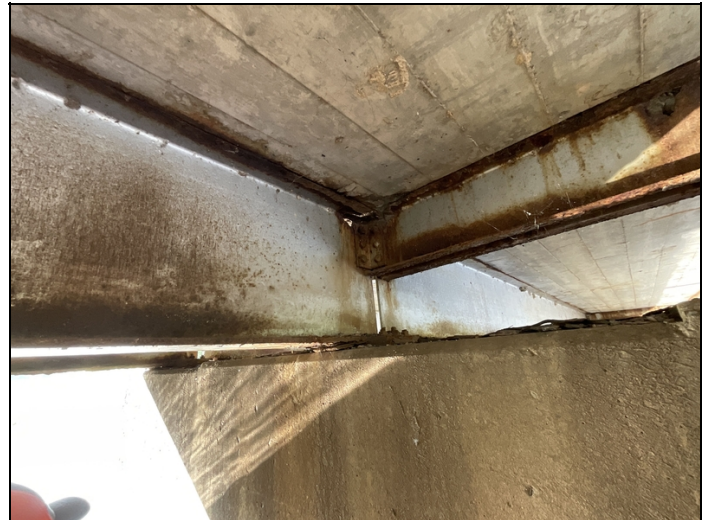
Bent 2 beam 2 3"x2" hole at top web and laminated rust at lower web and flange

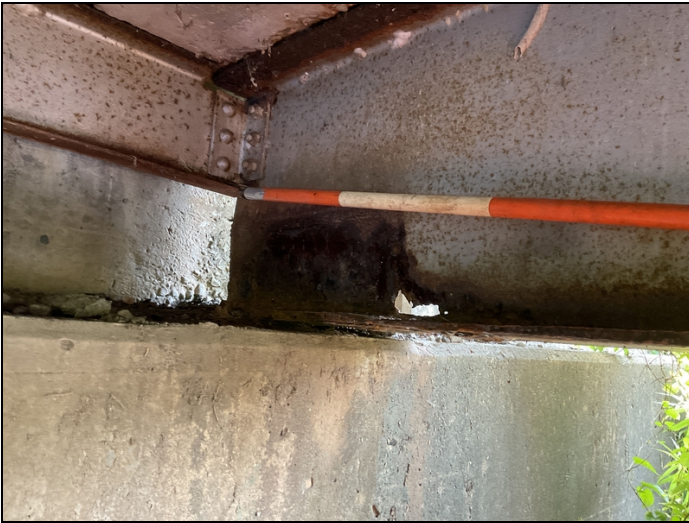
Bent 1 beam 1 has a 3"x6" hole and the lower web is a knife edge

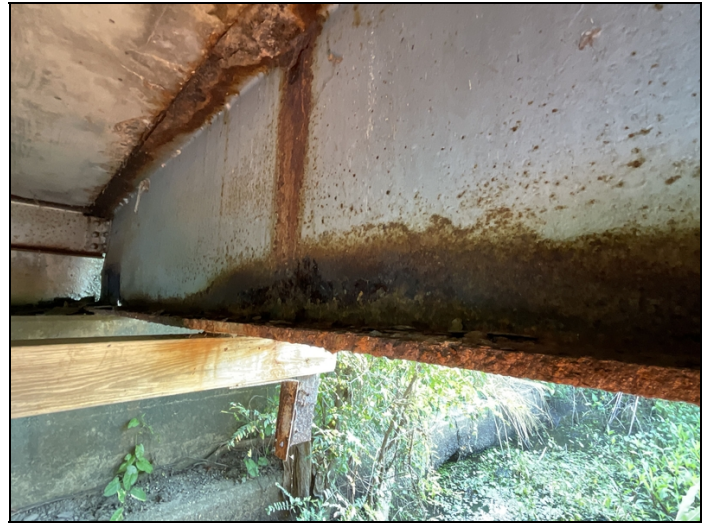
Bent 1 beam 1 has 8' corrosion

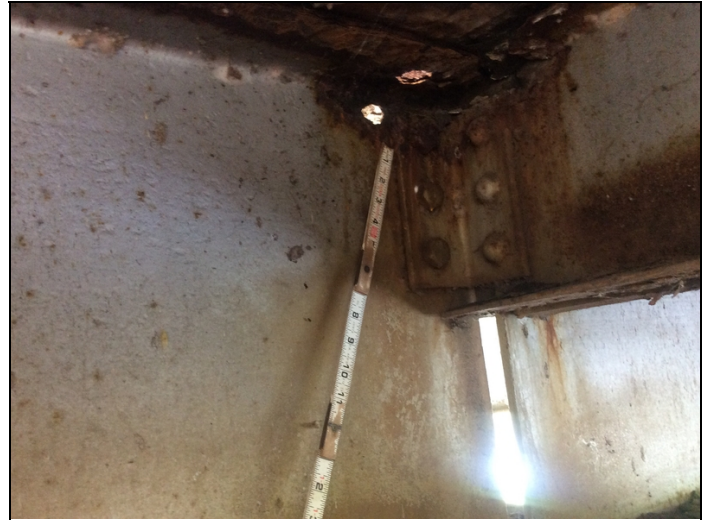
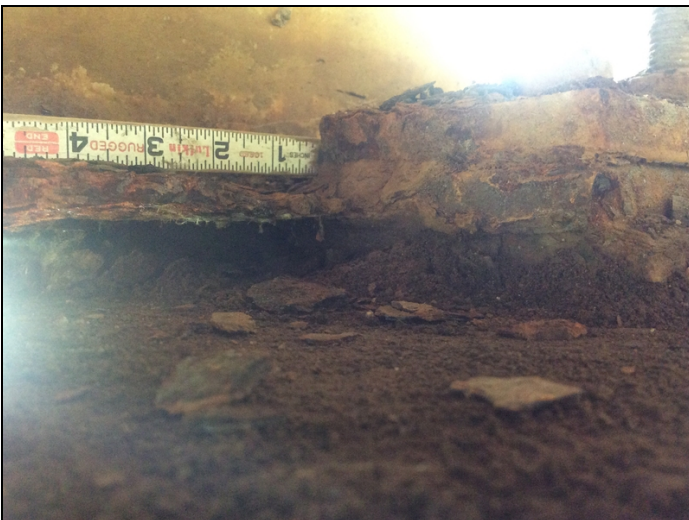
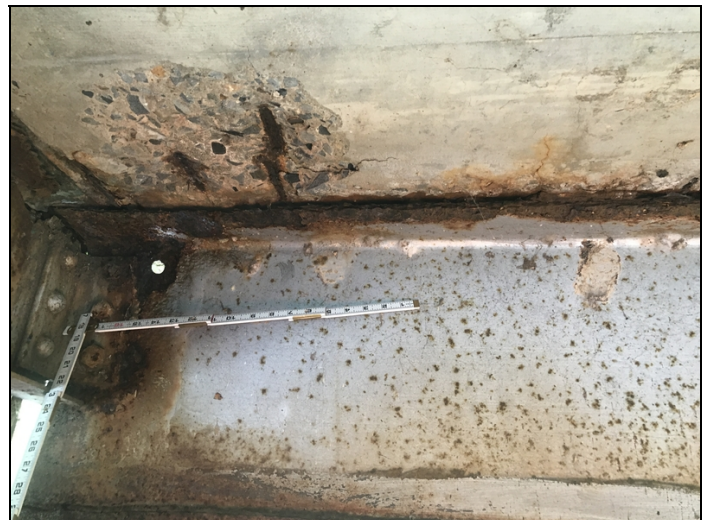
Span 4, bent 4, beam 1: hole in the upper web and the top flange has section loss to a knives edge.

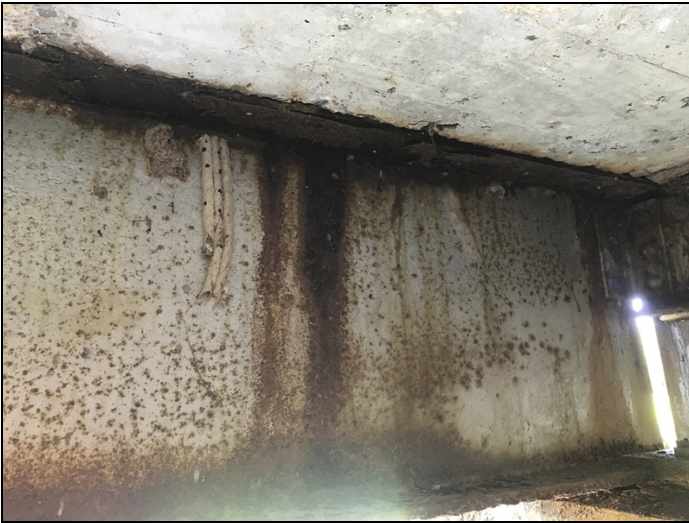
Span 1, bent 2, girder 1: top flange with section loss to a knife edge for approximately 2 foot in length.

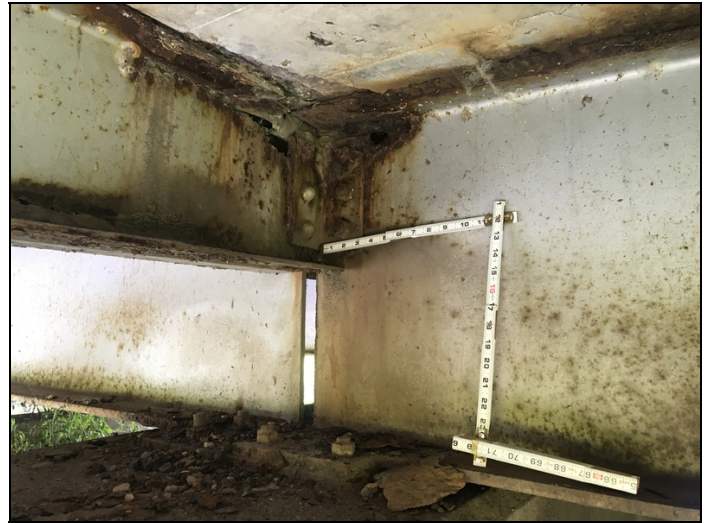
Span 1, bent 2, beam 2: hole in the upper web due to severe section loss to the web and the top flange.

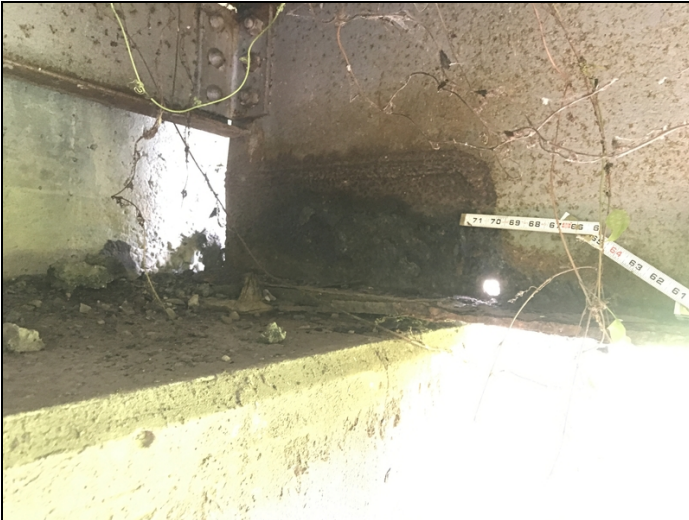
Span 1, bent 1, beam 1: a 1 inch hole in the lower web adjacent to a previous section loss repair. The repair and bottom flange have section loss to them.

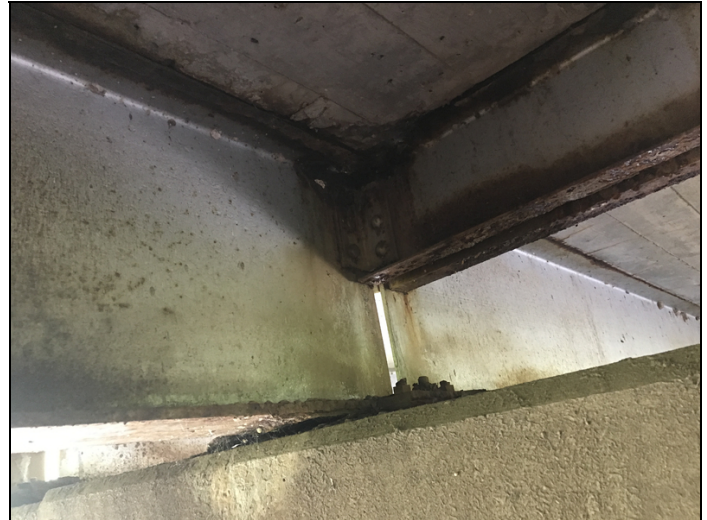
Span 2 girder 2 1" hole in upper web

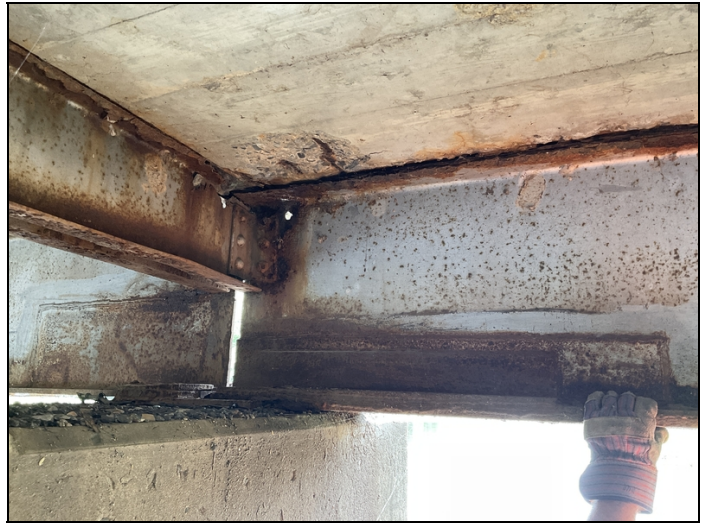
Bent 4, span 4, girder 1: upper web has a 1 inch hole and the upper flange has lost section to a knives edge

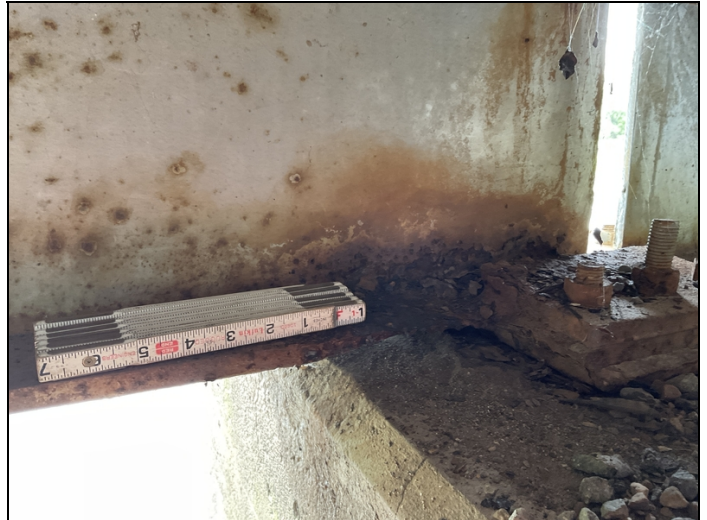
Bent 3 span 2 beam 1 has section loss on the right bottom flange is down to a knives edge

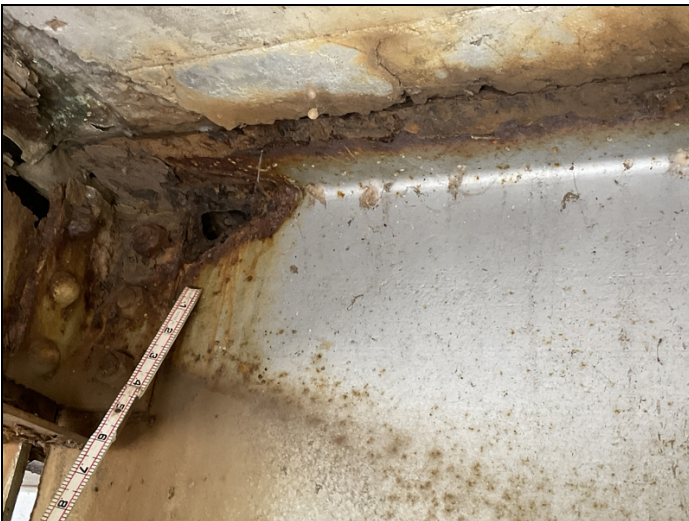
Bent 2 span 1 beam 2 has a one 1" x 2" hole in the upper web. Top flange is down to a knives edge.

Bent 2 span 1 beam 2 has a 1" x 2" hole in the upper web. Top flange is down to a knives edge.

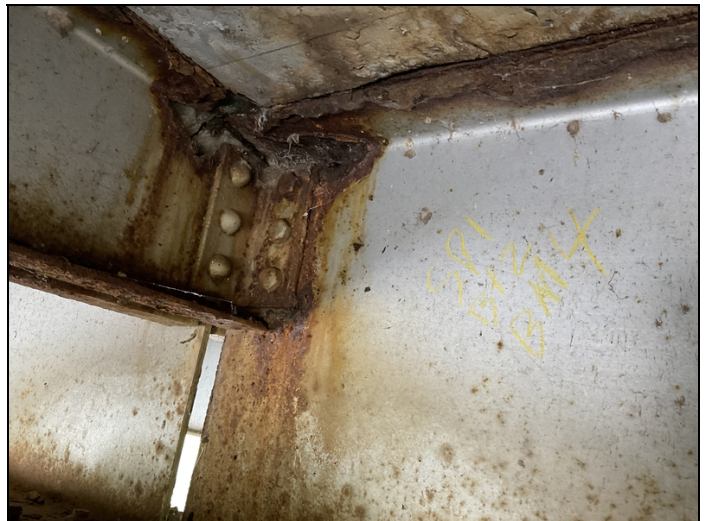
Bent 2 span 1 beam 4 has a one 1" hole in the upper web.

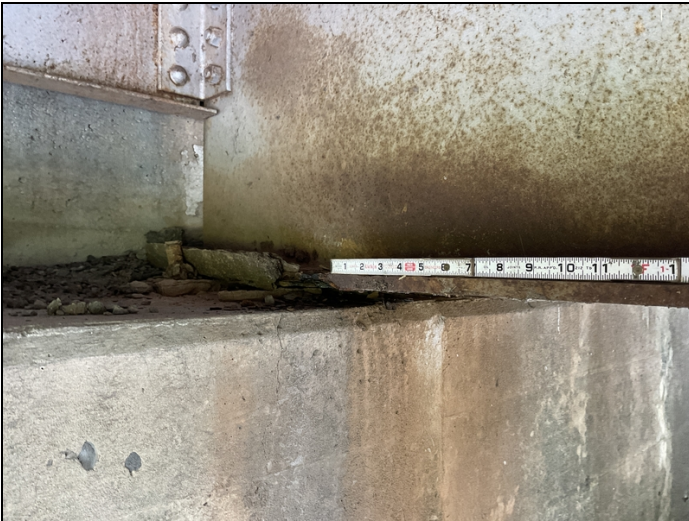
Bent 1 beam 4 bottom flange has section loss on the right bottom flange only 1/8" remains

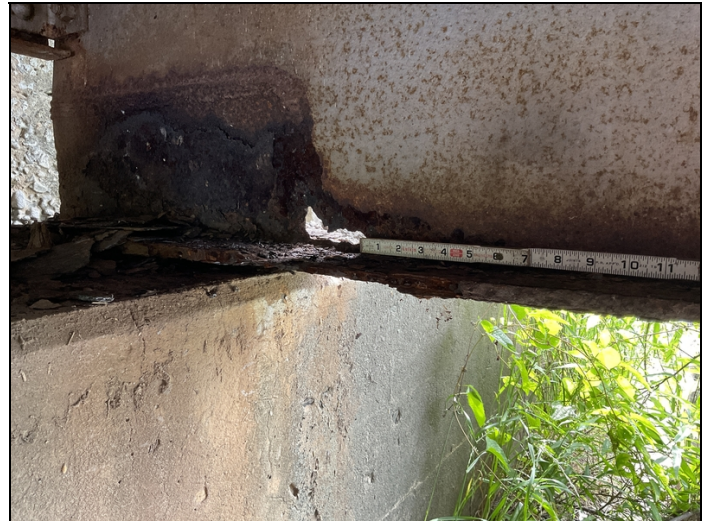
Bent 1 beam 1 has a 3" hole in bottom of web. Bottom flange on right side is down to a knives edge.

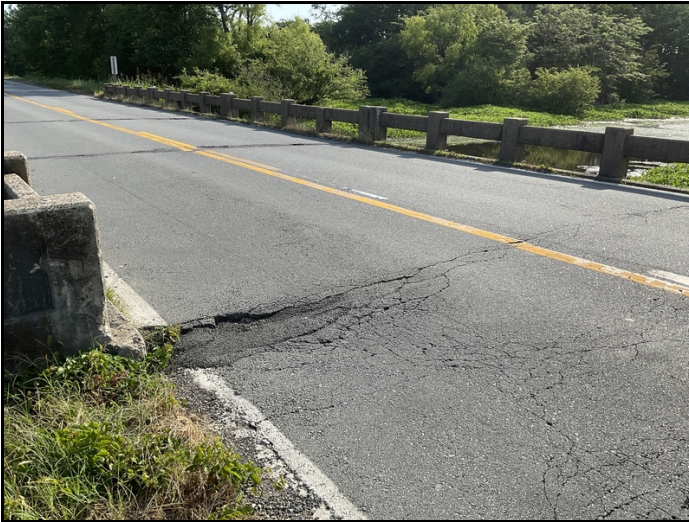
Pothole in asphalt overlay at bent 5 located at north end of bridge.

Pothole at bent 5

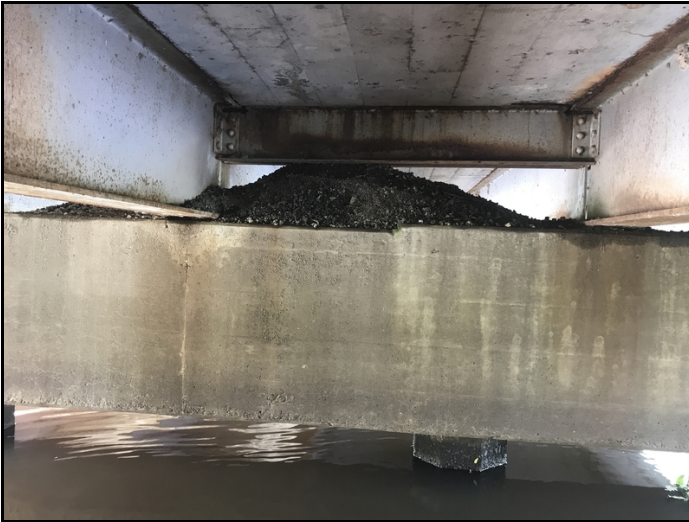
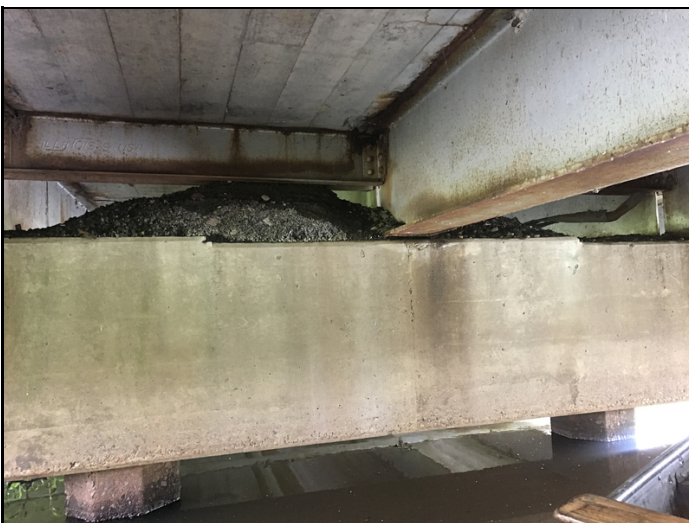
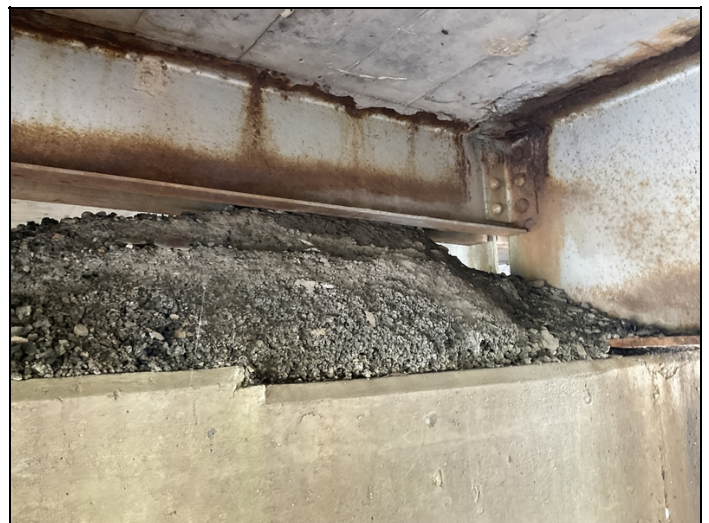
Bent 3: large amount of asphalt debris atop of cap and bottom flanges between girders 3 + 4. Similar condition at bent 4

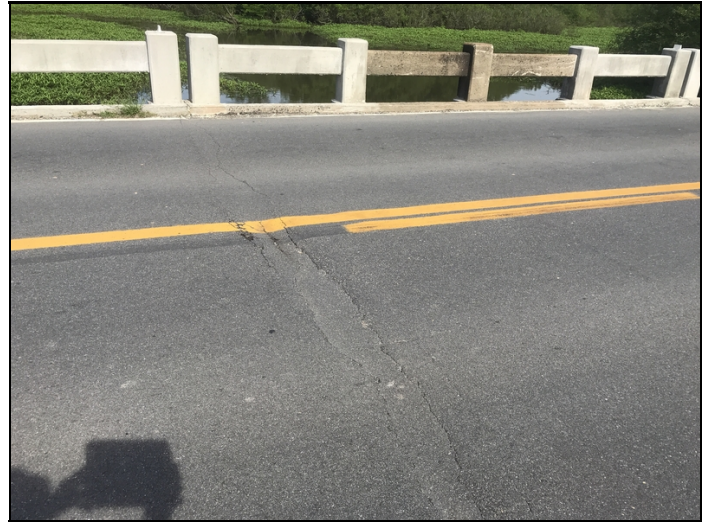
Bent 4: asphalt material is falling through joint leaving a bump in the roadway surface

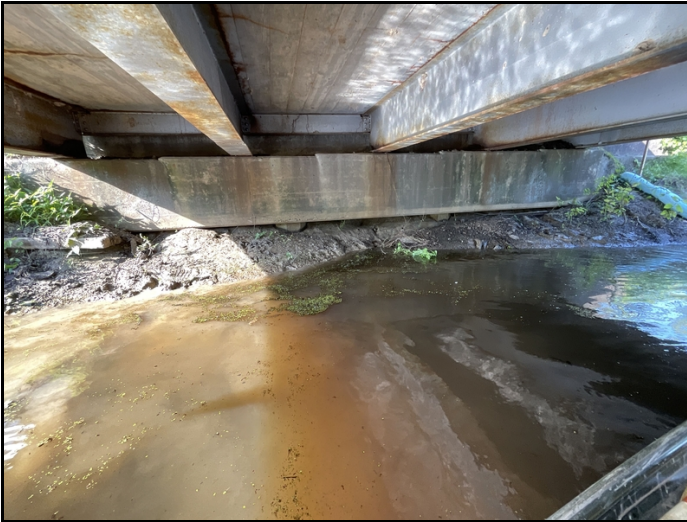
Erosion at bent 5 exposing 3 piles

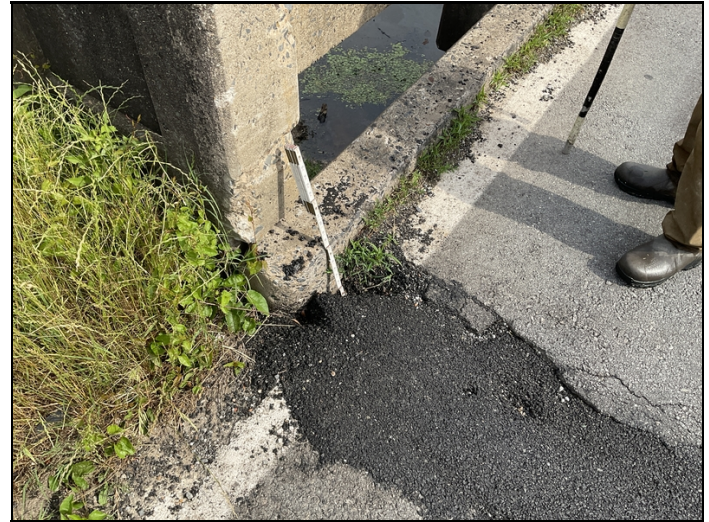
Erosion has caused a void in the right side of approach roadway at south end of bridge

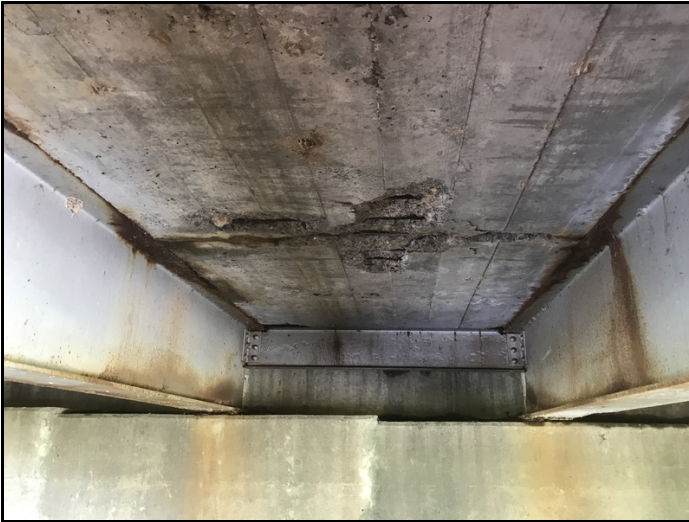
Soffit on all spans has large spalls with rebar exposed.

Span 1 soffit between girders 3 & 4: large spall with exposed rebar

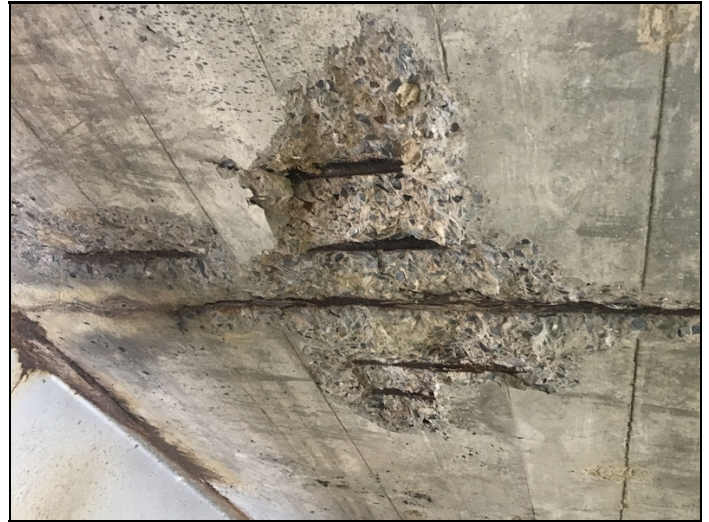
Span 1 large spall with exposed rebar

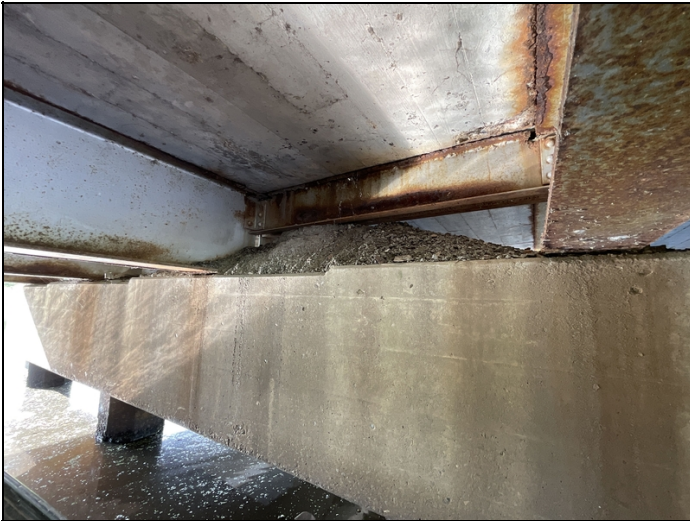
Bent 3 cap

Caps have dirt and debris around bearings

**A-58 - Cap Cleaning/Flushing Needed (Yes)**

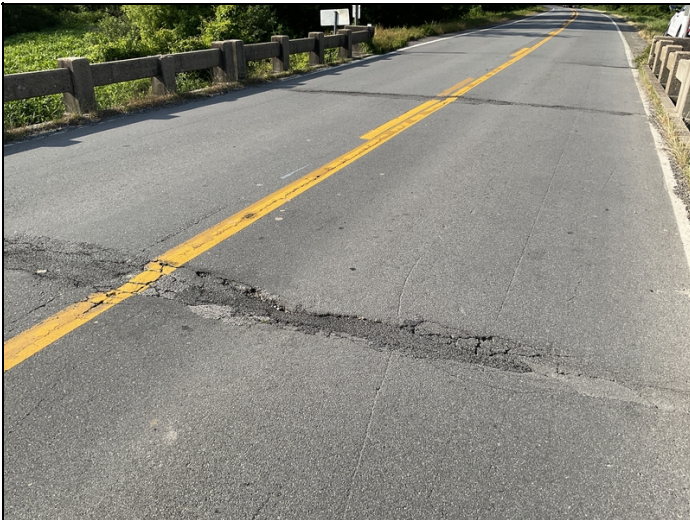
patched areas over joints have spalls

**A-59 - Joint Repair Needed (Yes)**
