Asset #01860(Routine)

US 63 Log 8.51 over LAGRUE CREEK

Location: 1.5 M S OF SH 86 EAST

Team Lead: Bryan Saunders, Inspection Date: 05/23/2023

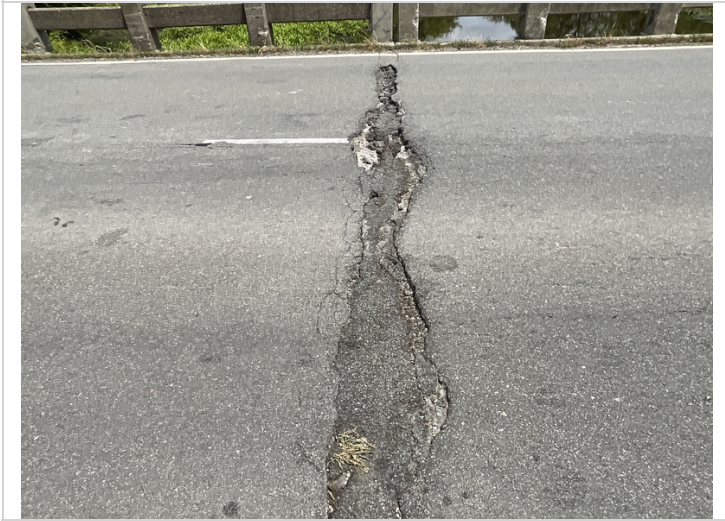
large potholes in the wearing surface over bent 2

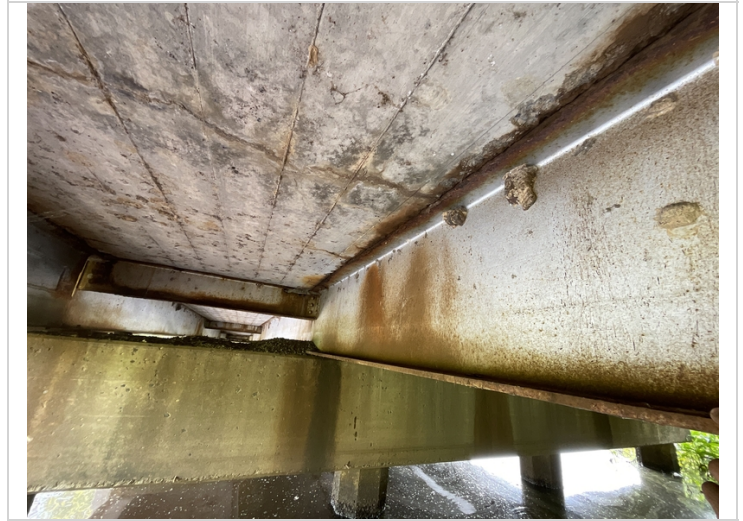
Deck over bent 2 beam 1,2,3,4 and 5 moving up to 1/4" due to not being composite to superstructure.

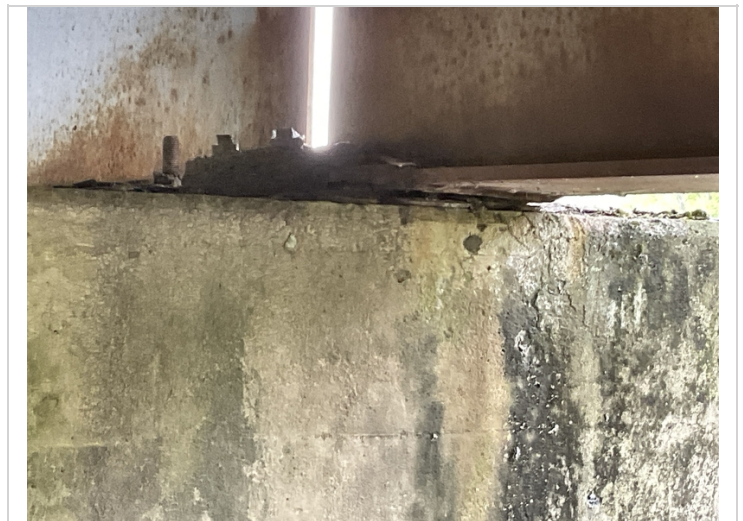
Bearings at bent 3

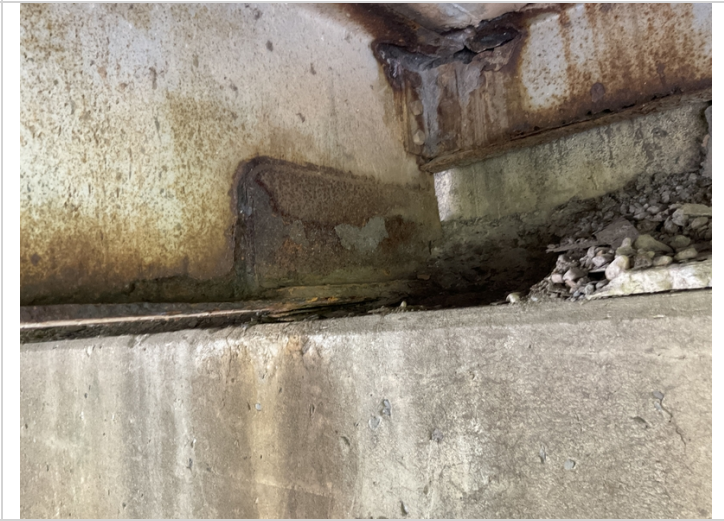
Bent 5 beam 3 has a 1"x1" hole in the haunch area

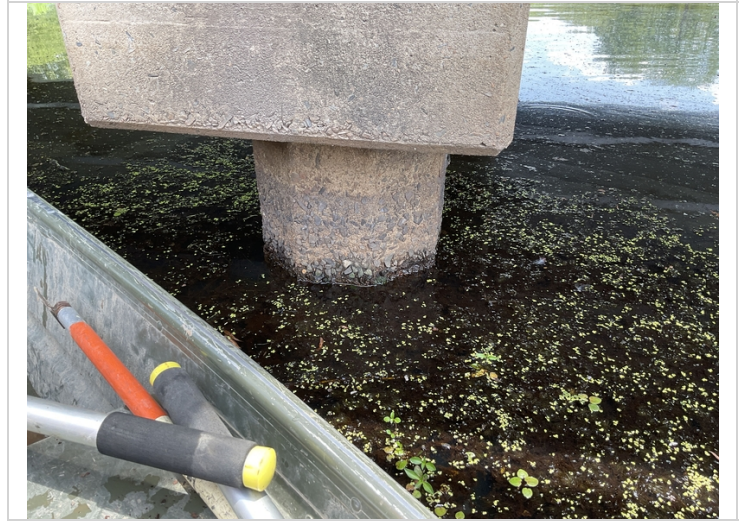
Abrasion at columns

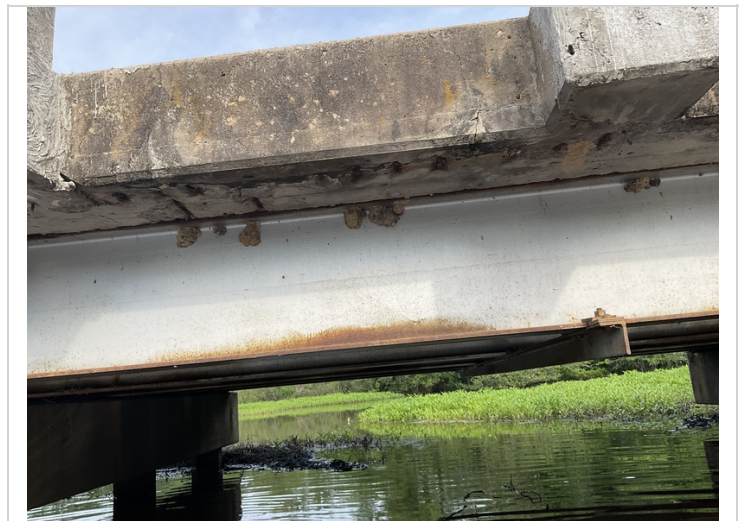
Exposed rebar on left side of span 2

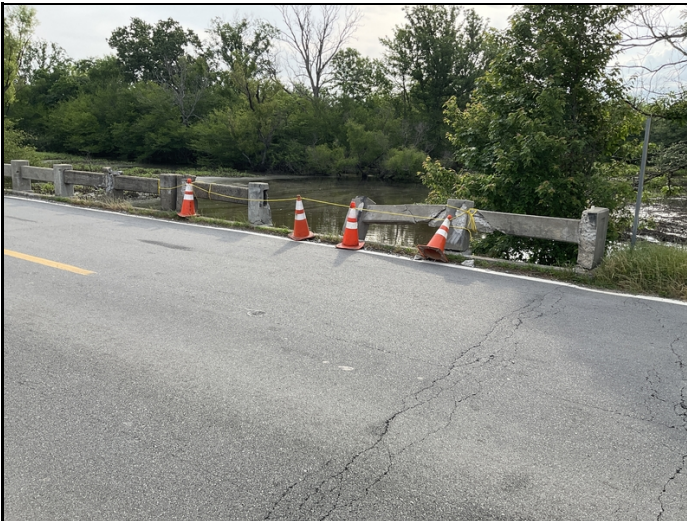
Left bridge rail in span in span 4 has been damaged from traffic impact. 6' of rail is missing. 5 post are damaged.

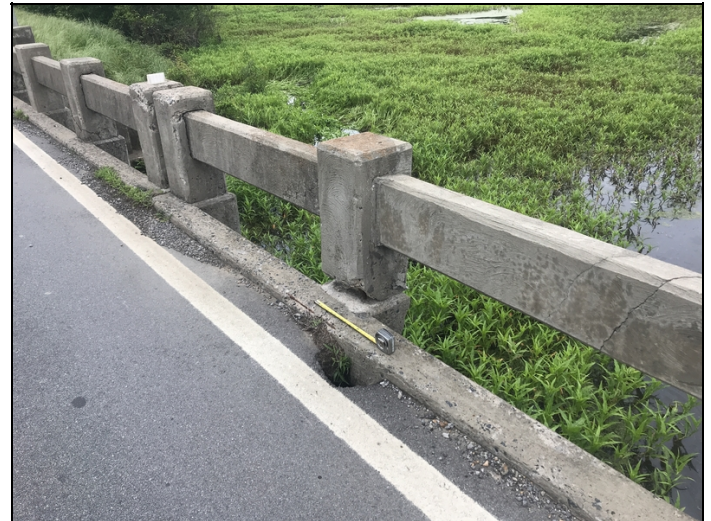
Right bridge rail in spans 3&4 have broken post.

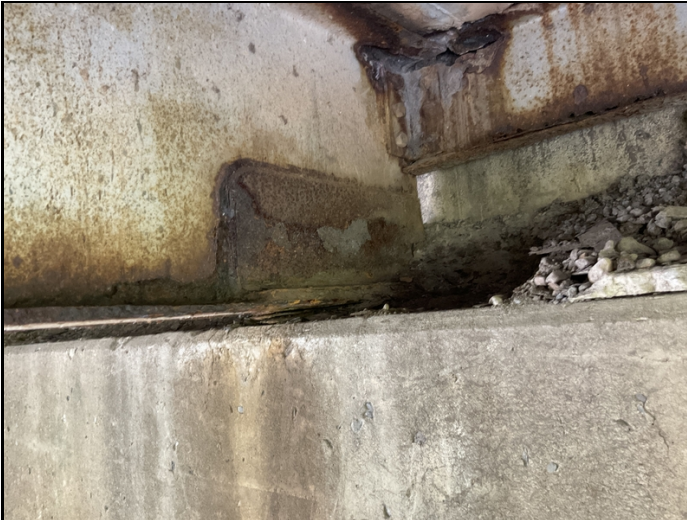
Bent 5 beam 3 has a 1"x1" hole in the haunch area

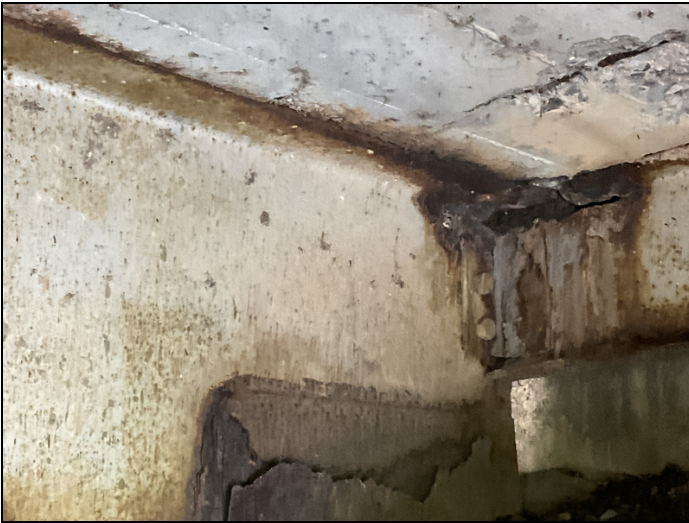
bent 5 beam 3 has a 1" hole in haunch area

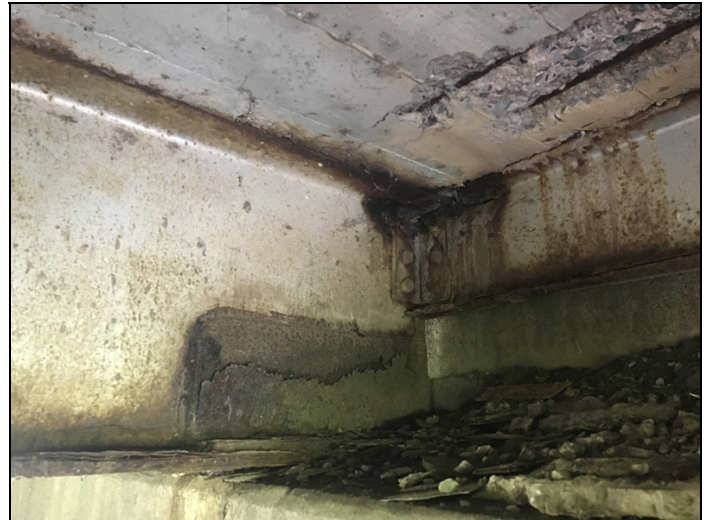
bent 5 beam 3 has a 1" hole in haunch area

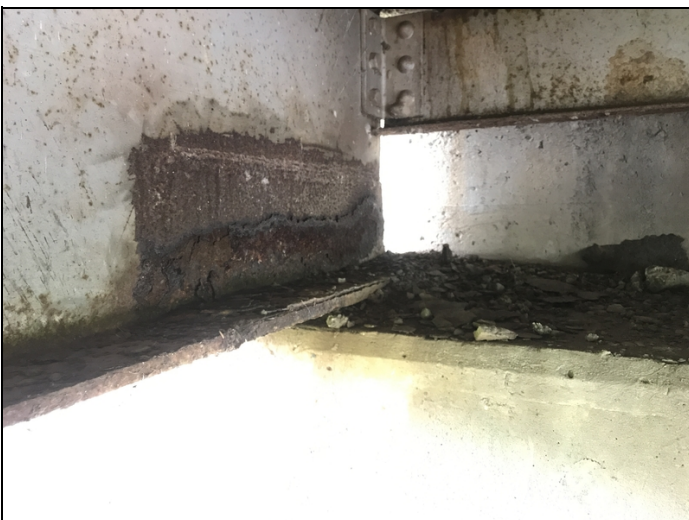
Span 1 @ bent 1: bottom flange with measurable section loss.

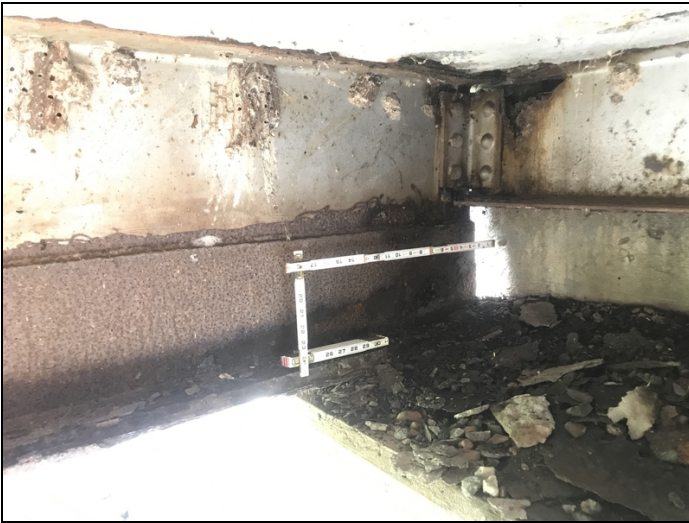
Bent 5, span 4, girder 1: beam end with measurable section loss.

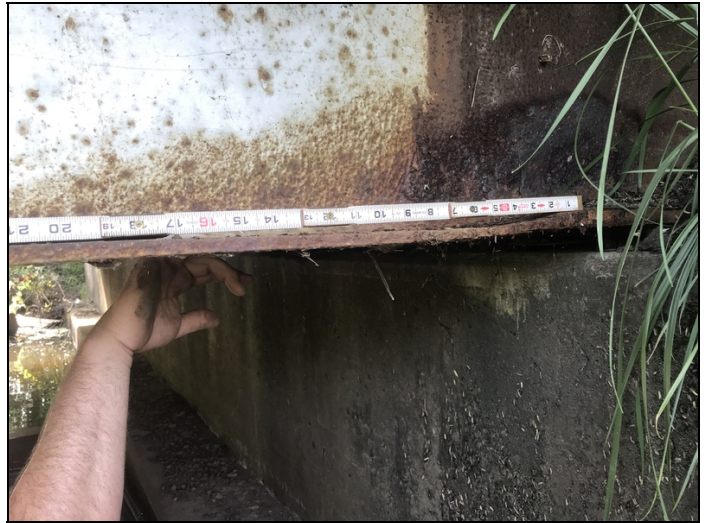
Bent 5, span 4, girder 5: 1/4" section loss to the bottom flange 25" out from backwall. Full flange thickness is 1/2".

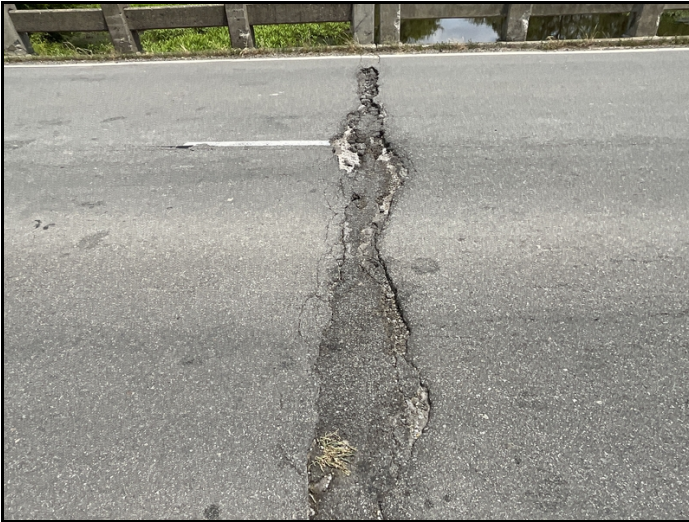
large potholes in the wearing surface over bent 2

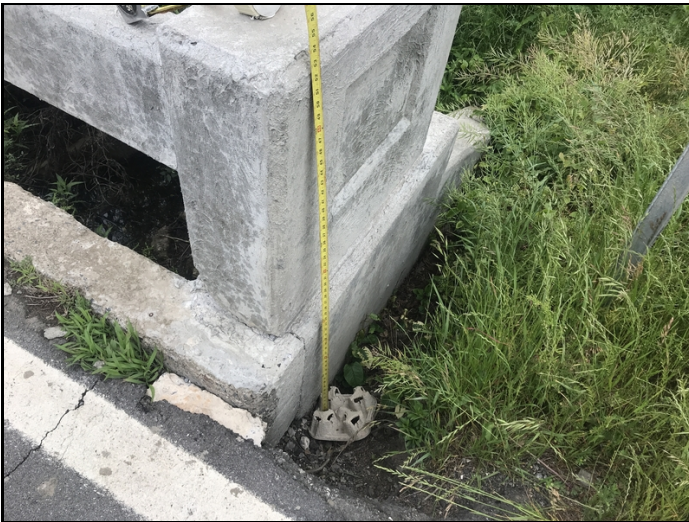
Erosion at north end of bridge at right wing wall

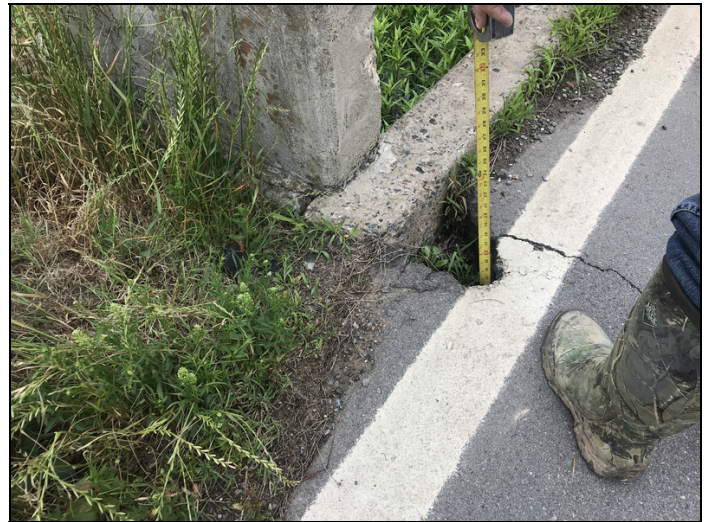
Erosion is causing a void under on the right side of approach roadway at south end of bridge.

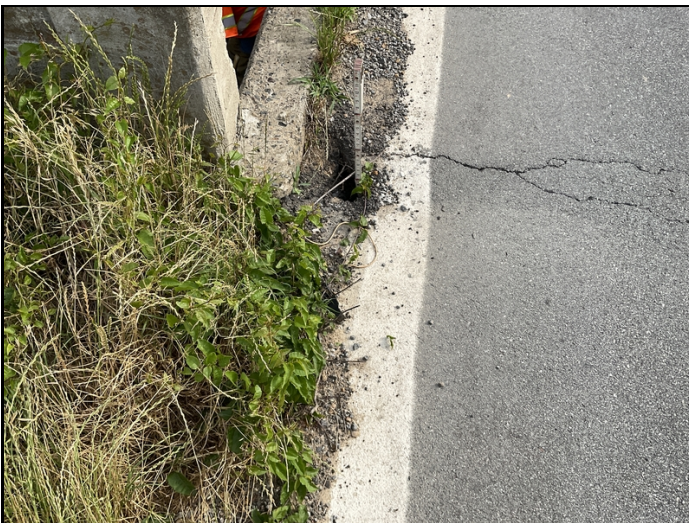
Erosion is causing a void under on the right side of approach roadway at south end of bridge.

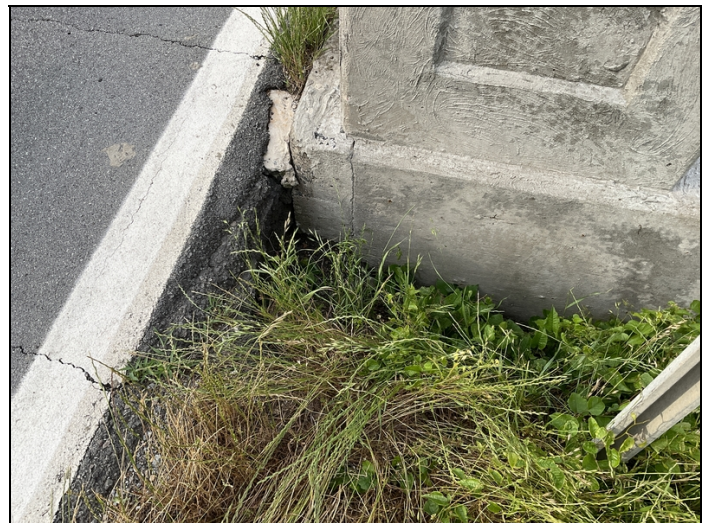
Erosion at north end of bridge at right wing wall
