Asset #M0756(Routine, Underwater type 2)

SH 33 Log 3.15 over HONEY CREEK

Team Lead: Bryan Saunders, Inspection Date: 03/20/2023

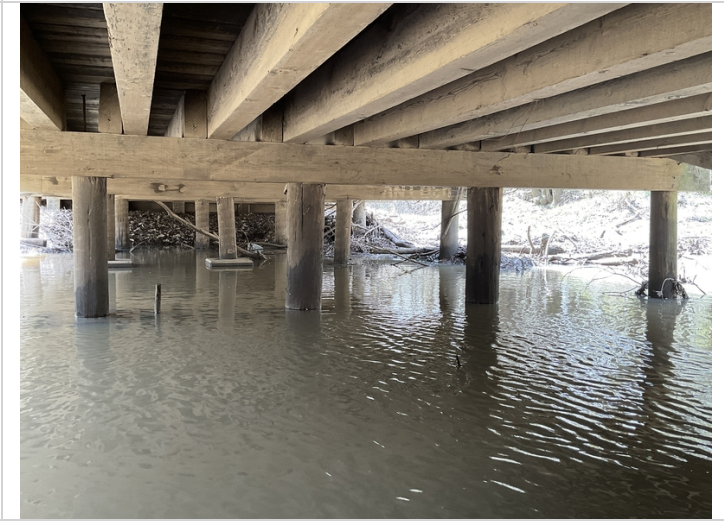
Split at bent 4 pile 3

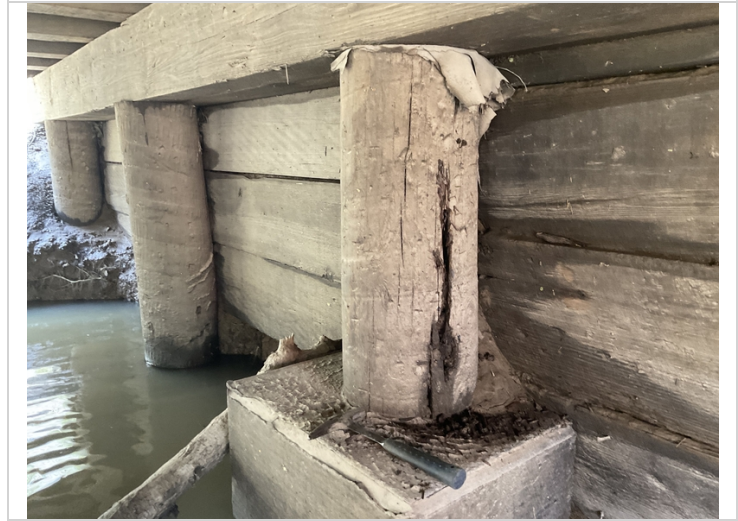
Bent 6 pile 3 has a decayed area 2' long 2" deep

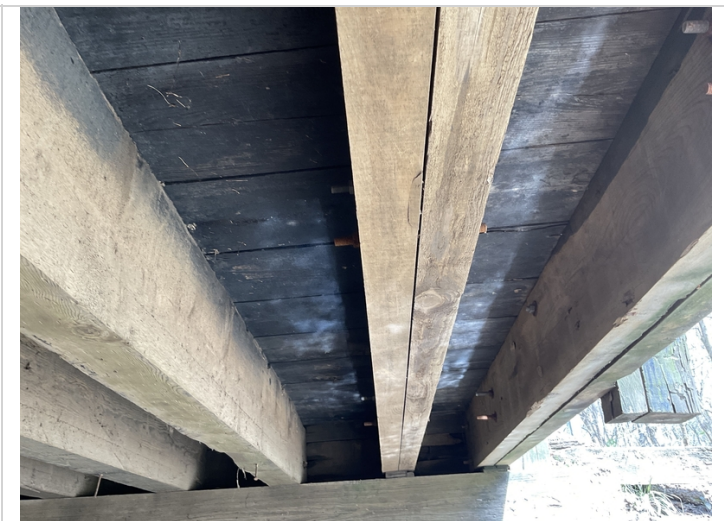
Span 5 girder 12 and 13 replaced with sandwiched beams

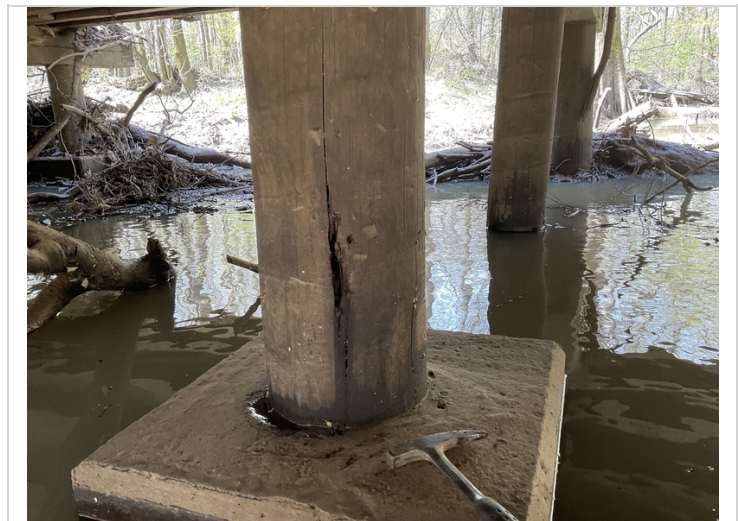
Bent 3 pile 3 split with decay

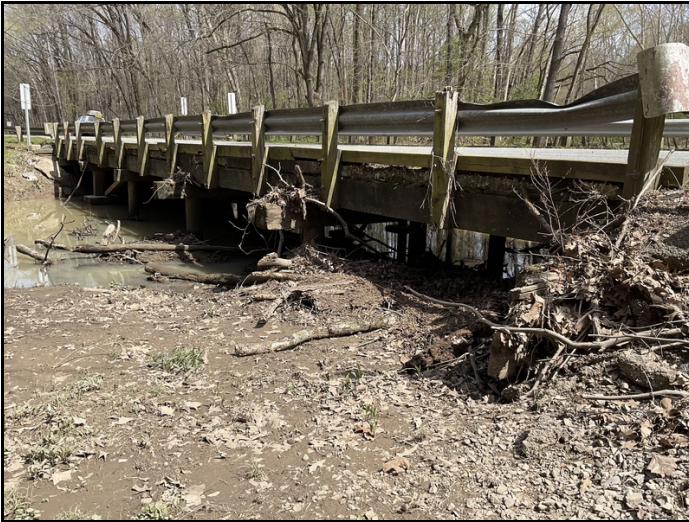
Debris at bent 2 and 3 upstream end

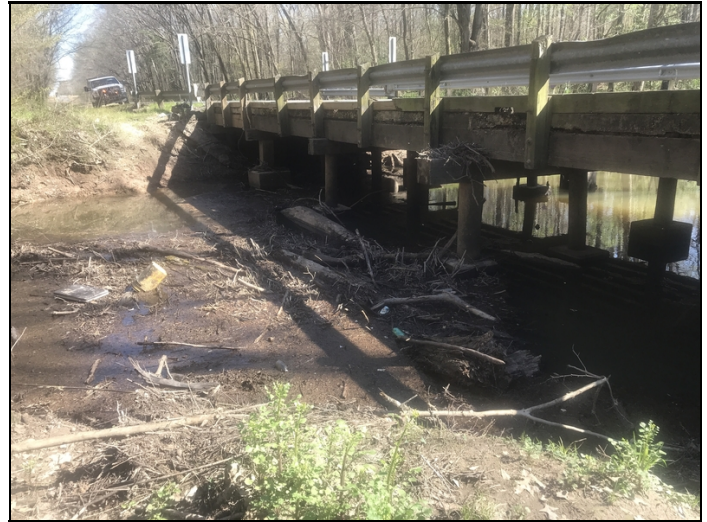
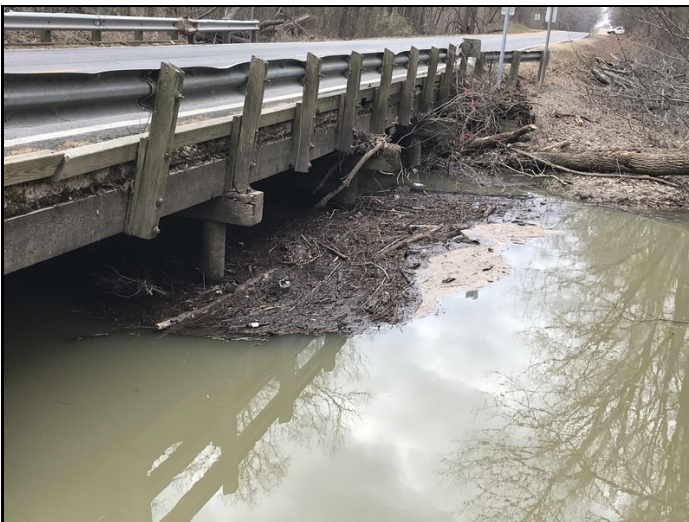
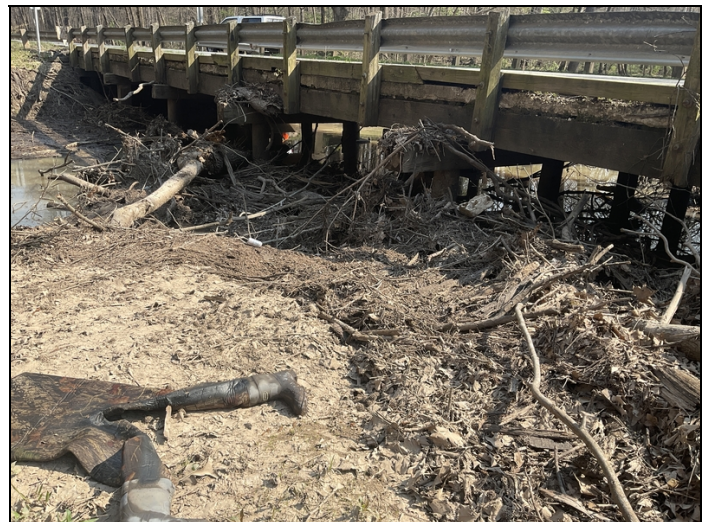
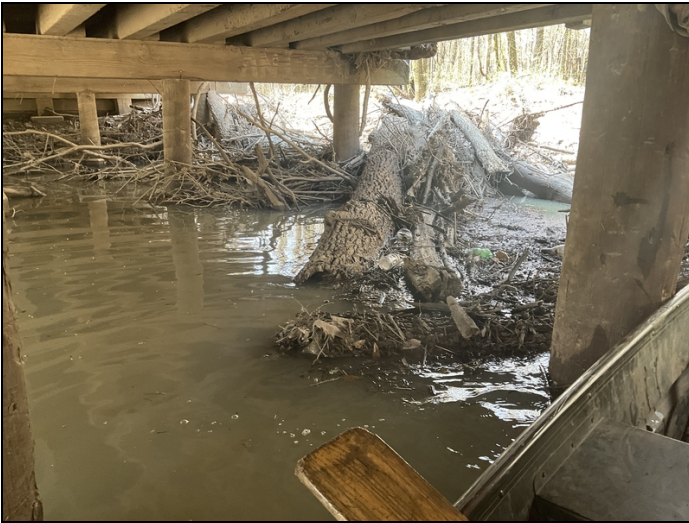
Logs and debris build up on west side of bridge restricting water flow

Logs and debris build up at west end of the bridge restricting water flow

Logs and debris build up at west end of the bridge

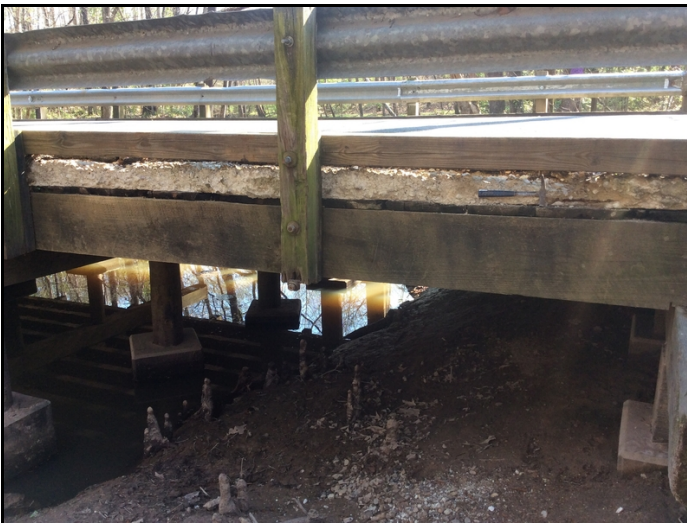
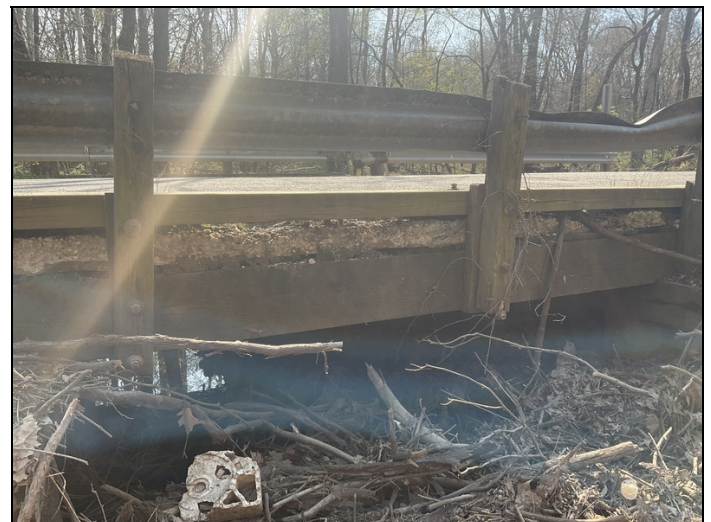
Deck both sides at gutter line have spalls due to concrete deterioration.

Span 1 left side spalling due to concrete deterioration.

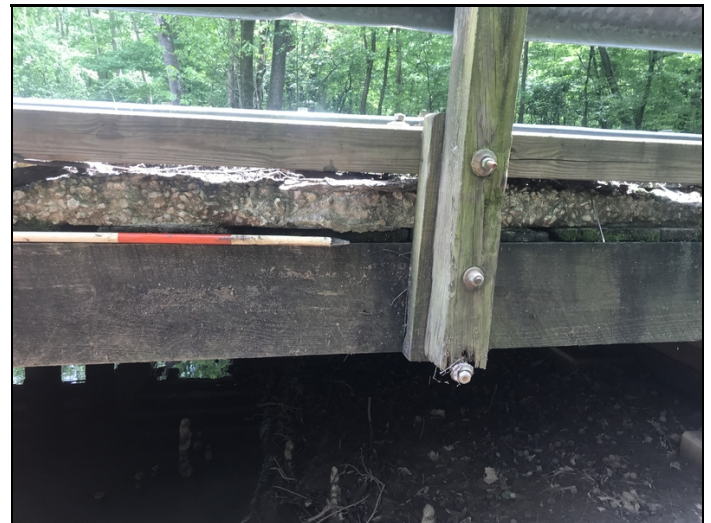
Span 1, left side of concrete deck is spalled

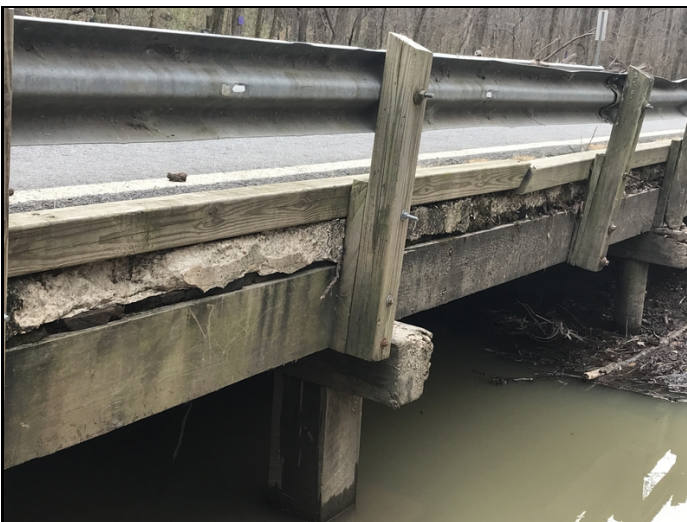
Span 2 and 3 right side of deck has spalls

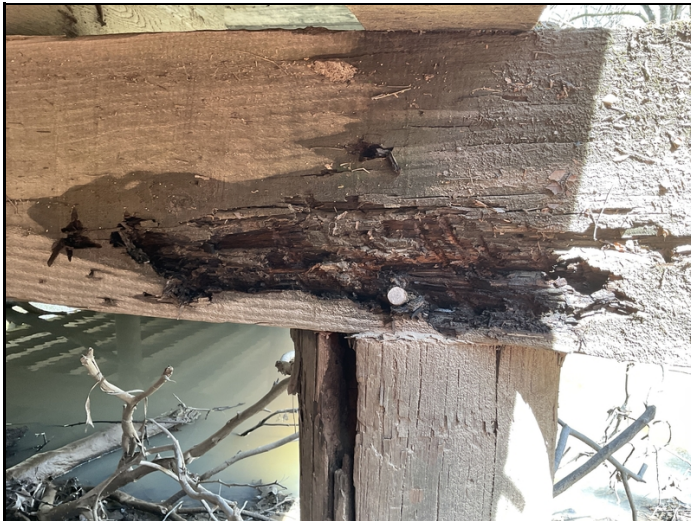
Bent 2 cap over pile 5 has a 2'x 6" x1" deep decay

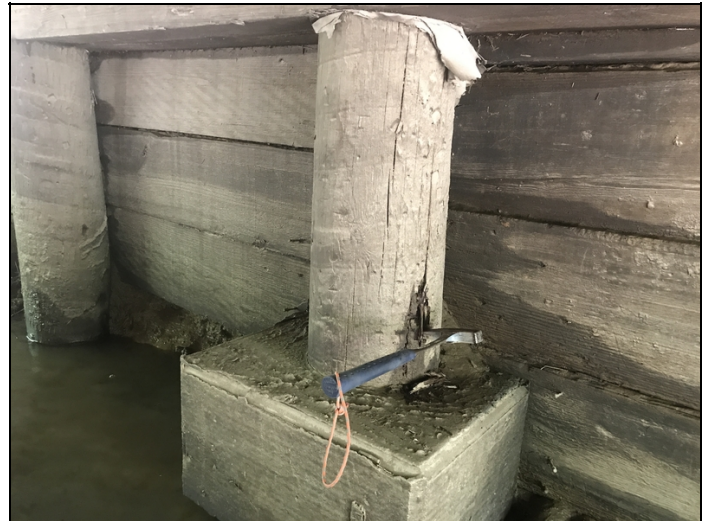
Bent 6, pile 3: the pile is cracked and is decaying.

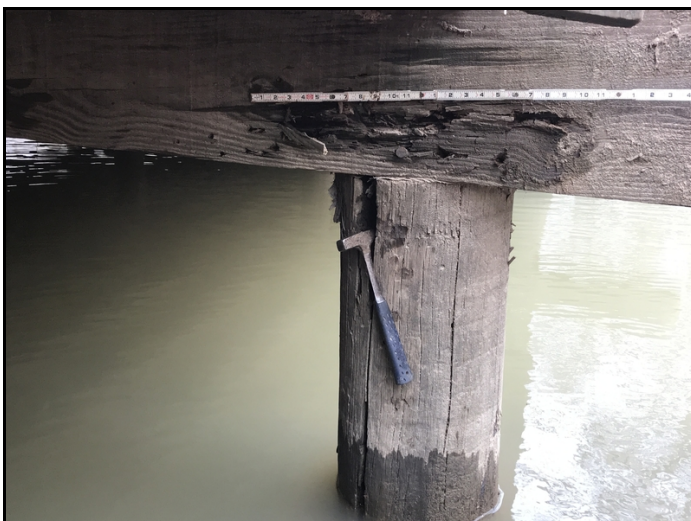
Bent 2 pile 5 is split and hollow at top. 2' of decay on cap.

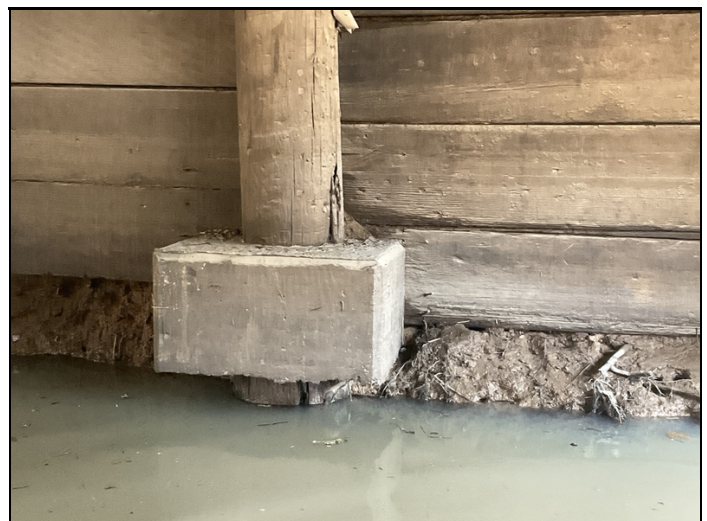
Bent 6 pile 3 is split and decayed at bottom near concrete collar

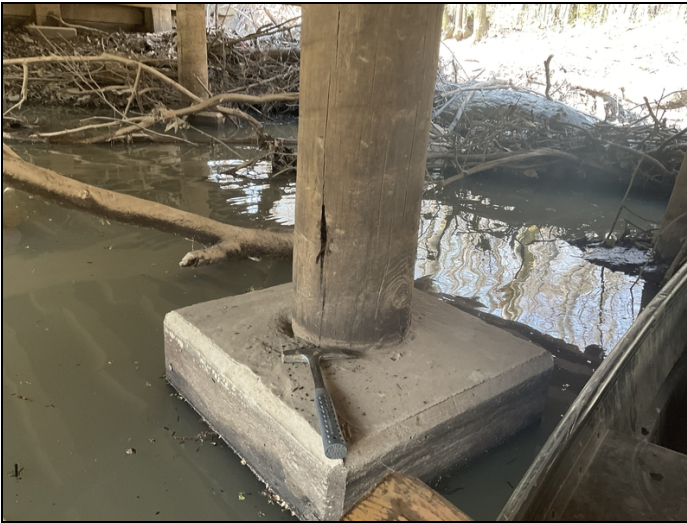
Bent 3 pile 3 is split and decayed.

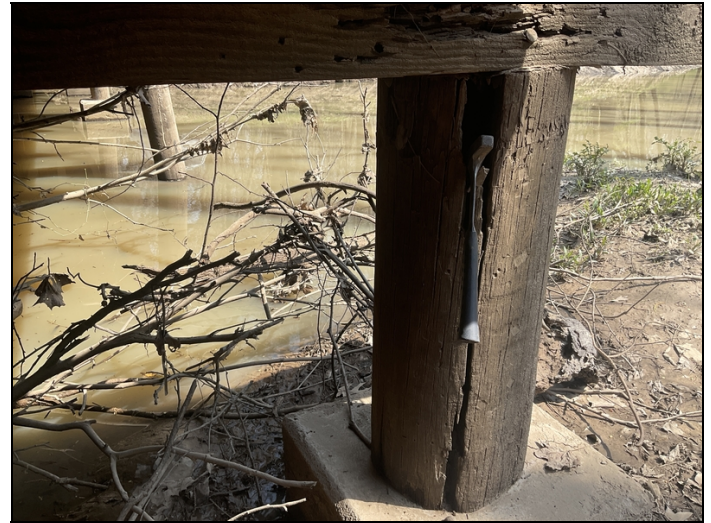
Bent 2 pile 5 is split and hollow at the top

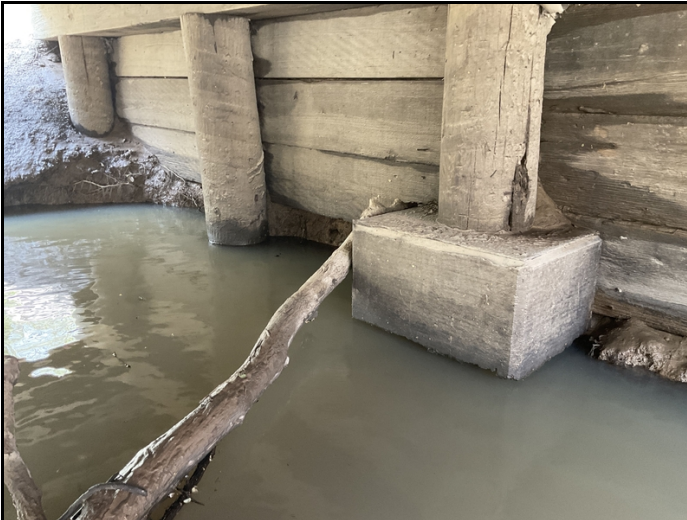
bent 6 has scour hole at west end undermining timber cribbing

Bent 6 scour hole

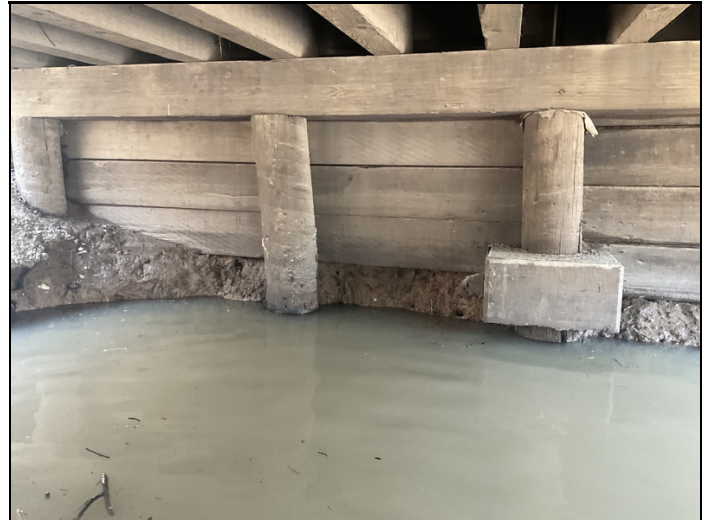
Timber cribbing at bent 6 is being undermined due to channel being block by trees and debris

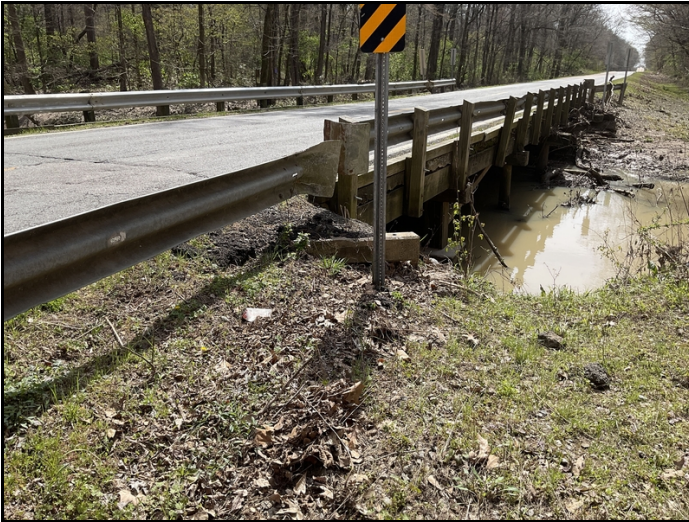
Approach guardrail post laid over due to traffic impact

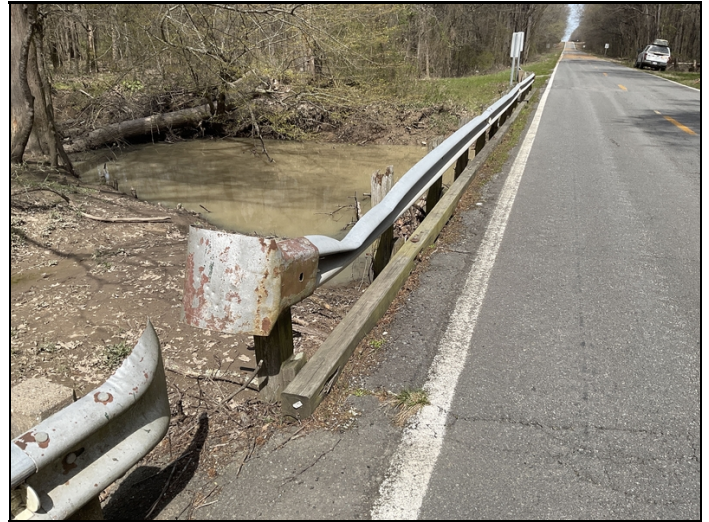
Guardrail damage at southwest end

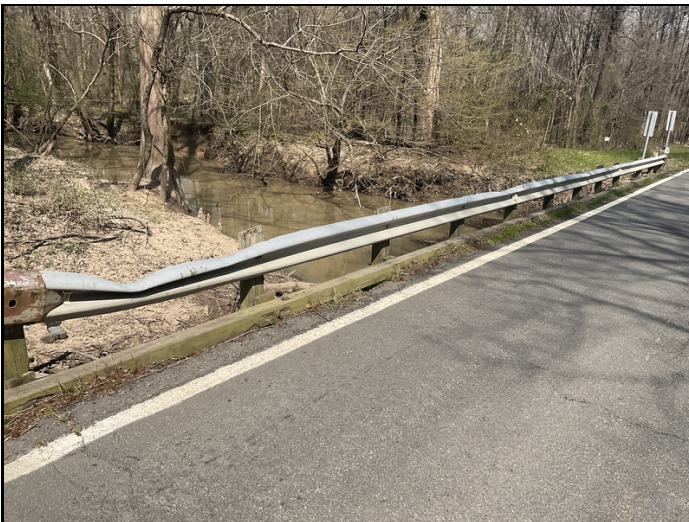
Left bridge rail is damaged
