Bridge #A6357 (Routine)
I-30 EB log 128.02 over OTTER CREEK

Location: 1.8 MI E JCT SH 111

Team Lead: Keith Harris Inspection Date: May 06, 2019

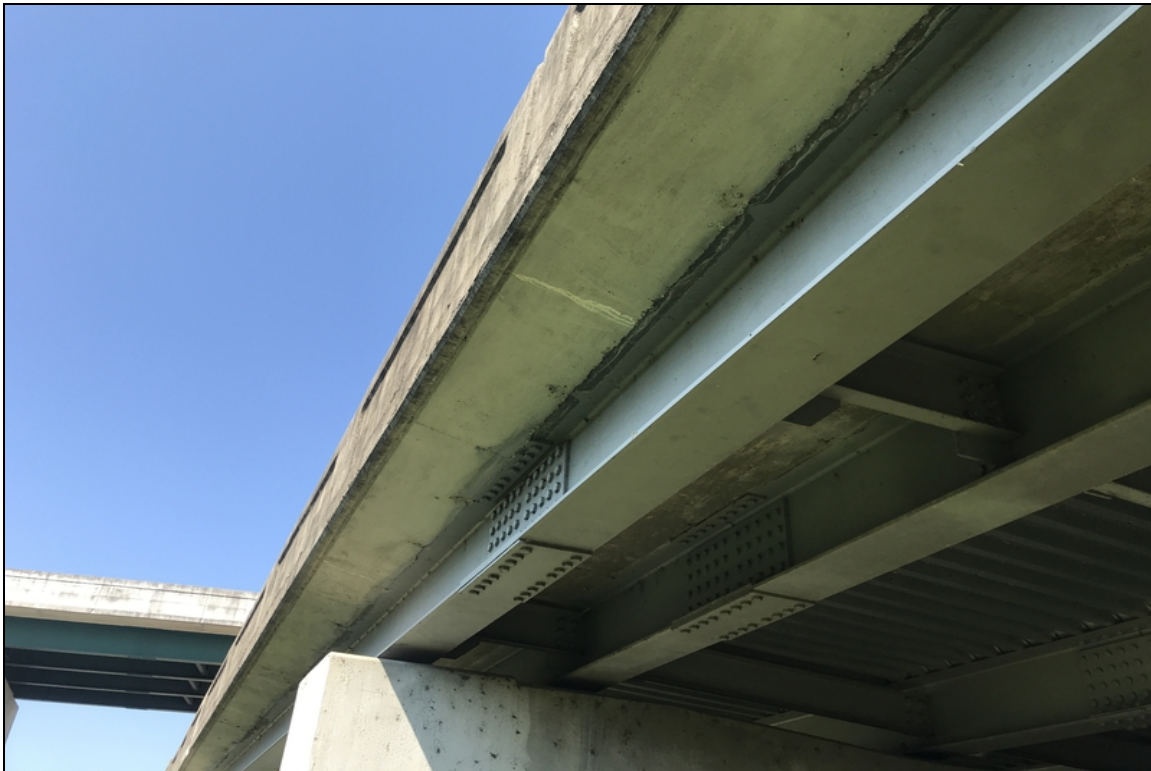
(12)	unsealed cracks in all spans up to Overhang has cracks with efflorescence						
107	Steel Open Girder/Beam	LF	1240	1239	1	0	0
1020	Connection	LF	1	0	1	0	0
515	Steel Protective Coating	SF	7031	7031	0	0	0

Crack with efflorescence on overhang

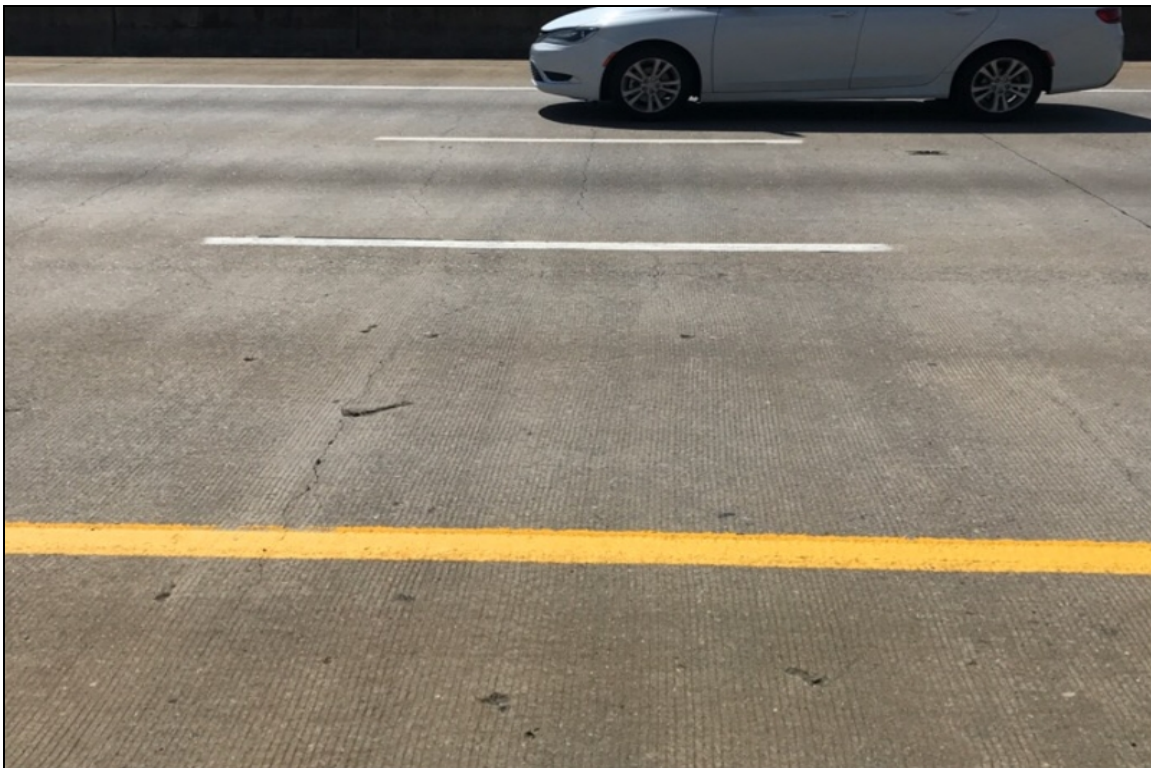
Span 4 unsealed cracks up to 1/8"

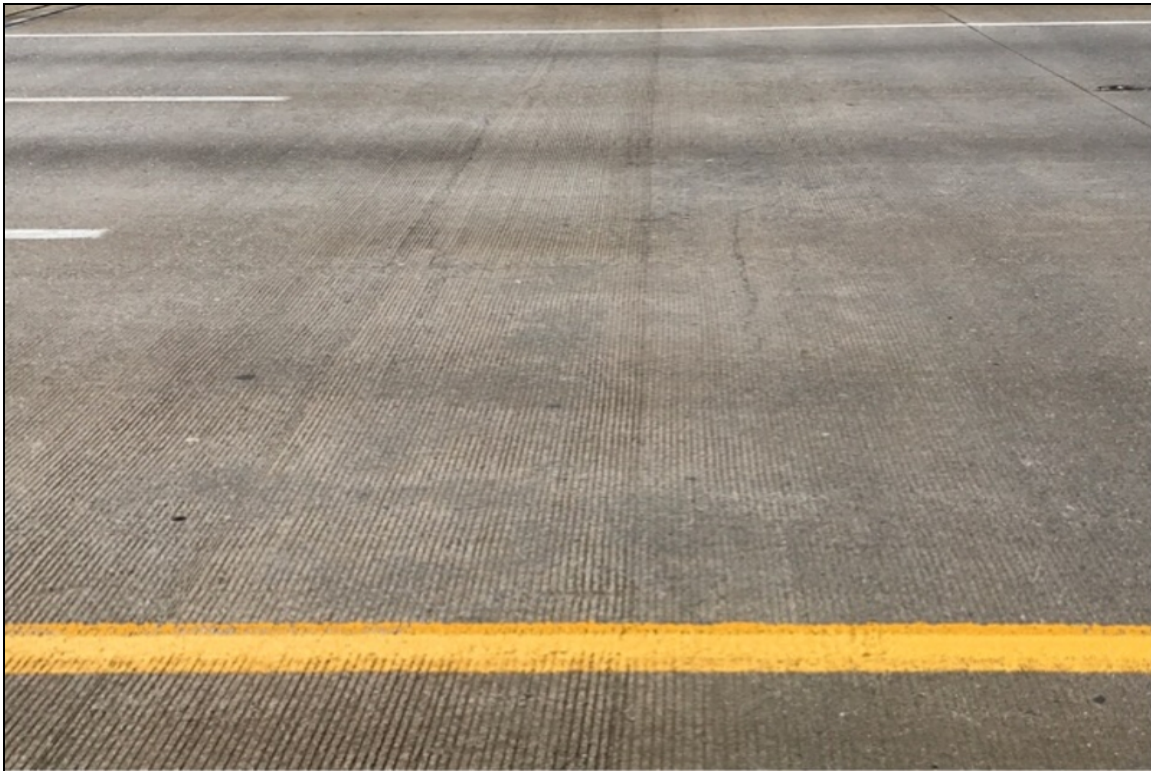
Span 5 unsealed cracks up to 1/8"

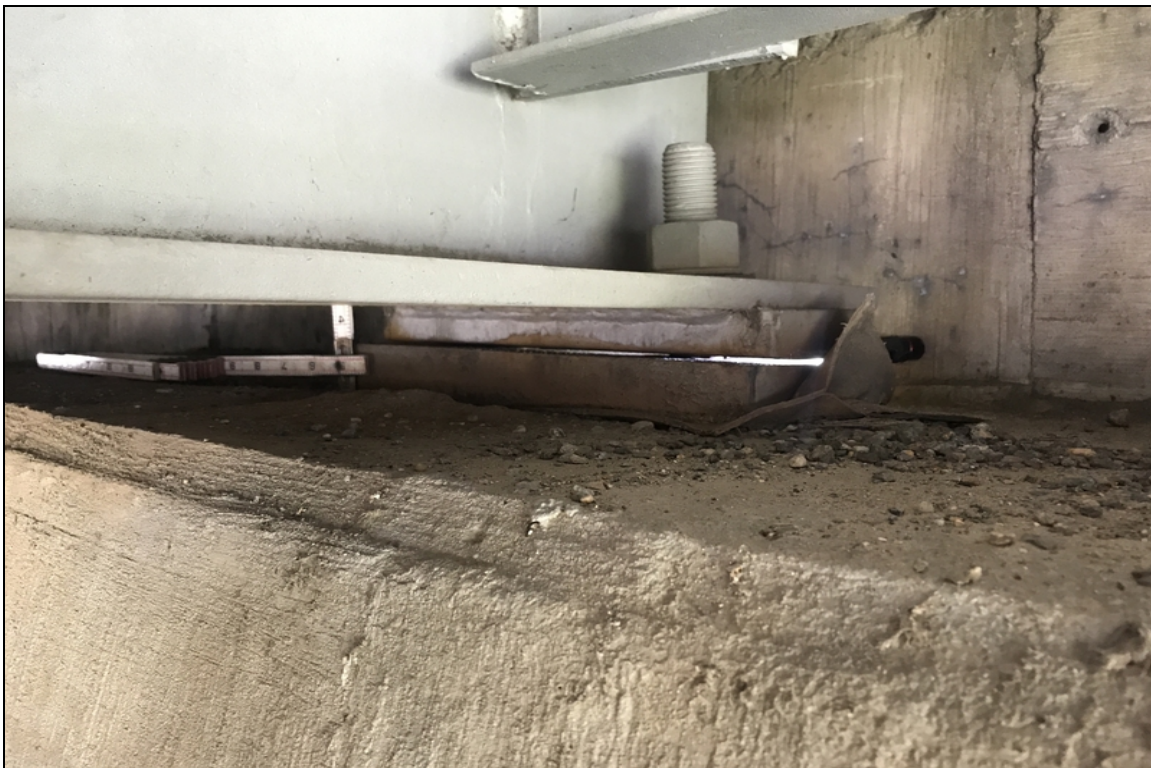
Bent 6 bearing 6 bearing is floating, causing the sole and masonry plates to collide against each other.

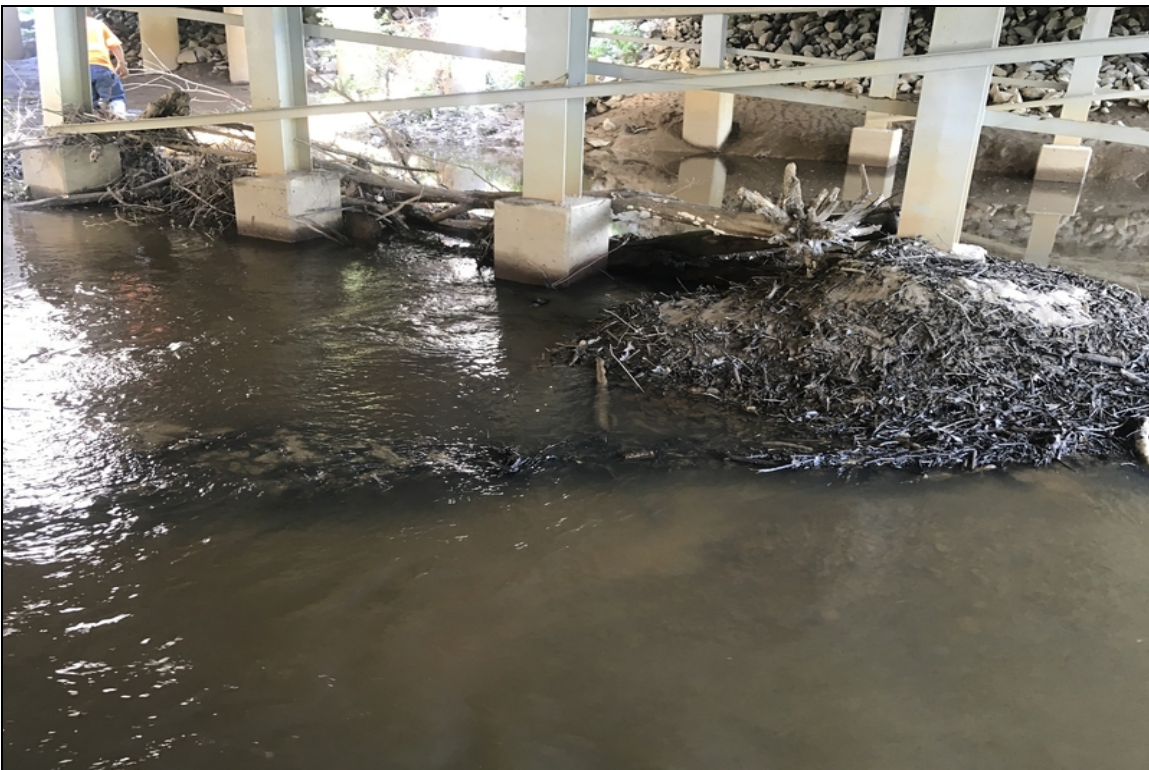
Bent 4 logs and debris restricting water flow

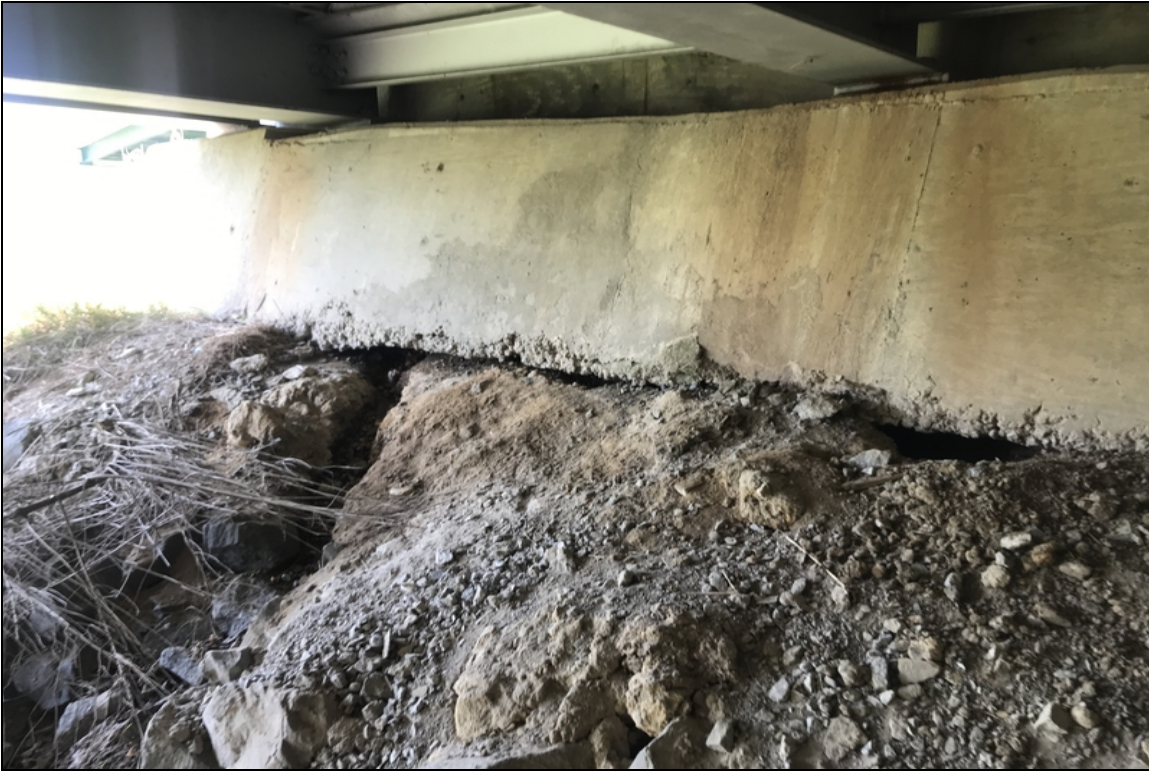
(215)	Spalls with rebar in back wall bent 6. Both abutments have small cracks. Added 5/17/17 Bent 1, between girders 7 & 8: material is being eroded from under the beam seat.						
225	Steel Pile	EA	36	0	36	0	0
1000	Corrosion	EA	36	0	36	0	0
515	Steel Protective Coating	SF	2790	2574	216	0	0
3420	Peeling/Bubbling/Cracking	SF	216	0	216	0	0

Bent 1, between girders 7 & 8: material is being eroded from under the beam seat exposing piling.

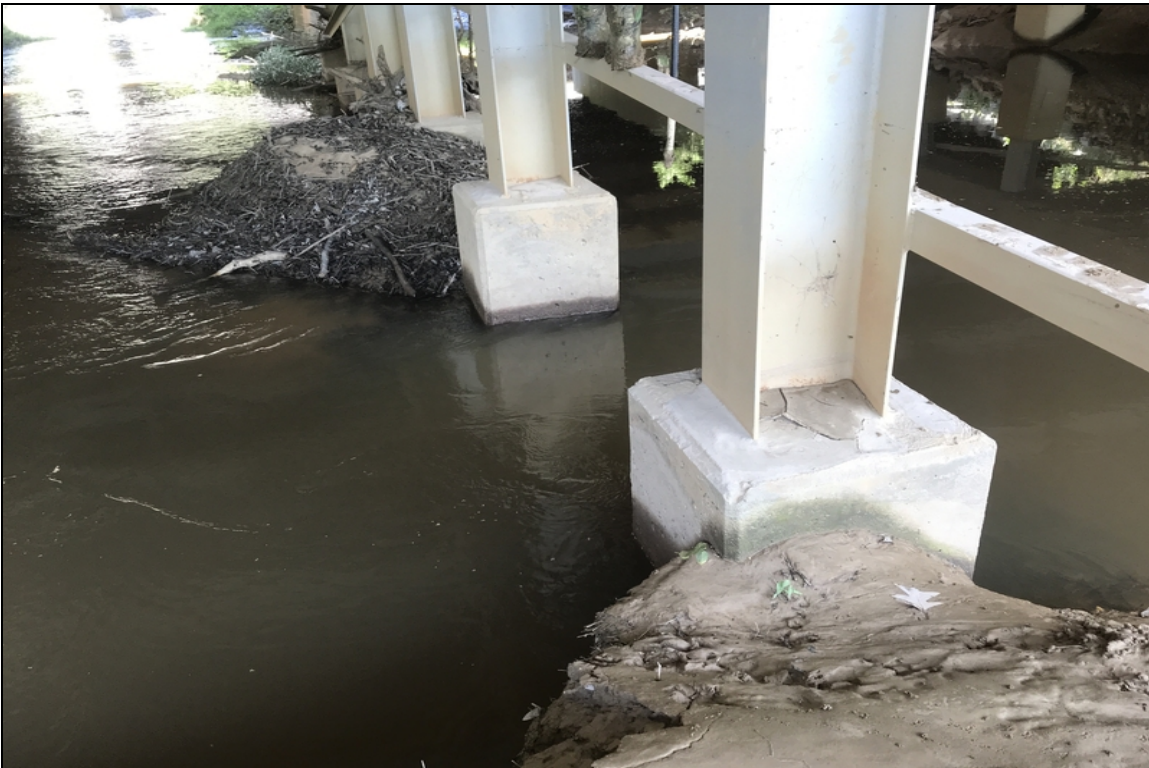
(225)	Steel Columns at bent # 2,3,4 & 5 Columns at top of encasement, dirt and silt causing rust to form.						
234	Reinforced Concrete Pier Cap	LF	238	237	1	0	0
1080	Delamination/Spall/Patched Area	LF	1	0	1	0	0

Bent 4 Pile at top of encasement has dirt and silt causing rust to form.
