Bridge #06911(Routine)

I-30 Log 121.36 over Hurricane creek

Team Lead: Chris Doggett Inspection Date: March 09, 2021

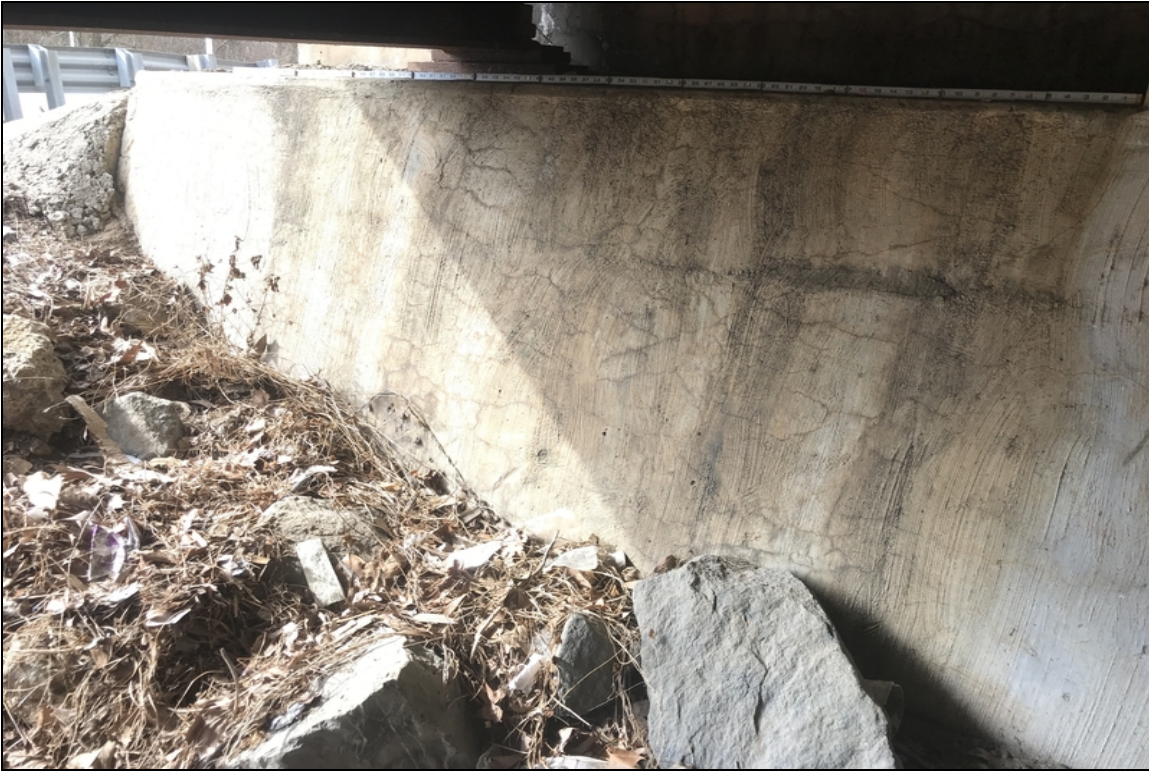
(215)							
Both abutments have heavy amounts of map cracking on the right end. Small scattered cracks with efflorescence in back wall of both abutments.							
234	Reinforced Concrete Pier Cap	LF	565	561	4	0	0
1080	Delamination/Spall/Patched Area	LF	2	0	2	0	0
1130	Cracking (RC and Other)	LF	2	0	2	0	0

Bent 1: right end of beam seat is map cracked.

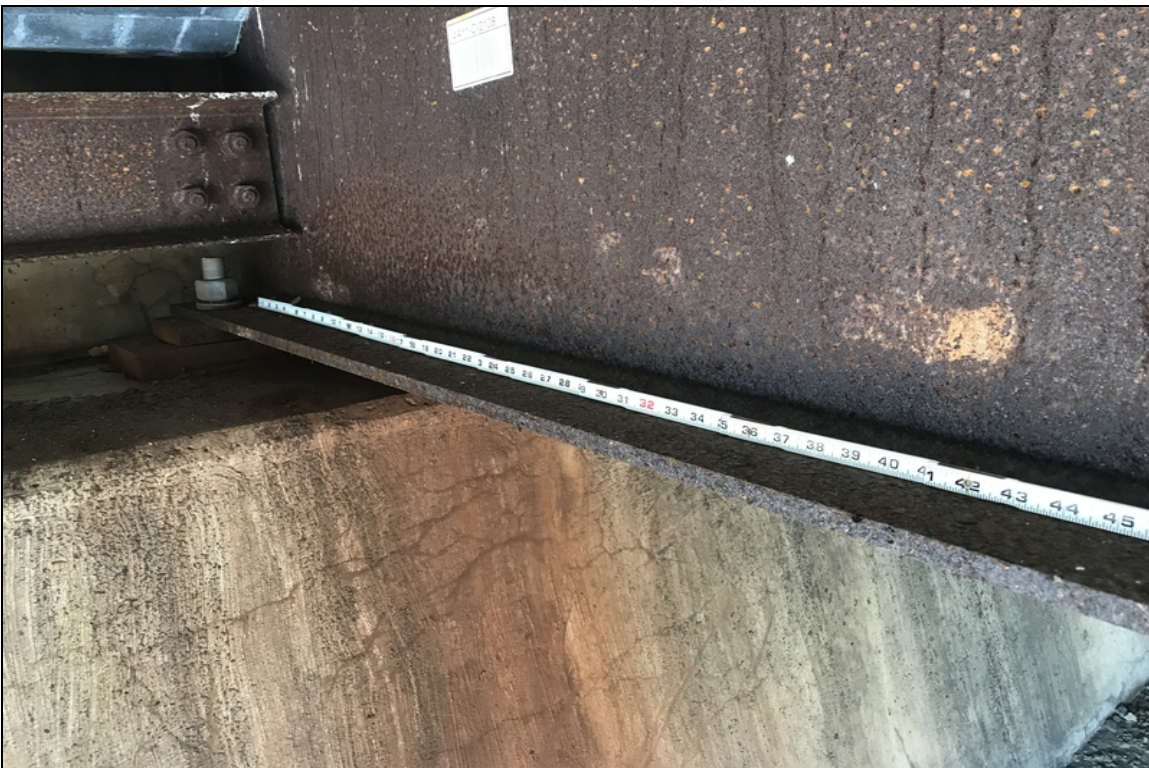
(107)							
Beam ends at bent 1,4 & 7 have small flakes less than 1/2" in diameter on the webs and bottom flanges.							
205	Reinforced Concrete Column	EA	35	34	1	0	0
1080	Delamination/Spall/Patched Area	EA	1	0	1	0	0

Span 1 beam 13 bottom web and upper haunch area of beam end have small flaking rust.  
Common all beam ends bent 1

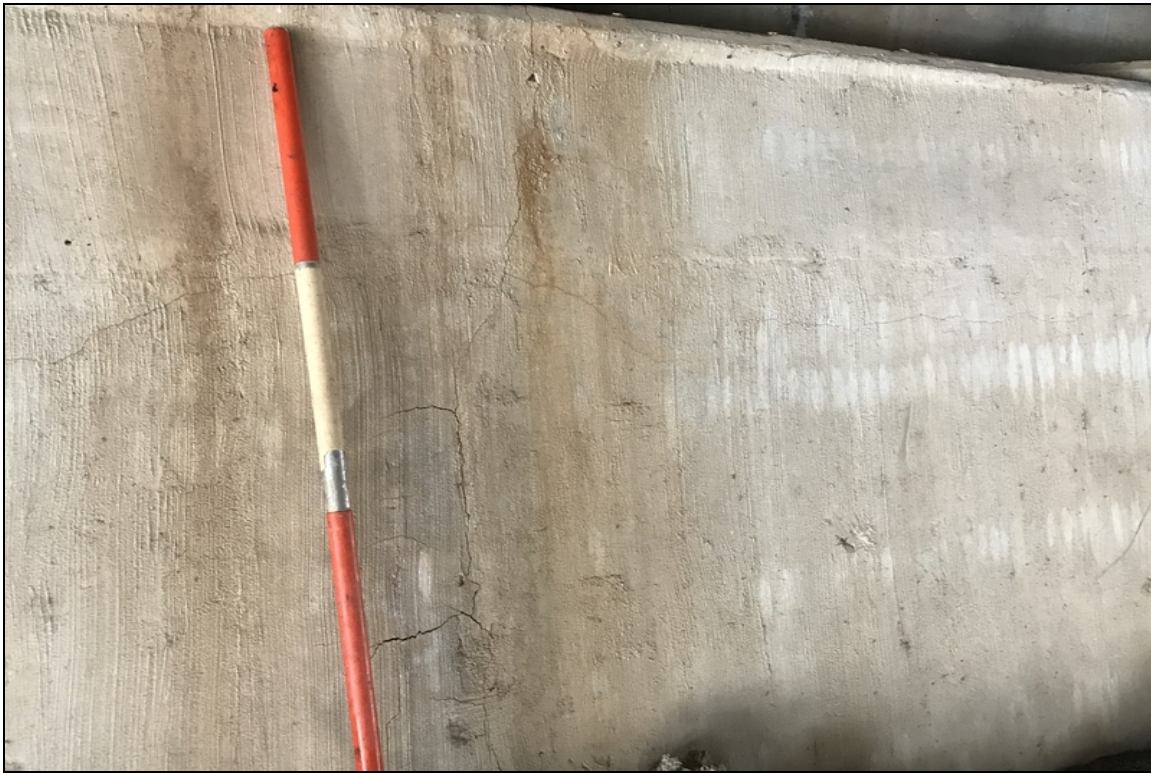
Bent 1: beam seat with vertical and horizontal cracking.

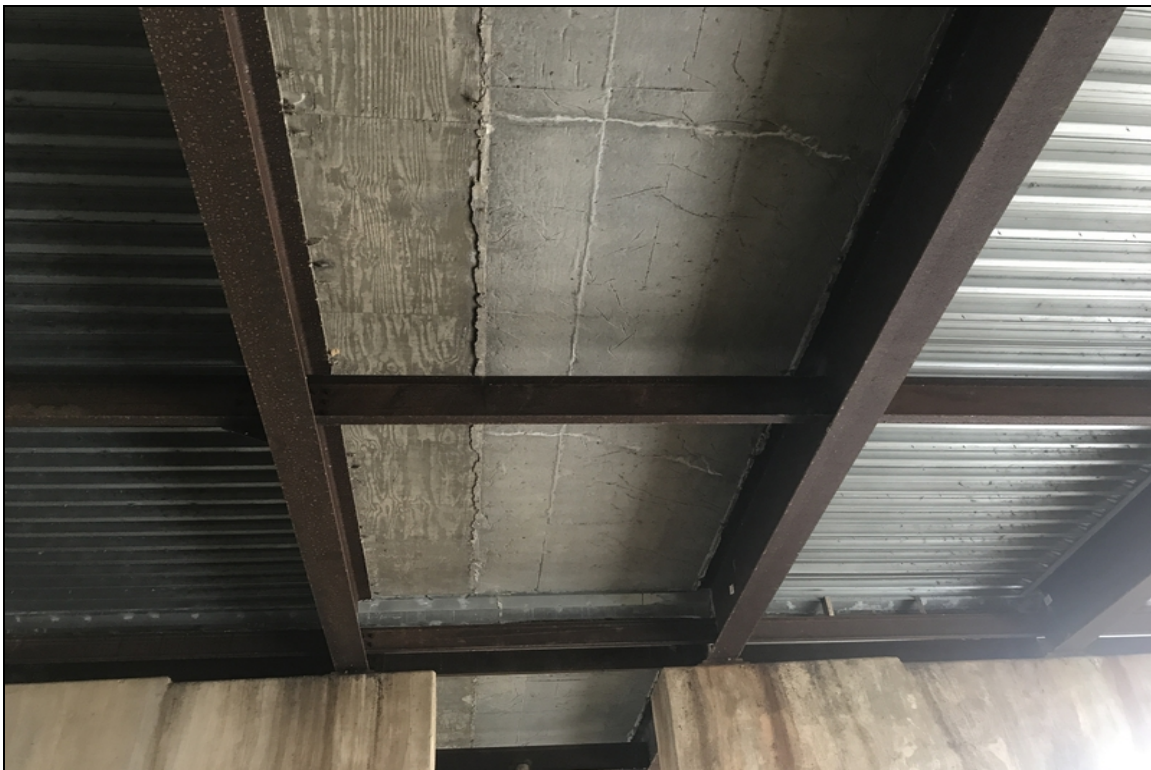
(12)							
Longitudinal and transverse cracks up to .040". Transverse cracks in the soffit overhangs and soffit of stage construction areas. ( no deck pans)							
107	Steel Open Girder/Beam	LF	2520	2492	28	0	0
1000	Corrosion	LF	28	0	28	0	0
515	Steel Protective Coating	SF	15271	15271	0	0	0

Span 4 soffit has transverse cracks with efflorescence.

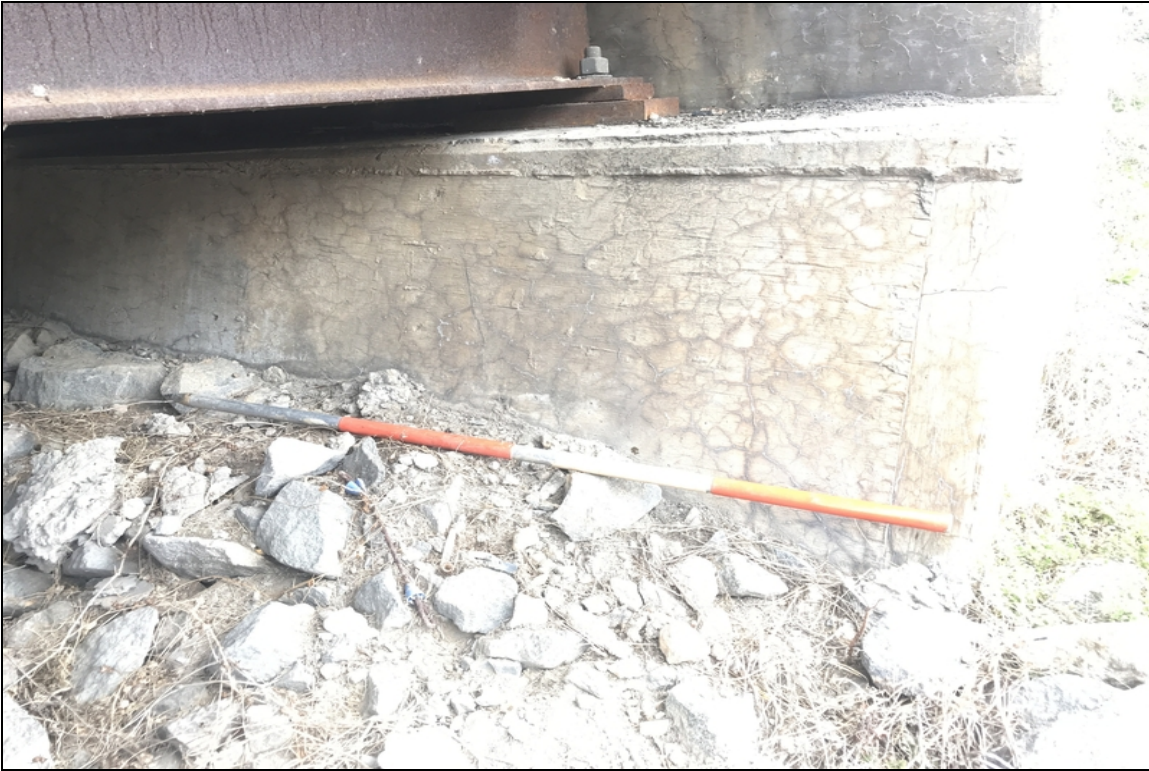
Bent 7: right end of cap has map cracking up to 6' in length.

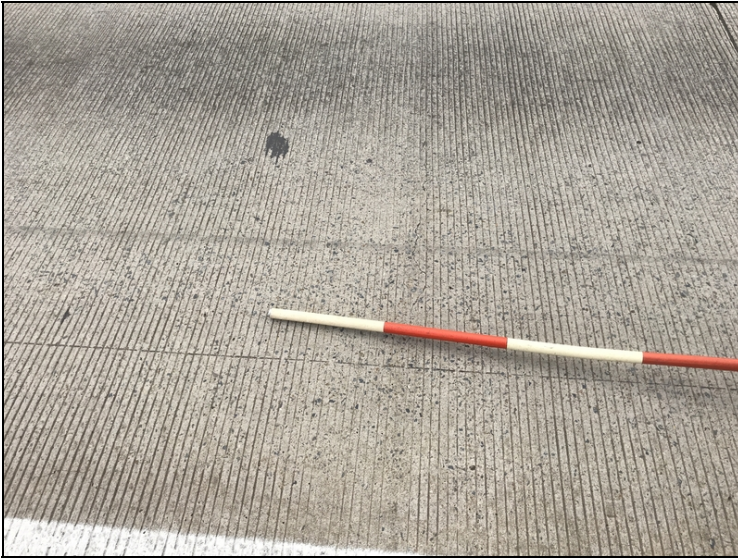
Deck has large unsealed transverse and longitudinal cracks up to 0.040 inch. See photos.

Span 6 deck has transverse cracks.

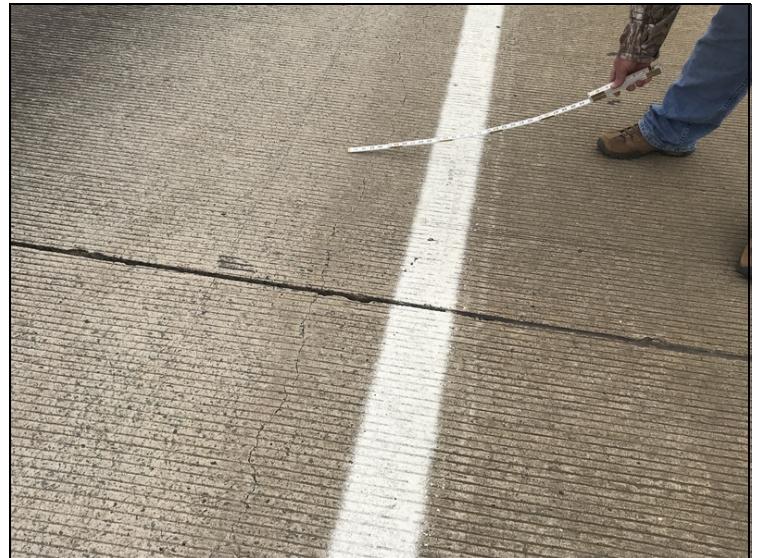
Span 2 deck has longitudinal cracks.
