Bridge #A6357(Routine)

I-30 EB log 128.02 over OTTER CREEK

Team Lead: Bryan Saunders Inspection Date: May 19, 2021

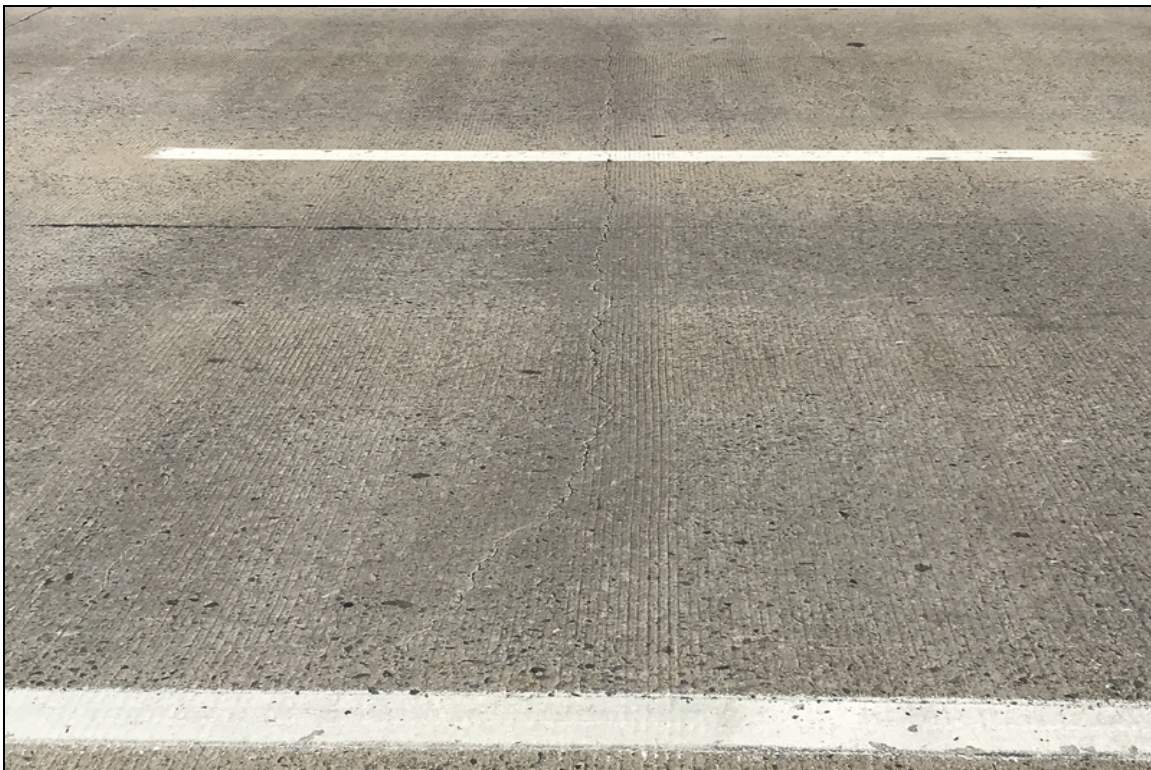
(12)	unsealed cracks in all spans up to .035" Overhang has cracks with efflorescence						
107	Steel Open Girder/Beam	LF	1240	1239	1	0	0
1020	Connection	LF	1	0	1	0	0
515	Steel Protective Coating	SF	7031	6605	426	0	0
3410	Chalking (Steel Protective Coatings)	SF	426	0	426	0	0

Span 4, large transverse crack.

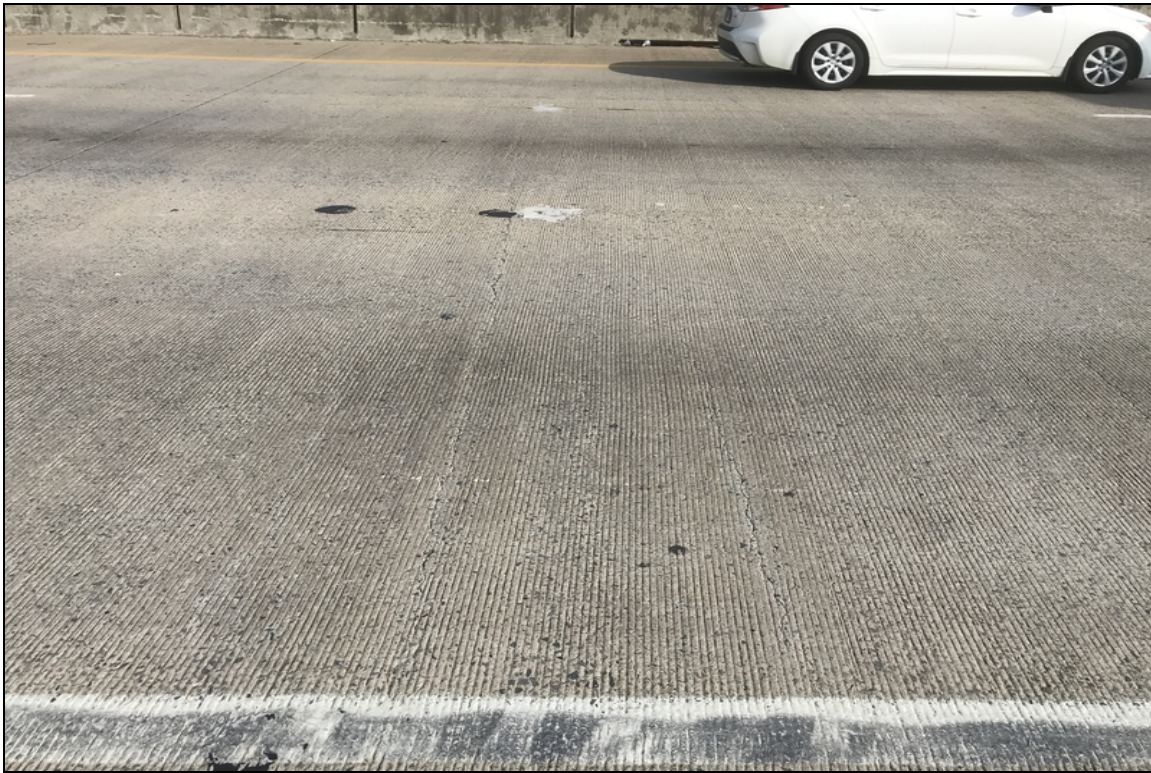
Span 2, large transverse cracks.

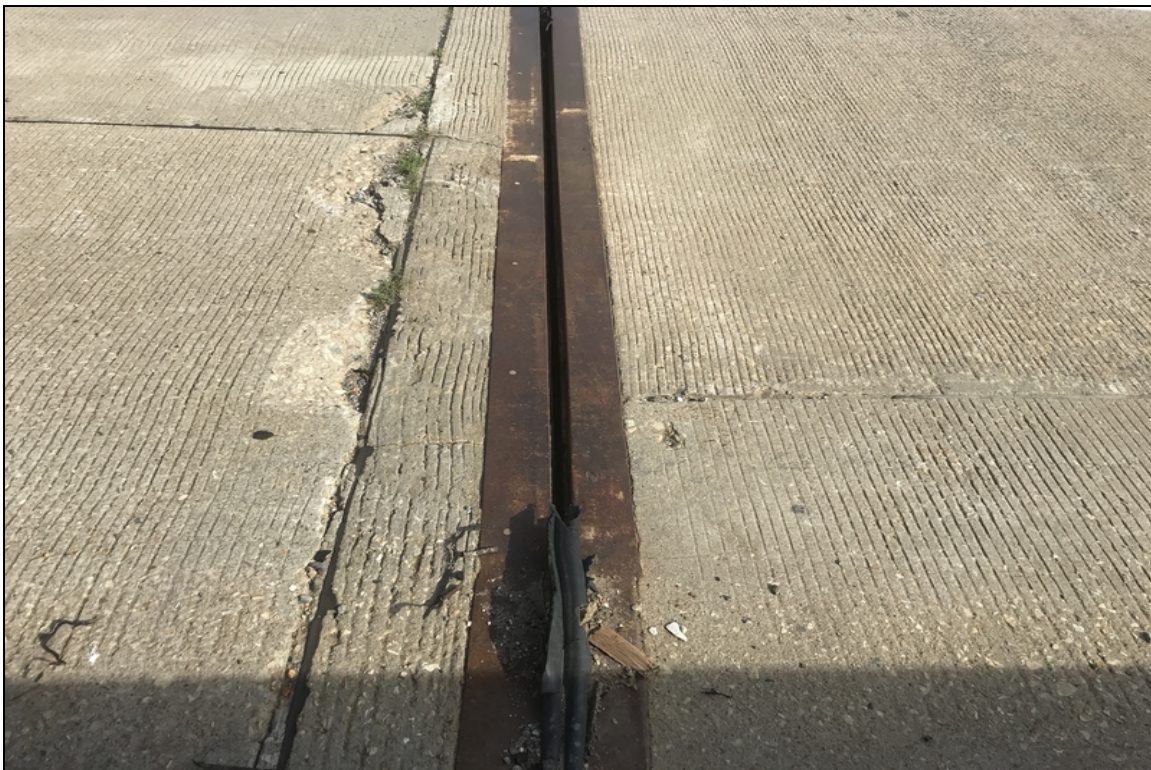
ELEM	DESCRIPTION	UNITS	TOTAL	CS1	CS2	CS3	CS4
2310	Leakage	LF	8	0	0	0	8
2330	Seal Damage	LF	63	0	40	23	0
(302)	Torn joint seal at bent 1						
311	Movable Bearing	EA	36	26	8	2	0
1000	Corrosion	EA	9	0	8	1	0
2220	Alignment	EA	1	0	0	1	0
(311)	Rust forming on the bearings at end bents. See photo. Bent 6, girder 1: dirt and debris accumulating around bearing allowing pack rust to form. Bent 6 Girder 6: bearing is floating, causing the sole and masonry plates to collide against each other.						
313	Fixed Bearing	EA	18	18	0	0	0
321	Reinforced Concrete Approach Slab	SF	2628	2508	115	5	0
1080	Delamination/Spall/Patched Area	SF	5	0	0	5	0
1130	Cracking (RC and Other)	SF	115	0	115	0	0
(321)	Spalls on west approach slab.						
331	Reinforced Concrete Bridge Railing	LF	280	280	0	0	0

Bent 1 right side, missing joint seal.

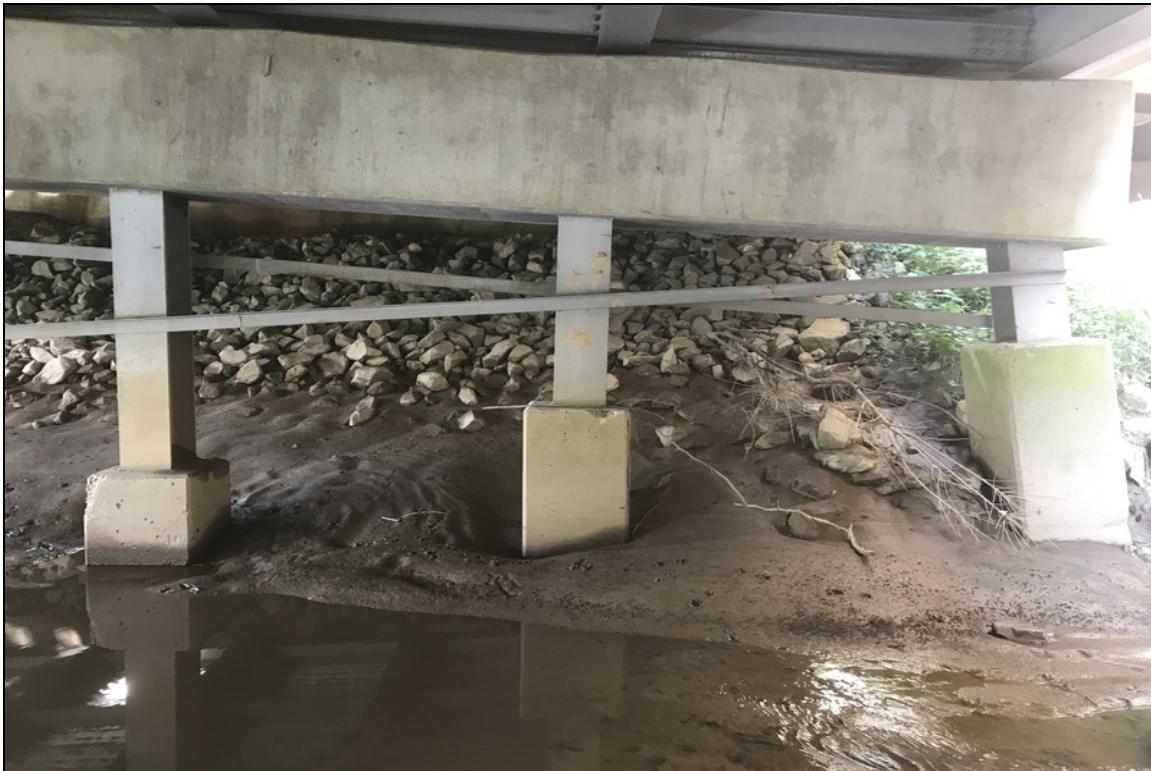
Bent 2, piles 1-3, spalls on concrete encasement.

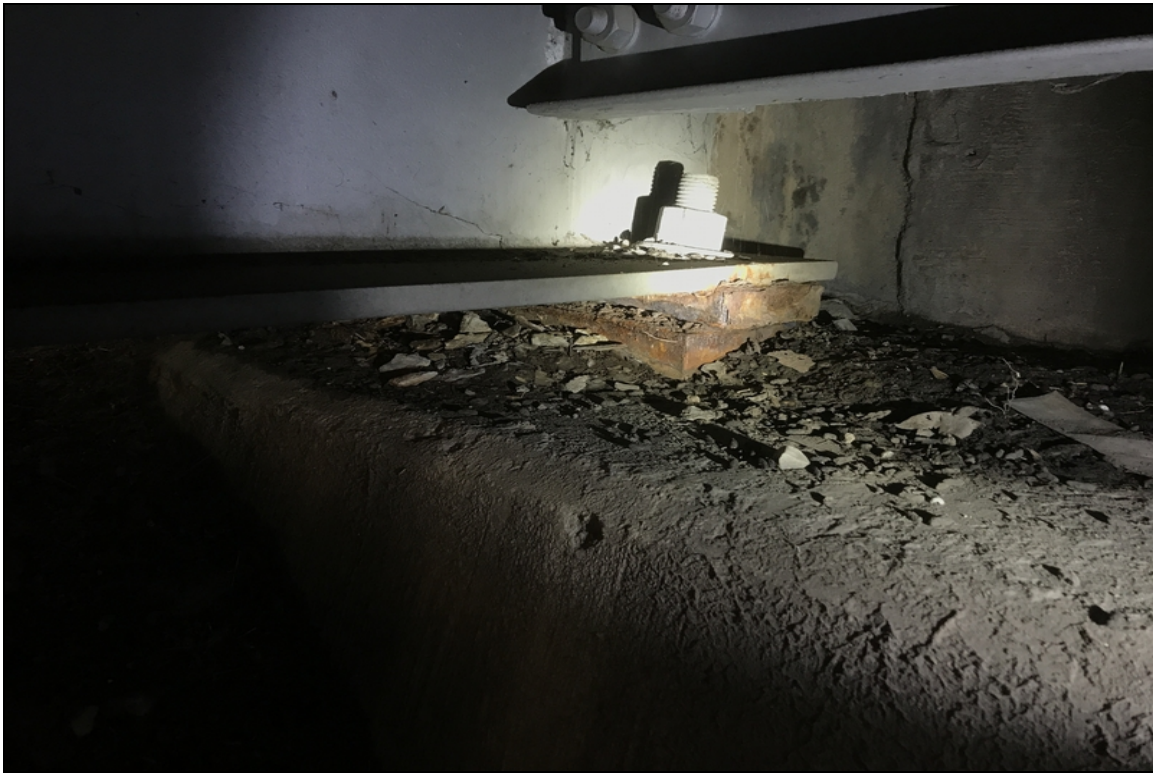
Bent 6 bearing 1, corrosion.

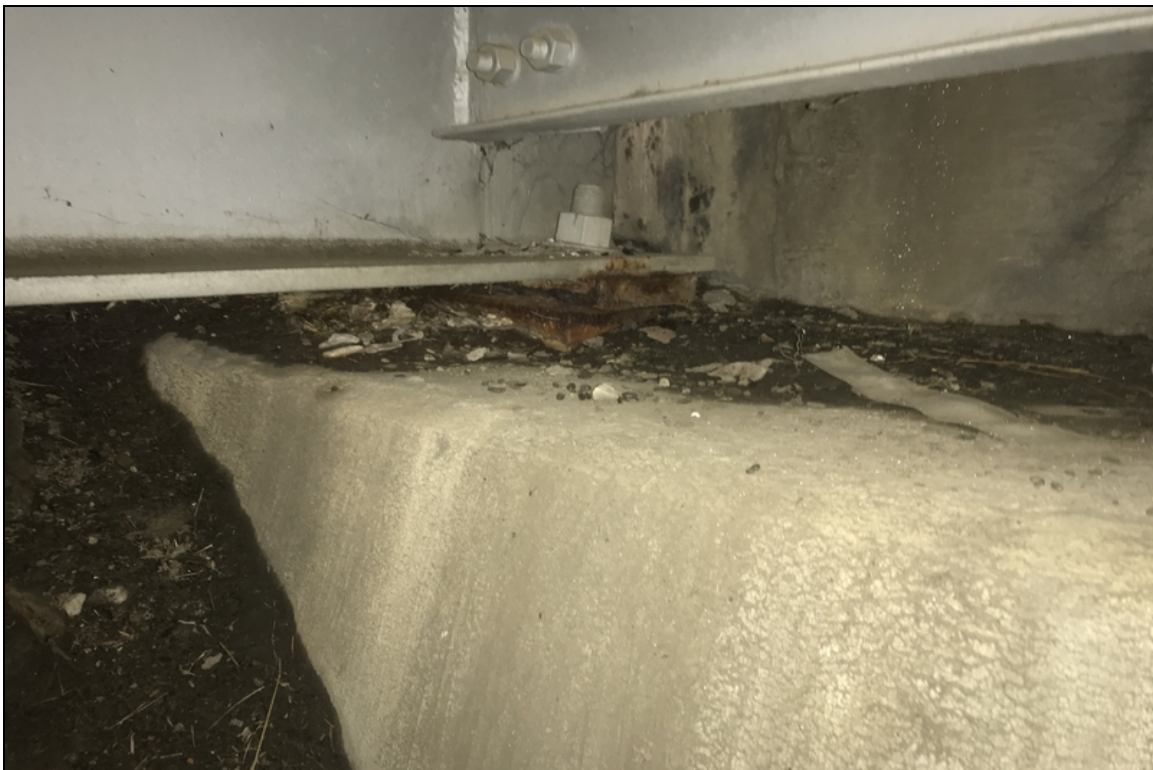
Bent 6 bearing 1, debris around bearing.

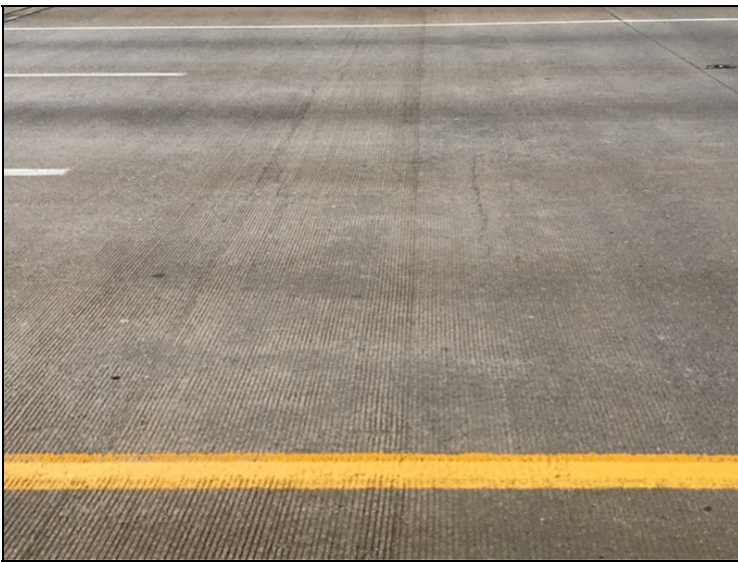
Deck has large unsealed cracks up to 1/8 inch wide and some on 3 to 4 feet centers.

Span 5 unsealed cracks up to 1/8"

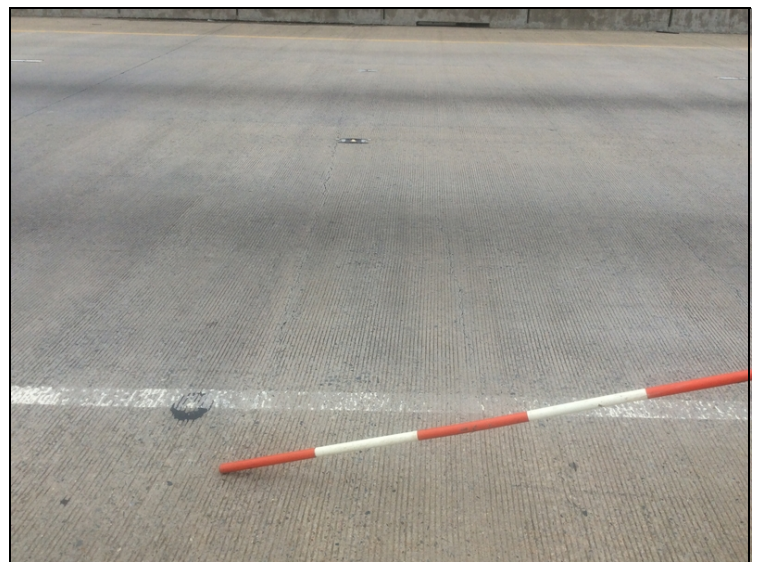
Span 2 large unsealed cracks up to 1/8" on 3 to 4 foot spacing. Common all spans.

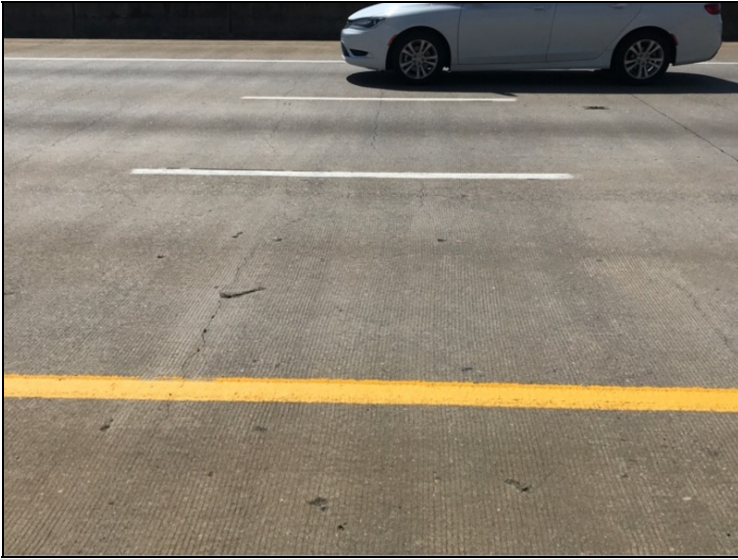
Span 4 unsealed cracks up to 1/8"

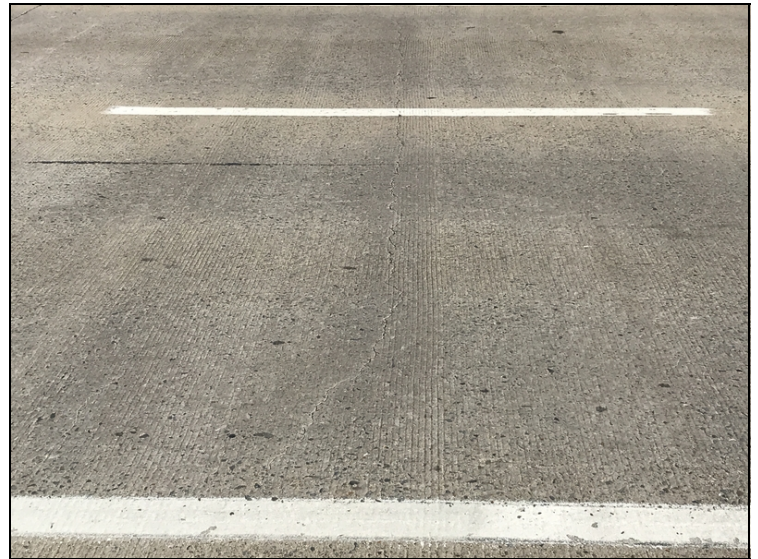
Span 4, large transverse crack.

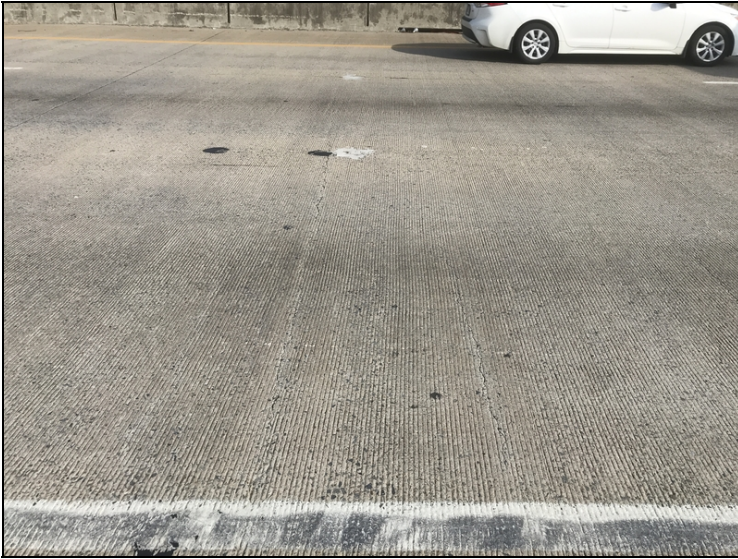
Span 2, large transverse cracks.

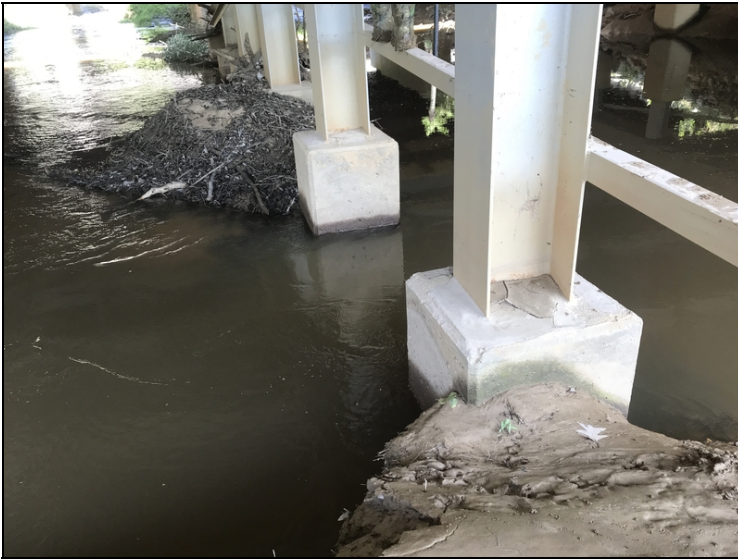
(225)	Silt and dirt sitting on top of the concrete encasement, causing the protective coating to lose its effectiveness.						
234	Reinforced Concrete Pier Cap	LF	238	237	1	0	0
1080	Delamination/Spall/Patched Area	LF	1	0	1	0	0

Steel Pile at bents 2,3,4 & 5
Pile at top of encasement, dirt and silt causing rust to form.

Bent 4 Pile at top of encasement has dirt and silt causing rust to form.

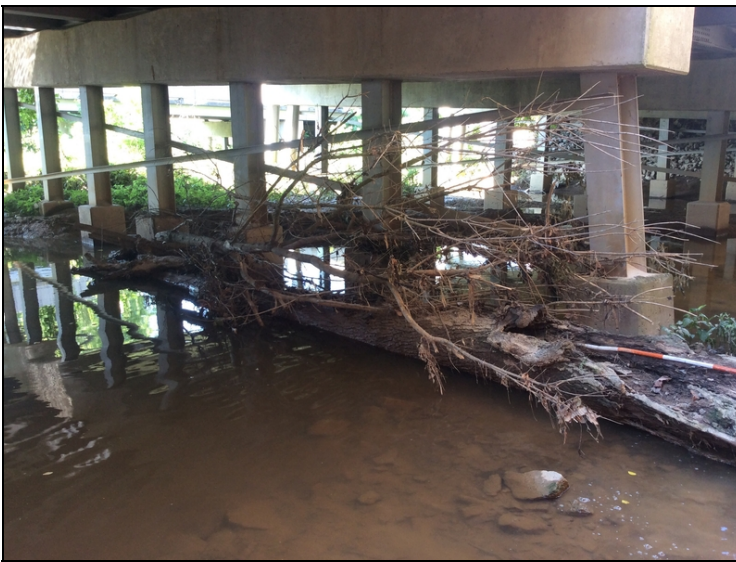
Bent 4 logs and debris restricting water flow.

Bent 4: large trees laying against piling

Assigned Pulaski 2 06602 9-28-15

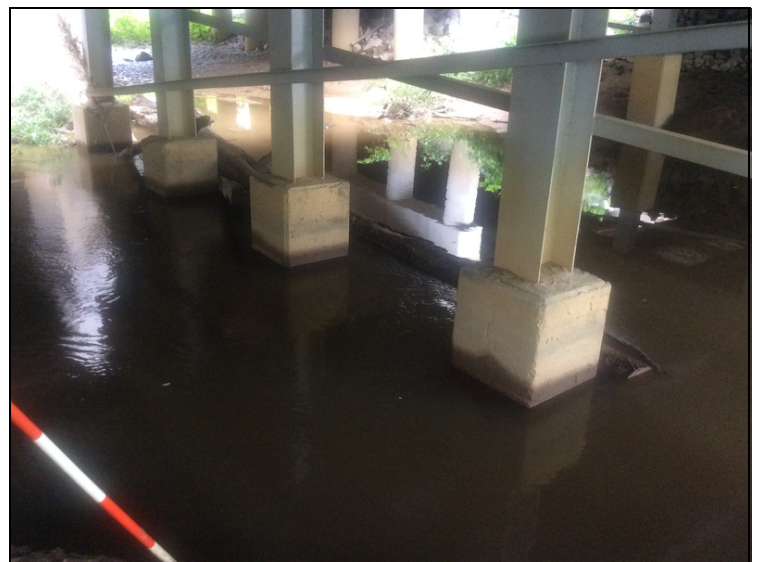
Bent 4 logs and debris restricting water flow.

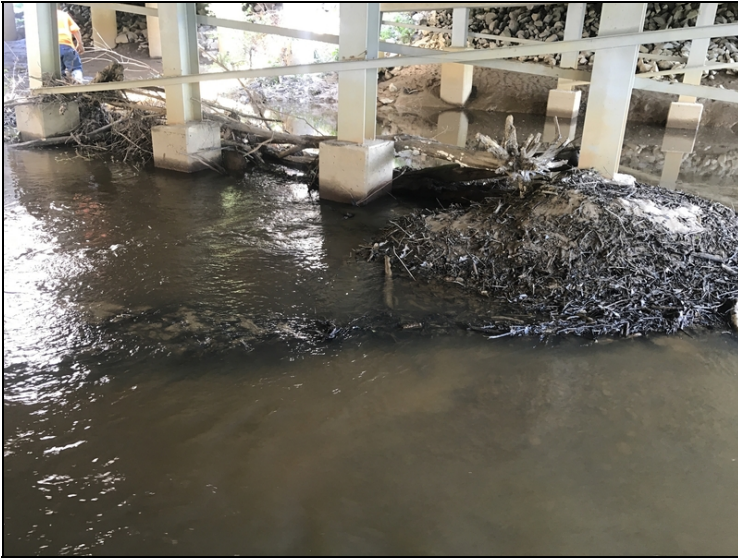
Bent 4 logs and debris restricting water flow

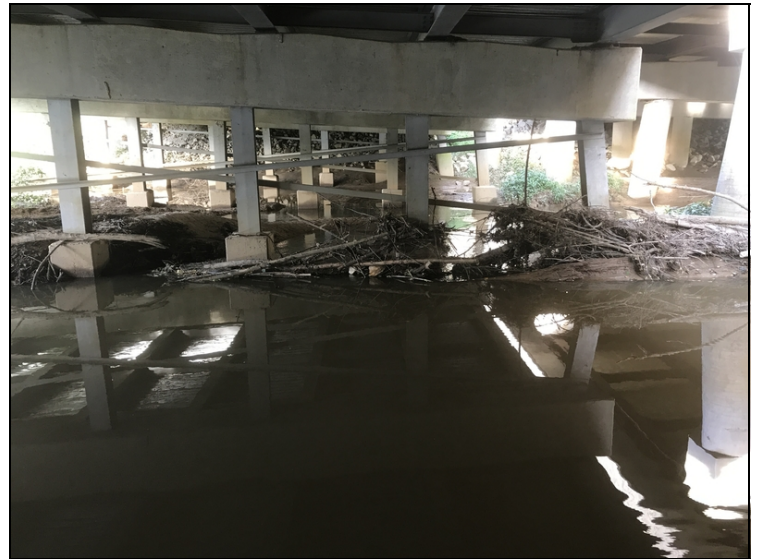
Bent 4, debris buildup around piling.

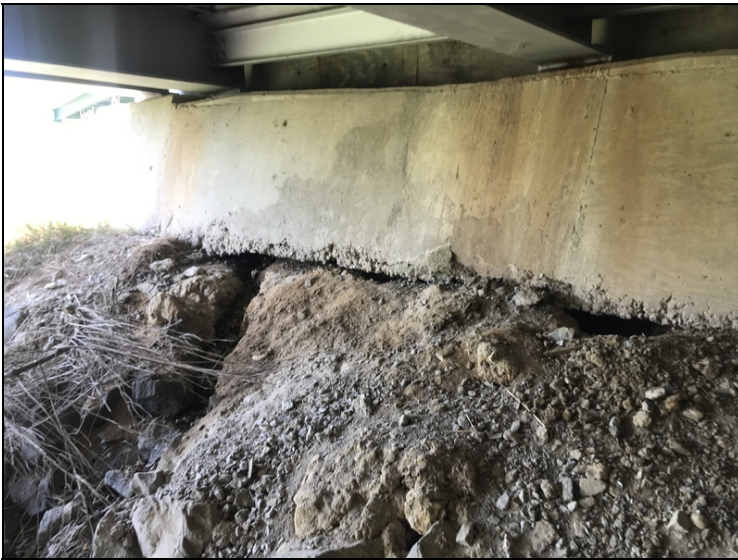
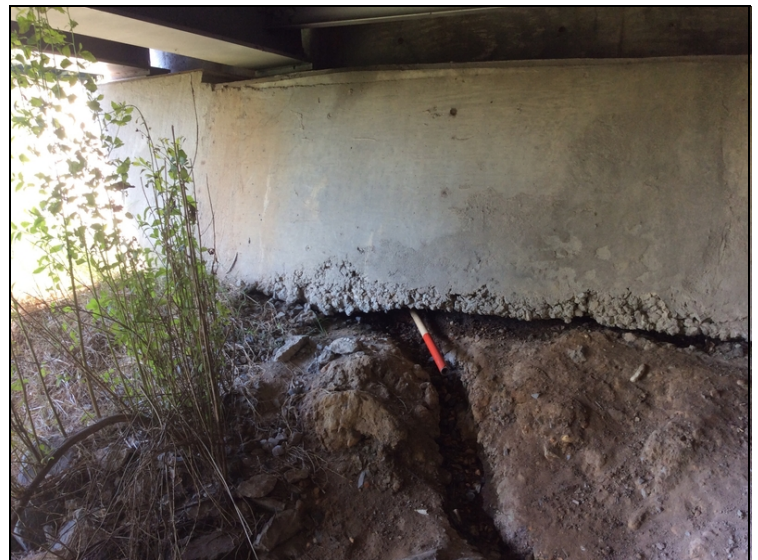
(215)	Spalls with rebar in back wall bent 6. Both abutments have small cracks. Added 5/17/17 Bent 1, between girders 7 & 8: material is being eroded from under the beam seat exposing the steel pile						
225	Steel Pile	EA	36	36	0	0	0
515	Steel Protective Coating	SF	2790	2580	210	0	0
3440	Effectiveness (Steel Protective Coatings)	SF	210	0	210	0	0

Bent 1, between girders 7 & 8: material is being eroded from under the beam seat exposing piling.

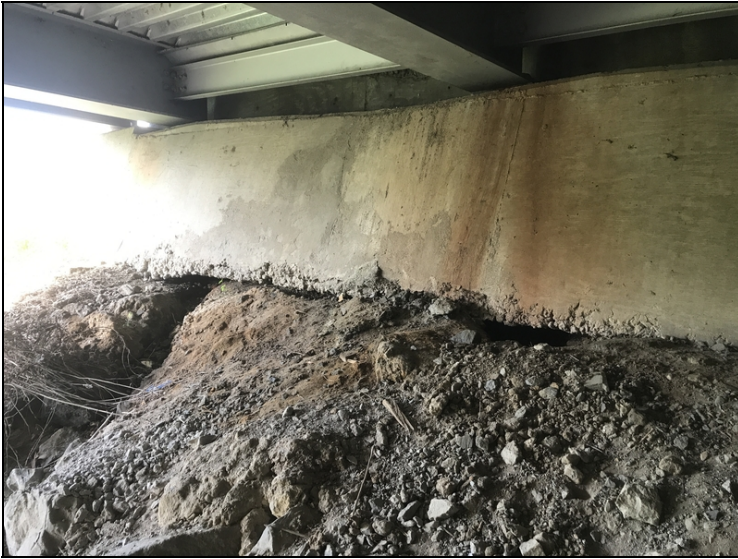
Bent 1, erosion under the abutment exposing pile
between beams 7 and 8.
