Bridge #B6357 (Routine)
I-30 WB Log 128.03 over Otter creek
Location: 2.0 M E SH111

Team Lead: Bryan Saunders Inspection Date: May 19, 2021

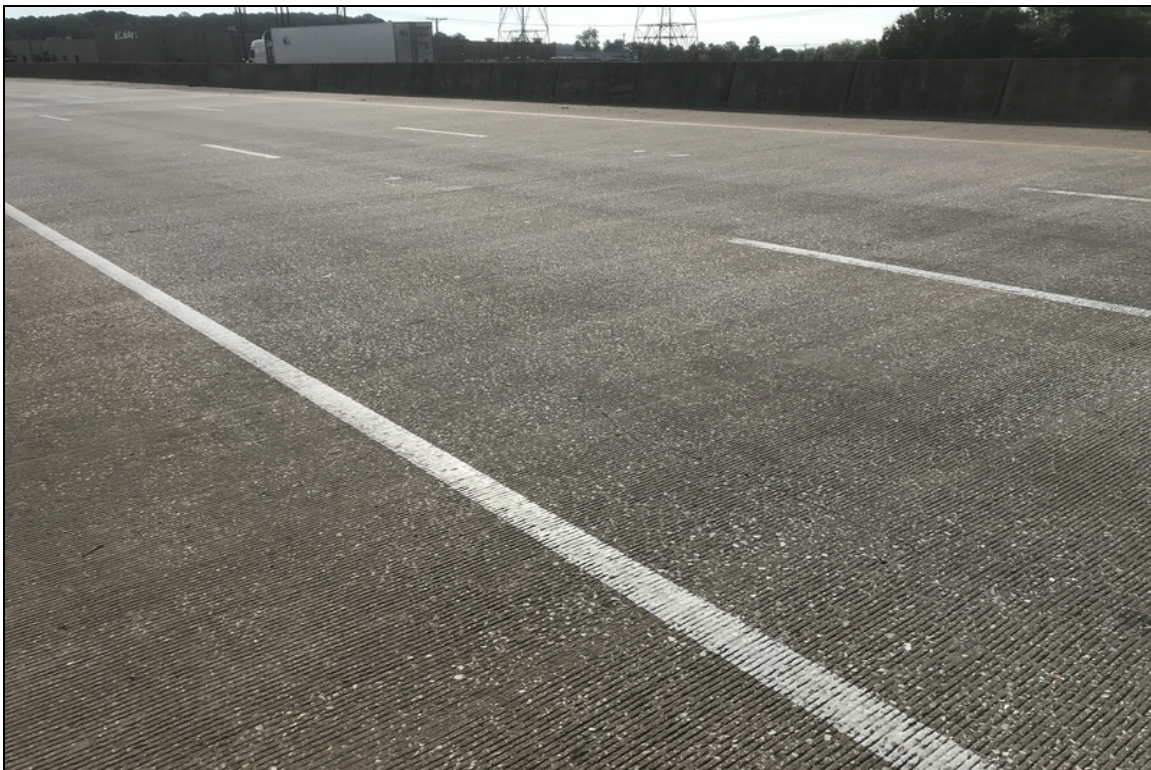
Deck overview

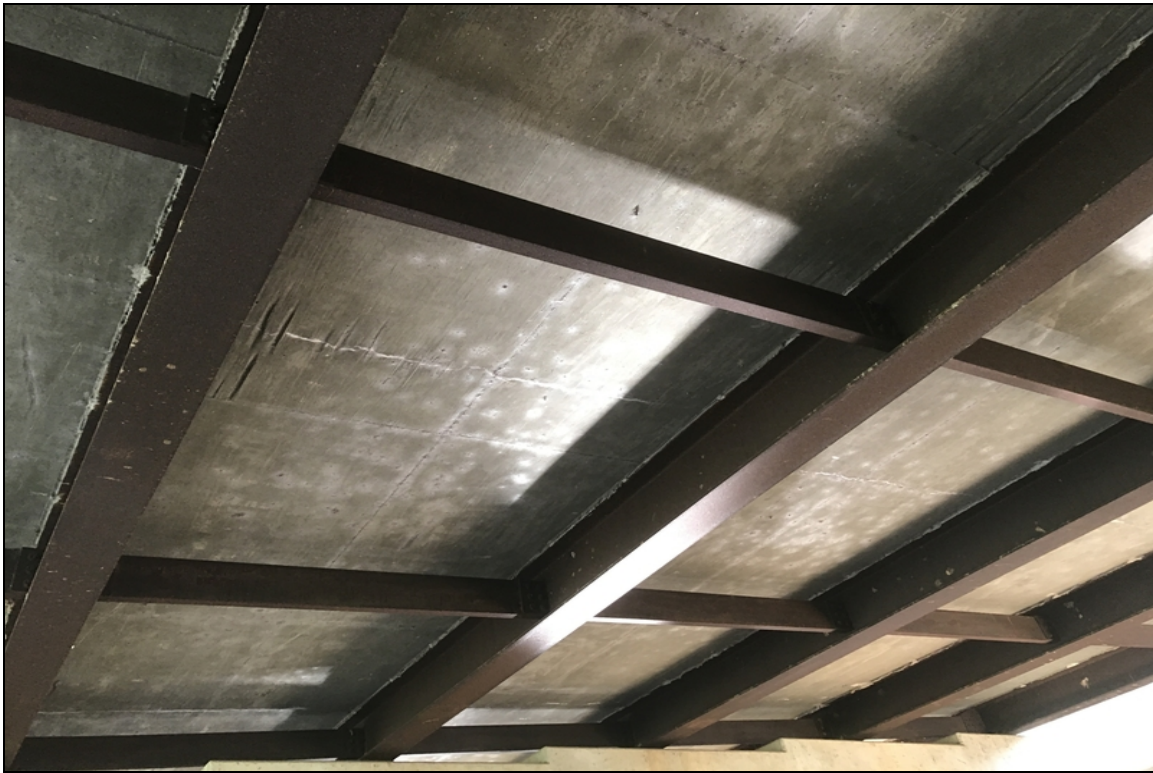
Typical soffit

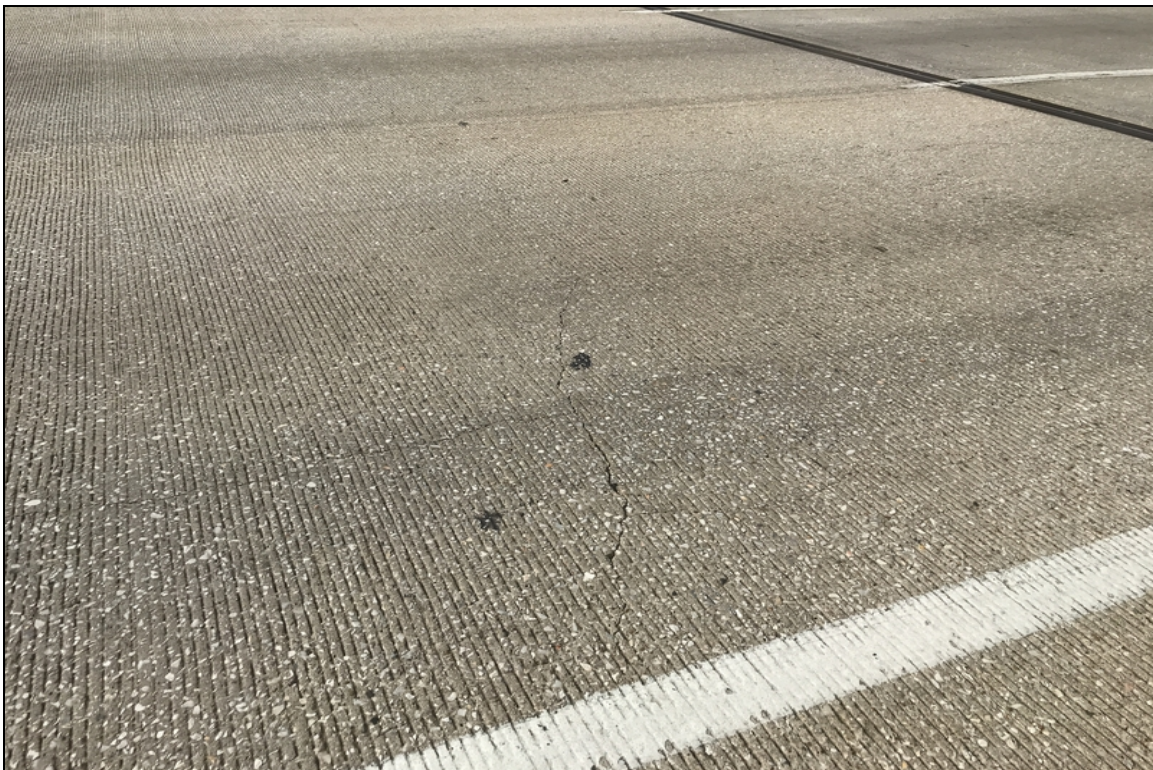
(12)	Deck all spans unsealed transverse and longitudinal cracks. Up to 0.40" Cracks with efflorescence in soffit. Patches where plowable markers were removed.						
107	Steel Open Girder/Beam	LF	980	980	0	0	0
515	Steel Protective Coating	SF	5586	0	5586	0	0
3430	Oxide Film Degradation Color/Texture Adherence(Steel Protective Coatings)	SF	5586	0	5586	0	0
(107-515)	The protective coating has a granular texture.						
215	Reinforced Concrete Abutment	LF	142	131	11	0	0
1080	Delamination/Spall/Patched Area	LF	2	0	2	0	0
1130	Cracking (RC and Other)	LF	9	0	9	0	0

Span 1, large transverse crack.

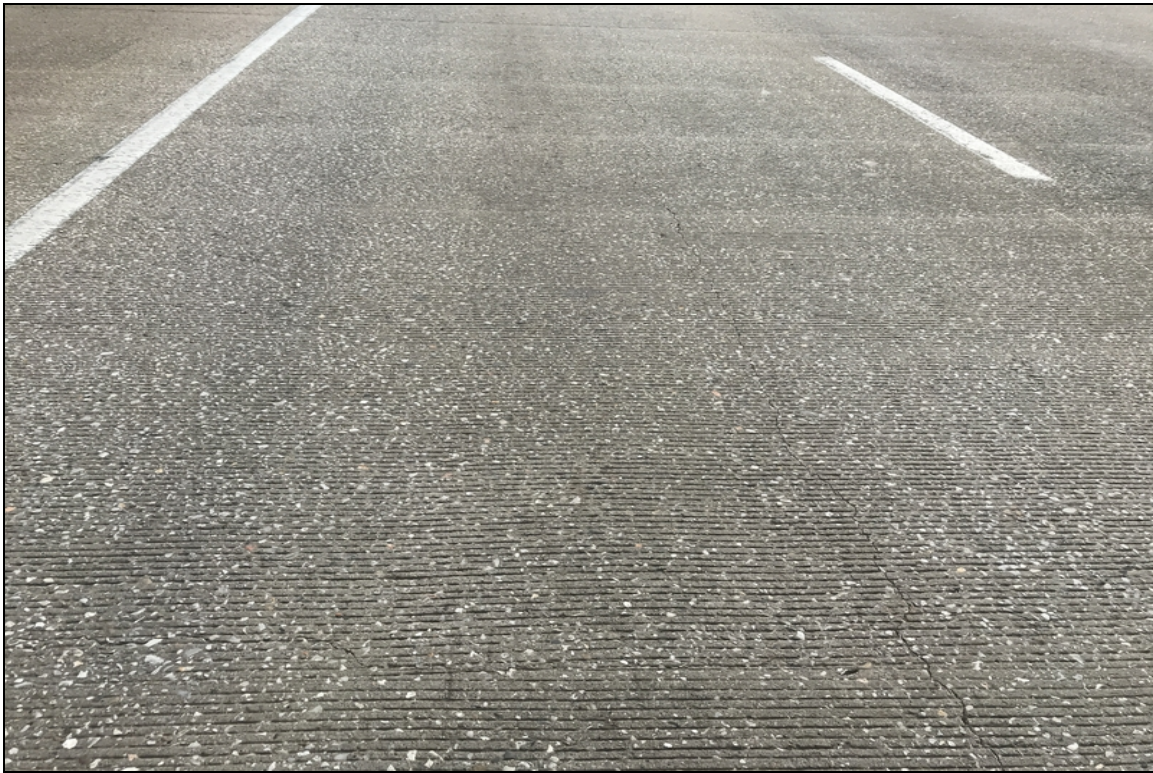
Span 3, longitudinal crack.

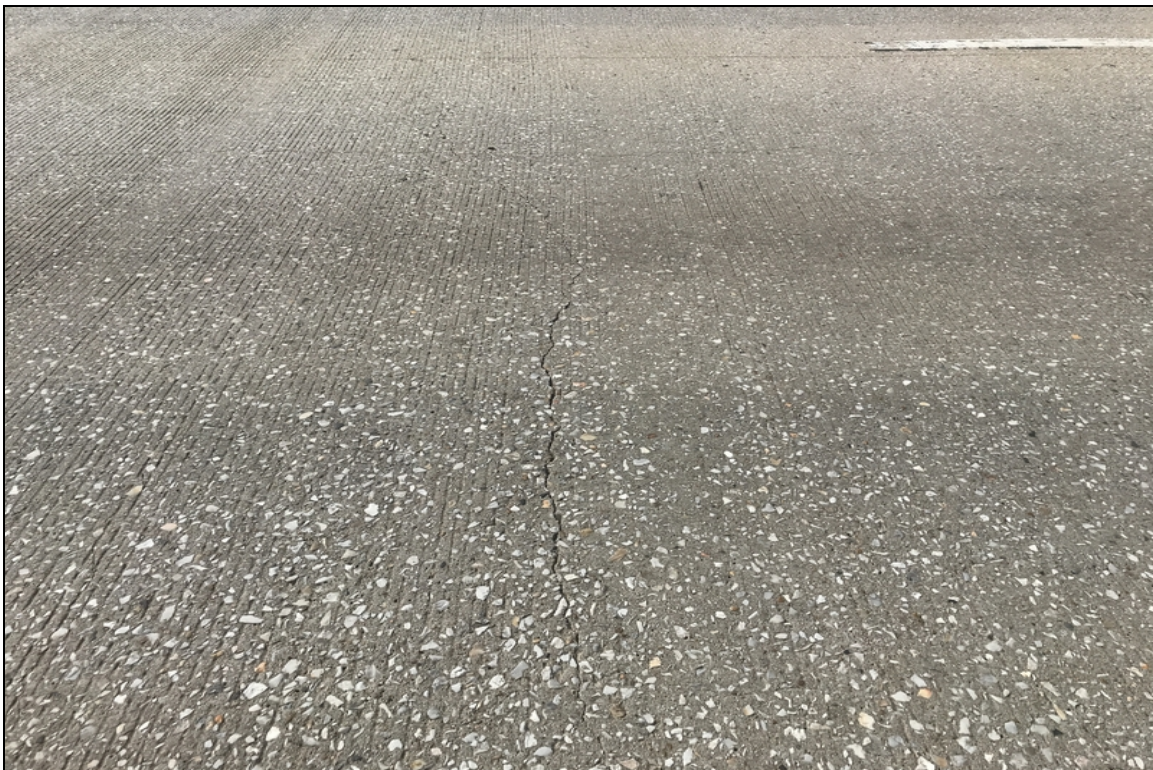
Span 5, large transverse crack.

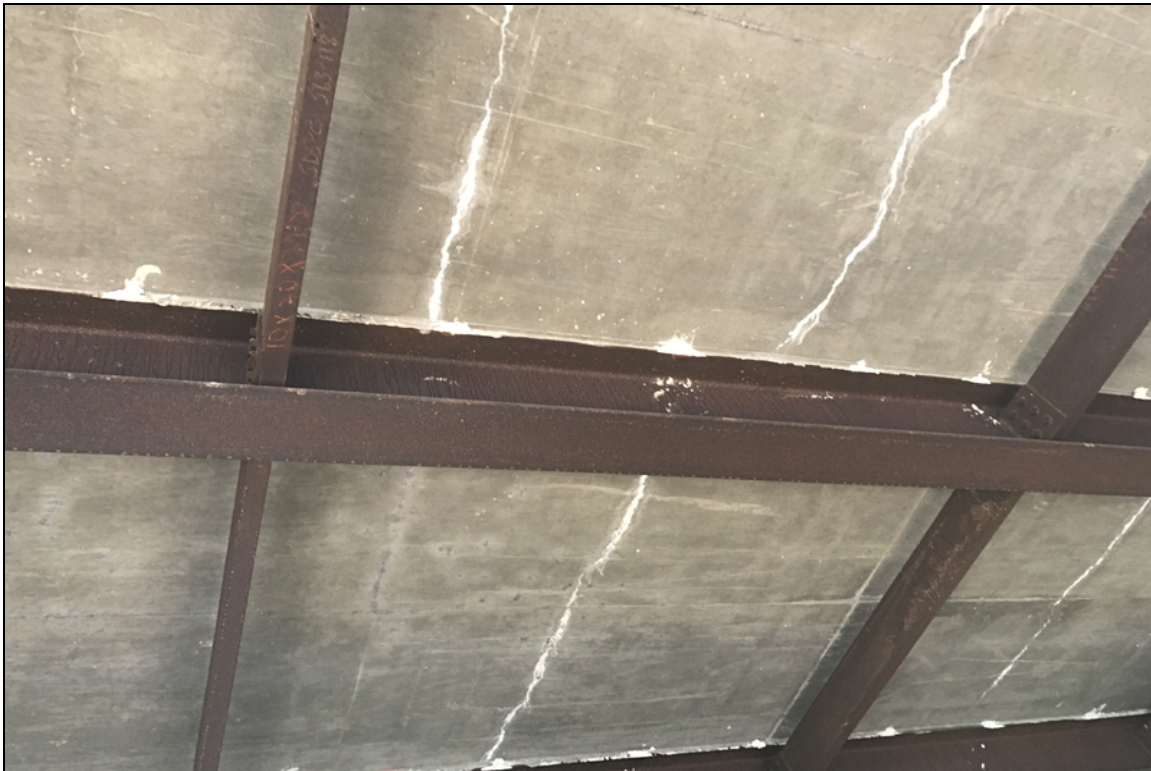
Span 4, cracks with efflorescence, typical.

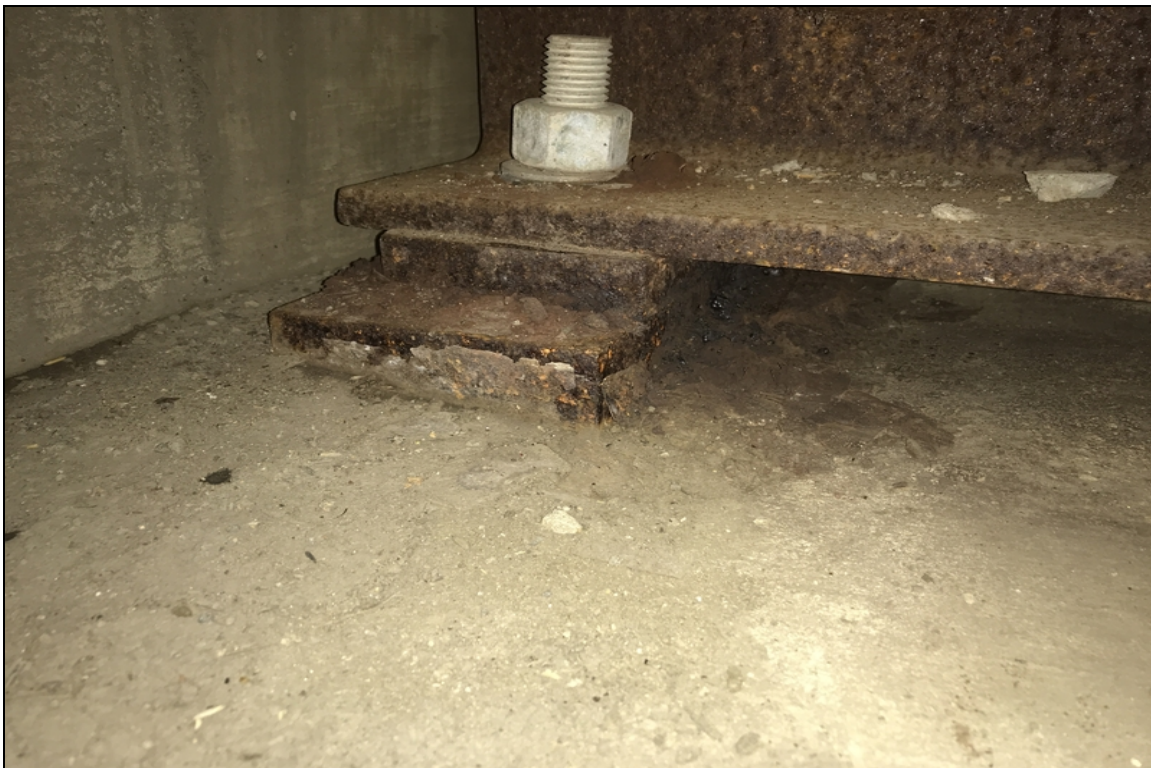
(311)	Bearings on bents 1 and 6 have minor corrosion.						
313	Fixed Bearing	EA	14	14	0	0	0
321	Reinforced Concrete Approach Slab	SF	2628	2628	0	0	0

Bent 1 bearing 4, corrosion.

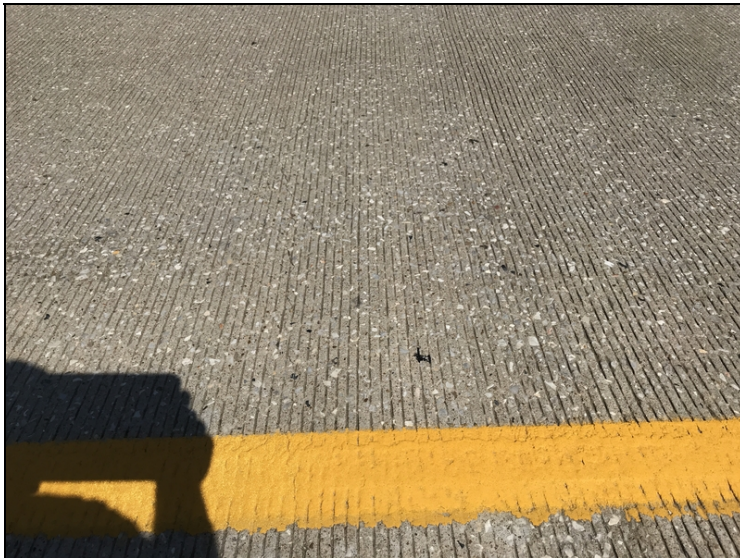
Deck all spans
Moderate sized unsealed transverse and longitudinal cracks.

Span 2 unseal crack

Date Reported: 09/20/2011
Priority: D- Routine
Type of Work: Repair
Status: Assigned
Component: Deck

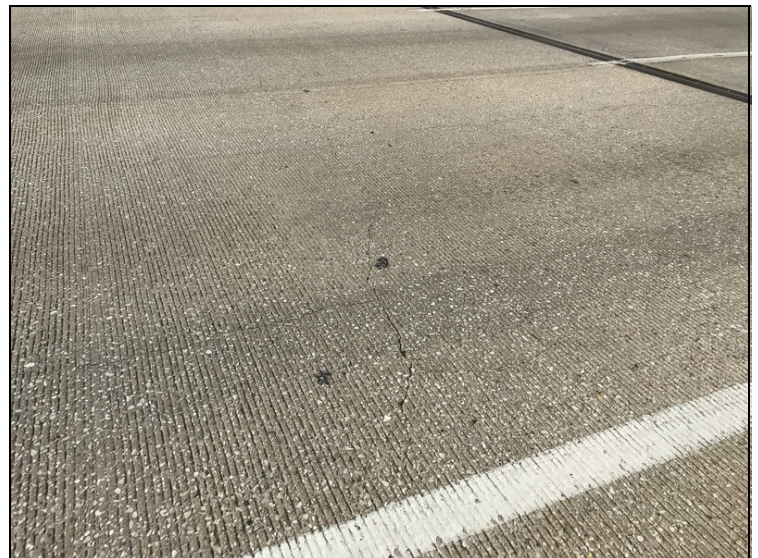
Span 1, large transverse crack.

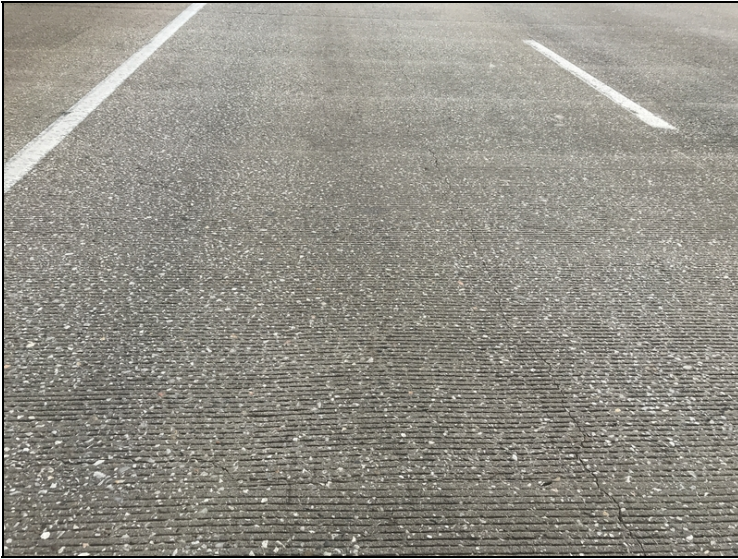
Span 3, longitudinal crack.

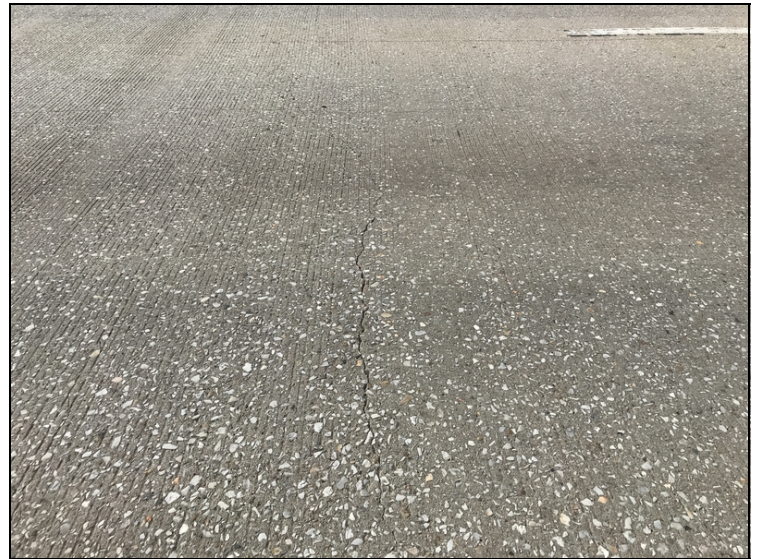
Span 5, large transverse crack.
