Bridge #A6919(Routine)

I-30 WB Log 130.62 over SH 338/Baseline Rd.

Team Lead: Bryan Saunders Inspection Date: May 25, 2021

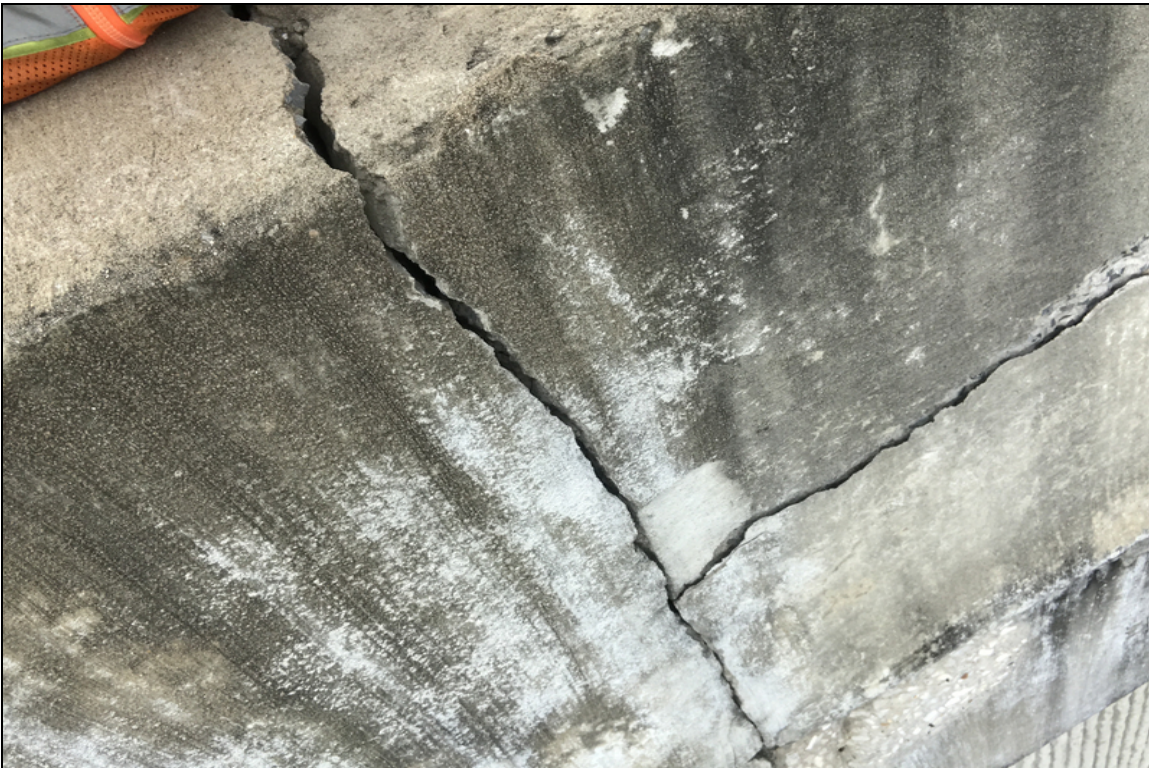
Large delamination in the parapet wall on the north side at bent 1

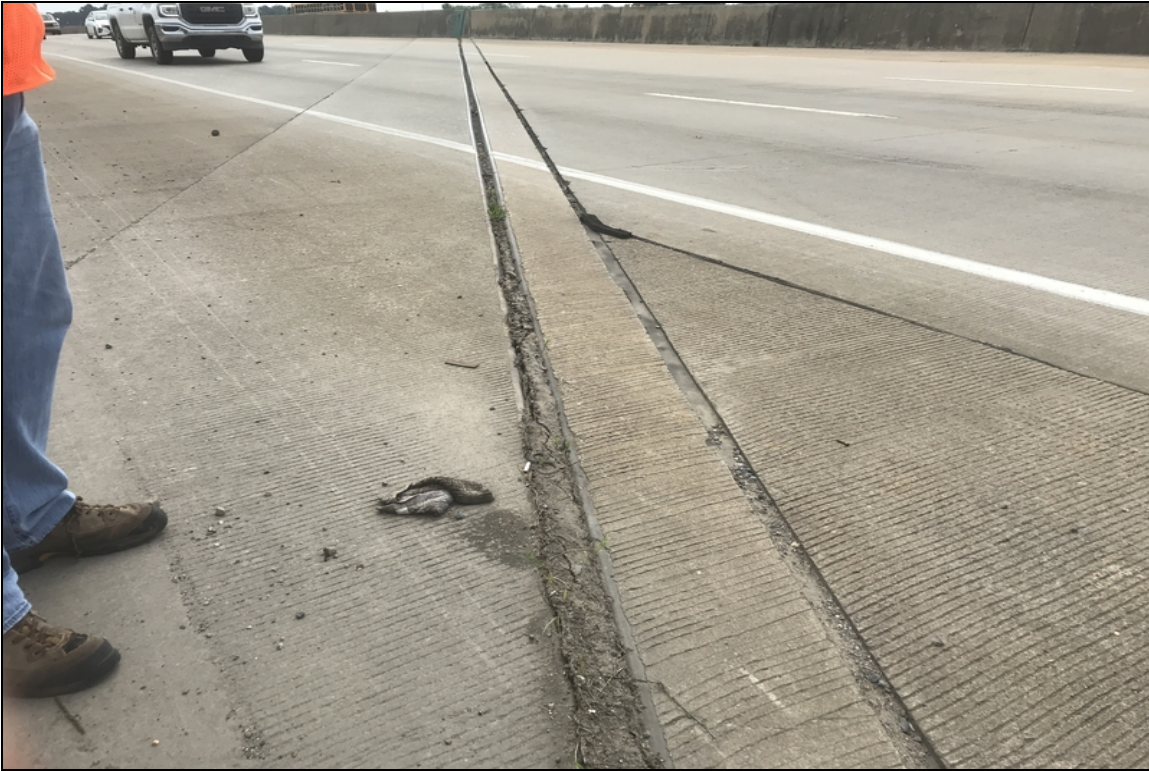
Joint at bent 1 has debris impactation on shoulder and 10' of torn and leaking joint in right hand lane

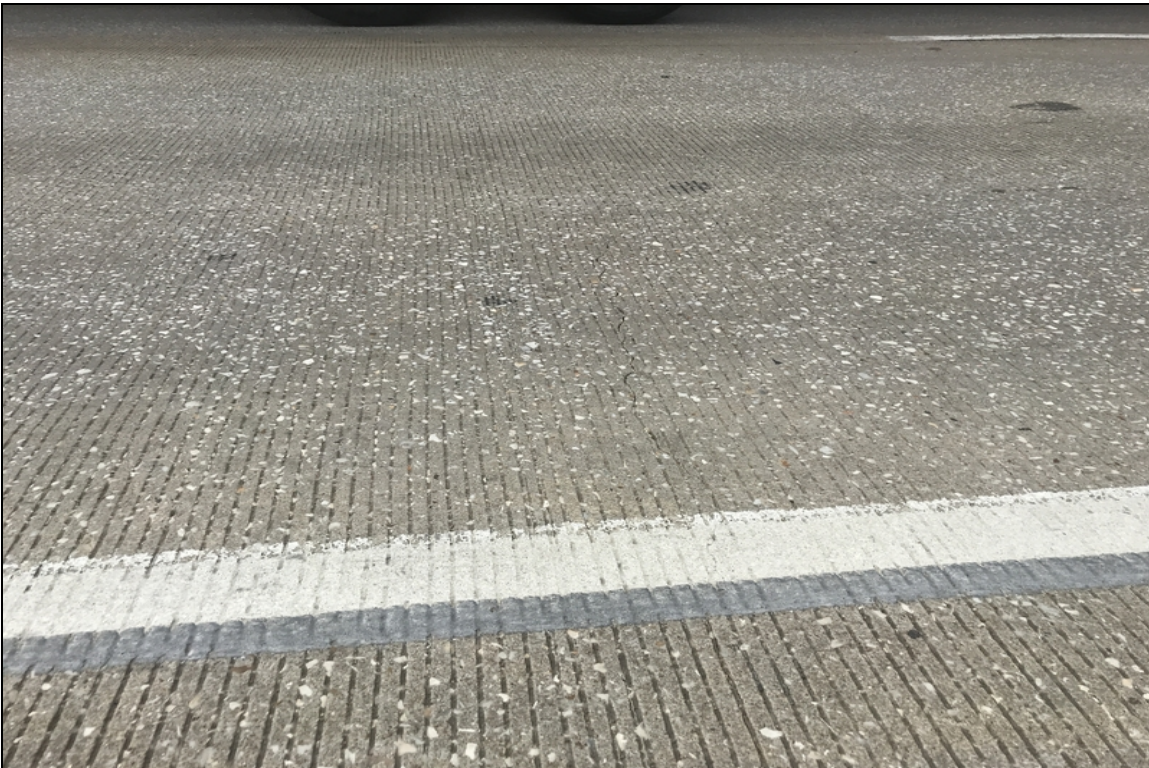
Deck has large transverse cracks up to .040"

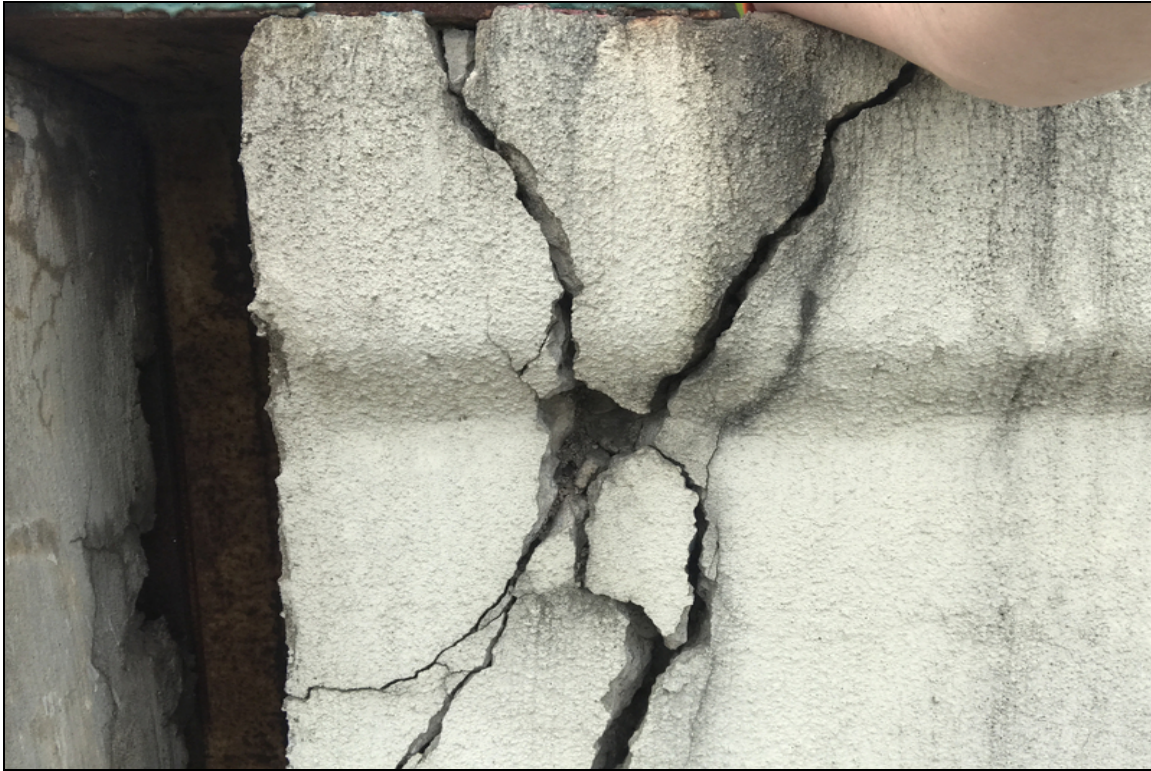
North side at bent 2 parapet wall has large cracks and spalls from traffic impact

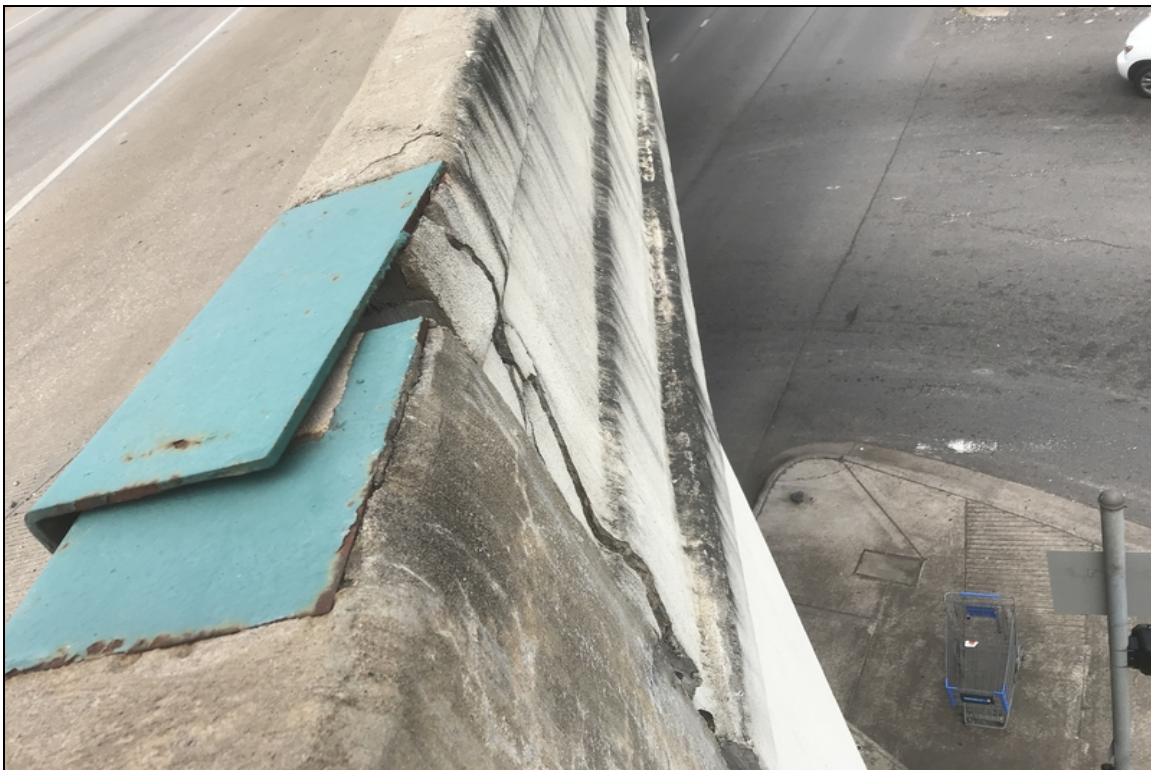
North side at bent 2 parapet wall has large cracks and spalls from traffic impact

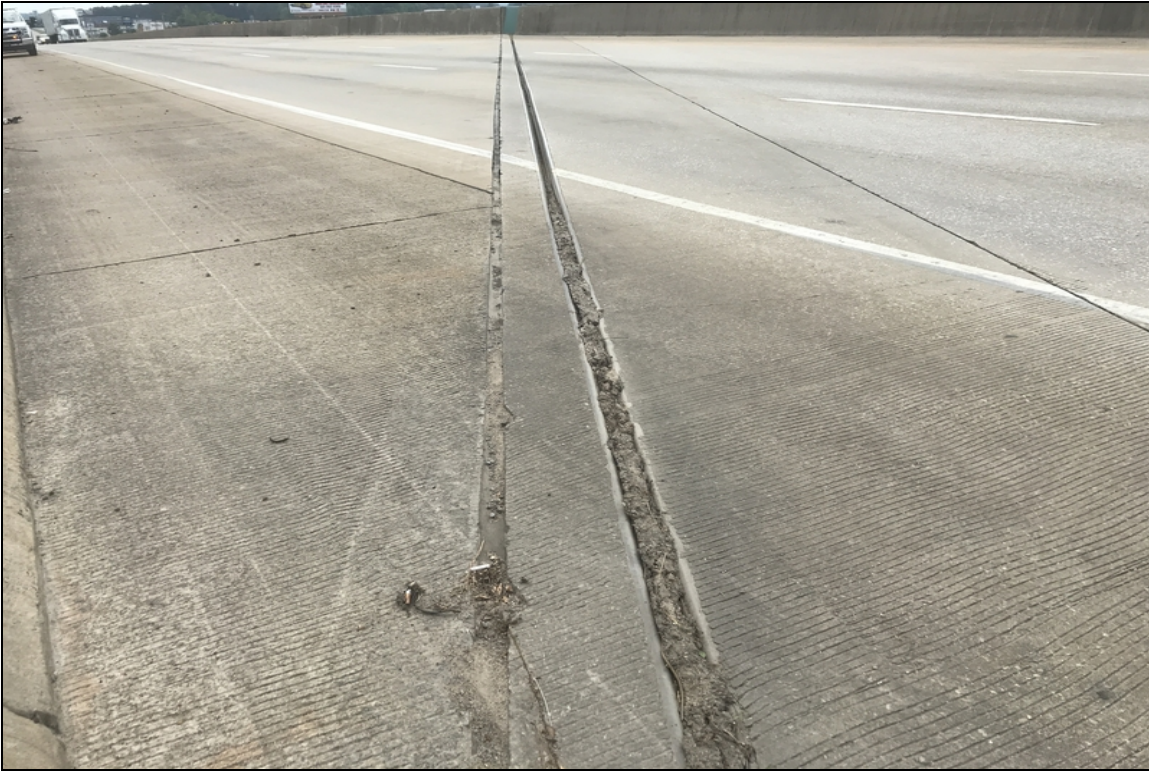
Joint at bent 2 has debris impactation on shoulder

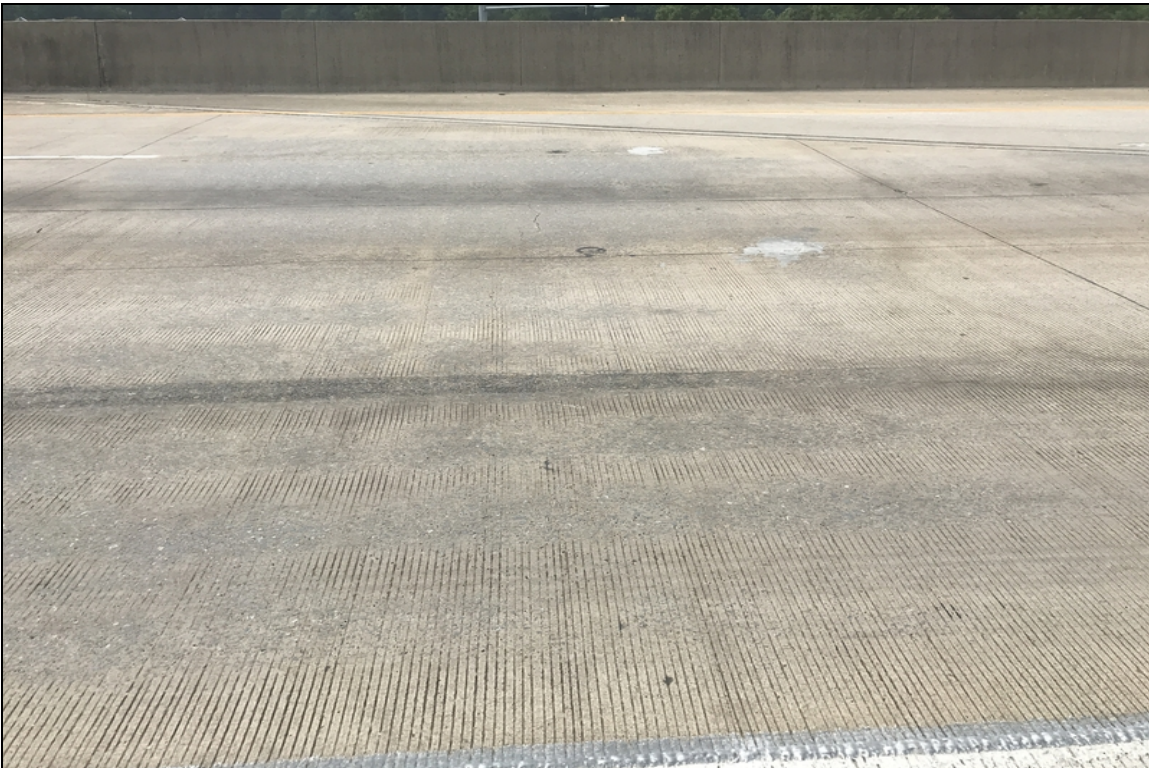
Large Transverse cracks up to .040" in the approach slabs

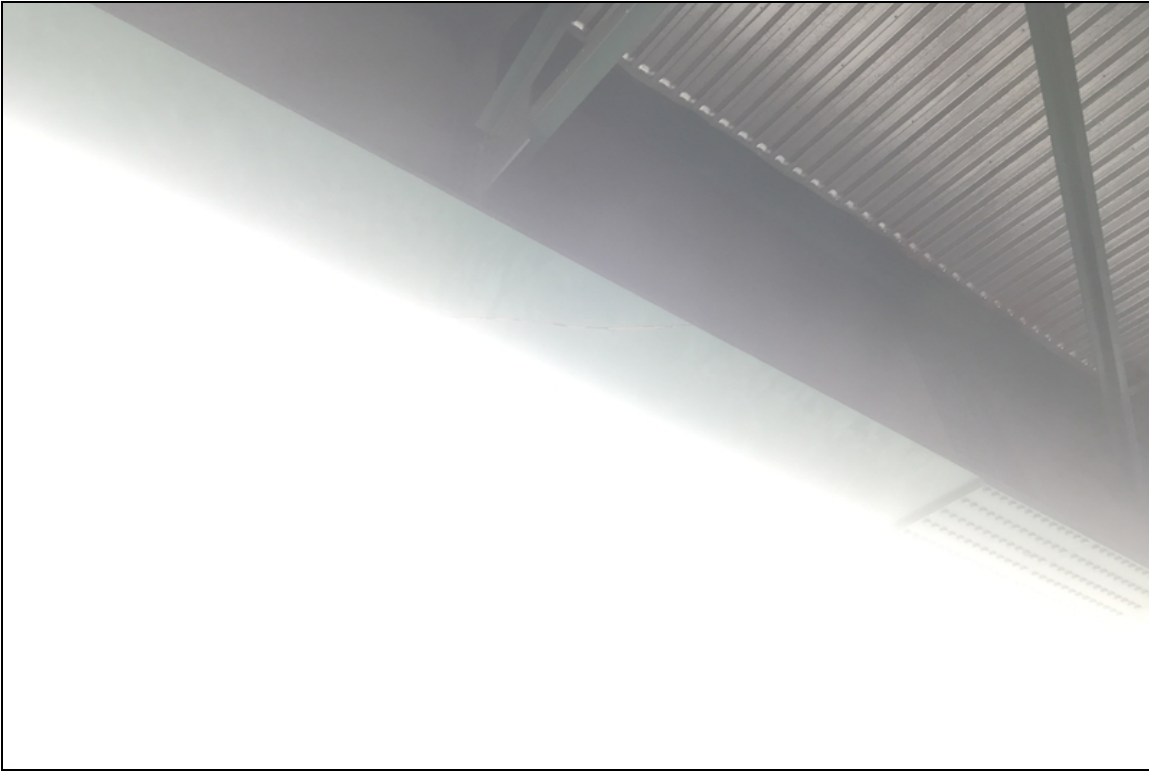
Scraped paint in girder1 diaphragm 2

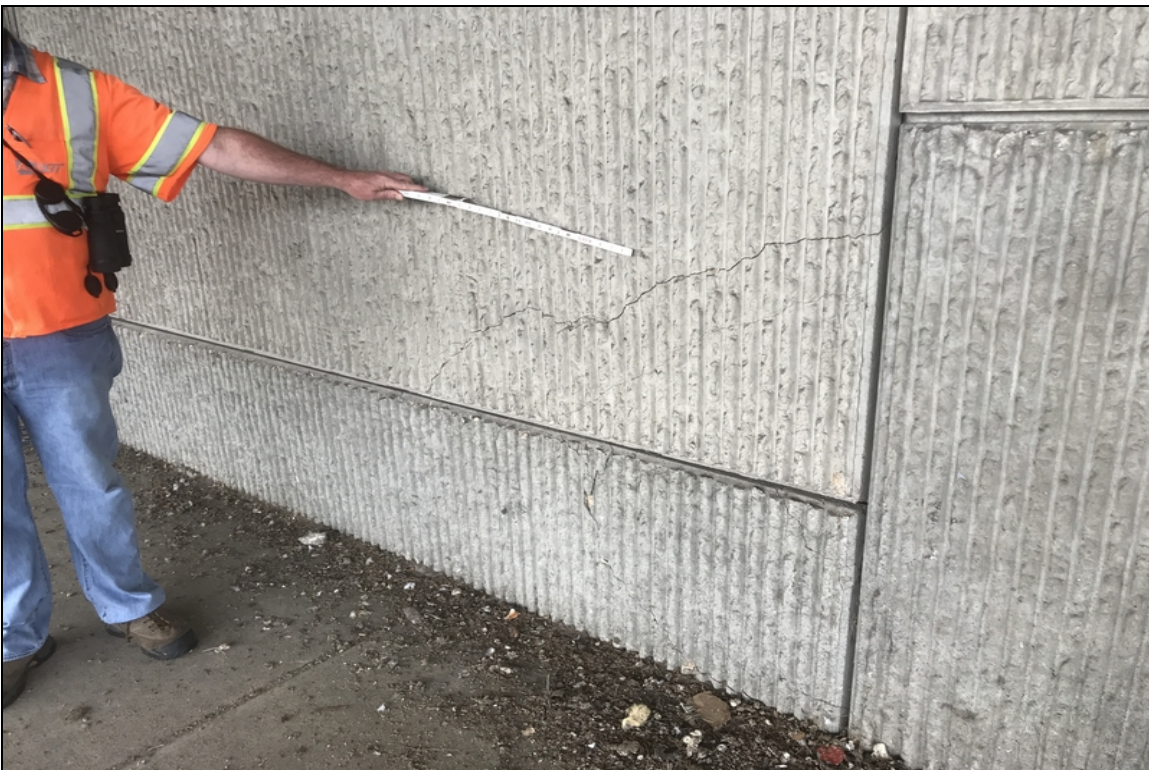
Cracks in MSE wall at bent 1 between girder 4 and 5 traffic impact

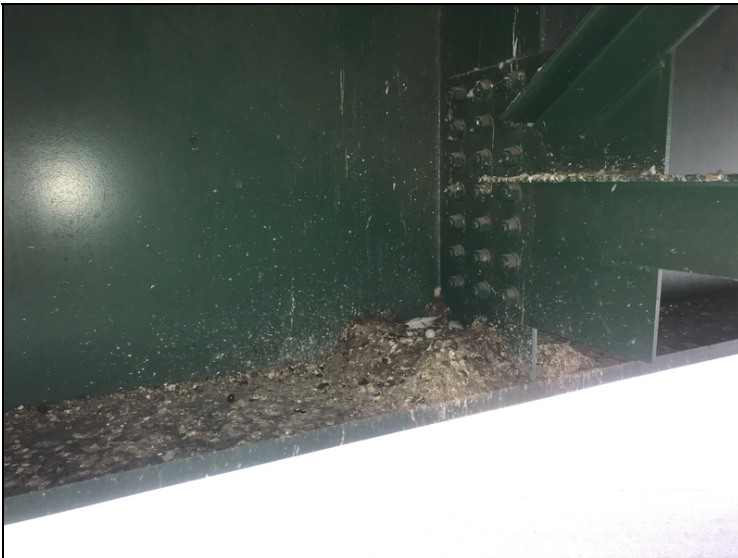
Bird droppings 2 to 3 inches deep on girders end at both abutments.

Large deposits of bird feces at beam ends

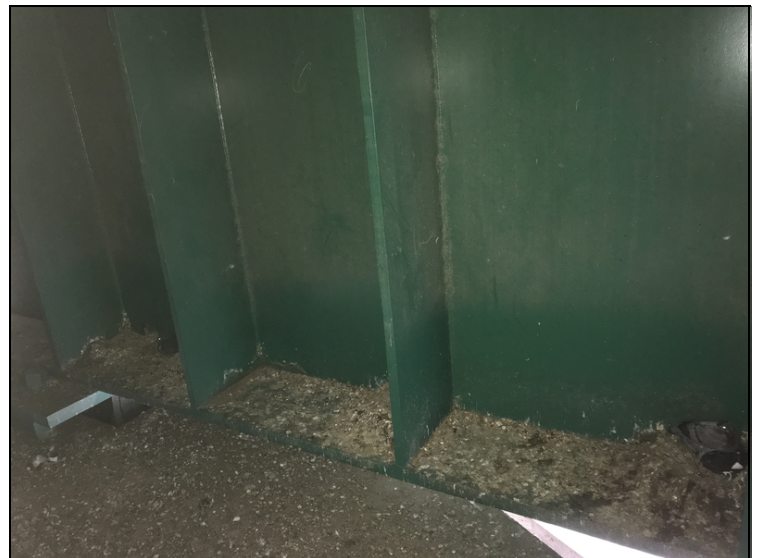
Bent 2 girder 6, bird nests on bottom flange, typical.

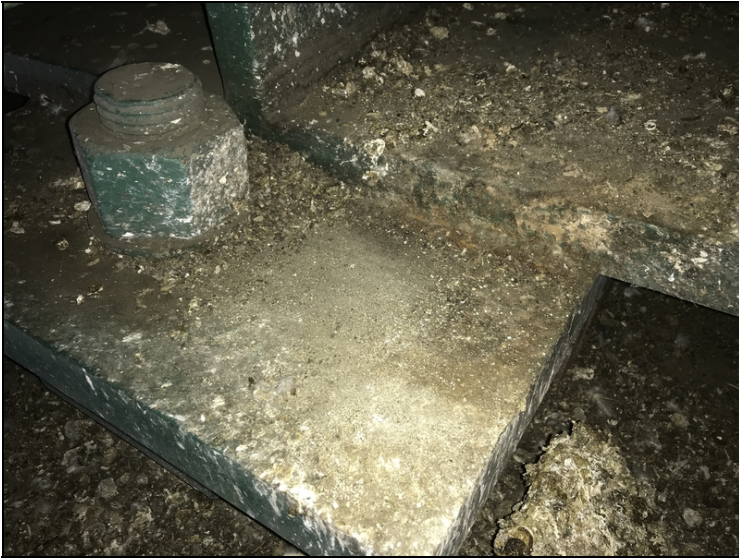
Bent 2 bearing 2 has piles of bird feces around
sole plate

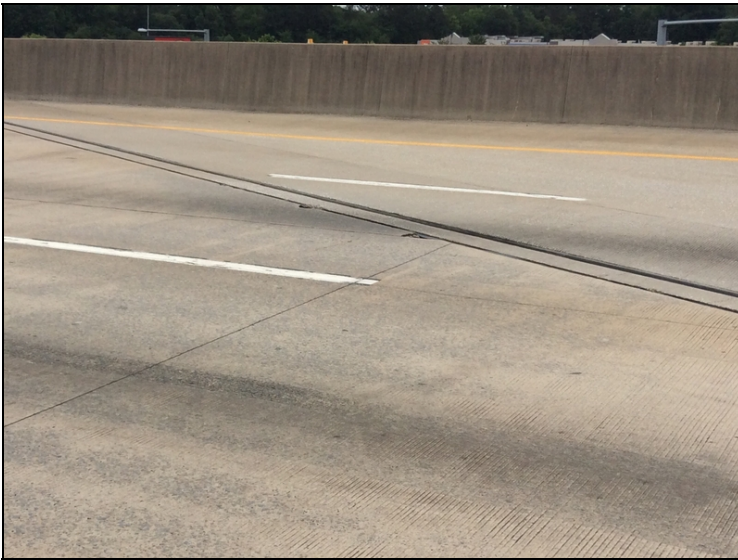
Approach slab at abutment 2 has small spalls.

Small spalls in approach slab at bent 2

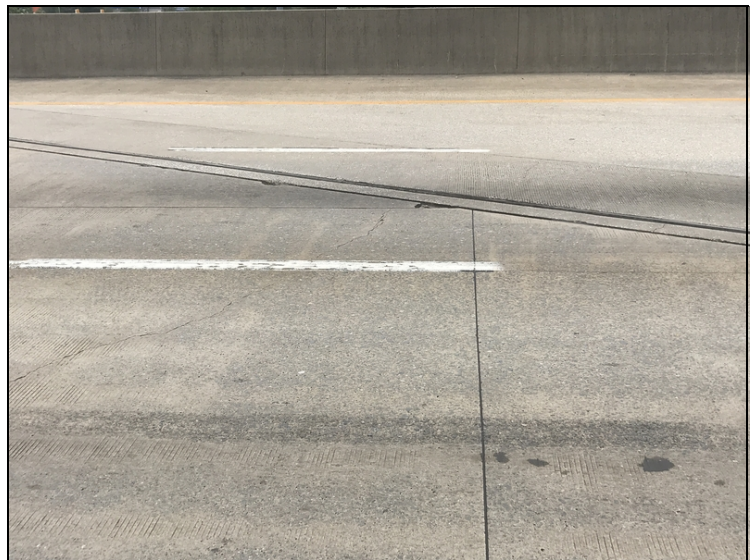
Spall at bent 2 in middle lane

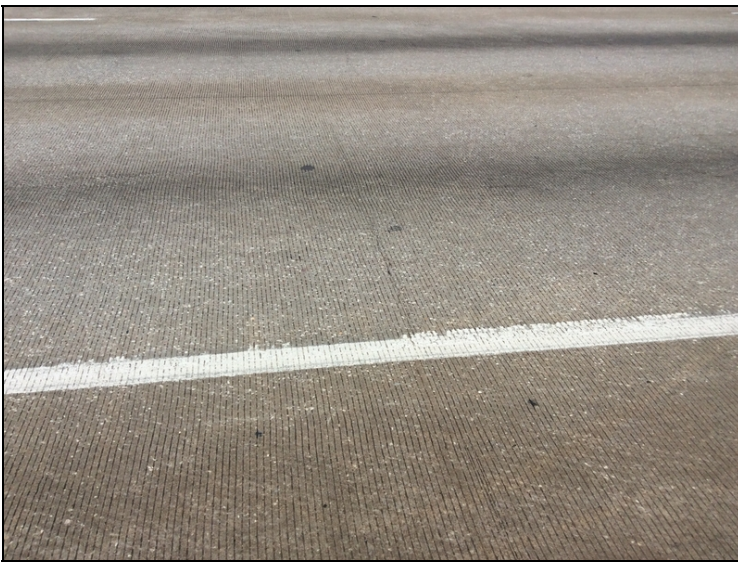
Unsealed deck cracks up to 0.040 inch.

Cracks in deck up to 0.040"

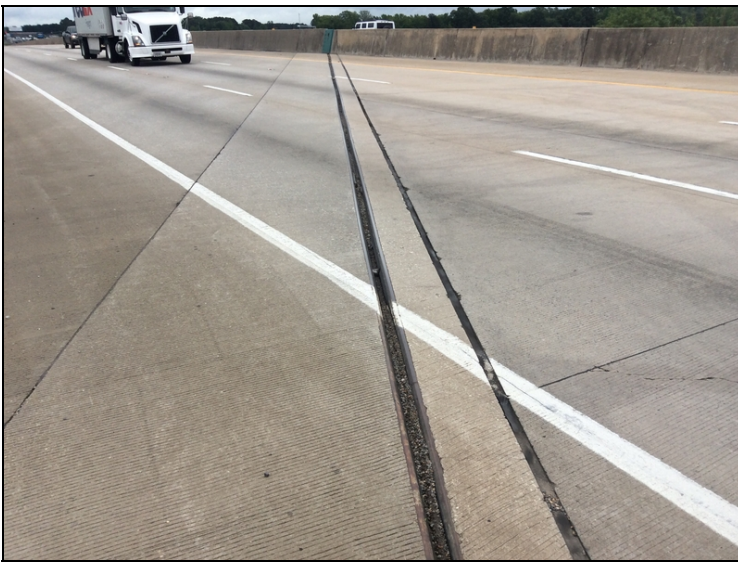
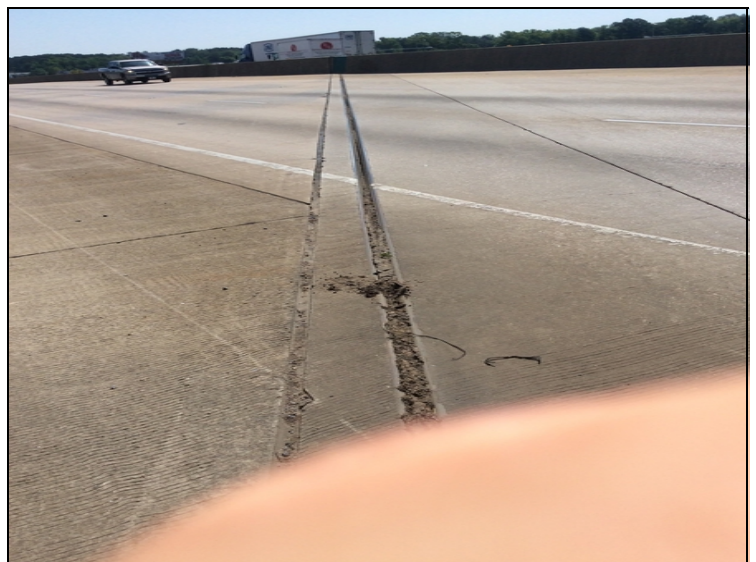
Deck joints are half full of debris.

Joints are half full of debris
