Bridge #B6919(Routine)

I-30 EB Log 130.62 over SH 338/Baseline Rd.

Location: I-30, Sec. 23, Log 130.62

Team Lead: Bryan Saunders Inspection Date: May 25, 2021

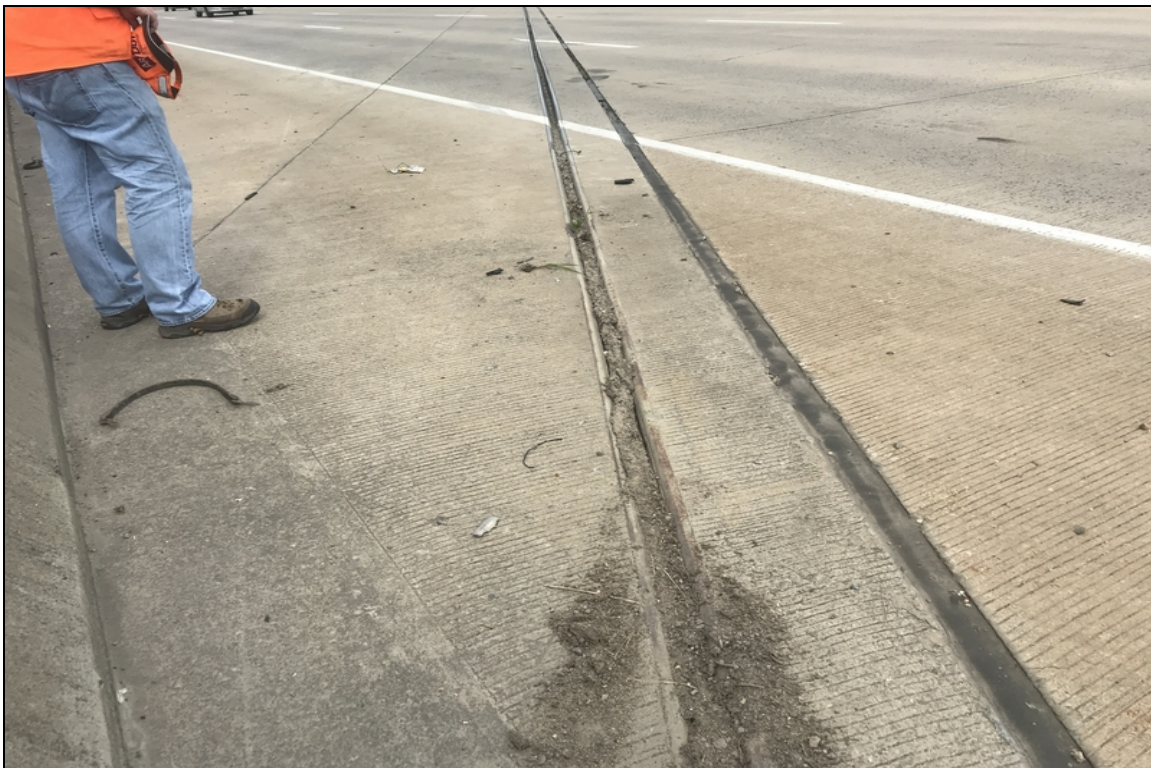
(300)	Both joints are full of debris.						
310	Elastomeric Bearing	EA	12	12	0	0	0
321	Reinforced Concrete Approach Slab	SF	5995	4825	810	360	0
1130	Cracking (RC and Other)	SF	1170	0	810	360	0

Joint at bent 2 are full of debris

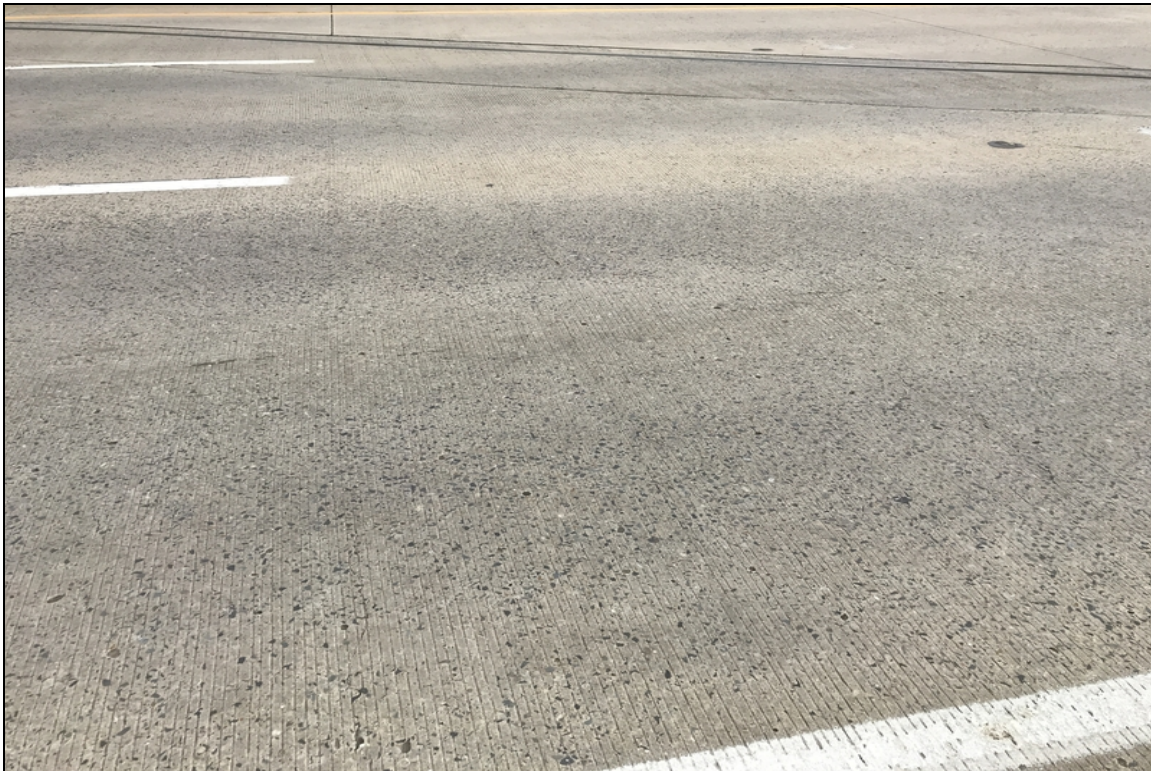
ELEM	DESCRIPTION	UNITS	TOTAL	CS1	CS2	CS3	CS4
12	Reinforced Concrete Deck	SF	14298	12869	1429	0	0
1130	Cracking (RC and Other)	SF	1429	0	1429	0	0
(12)	Scattered transverse cracks up to 0.040wide.						
107	Steel Open Girder/Beam	LF	1452	1452	0	0	0
515	Steel Protective Coating	SF	43378	43378	0	0	0

deck has large transverse cracks up to .040"

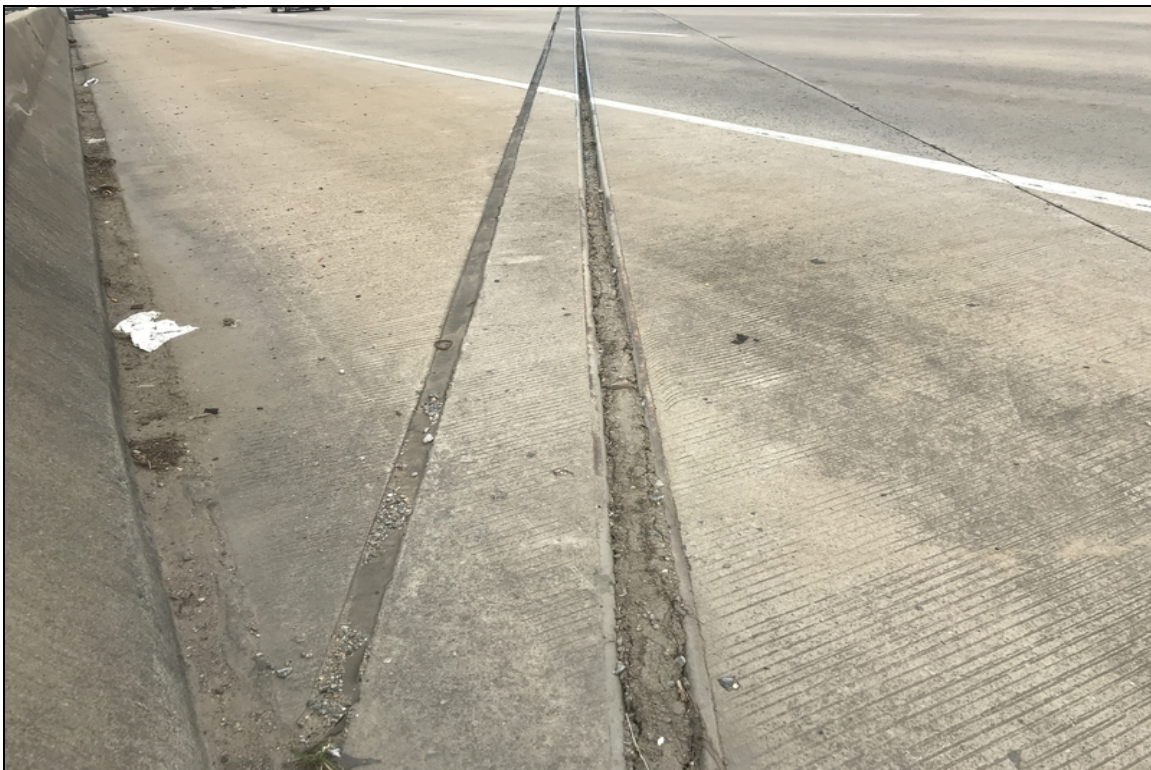
Joint at bent 1 is full of debris

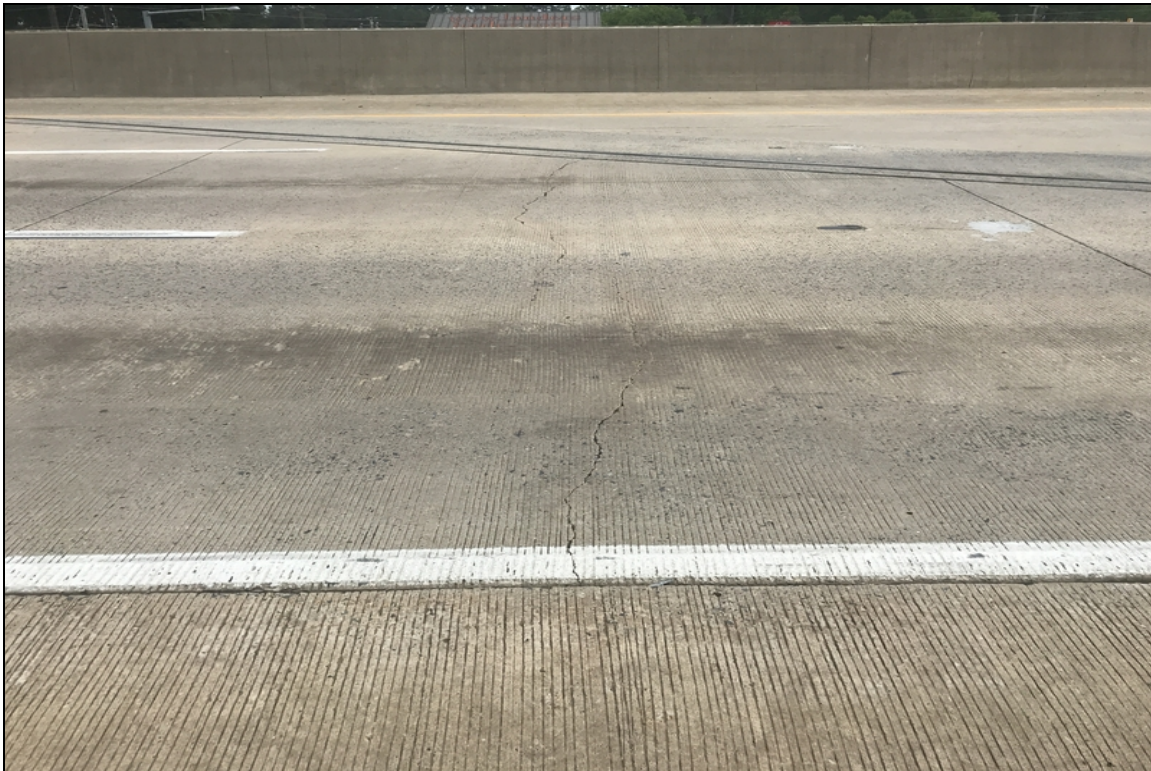
(321)	Large cracks in both approach slabs.						
331	Reinforced Concrete Bridge Railing	LF	484	399	85	0	0
1130	Cracking (RC and Other)	LF	85	0	85	0	0

approach slabs have large tranverse and longitudinal cracks

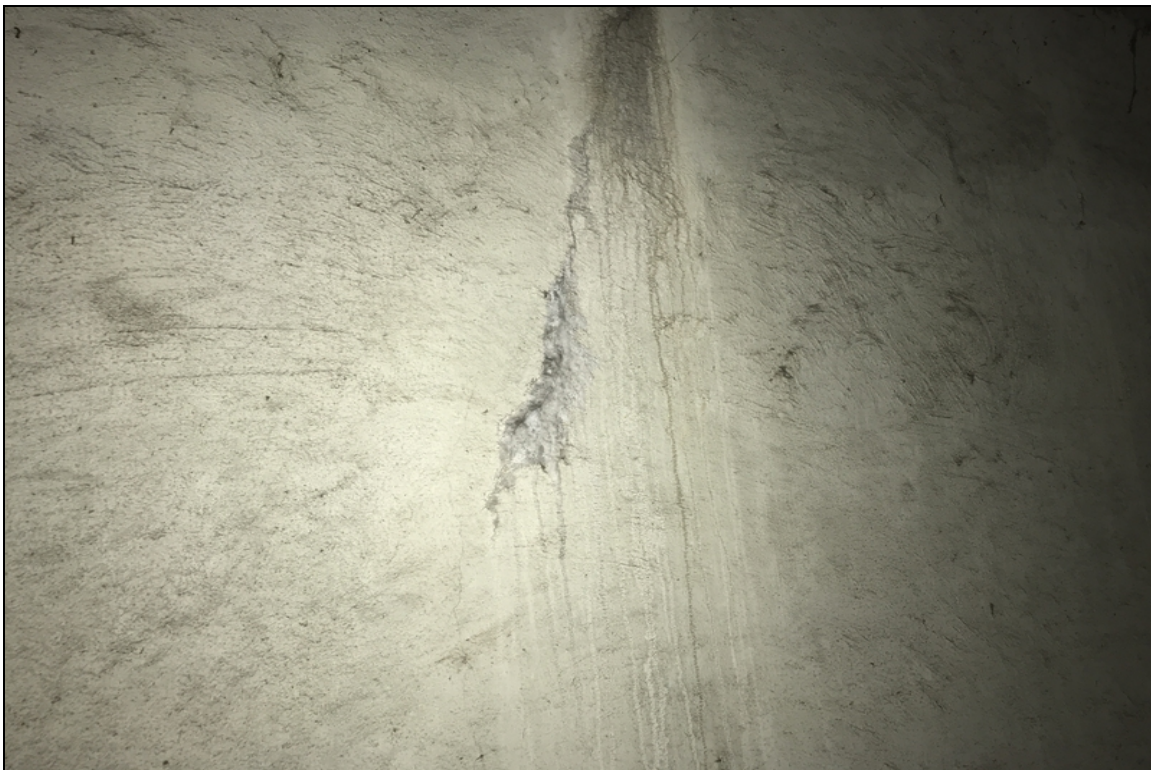
abutment at Bent 2 between girders 2 and 3, crack with efflorescence.

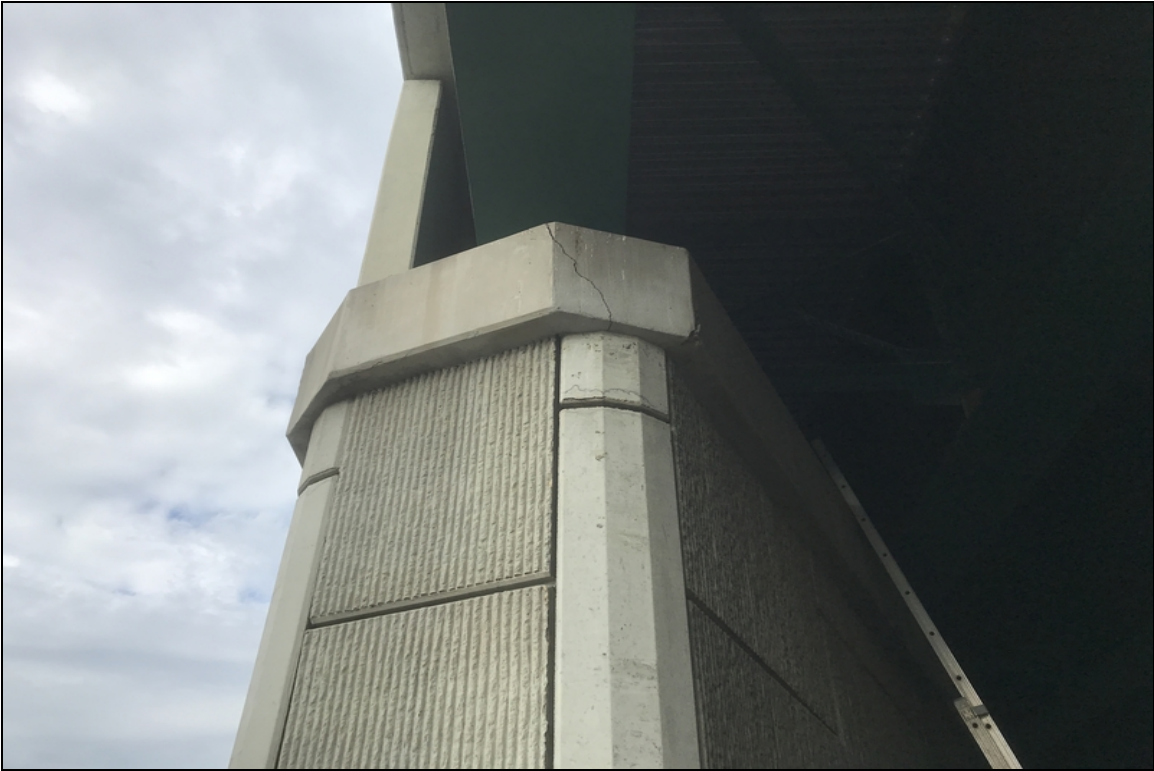
Crack in MSE wall at south west end

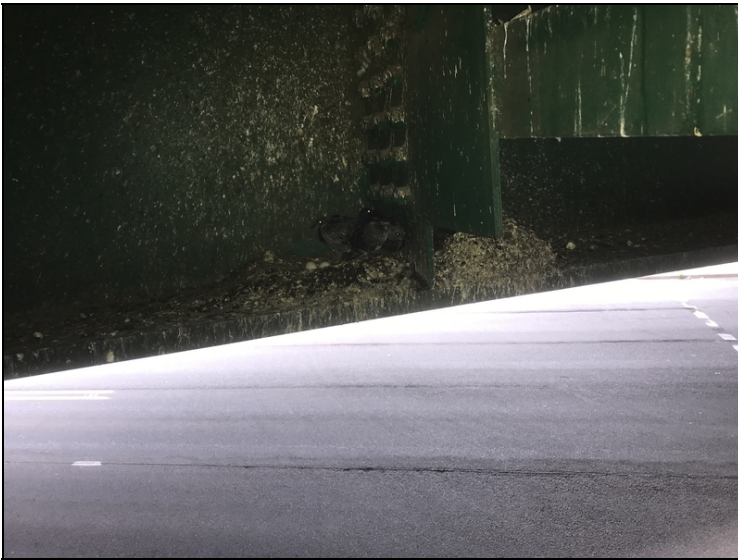
(107)	beam ends at both abutments have large piles of bird feces around stiffeners						
215	Reinforced Concrete Abutment	LF	366	363	3	0	0
1120	Efflorescence/Rust Staining	LF	1	0	1	0	0
1130	Cracking (RC and Other)	LF	2	0	2	0	0
300	Strip Seal Expansion Joint	LF	270	9	261	0	0
2310	Leakage	LF	10	0	10	0	0
2350	Debris Impaction	LF	251	0	251	0	0

Bird droppings 2 to 3 inches deep on girders end at both abutments.

Bird feces on girder ends and at stiffeners

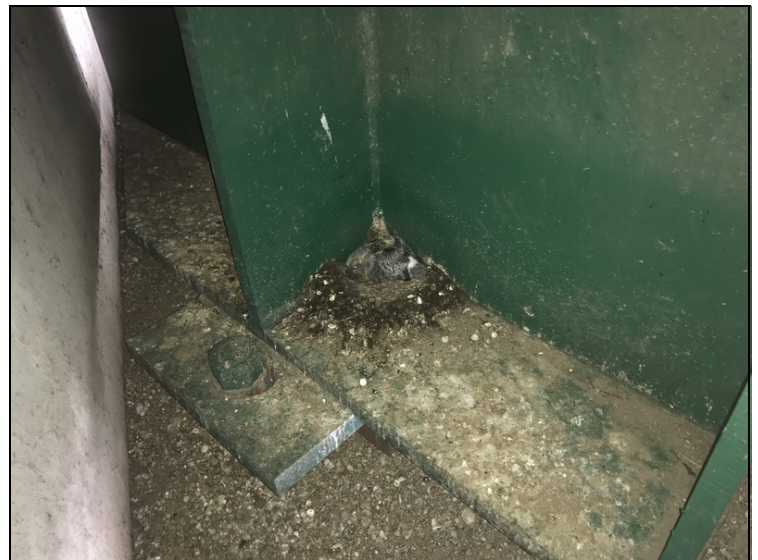
Bent 2 Girder 5, nest on bottom flange.

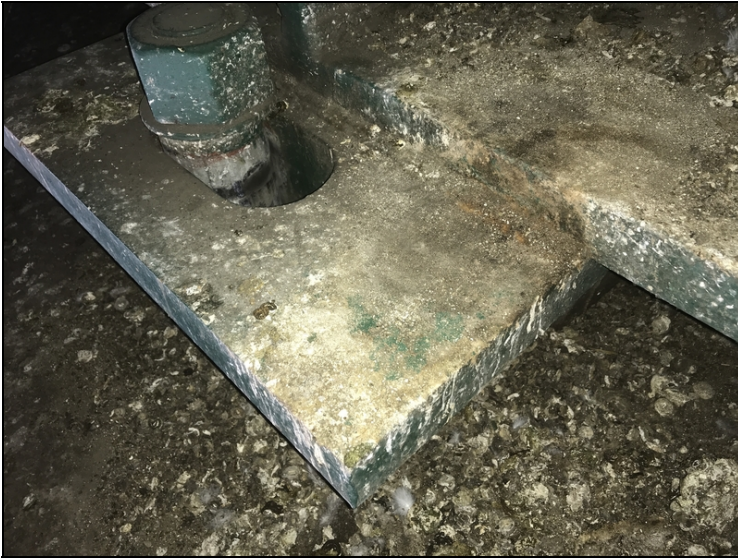
droppings around sole plate causing rust to form

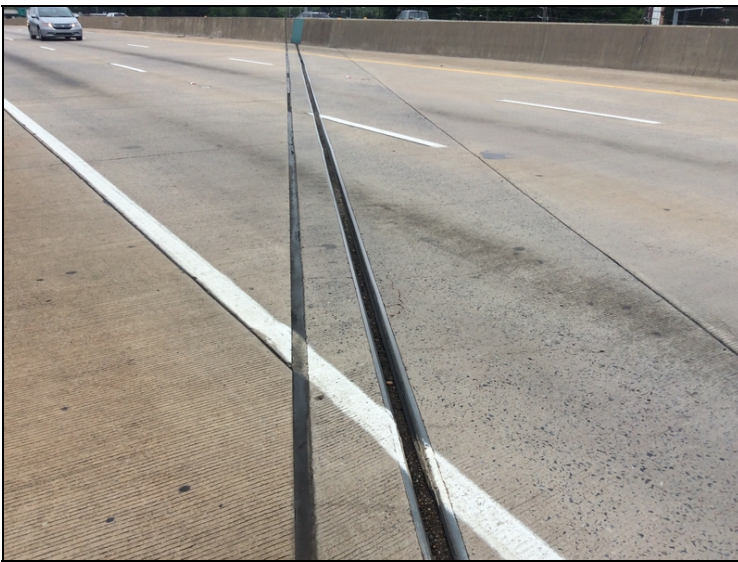
Deck joints are half full of debris.

Bent 1 joint seal half full of debris

Assigned Pulaski 2 06602 9-23-15

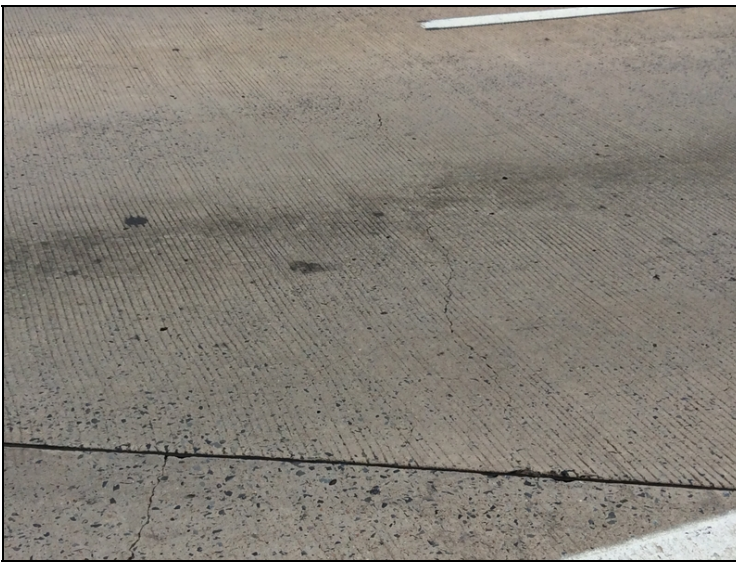
Unsealed deck cracks up to 0.040 inch.

Deck at Bent 1cracks up to 0.040"
