Bridge #A6920(Routine)
I-30 EB Log 132.19 over US 70, U.P.R.R.,Fr.Rd.

Location: 2 M NE Jct SH338

Team Lead: Bryan Saunders Inspection Date: April 19, 2021

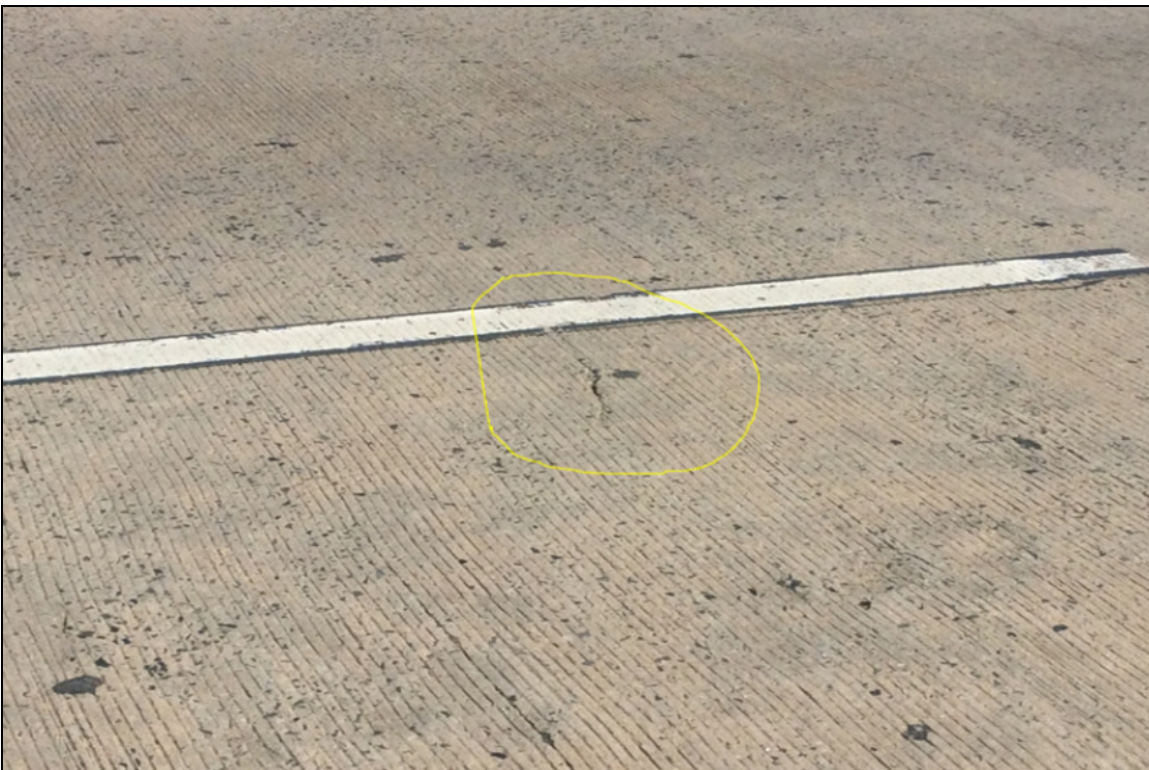
Span 3, large crack.

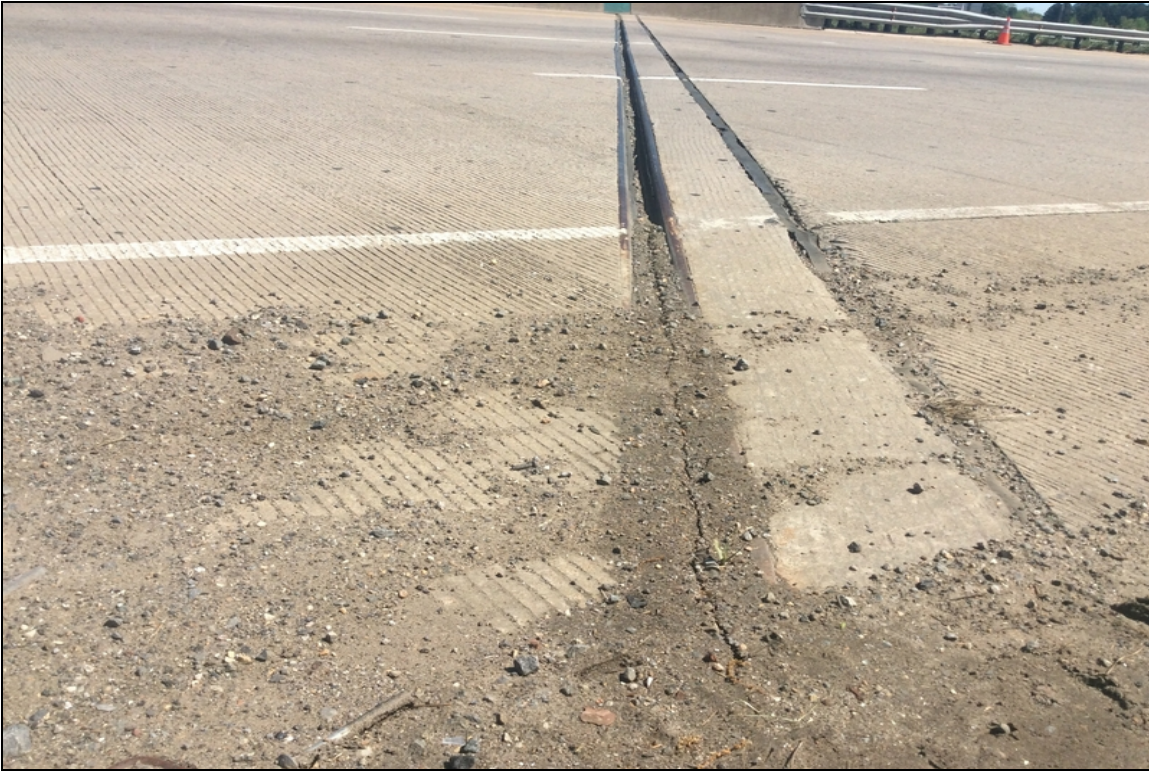
Bent 4, debris impacting the joint.

Joints are impacted by debris on the shoulders at bents 1 and 4.

Date Reported: 04/19/2021
Priority: D- Routine
Type of Work: Clean
Status: Open
Component: 300 - Strip Seal Expansion Joint

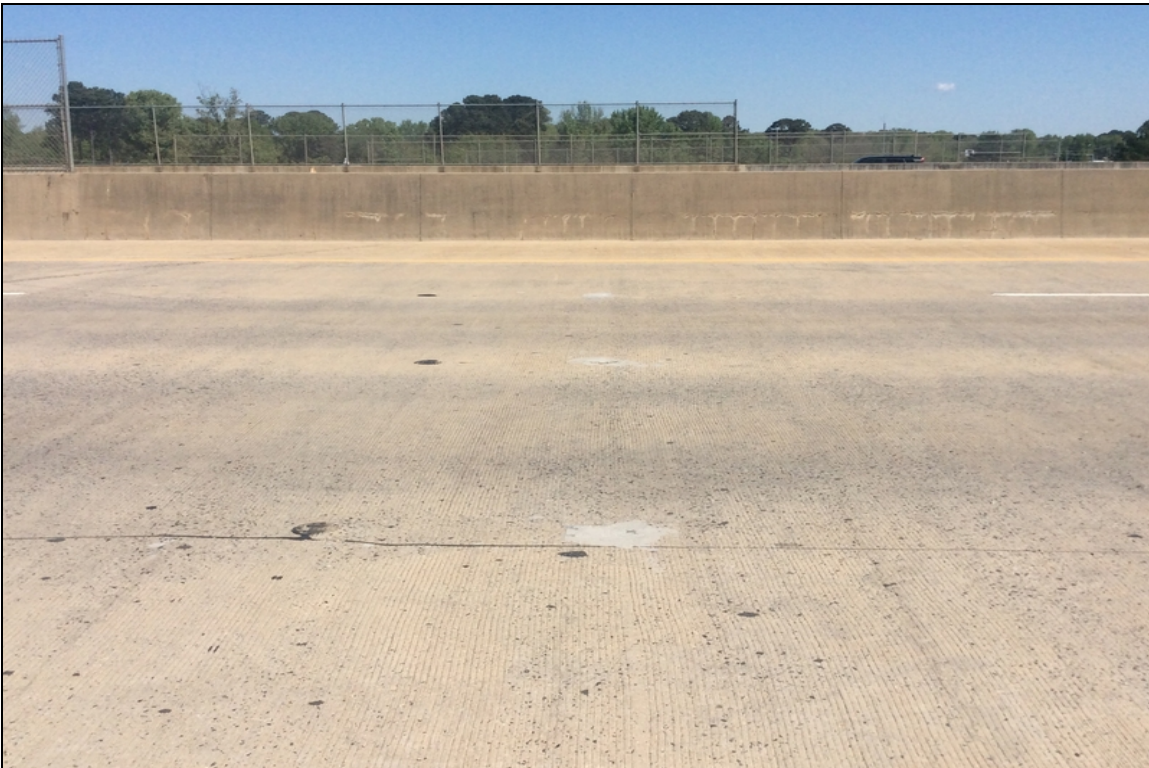
Span 3, patches.

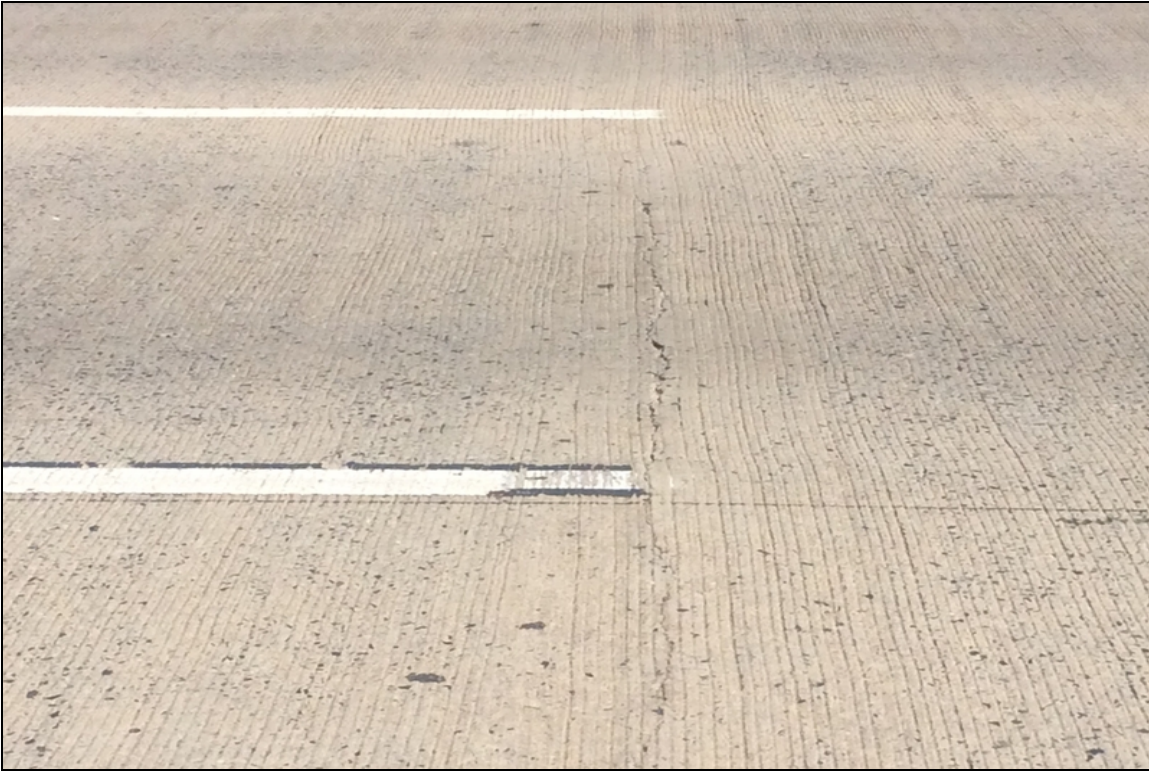
(12)							
Deck has unsealed transverse and longitudinal cracks up to 0.050". Patches in all spans where plowable markers have been removed.							
107	Steel Open Girder/Beam	LF	2877	2877	0	0	0
515	Steel Protective Coating	SF	42825	37723	5102	0	0
3420	Peeling/Bubbling/Cracking	SF	2	0	2	0	0
3410	Chalking (Steel Protective Coatings)	SF	5100	0	5100	0	0
(107-515)							
Outside Girders are chalking							
205	Reinforced Concrete Column	EA	6	6	0	0	0
215	Reinforced Concrete Abutment	LF	226	218	8	0	0
1120	Efflorescence/Rust Staining	LF	4	0	4	0	0
1130	Cracking (RC and Other)	LF	4	0	4	0	0

Span 2, large transverse cracks.

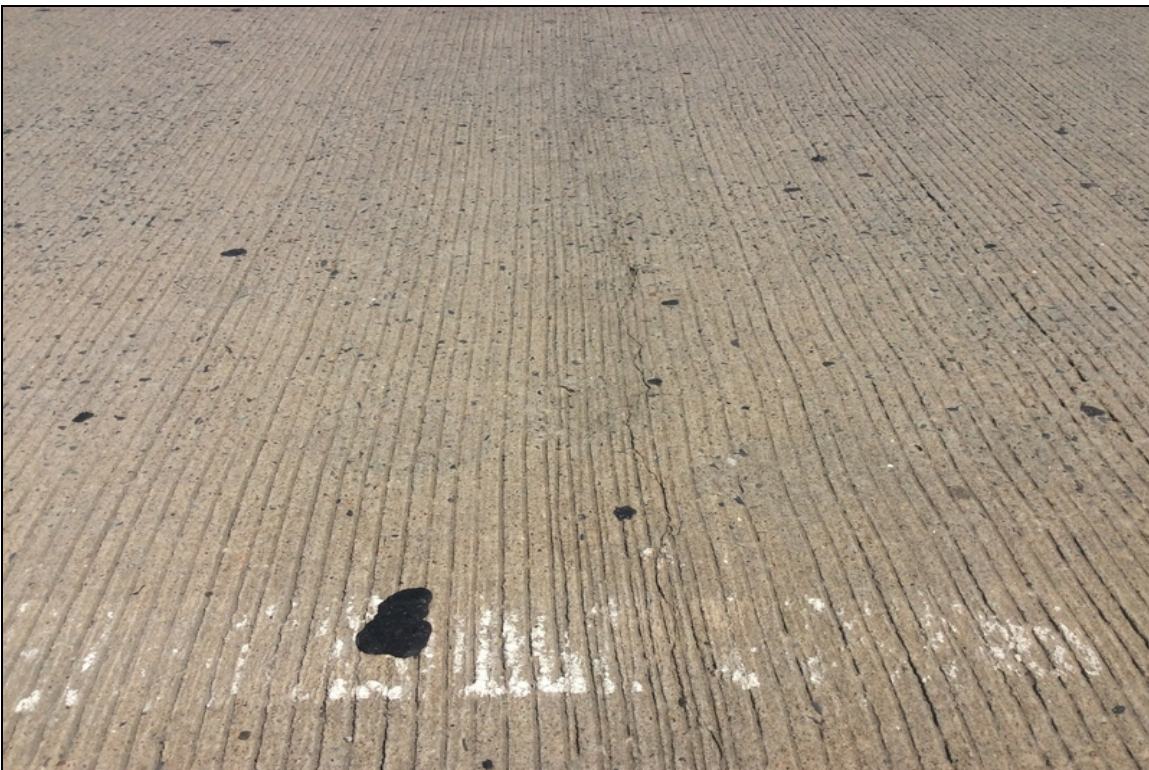
Span 1, large transverse cracks.

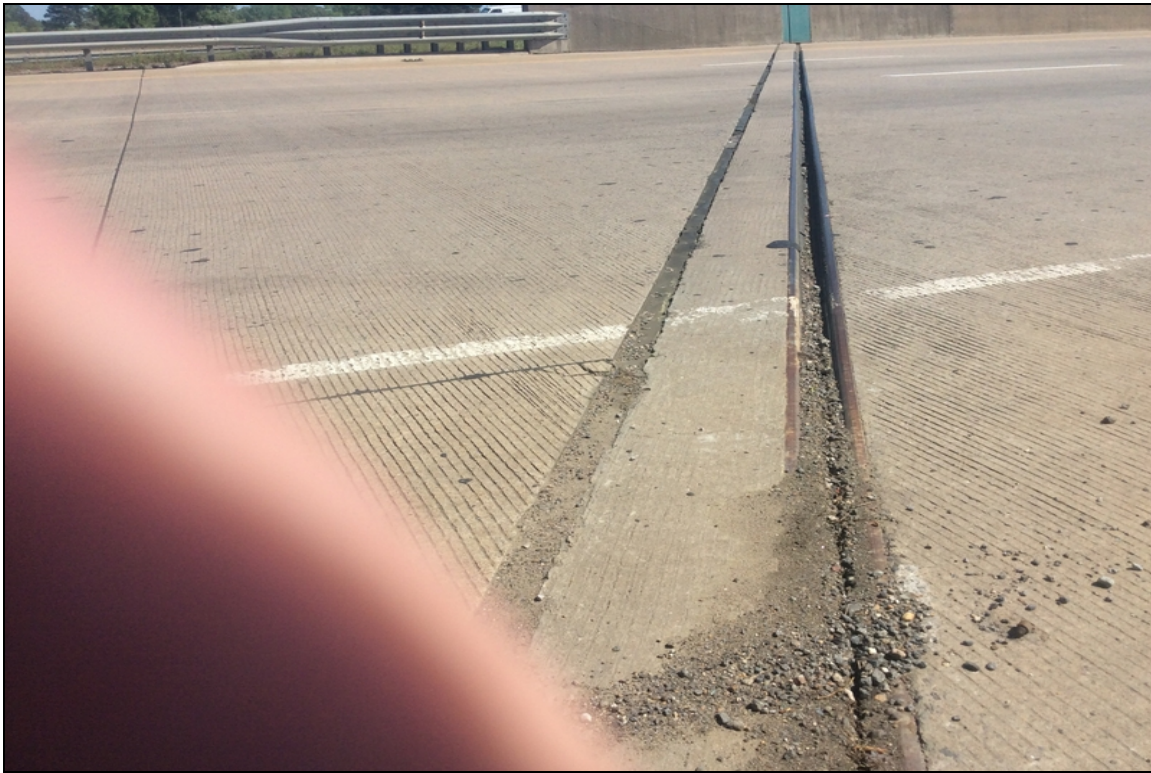
Bent 1, debris impacting the joint.

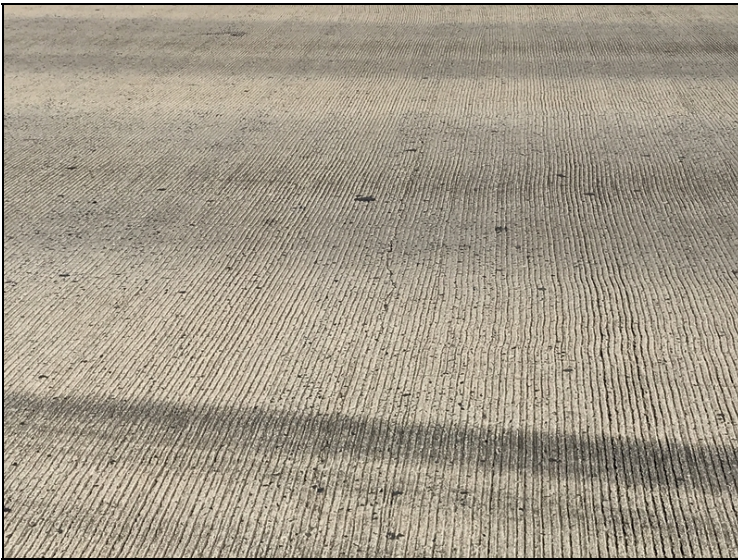
Deck has unsealed transverse and longitudinal cracks up to 0.030 inch.

Deck crack up to 0.030".

Date Reported: 04/18/2011
Priority: C - Important
Type of Work: None
Status: Monitor
Component:

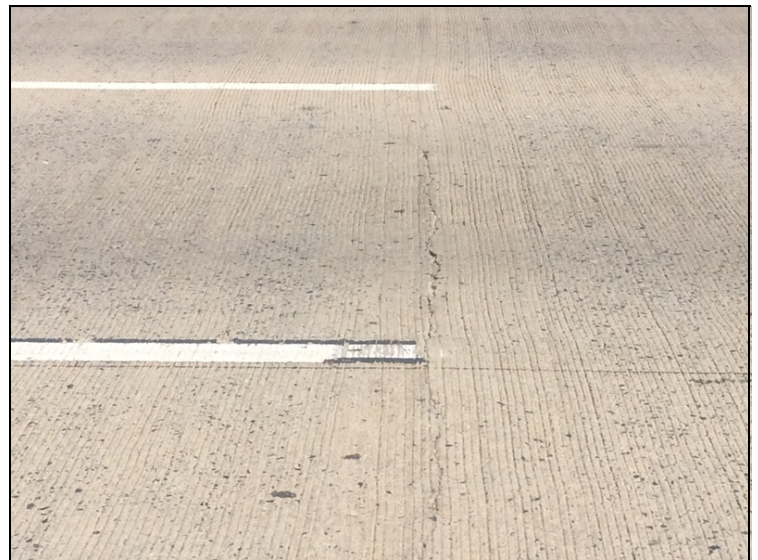
Span 2, large transverse cracks.

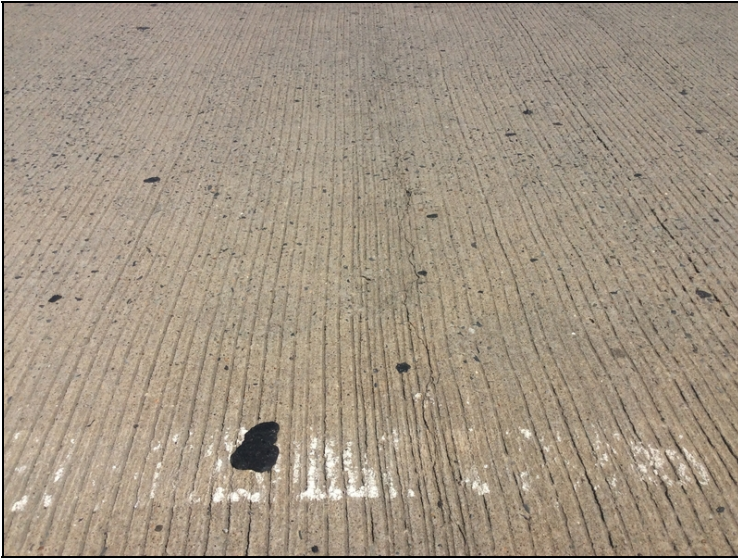
Span 1, large transverse cracks.

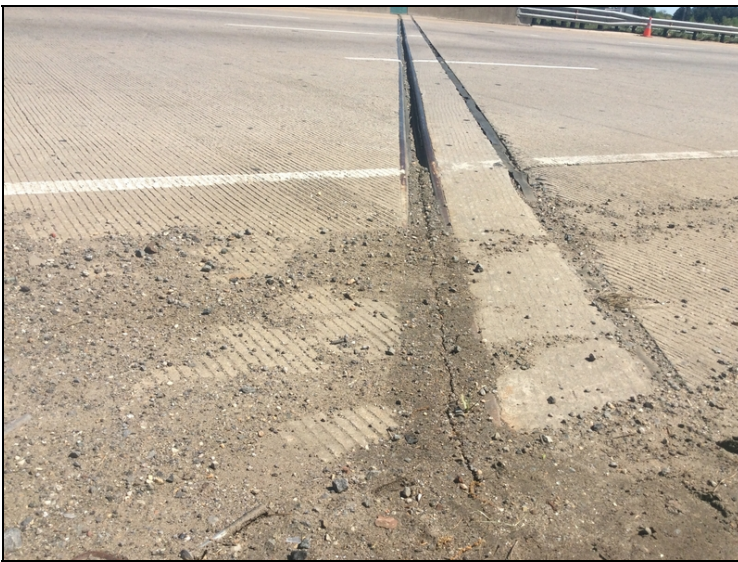
Bent 4, debris impacting the joint.

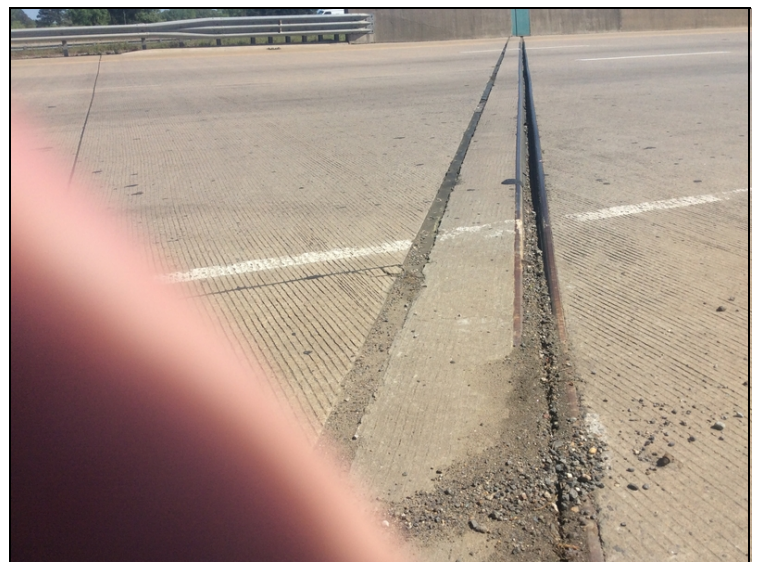
Bent 1, debris impacting the joint.
