Bridge #B6920(Routine)

I-30 WB Log 132.18 over US 70, U.P.R.R., Frnt Rd

Location: 2 MI NE JCT SH 338

Team Lead: Bryan Saunders Inspection Date: April 19, 2021

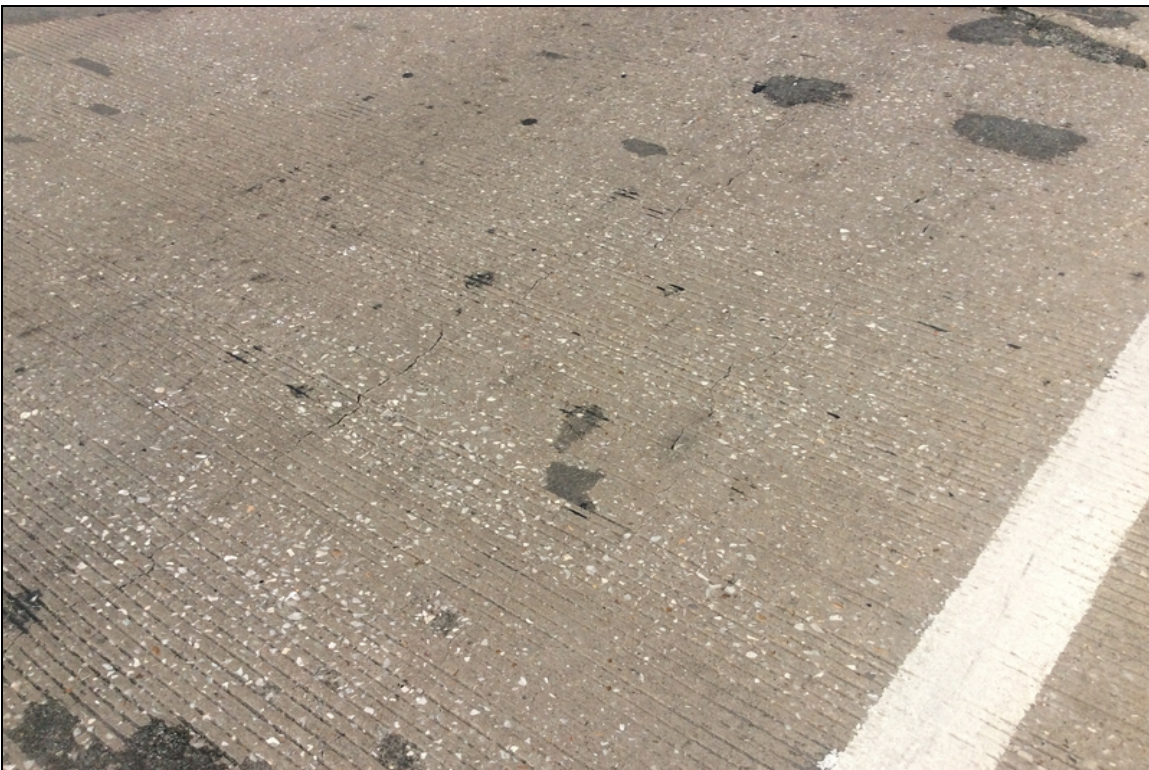
Span 3, large cracks and patches.

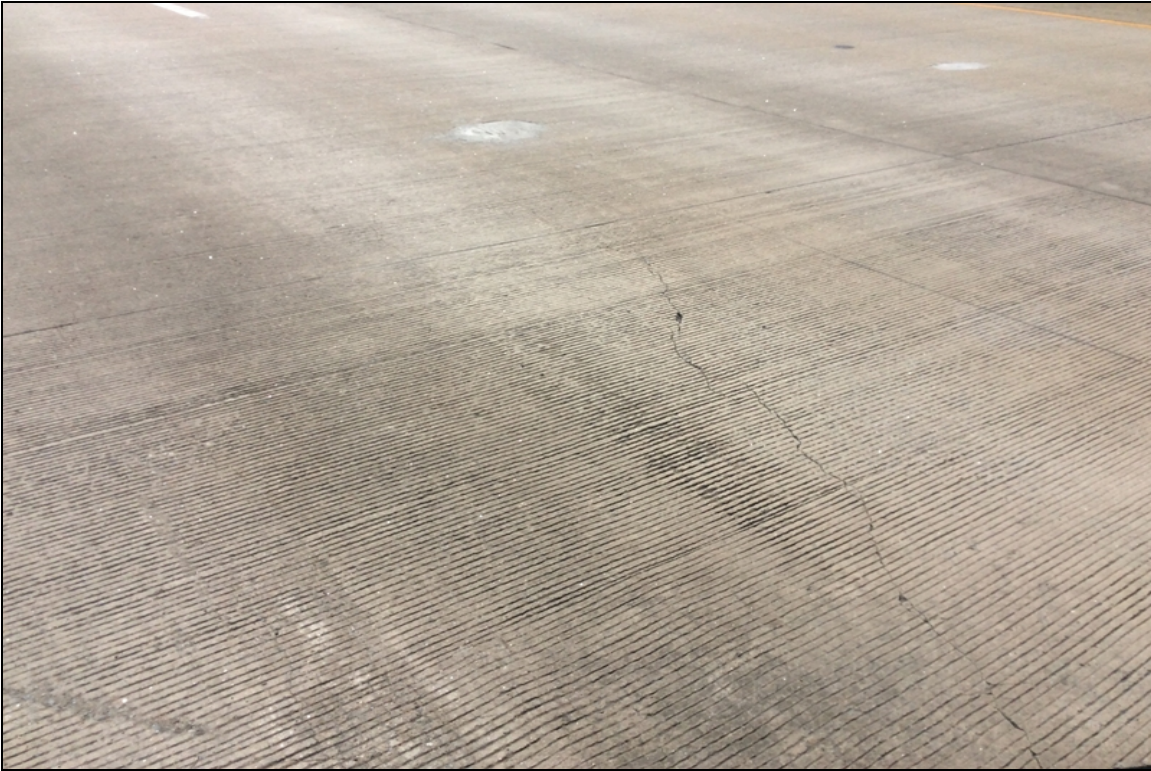
(321)							
Both approach slabs have cracks and patches.							
331	Reinforced Concrete Bridge Railing	LF	802	525	277	0	0
1130	Cracking (RC and Other)	LF	277	0	277	0	0

Bent 4 approach slab, large crack.

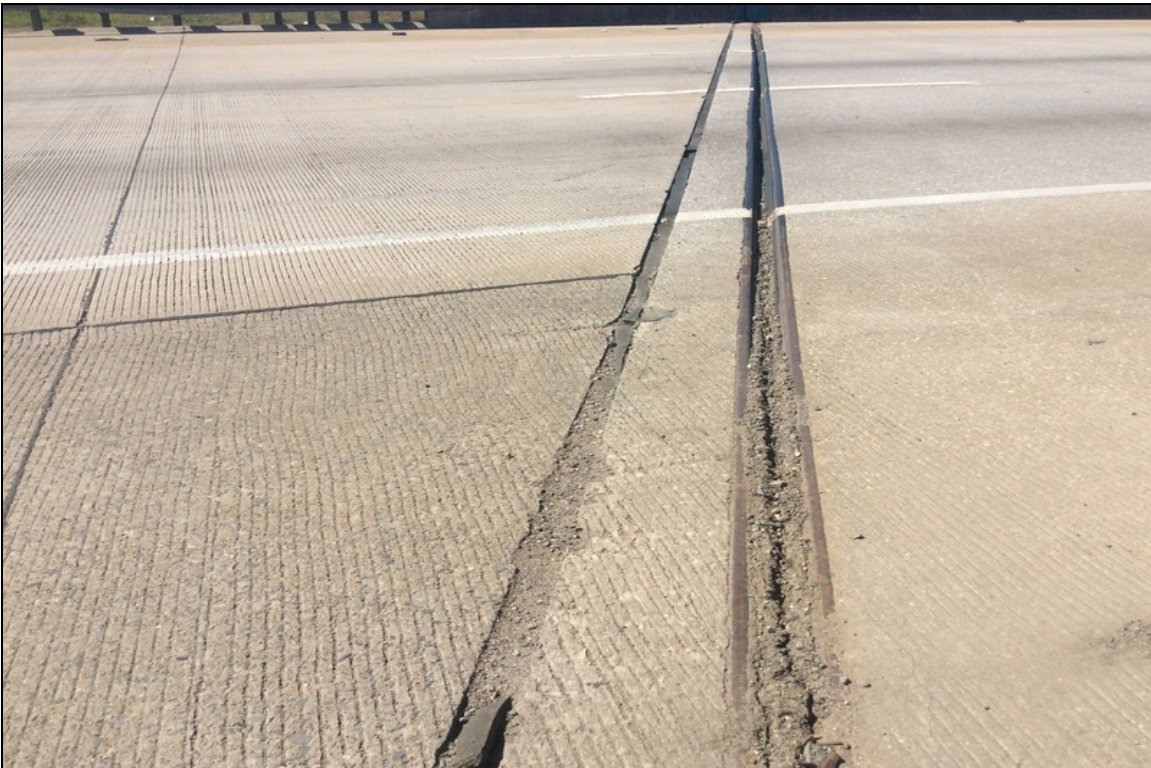
(300)							
Both joint seals are full of debris.							
310	Elastomeric Bearing	EA	24	24	0	0	0
321	Reinforced Concrete Approach Slab	SF	3840	3726	93	21	0
1080	Delamination/Spall/Patched Area	SF	4	0	4	0	0
1130	Cracking (RC and Other)	SF	110	0	89	21	0

Bent 4 joint impacted by debris.

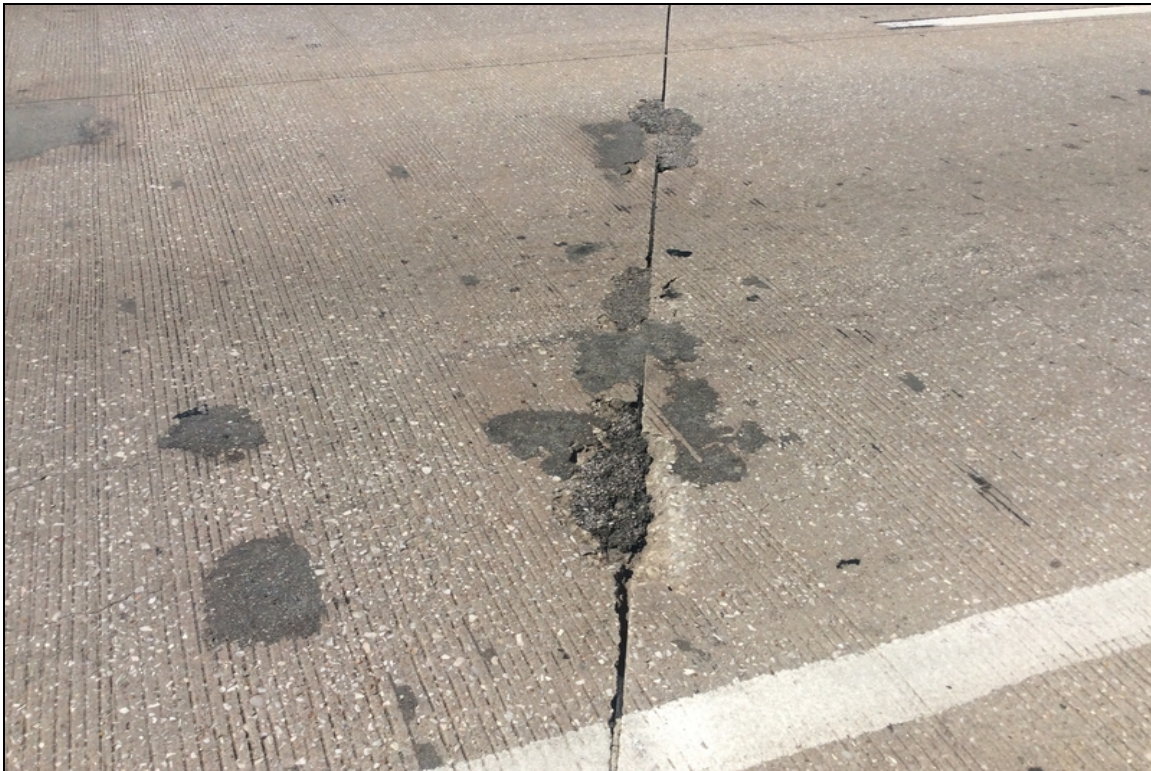
(12)							
Spalls at bent 3 that have been filled with asphalt or epoxy. Patches where plowable markers have been removed in all spans. Most cracks have been sealed in the right and center lanes.							
107	Steel Open Girder/Beam	LF	2406	2406	0	0	0
515	Steel Protective Coating	SF	40526	38106	2420	0	0
3410	Chalking (Steel Protective Coatings)	SF	2420	0	2420	0	0
(107-515)							
Girder 5, outside web and bottom flange are chalking.							
205	Reinforced Concrete Column	EA	6	6	0	0	0
215	Reinforced Concrete Abutment	LF	202	191	11	0	0
1130	Cracking (RC and Other)	LF	11	0	11	0	0

Bent 3, asphalt patches are failing.

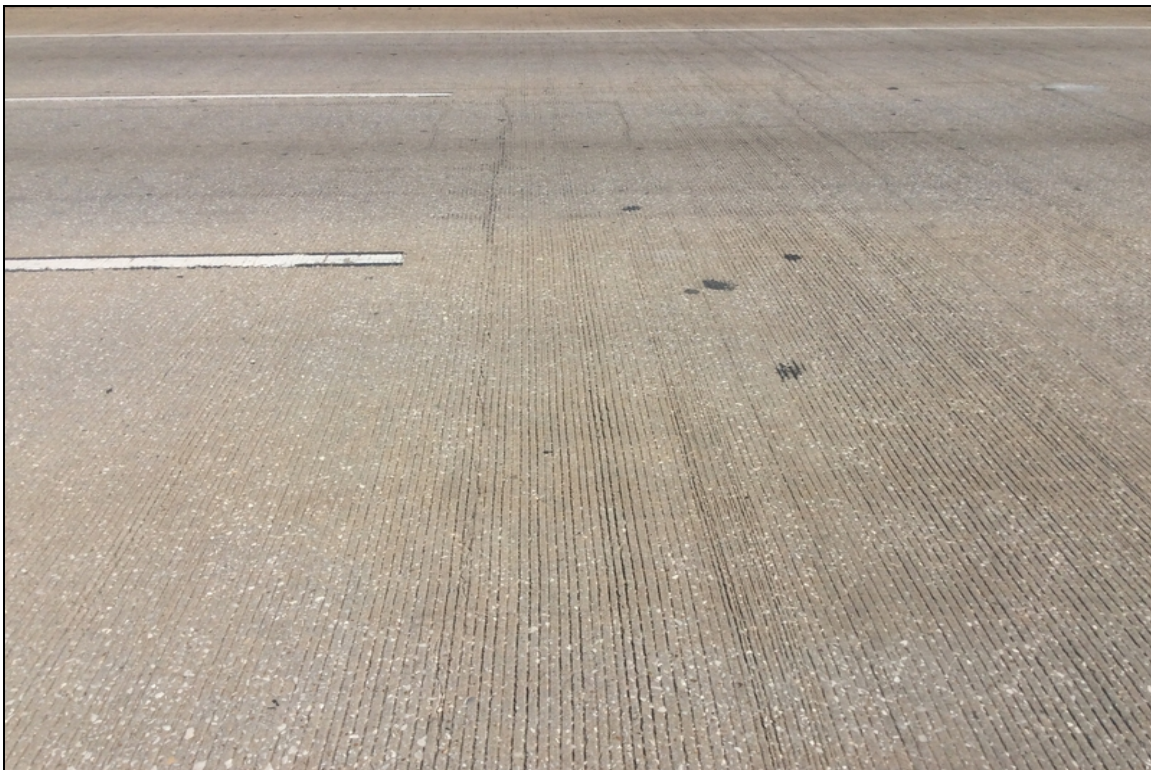
Span 2, large transverse cracks.

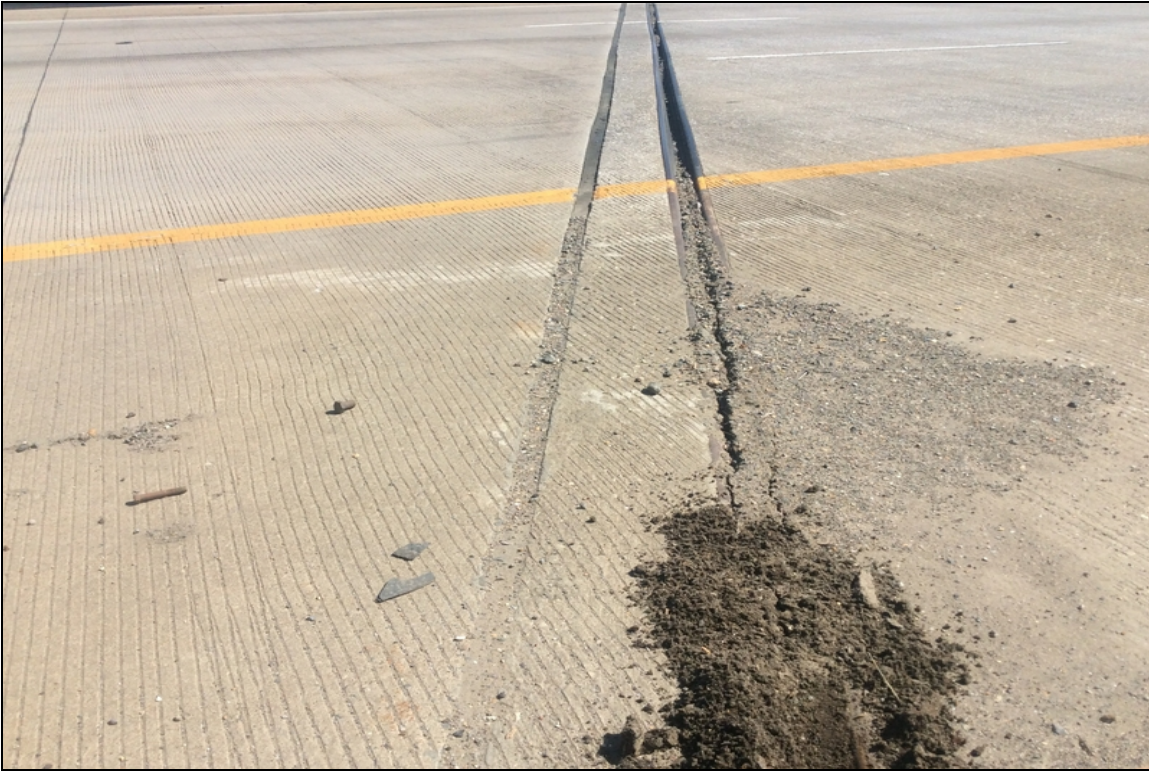
Bent 1 joint impacted by debris.

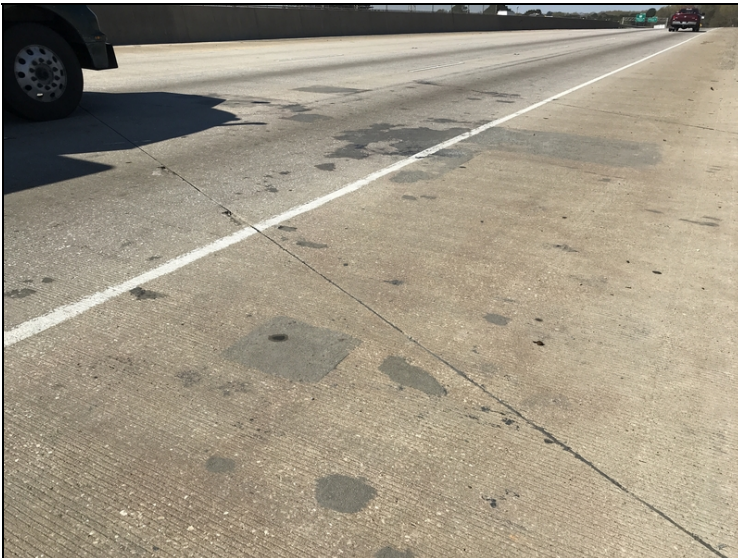
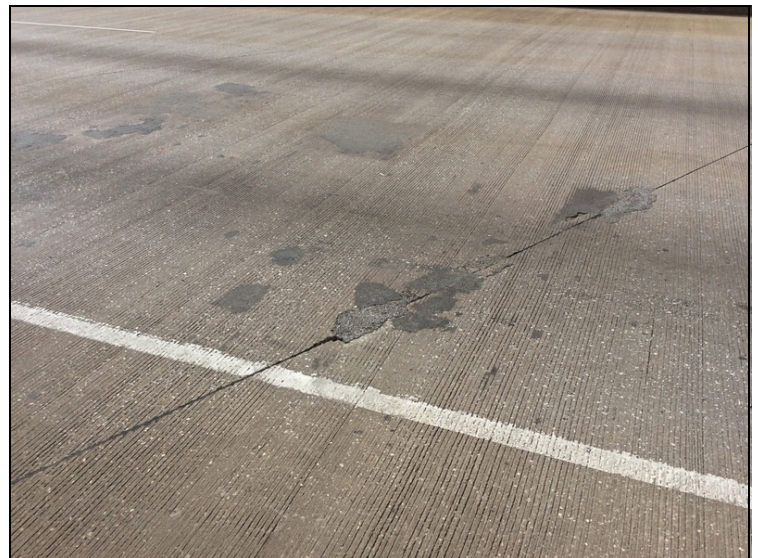
Deck has small spalls over bent 3.

Bent 3: Spalls have been filled with asphalt and epoxy patches which are beginning to fail.

Span 3, spalls patched with epoxy & asphalt.

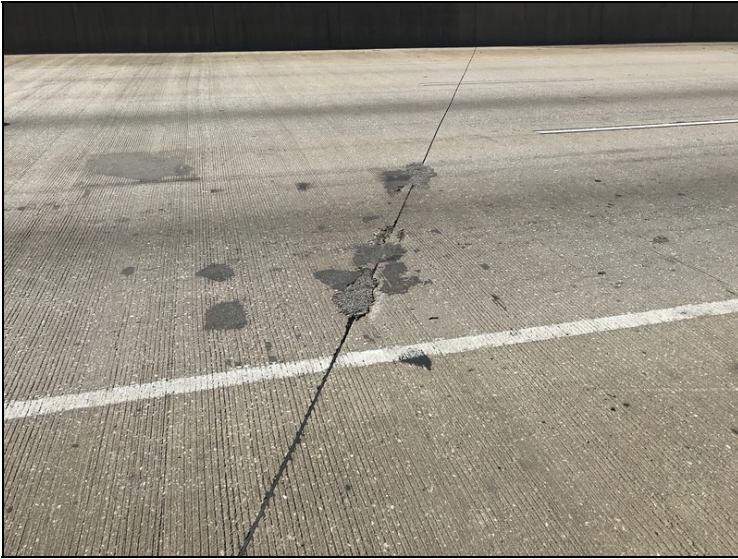
Spalls filled with asphalt over Bt. 3.

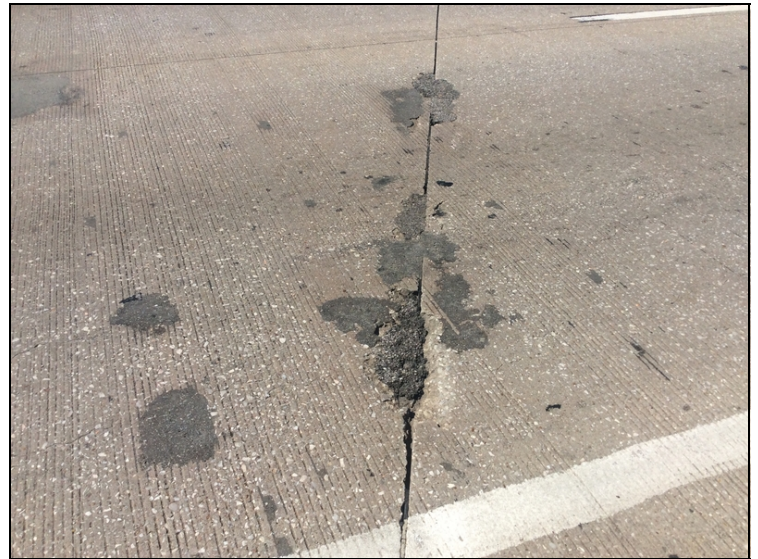
Bent 3, asphalt patches are failing.

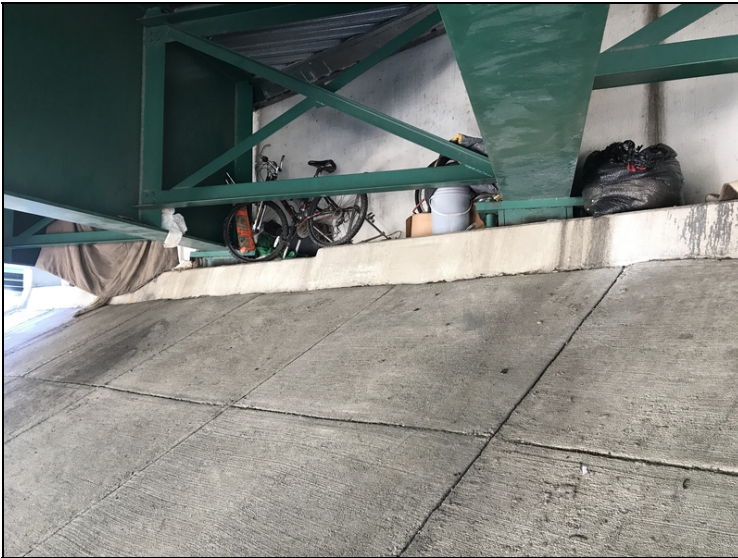
Trash and bedding from transient under bridge. Photo

Trash and bedding from transient under bridge.

The trash and bedding has been removed as of April 19, 2021.

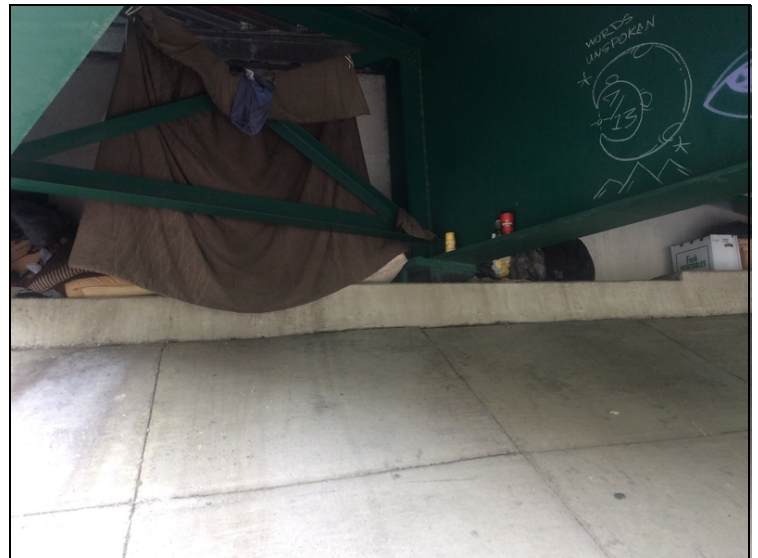
Bent 4 transient living under bridge.

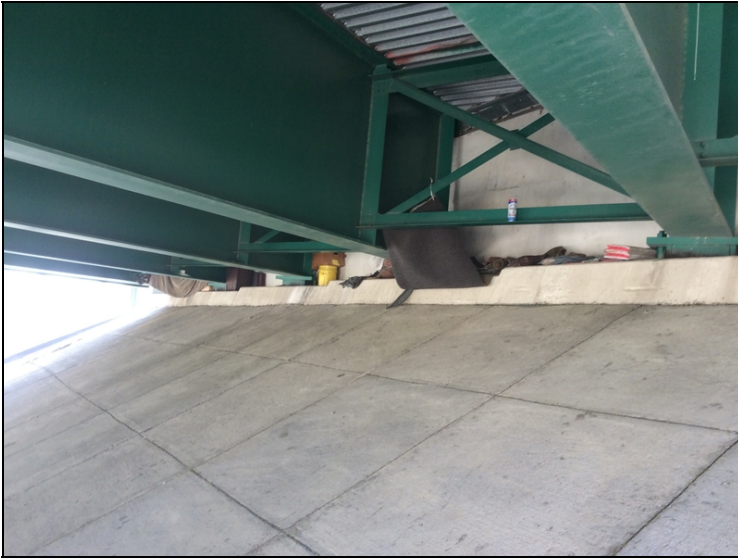
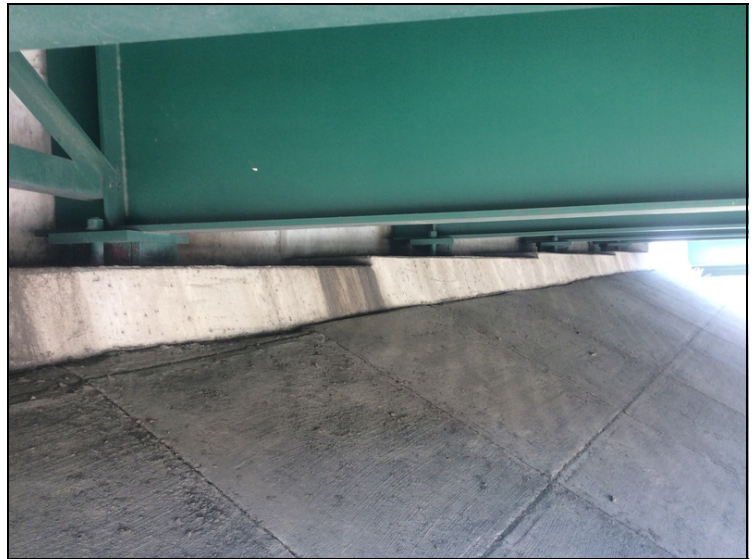
Bent 1, trash and bedding has been removed.

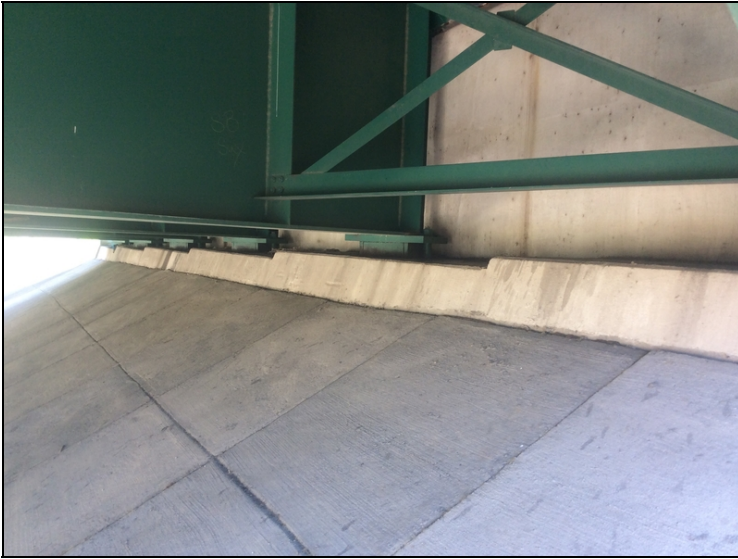
Bent 4, most trash and bedding has been removed.

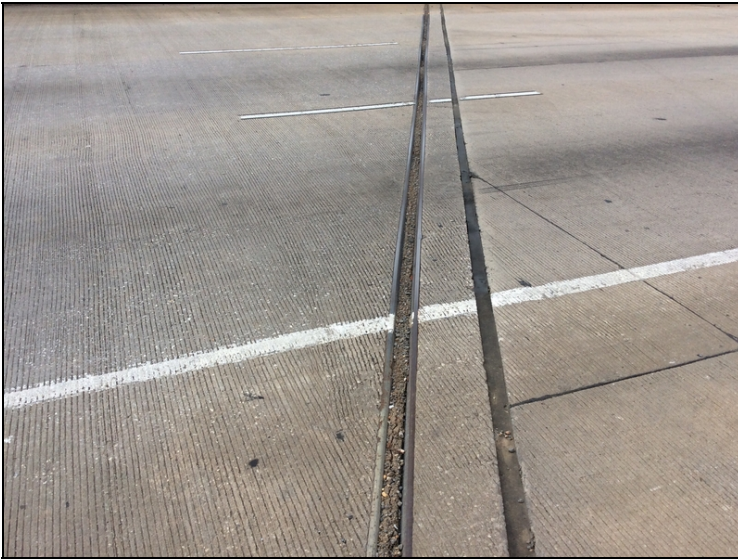
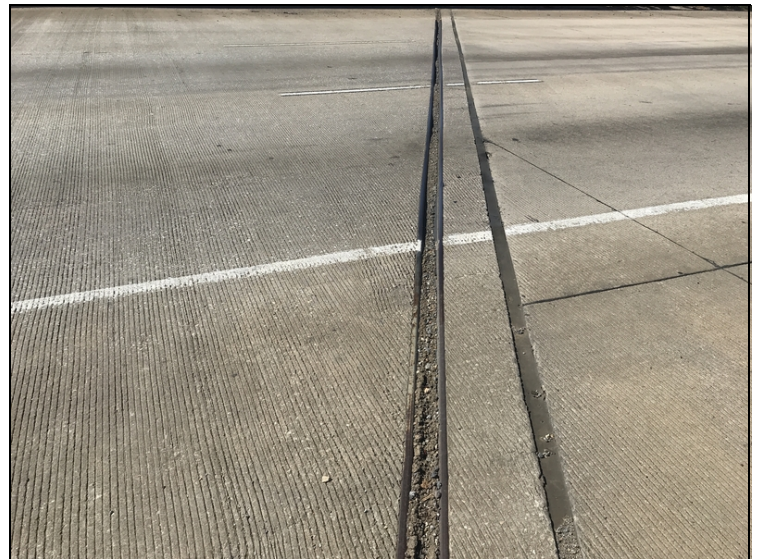
Bent 1 & 4: Both joints are full of debris that is beginning to restrict movement.
April 19, 2021: The joints are full of debris on the shoulders at bents 1 and 4.

Bt. 1, joint full of debris.

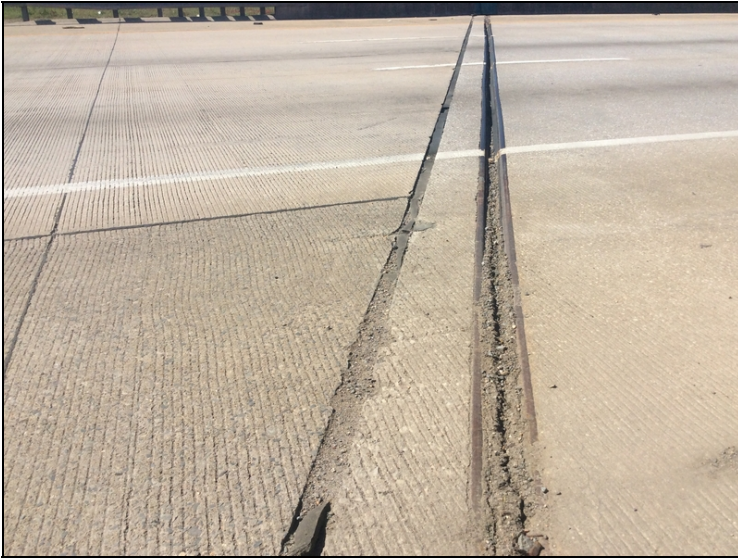
Bent 4 joint impacted by debris.

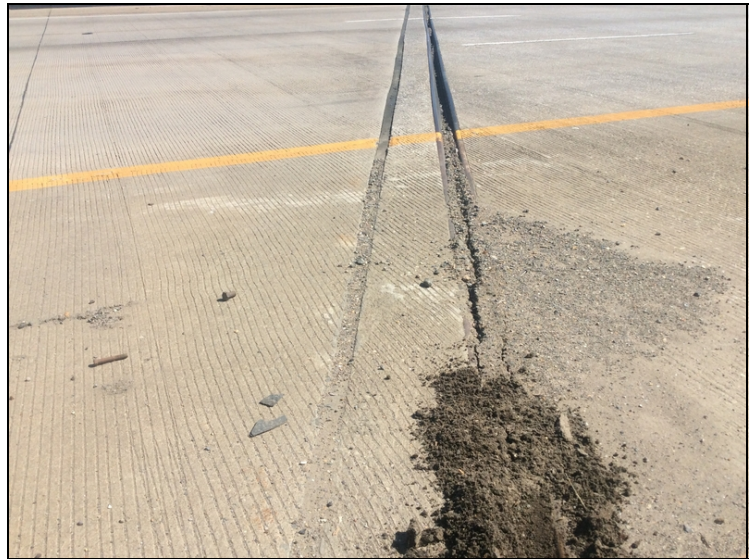
Bent 1 joint impacted by debris.
