**Bridge #A2804(Routine)**  
**I-30 EB Log 127.52 over CROOKED CREEK**

**Location: 1.2 MI E SH 111**

**Team Lead: Chris Doggett Inspection Date: August 16, 2021**

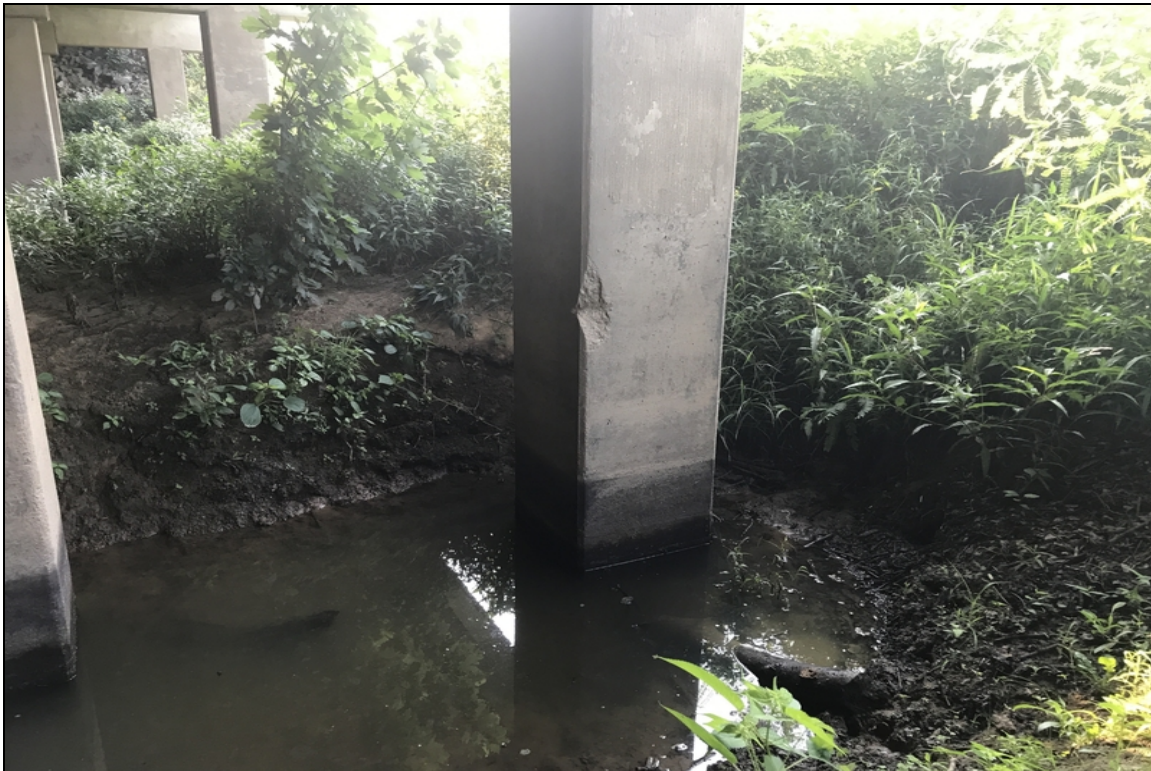
Bent 4 column 4: back side with a spall.

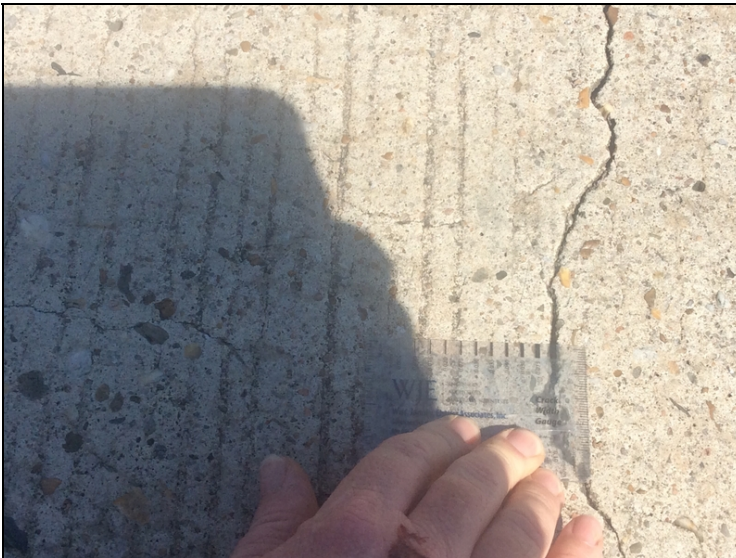
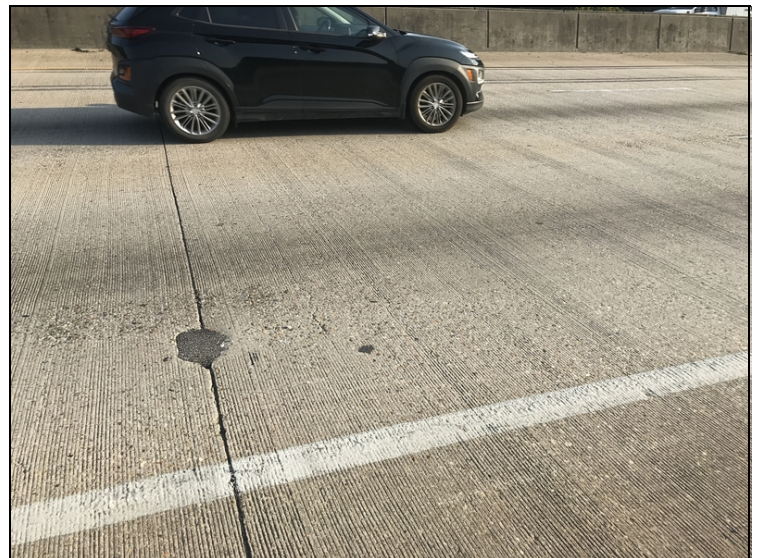
Deck surface all spans  
Scattered unsealed cracks in the deck up to .050"

Span 2: numerous unsealed transverse cracks and small spall filled with asphalt.

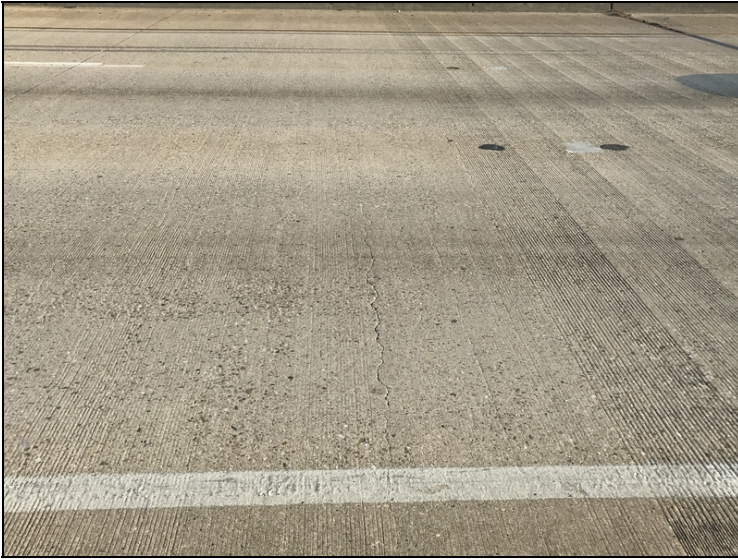
Span 4: large unsealed transverse crack.

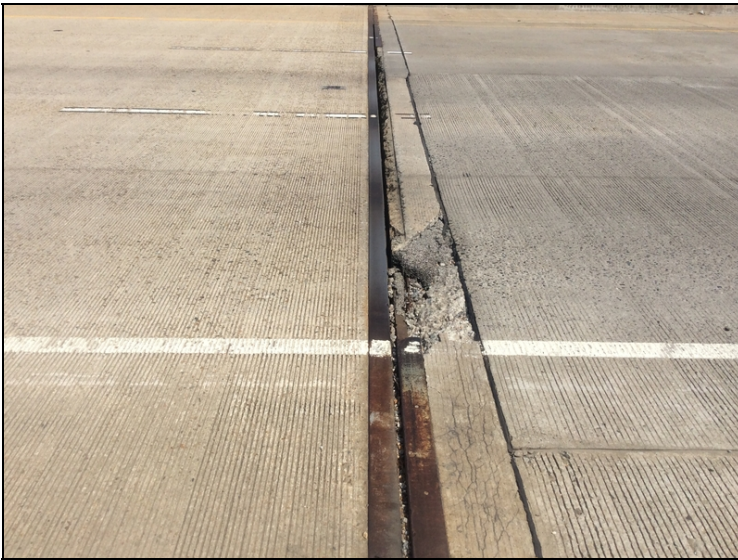
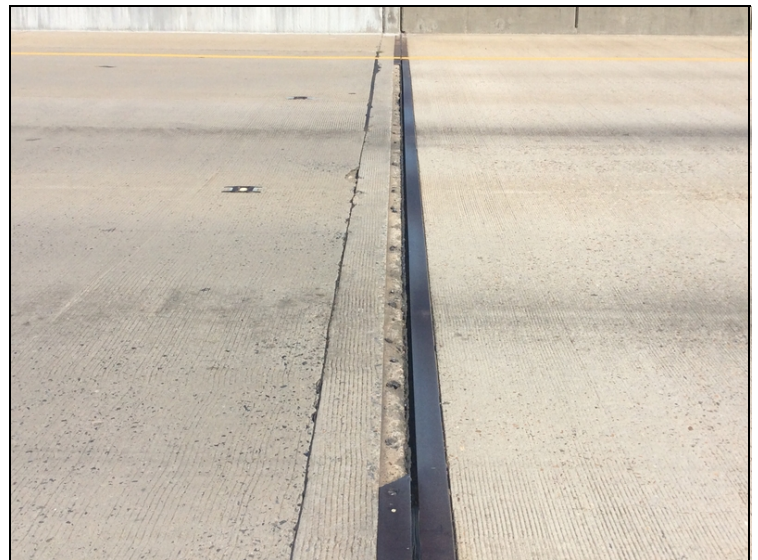
(215)	Scattered cracks in both abutments. Bent 7 top of back wall at right shoulder has a spall with exposed rebar. See photo.						
234	Reinforced Concrete Pier Cap	LF	288	287	1	0	0
1080	Delamination/Spall/Patched Area	LF	1	0	1	0	0
302	Compression Joint Seal	LF	167	0	0	25	142
2310	Leakage	LF	105	0	0	25	80
2360	Adjacent Deck or Header	LF	62	0	0	0	62

(302)	Joint seals at both abutments have lost bond and leak. 62' of joint armor missing at bent 1 & 6. See photo.

Bent 7 joint armor and seal missing. Spall with exposed rebar in back wall of abutment.

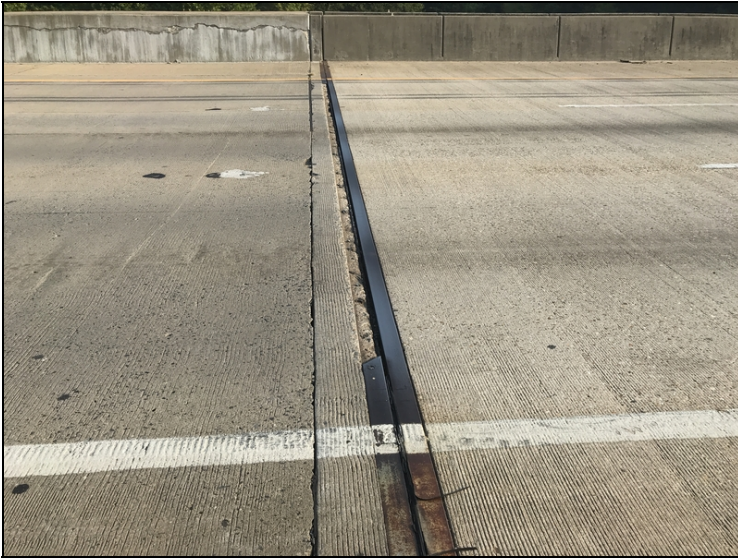
Bent 1 and Bent 7 Joint armor missing

Bent 1: majority of joint seal missing and 36' of joint armor missing.

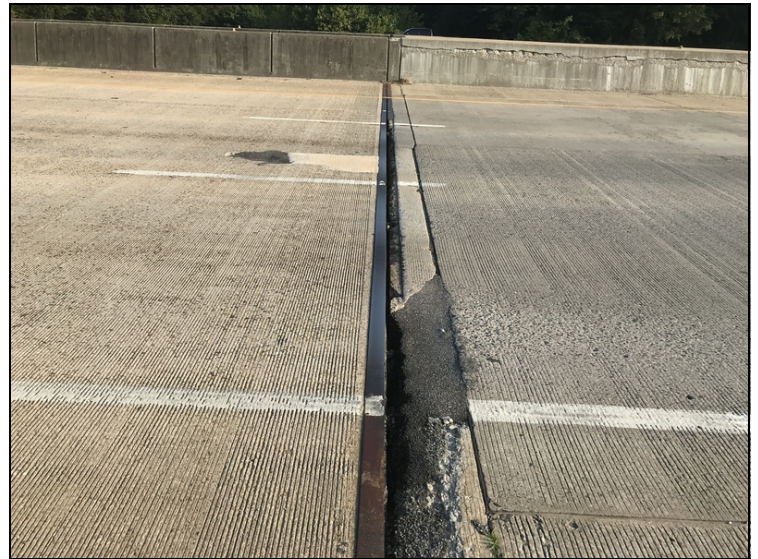
Bent 7: entire joint seal missing, spall filled with asphalt in the right lane, spall filled with asphalt in the center lane, and joint armor missing in the right 2 lanes.

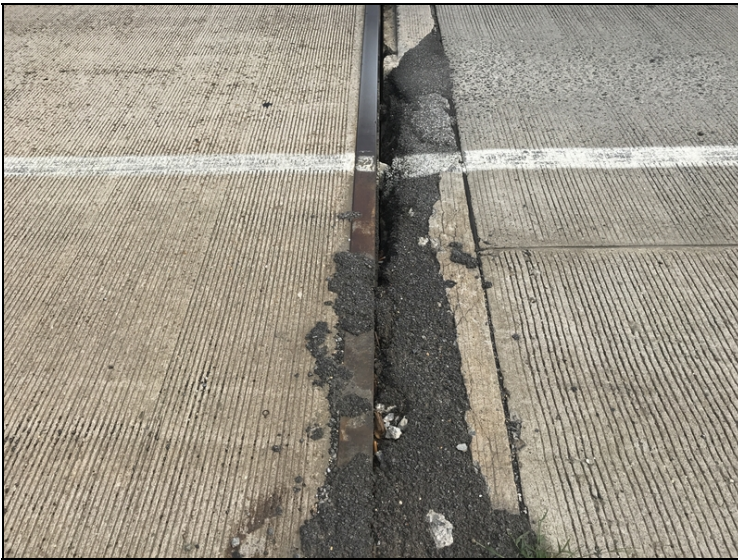
Bent 7 top of backwall right lane and shoulder has spall filled with asphalt.

Bent 7 spall filled with asphalt in top of back wall

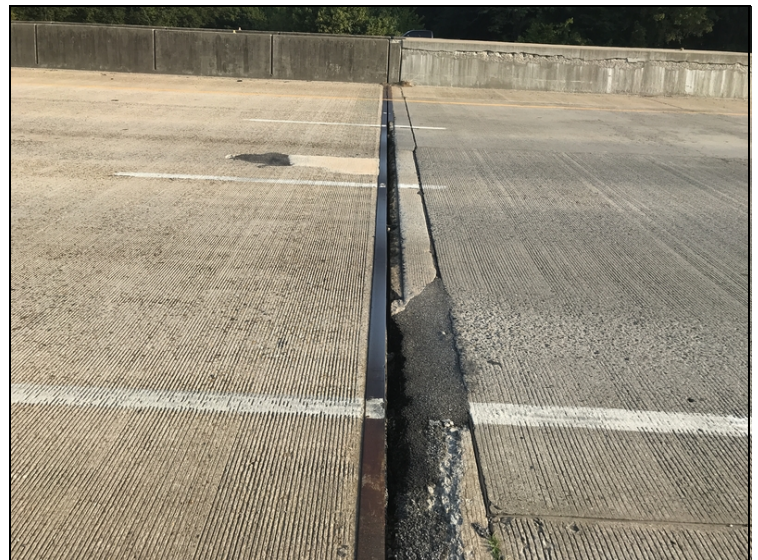
Bent 7: entire joint seal missing, spall filled with asphalt in the right lane, spall filled with asphalt in the center lane, and joint armor missing in the right 2 lanes.

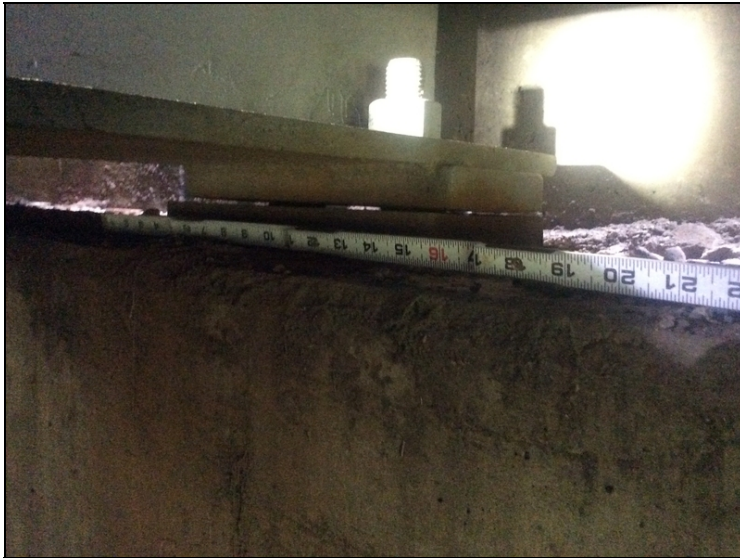
Bent 7 abutment, bearing at girder 4 and 5. Also, Bent 4, span 3, beam 5:  
Gap between bearing and masonry plate.

Span 6 bearing 4 gap between bearing and masonry plate. Common at bearing 5 this bent.

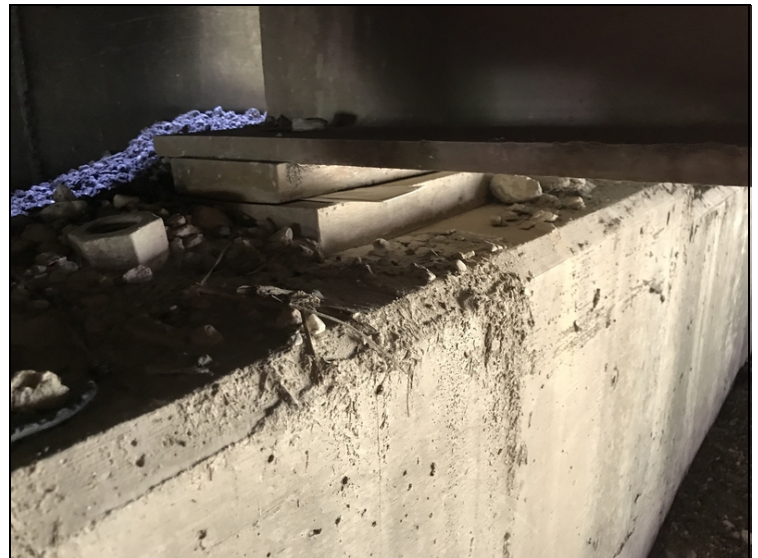
Bent 7 abutment, bearing at girder 5.  
Gap between bearing and masonry plate.

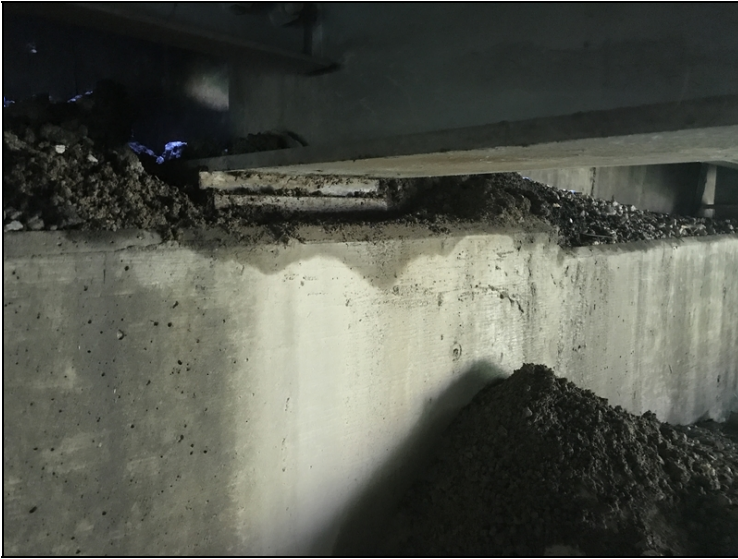
ELEM	DESCRIPTION	UNITS	TOTAL	CS1	CS2	CS3	CS4
311	Movable Bearing	EA	32	16	16	0	0
1000	Corrosion	EA	16	0	16	0	0
(311)							
Bent 7, beam 4&5, and Bent 4, span 3, beam 5: The bearings have a gap of 1/16" to 1/8" between the bearing and masonry plate. When beams are loaded with heavy traffic the bearings slap the masonry plate. See photo.							
313	Fixed Bearing	EA	32	32	0	0	0
321	Reinforced Concrete Approach Slab	SF	4180	3929	251	0	0
1080	Delamination/Spall/Patched Area	SF	1	0	1	0	0
1130	Cracking (RC and Other)	SF	250	0	250	0	0
(321)							
West approach slab spall at backwall.							
Diagonal and transverse cracks in the slab on the west side.							
331	Reinforced Concrete Bridge Railing	LF	360	302	58	0	0
1080	Delamination/Spall/Patched Area	LF	12	0	12	0	0
1130	Cracking (RC and Other)	LF	46	0	46	0	0

Bent 7, girder 5: beam 5: Bearing with a gap between the sole plate and masonry plate hitting hard with live load over this location.

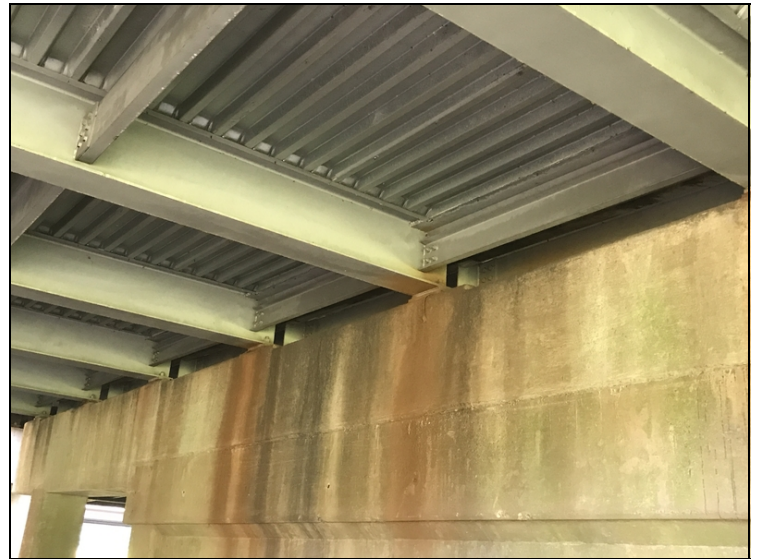
Bent 4, span 3, beam 5: Bearing with a gap between the sole plate and masonry plate hitting hard with live load over this location.

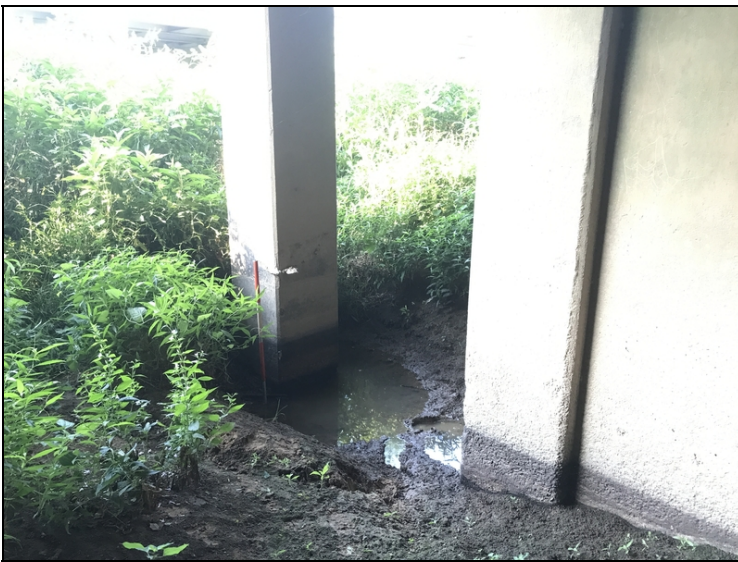
(210)	All pier walls have minor abrasion. Local scour to all piers.						
215	Reinforced Concrete Abutment	LF	157	122	21	14	0
1080	Delamination/Spall/Patched Area	LF	3	0	0	3	0
1090	Exposed Rebar	LF	11	0	0	11	0
1130	Cracking (RC and Other)	LF	21	0	21	0	0

Right side of bent 5 with local horse shoe scour. Most all bents with local scour action at the columns.

Right side of bent 5 with local horse shoe scour.

**Date Reported:** 08/16/2021  
**Priority:** C - Important  
**Type of Work:** Repair  
**Status:** Open  
**Component:** Channel

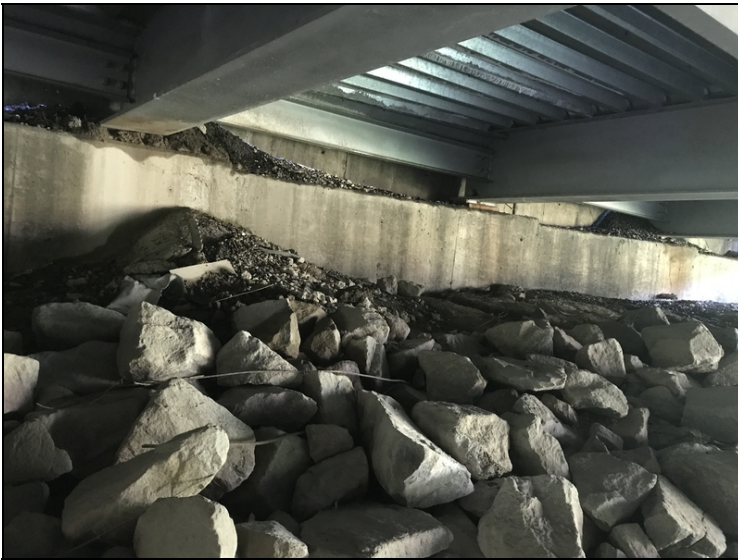
Bents 1 and 7: entire joint seals are missing at both locations and debris is accumulating around bearings and beam ends.

Bent 7: joint seal missing allowing dirt and debris to accumulate around bearings.

**Date Reported:** 08/16/2021  
**Priority:** C - Important  
**Type of Work:** Replace  
**Status:** Open  
**Component:** 302 - Compression Joint Seal
