Bridge #B6926(Routine)

I-30 WB Log 127.52 over Crooked creek

Team Lead: Chris Doggett Inspection Date: August 16, 2021

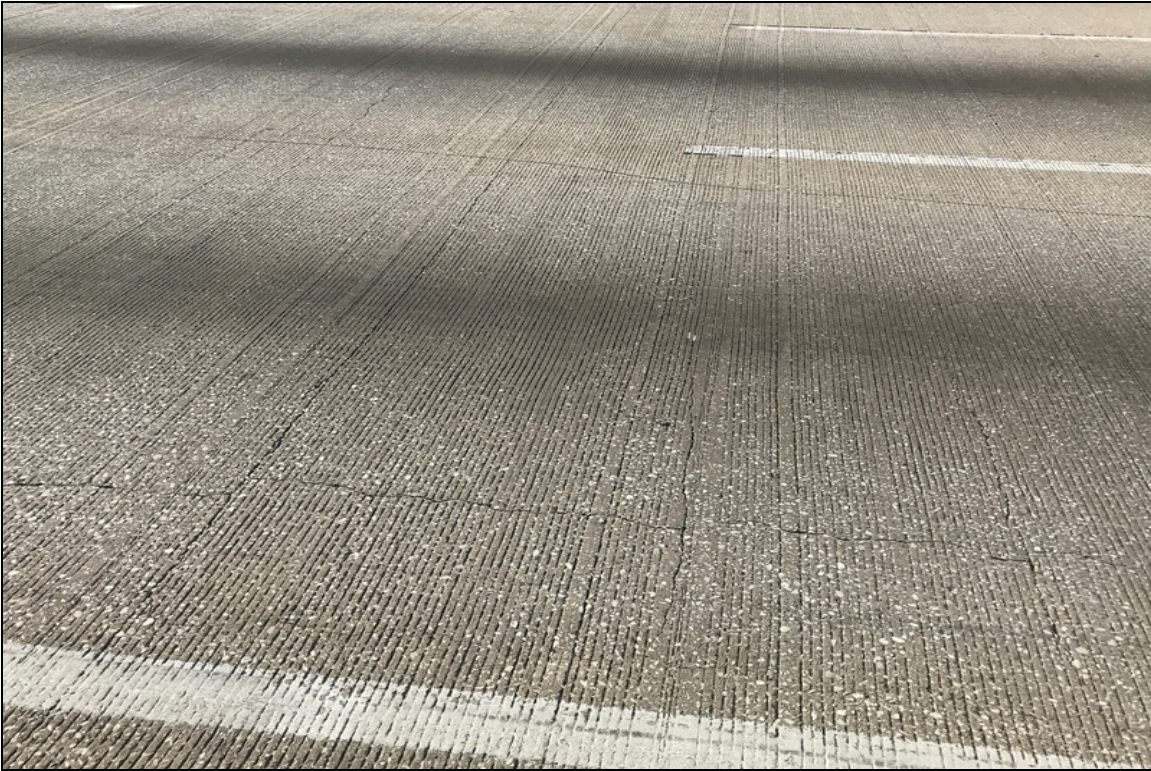
Span 5: unsealed transverse and longitudinal cracking up to 0.040" in width.

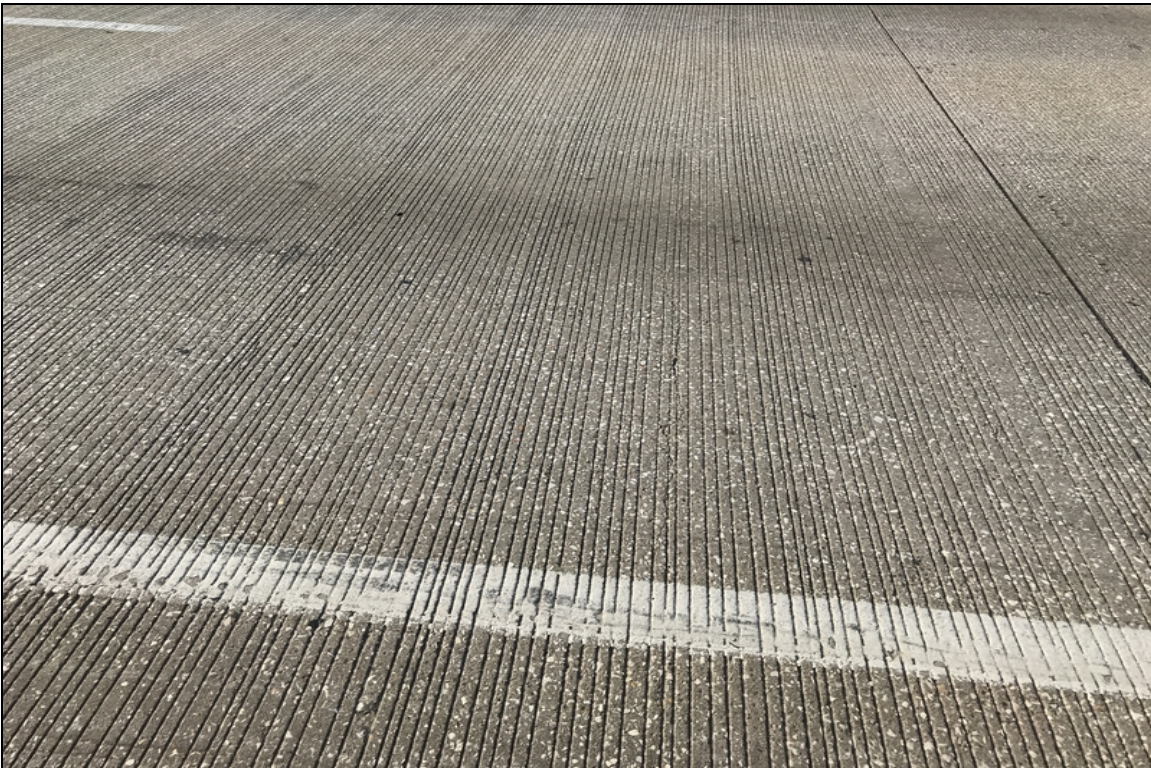
Span 2: unsealed transverse cracking.

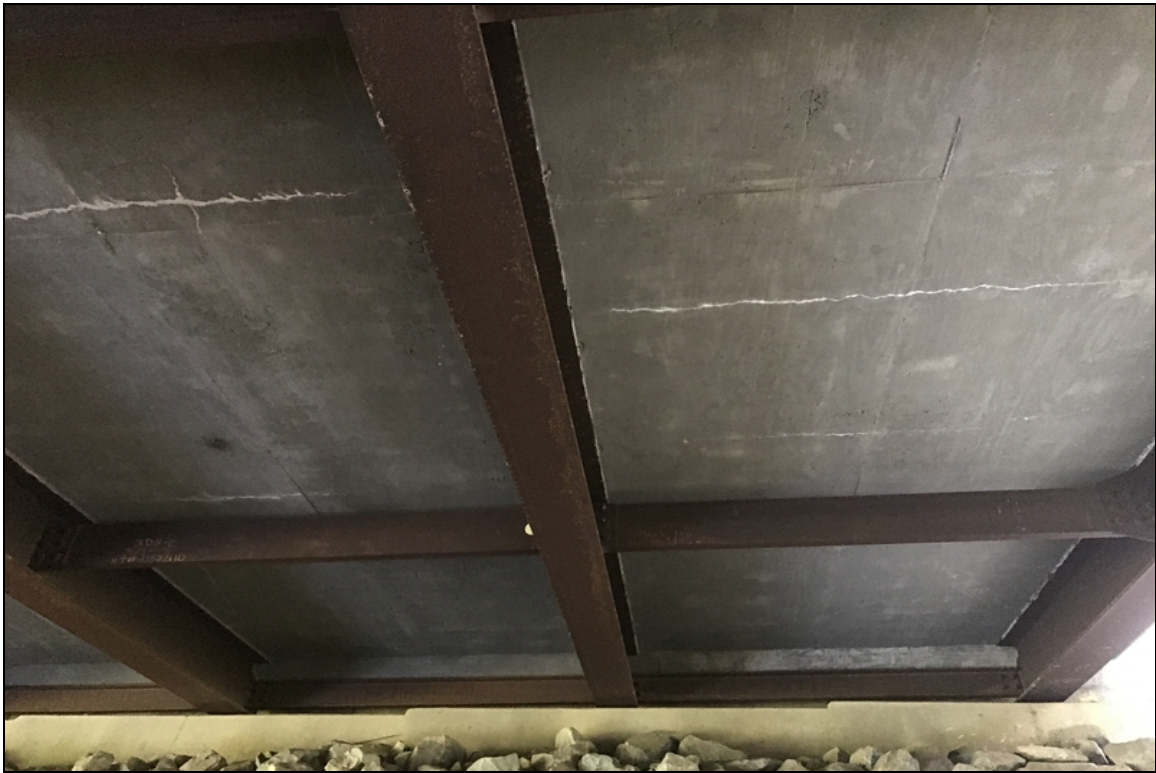
Span 7: soffit with multiple transverse cracks with efflorescence staining.

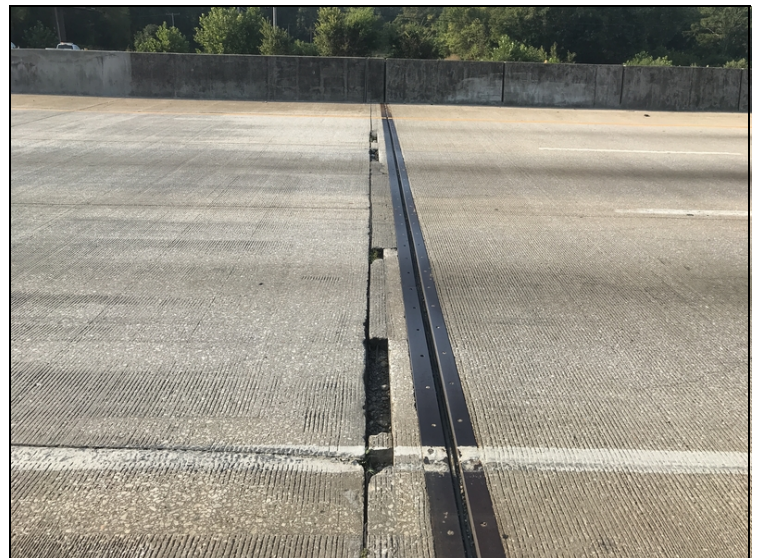
Bent 7: multiple open spalls in the headwall

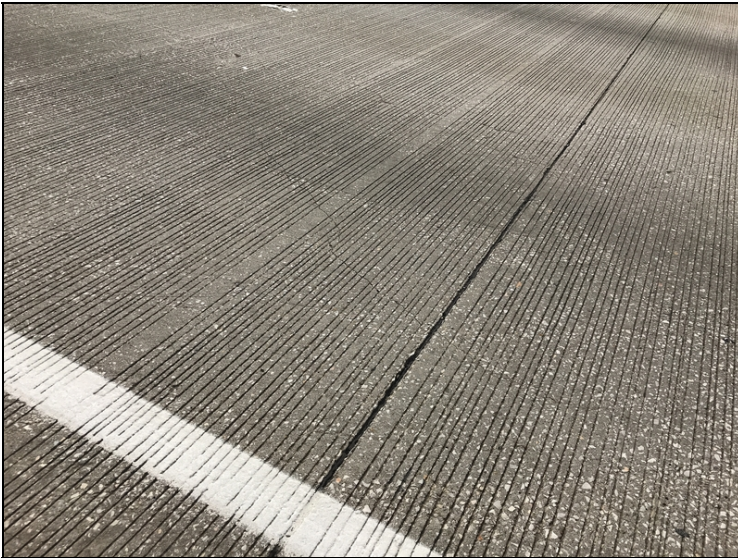
Deck surface of all spans

Unsealed transverse and longitudinal cracks in all spans up to 0.040 inch

Span 2 Unsealed transverse and longitudinal cracks in all spans up to 0.040 inch

Date Reported: 09/20/2011
Priority: C - Important
Type of Work: Repair
Status: Monitor
Component: 12 - Reinforced Concrete Deck

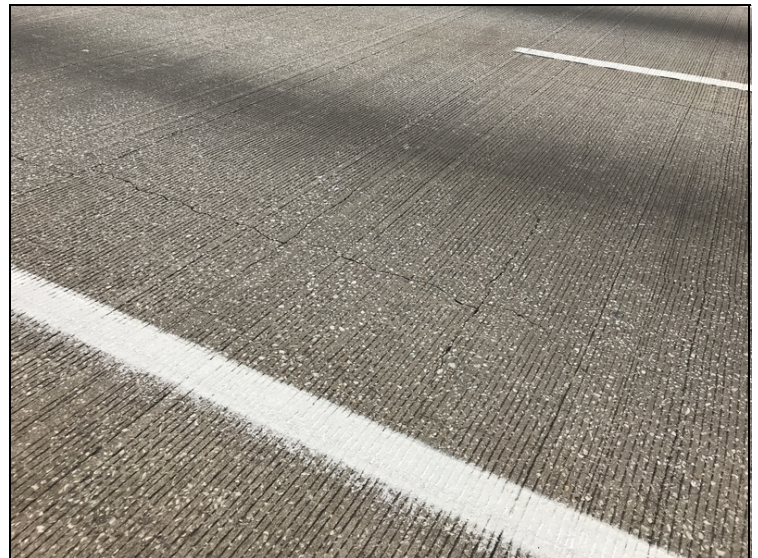
Span 5 Unsealed transverse and longitudinal cracks in all spans up to 0.040 inch

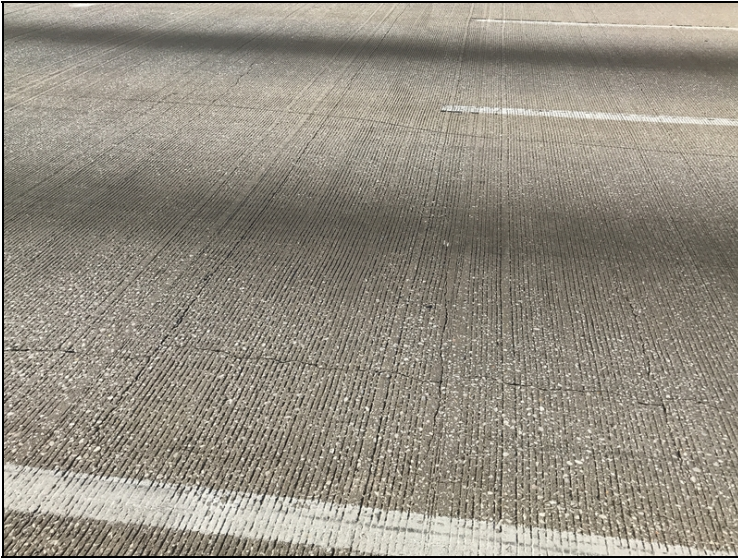
Span 5: unsealed transverse and longitudinal cracking up to 0.040" in width.

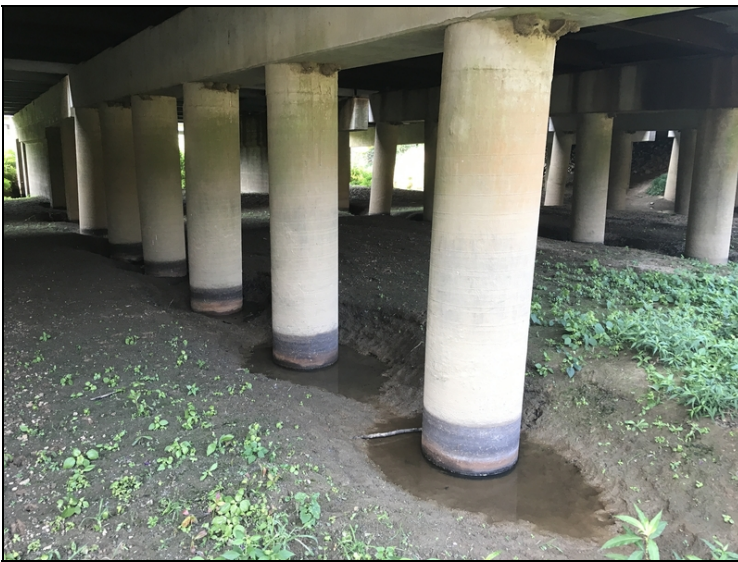
Bent 5: local scour at all columns on this bent. Common to bents 2,3,4, and 6.

Bent 5: local scour at all columns on this bent.
Common to bents 2,3,4, and 6.

Date Reported: 08/16/2021
Priority: C - Important
Type of Work: Repair
Status: Open
Component: 225 - Steel Pile
