**Bridge #01467 (Routine)**  
**US 70 Log 6.89 over WHITE OAK DITCH**  
**Location: 2.00 MI W OF CARLISLE**

**Team Lead: Chris Doggett Inspection Date: September 11, 2019**

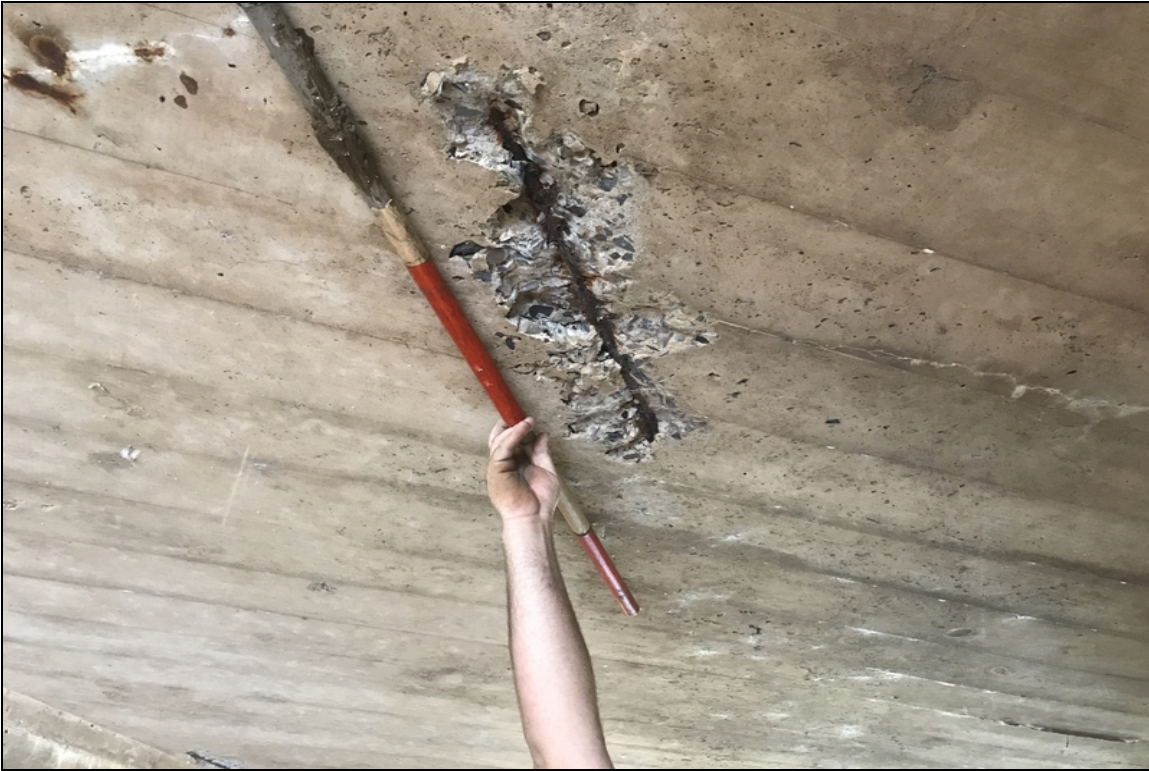
(38)							
Span 1 has a longitudinal crack near centerline. 0.015 inch avg. Span 3 has two longitudinal cracks with efflorescence, 0.020 inch avg and one spall with exposed rebar near centerline and a spall with efflorescence and exposed rebar on the right edge near bent 4. The right side of span 4 has cracking with efflorescence. See photo.							
110	Reinforced Concrete Open Girder/Beam	LF	170	169	1	0	0
1090	Exposed Rebar	LF	1	0	1	0	0

Span 3: soffit has a spall with exposed rebar

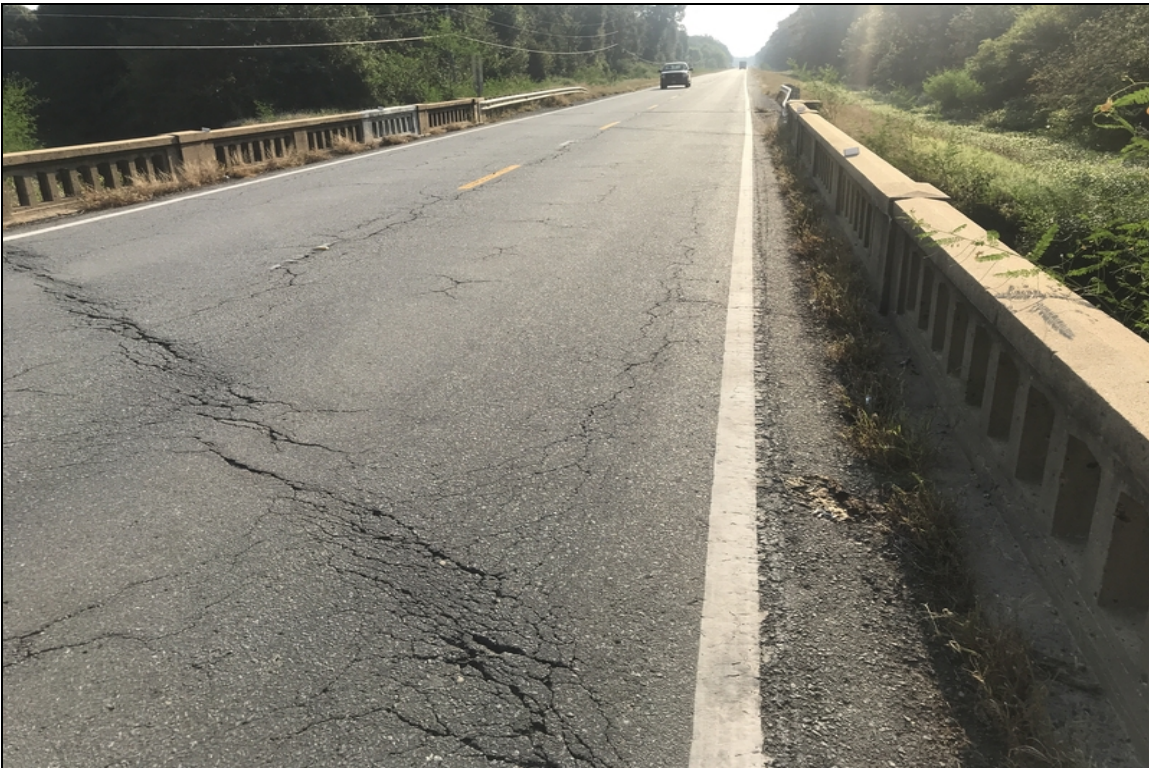
Deck view

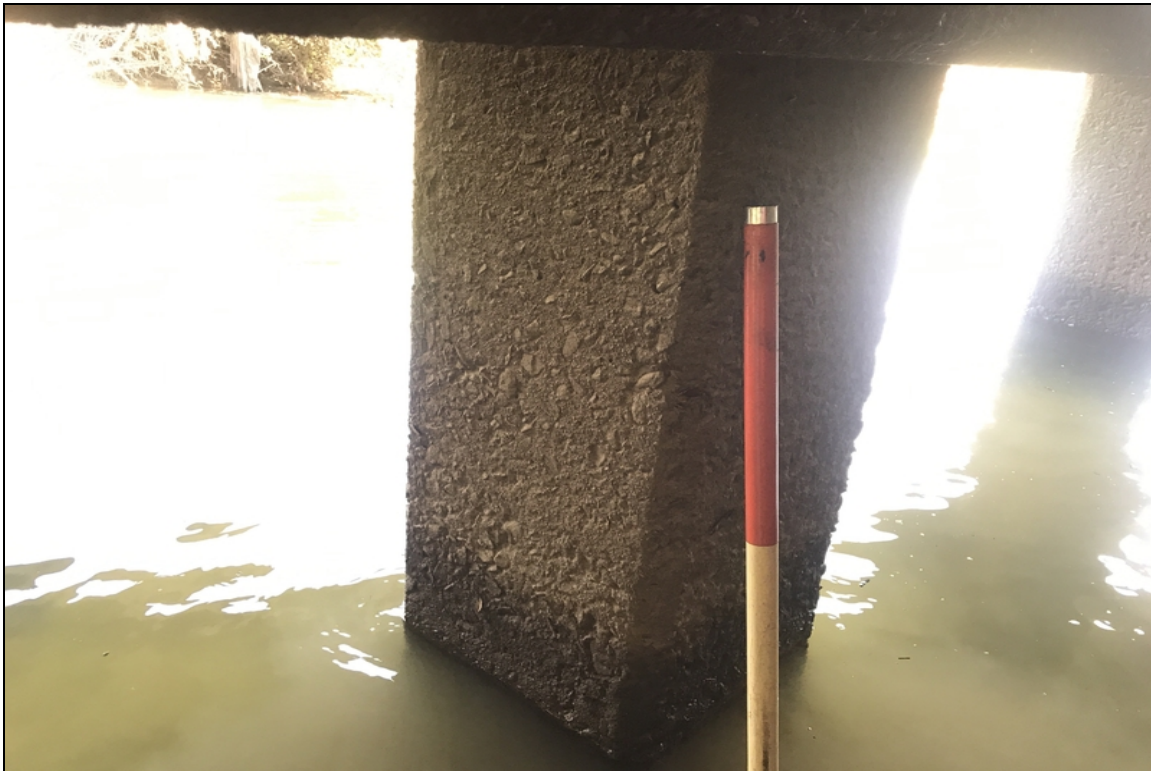
ELEM	DESCRIPTION	UNITS	TOTAL	CS1	CS2	CS3	CS4
Bent 1 pile 1 has severe abrasion at water line. See photo. All of the pile have abrasion with some lose of small aggregate.							
234	Reinforced Concrete Pier Cap	LF	62	59	0	3	0
1080	Delamination/Spall/Patched Area	LF	0	0	0	0	0
1090	Exposed Rebar	LF	3	0	0	3	0
(234)							
Bent 2, right end back face. Bent 3, back side near pile 2.							
331	Reinforced Concrete Bridge Railing	LF	131	131	0	0	0

Bent 3, pile 2: pile has heavy abrasion, all pile are in similar condition

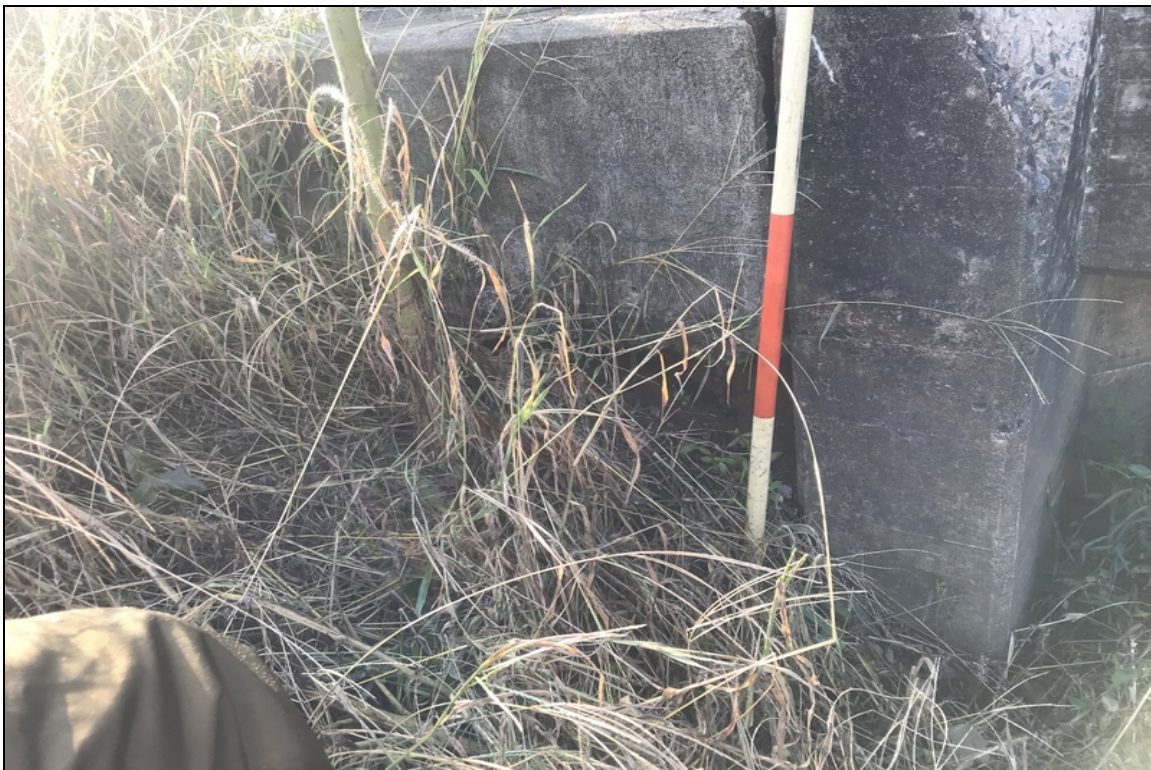
Bent 4: erosion action has undermined the left concrete rail end treatment.
