Bridge #01469(Routine)

US 70 Log 7.48 over BAYOU TWO

Location: 1.1 MI W OF CARLISLE

Team Lead: Chris Doggett Inspection Date: September 11, 2019

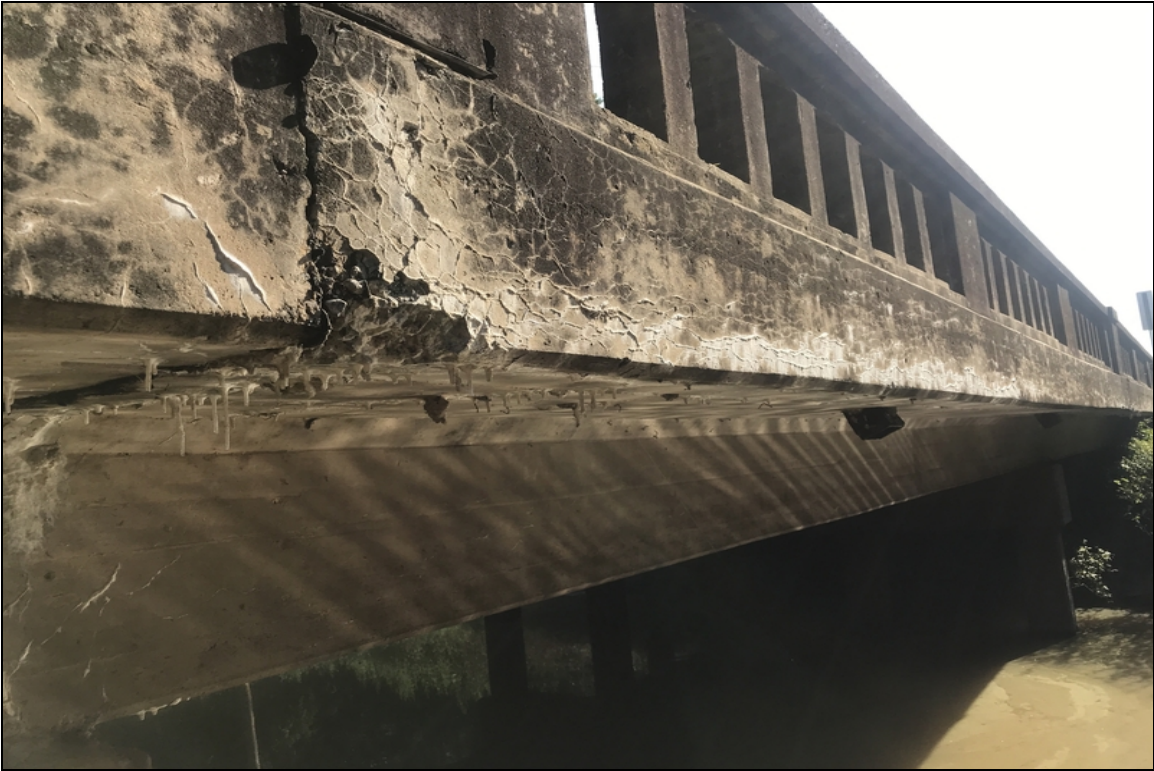
(16) All spans, both sides of the fascia have cracking with efflorescence, photo linked. Span 3, between all girders a large transverse crack with efflorescence. Span 3, between girders 1 & 2, 6' of spall with exposed rebar, other small Spalls with exposed rebar scattered. Also scattered small delams.							
110	Reinforced Concrete Open Girder/Beam	LF	515	396	113	6	0
1080	Delamination/Spall/Patched Area	LF	2	0	0	2	0
1090	Exposed Rebar	LF	3	0	1	2	0
1120	Efflorescence/Rust Staining	LF	14	0	12	2	0
1130	Cracking (RC and Other)	LF	100	0	100	0	0

Span 2, Right side facia: numerous cracks with efflorescence staining

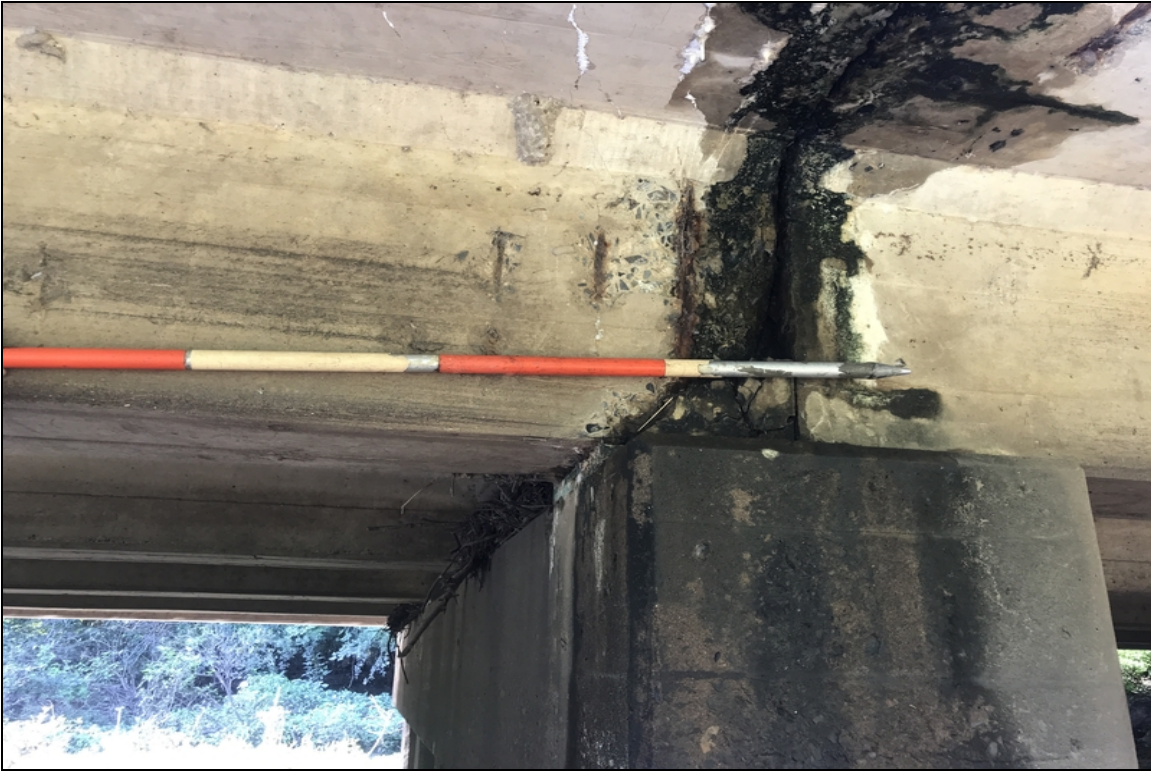
(110) Span 1 girder 1 spall with exposed rebar on right side. Span 2, girder 1 has spall with exposed rebar on the left side & a delam on the right side at bent 2, photo linked. Span 2 girder 5 has cracking with efflorescence on the end at bent 2, photo linked. Hairline cracks scattered on the sides of all girders. Span 3, girder 5 has a 25' hairline crack at the top of the left haunch.							
215	Reinforced Concrete Abutment	LF	70	70	0	0	0
227	Reinforced Concrete Pile	EA	10	0	10	0	0
1190	Abrasion/Wear (PSC/RC)	EA	10	0	10	0	0

Span 2, bent 2, girder 1: spall with exposed rebar that has lost section

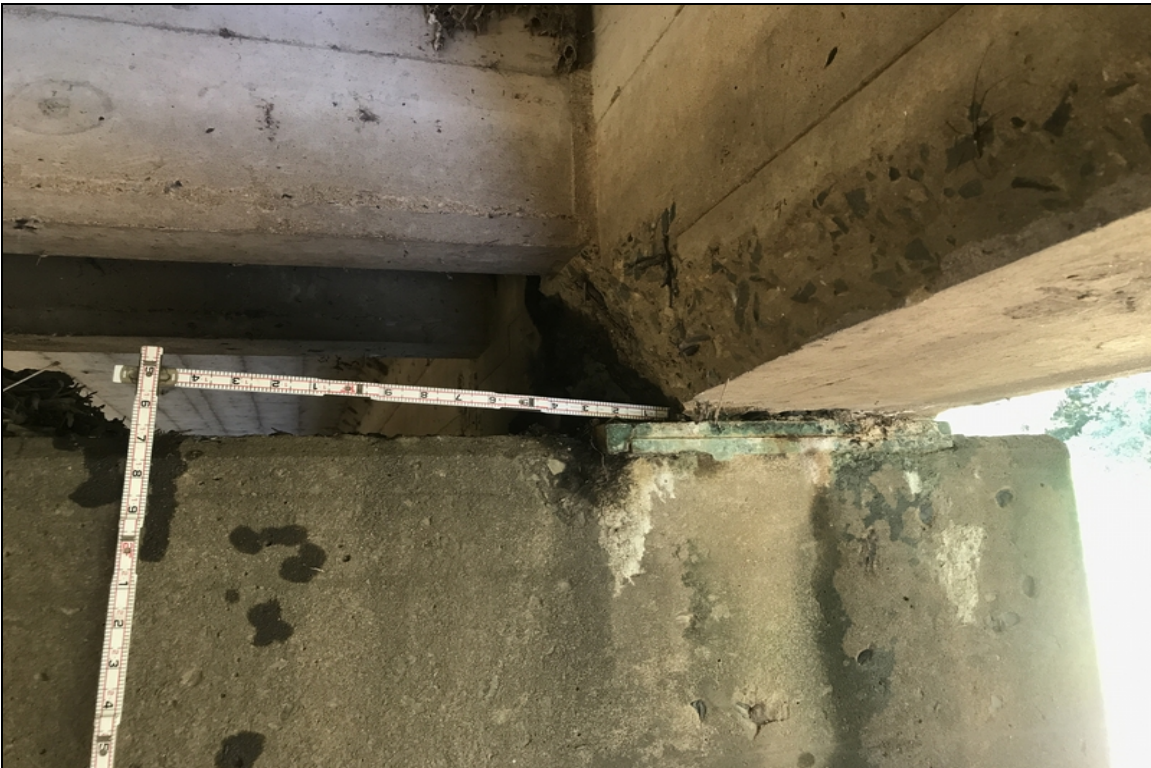
Span 2, bent 2, girder 1: opposite side with a large spall and exposed rebar and loss of bearing.  
There are 9" of bearing area remaining.
