Bridge #06675(Routine)

US 70-District 6 over White River-Prairie Co.

Team Lead: Monty Frazier Inspection Date: January 14, 2020

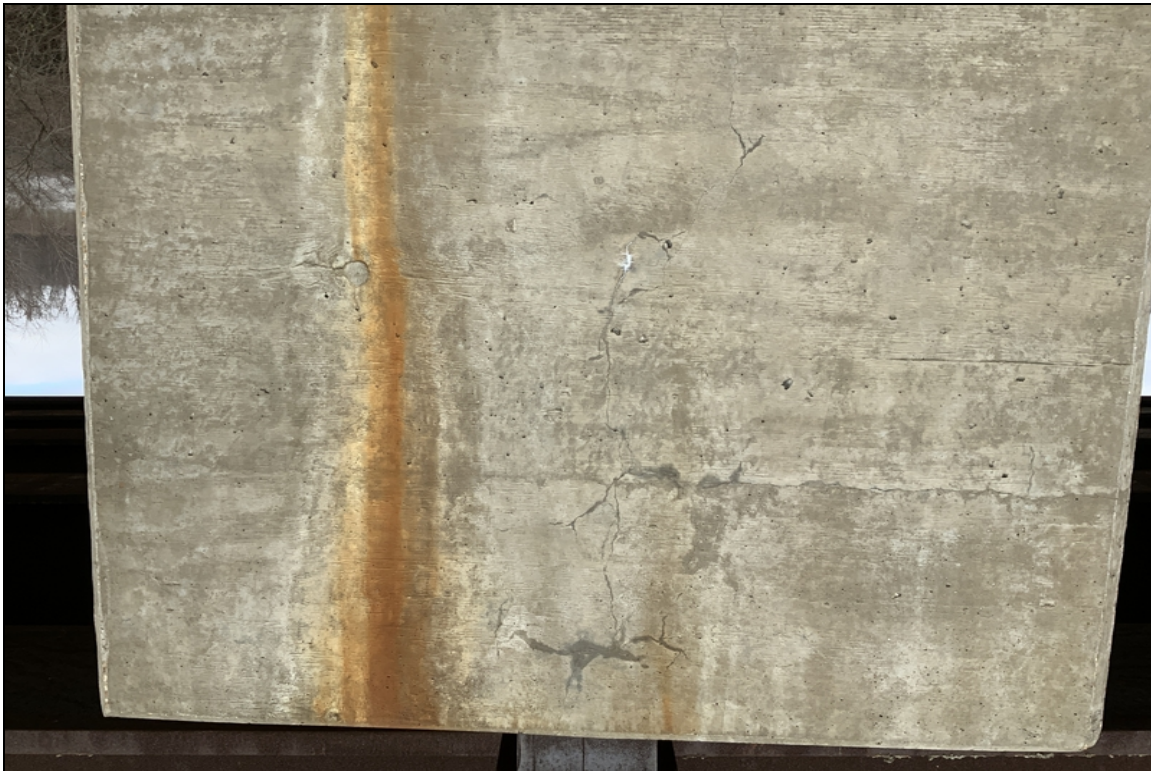
Bent 6 right end of cap map cracking.

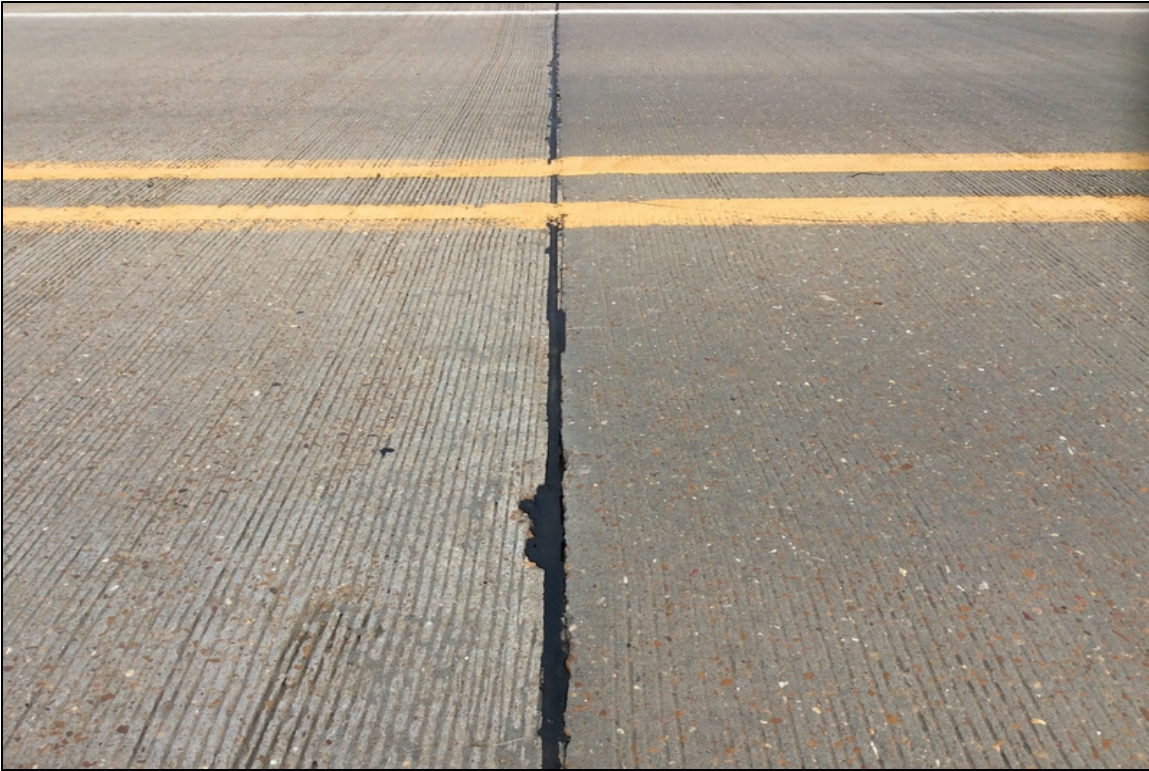
Various saw joints throughout the driving surface has deteriorated and is causing water to leak through and corrode the SIP forms

010-21-2020 - joint has failed water has started corrosion to SIP forms located at Span 10 at girders 3'4 ,5 and Span 16 between girders 3 and 4.

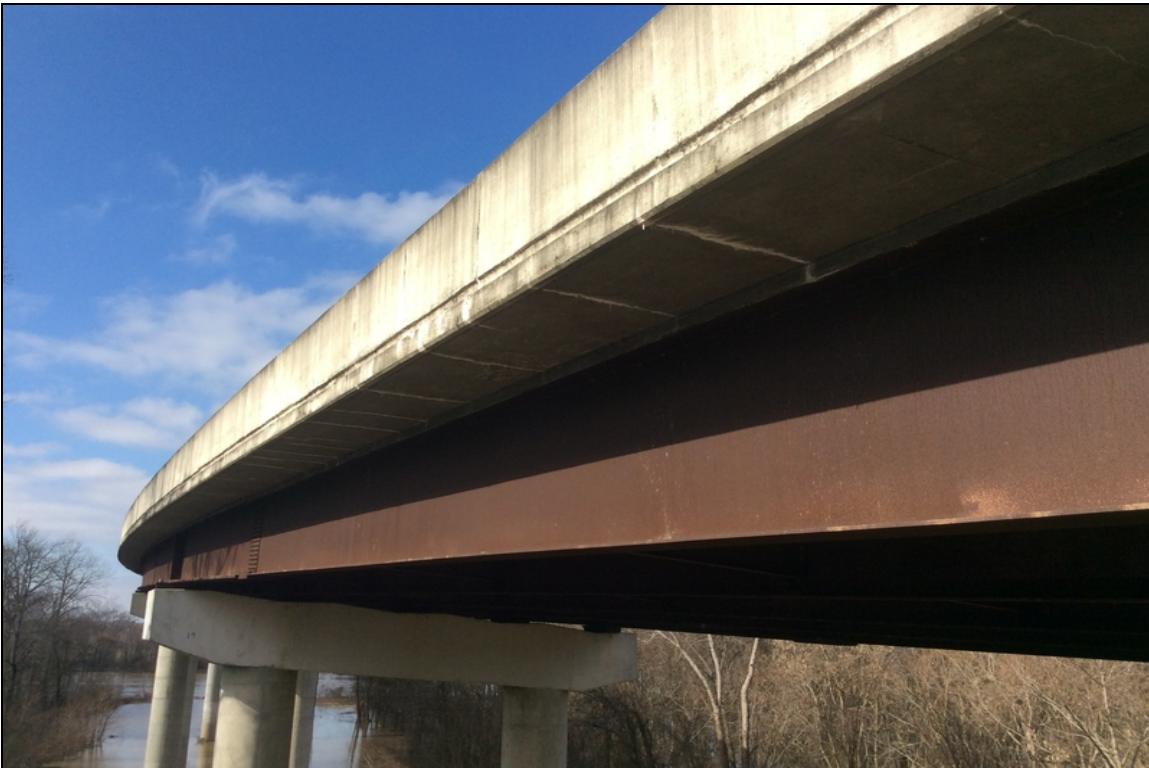
Typical transverse cracking with efflorescence along the overhang throughout the structure (visible from the under surface of the deck)

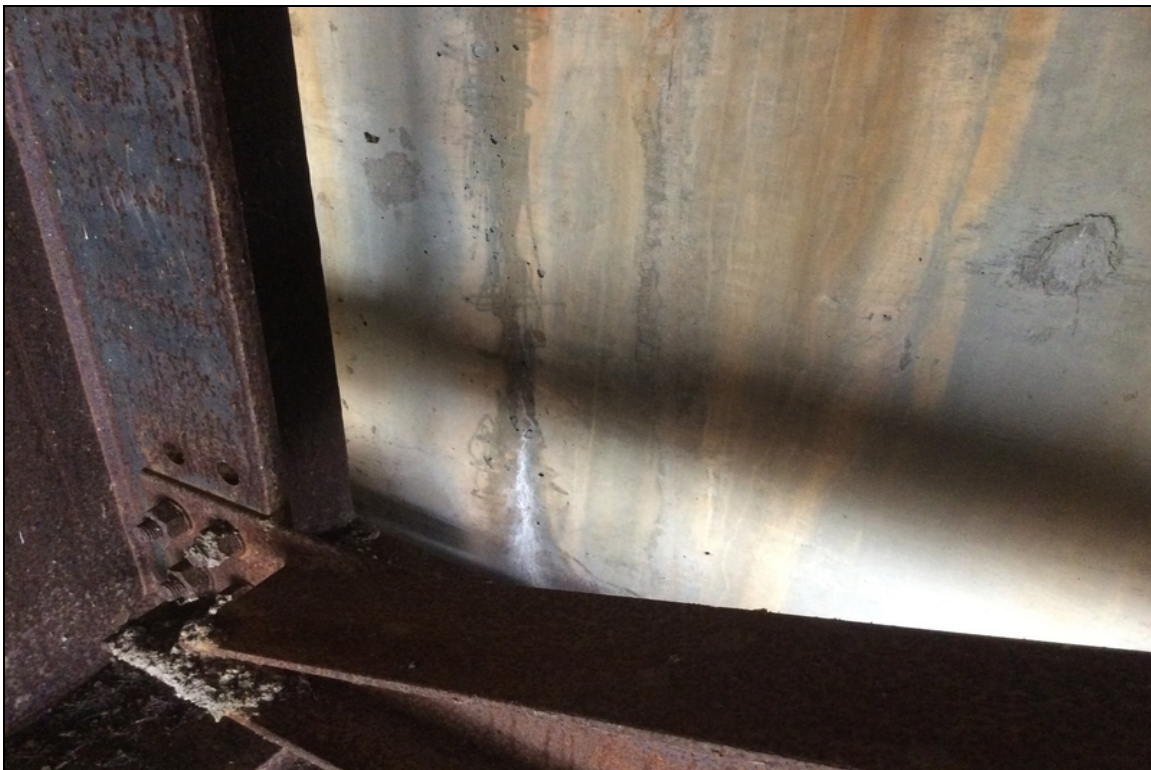
West Abutment has one vertical crack with efflorescence

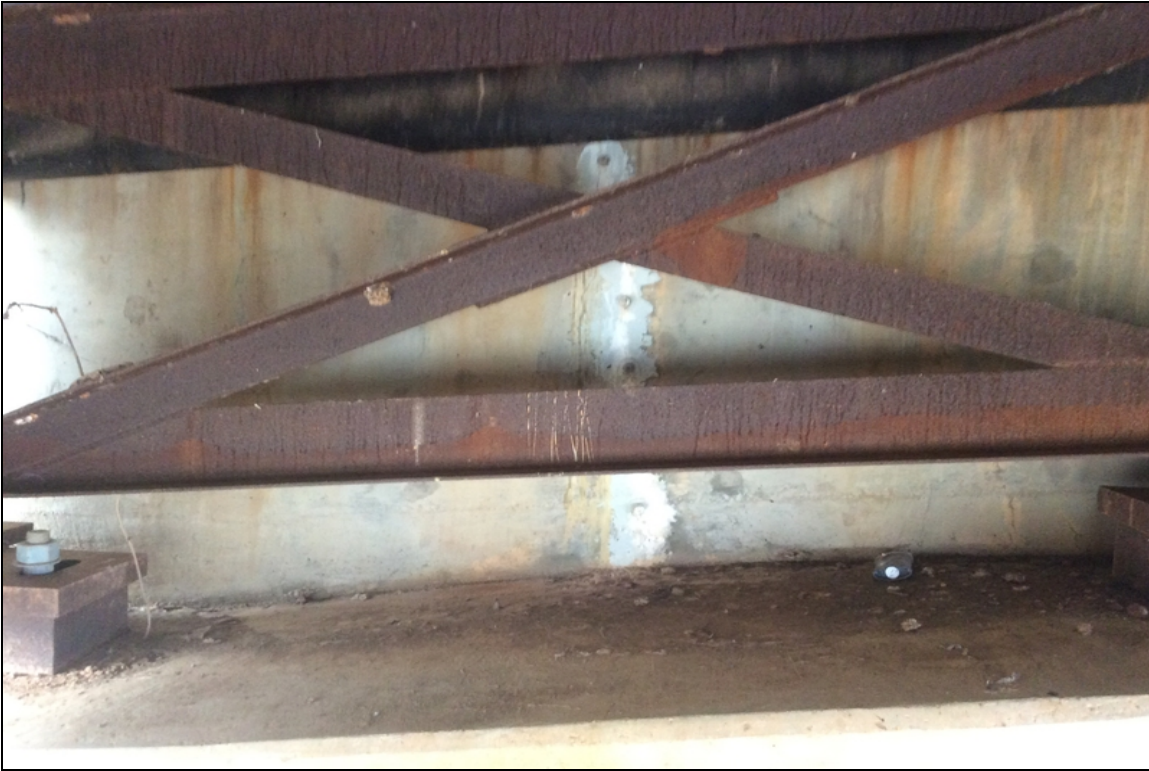
Bent 1 (West Abutment) has 3 epoxy crack in bays 2 thru 4 and are functioning as intended

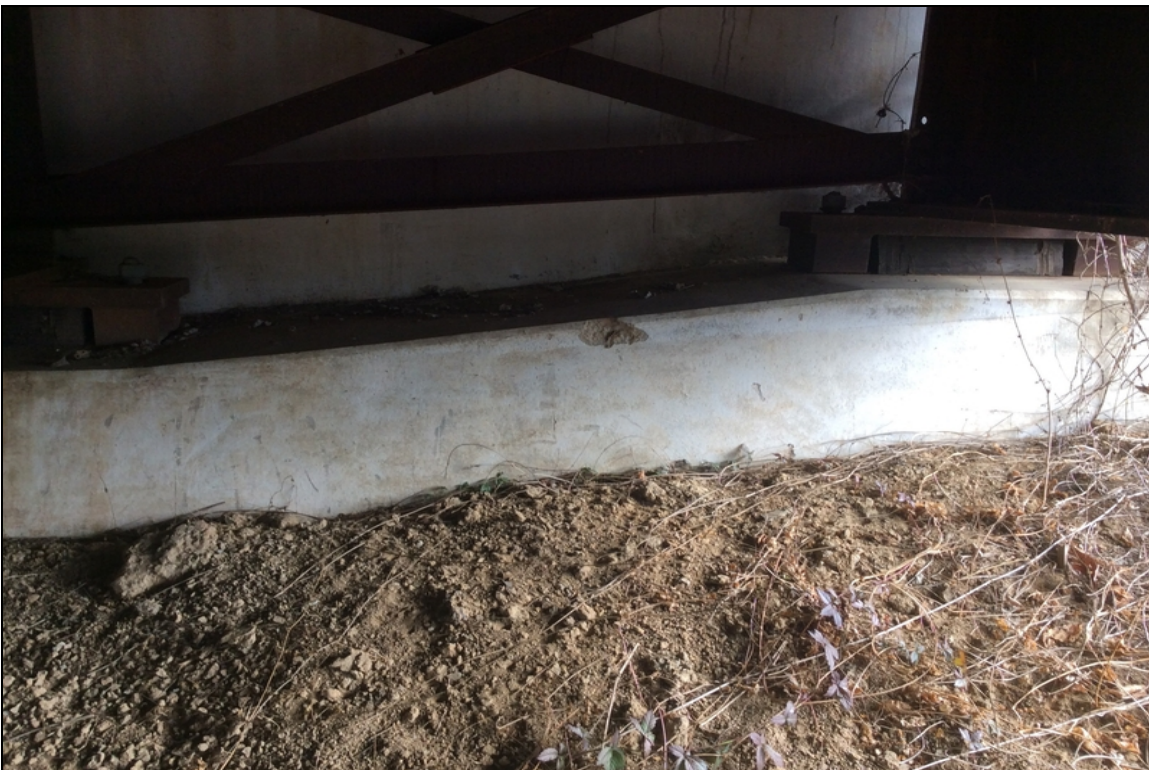
Bent 24 (East Abutment) has one shallow spill along the bridge seat between bay 4

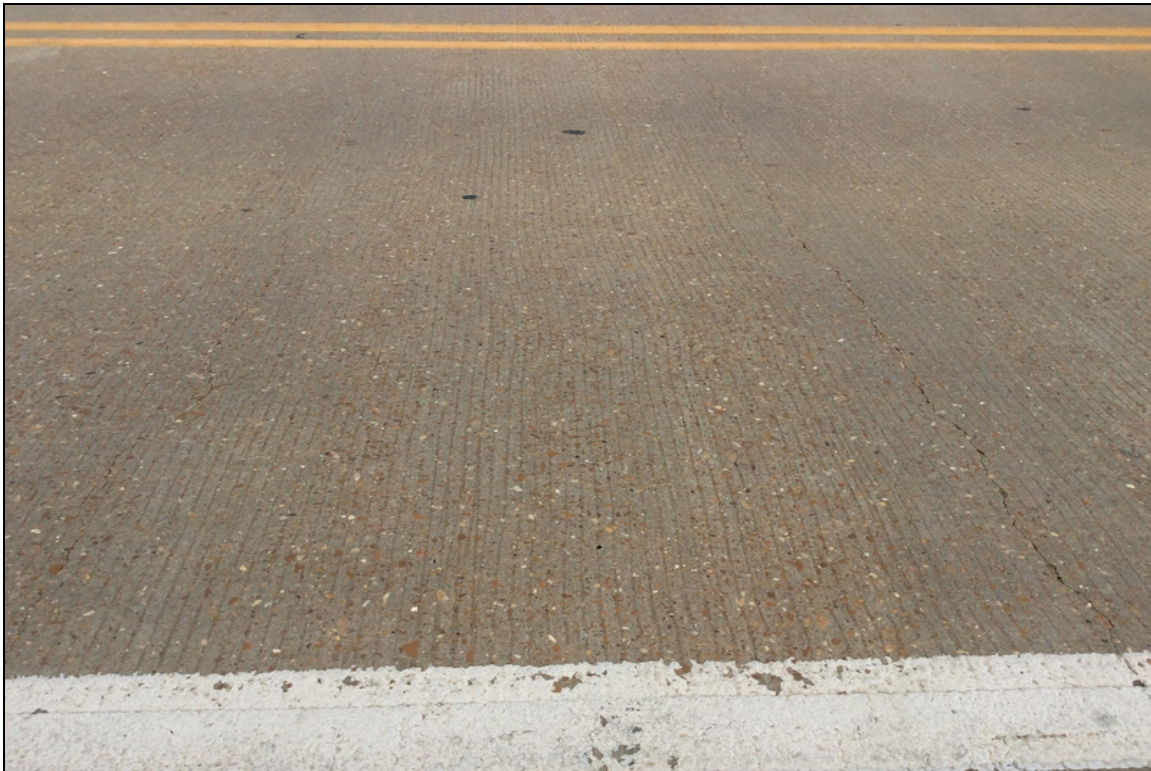
Typical transverse cracking at various spacing throughout the driving surface

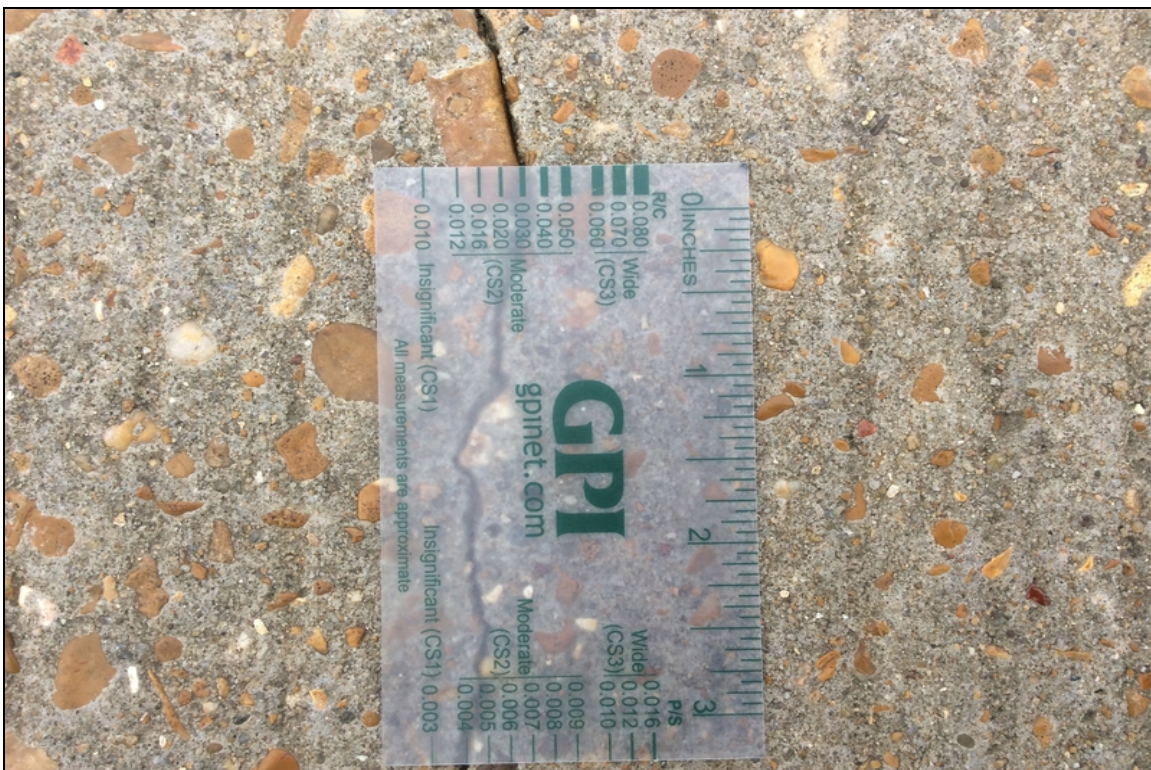
Typical crack width throughout the driving surface

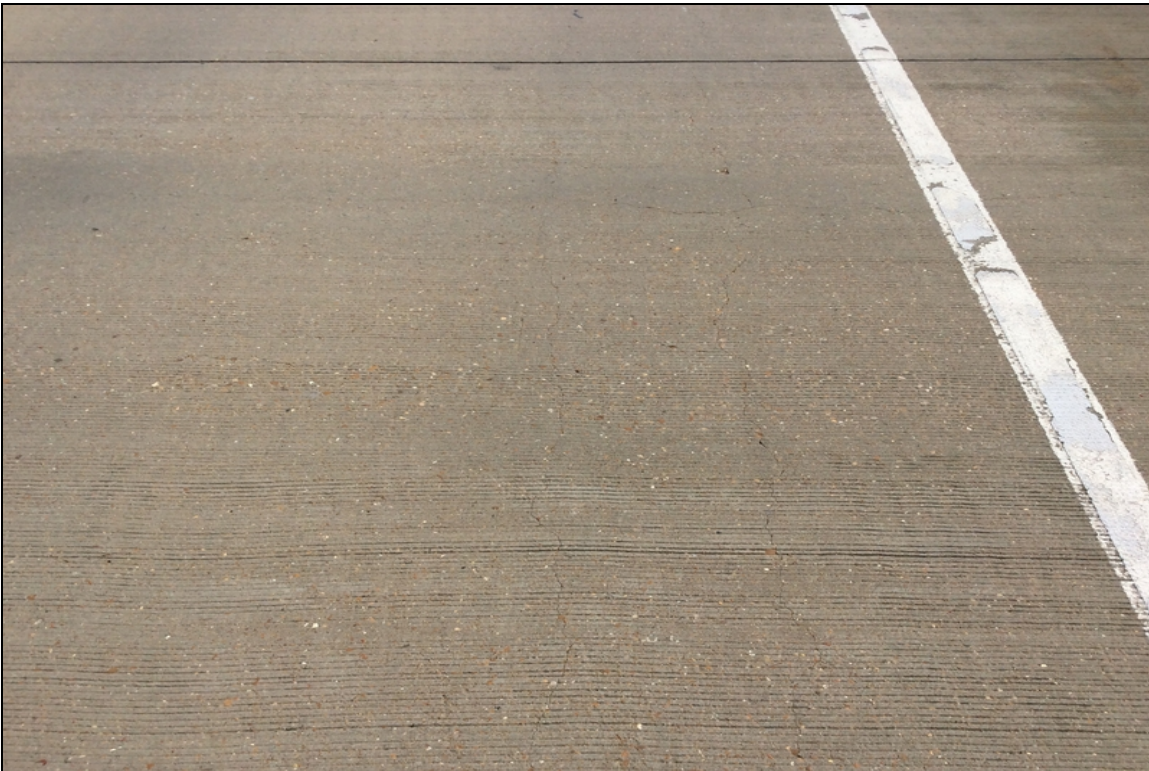
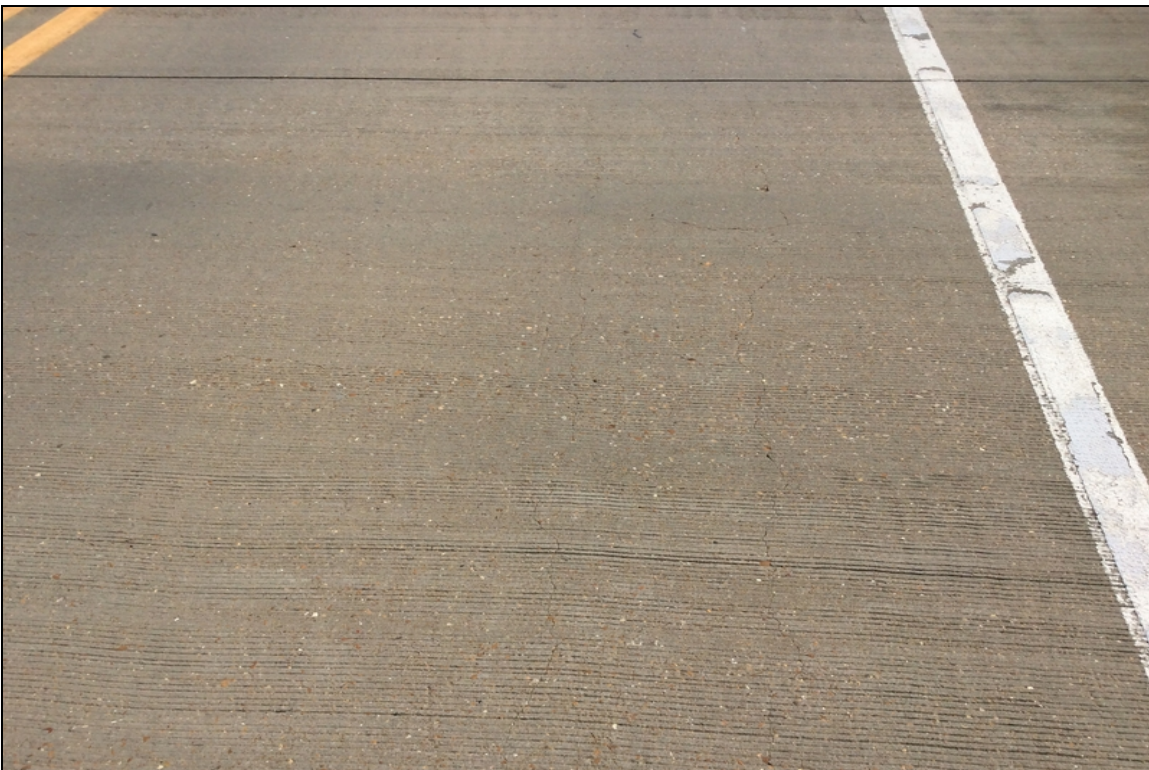
Typical map cracking in random locations throughout the driving surface

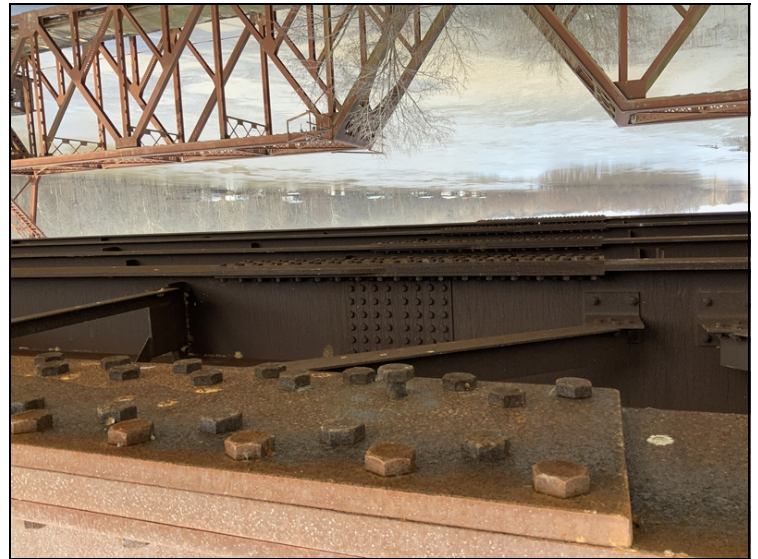
Span 12 Girder 2 Loose bolt at first splice plate connection.
Span 12 Girder 5 Loose bolt at second splice plate connection.
Span 13 Girder 2 Loose bolt at lateral bracing between the third and fourth splice plate.
Span 14 Girder 4 Loose bolt at second splice plate connection.
Span 16 Girder 2 Loose bolt at first splice plate connection.

Span 12 first splice plate ahead bent 12 girder 5
loose bolt.

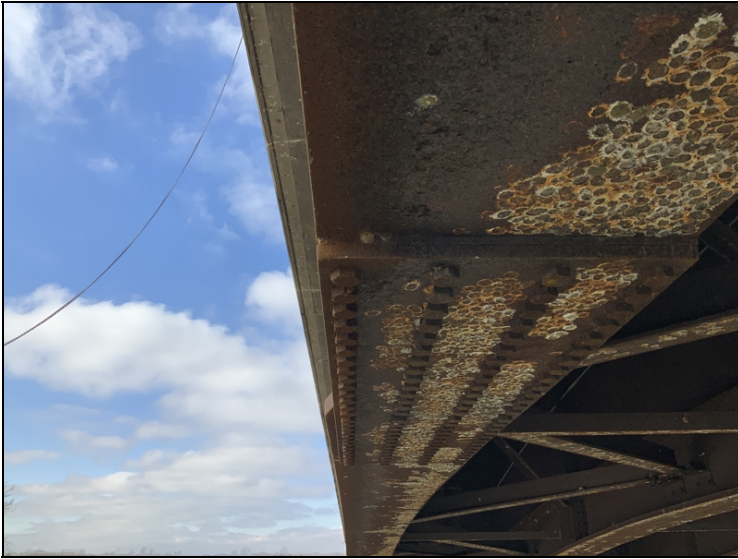
01-21-2020 - Maintenance items still exist. Added New Exterior girders have active corrosion with flaking rust located in bottom flange.this is typical with main river channel girders.

Span 13 girders 1 and 5 active corrosion with flaking rust to bottom flange typical throughout main spans.

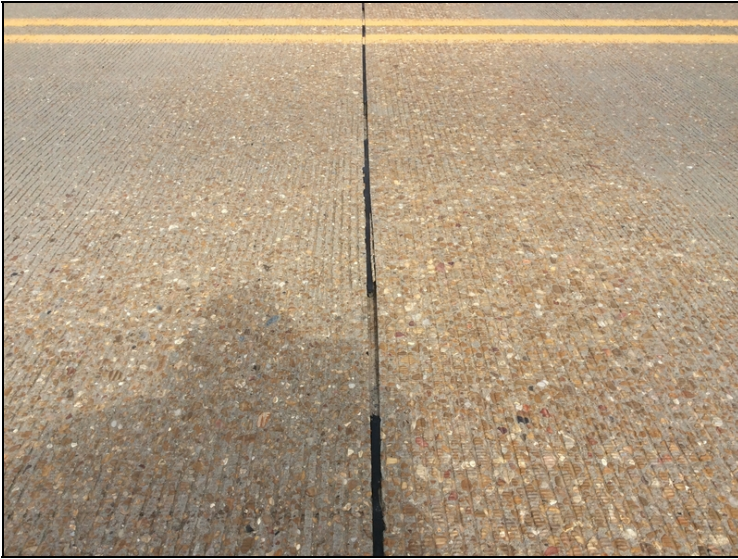
Large areas of missing and leaking joint seals at the following locations.

Typical missing and deteriorated saw joints in various locations throughout the structure.

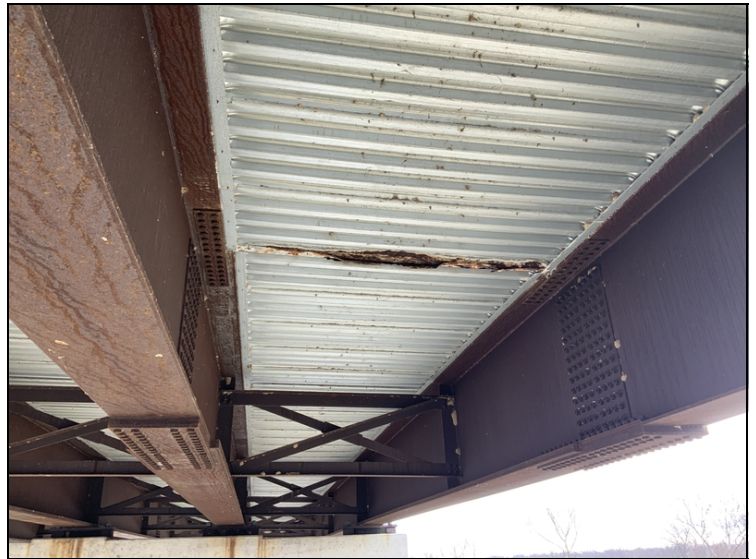
Span 10 at girders 3'4 and 5 active corrosion to sip forms.

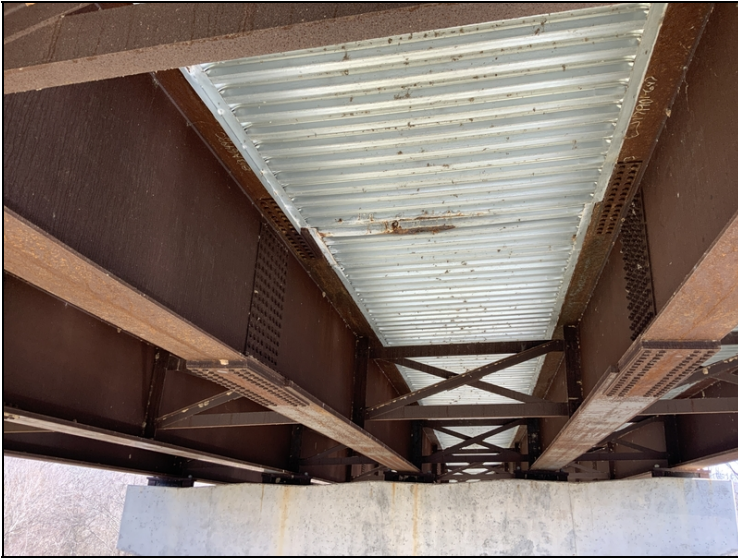
Span 16 between girders 3 and 4 active corrosion to sip forms.

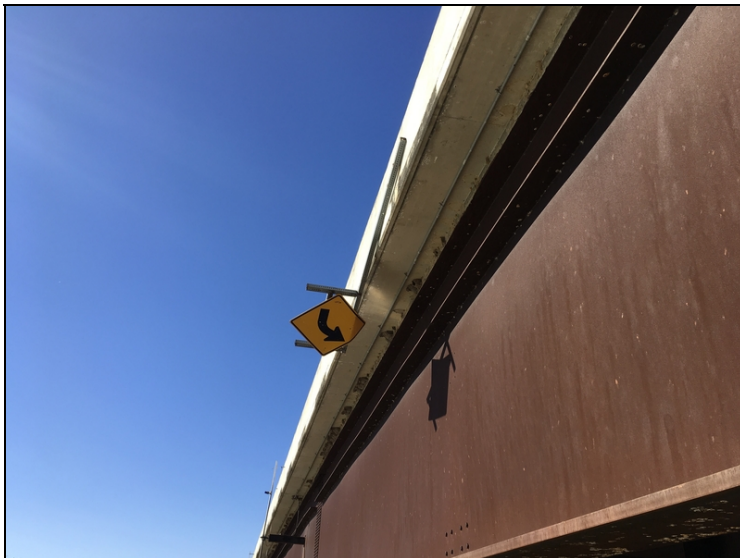
* Span 13 Right has broke sign post brackets with the sign hanging over the side not visible to the traveling public.

Span 13 right side sign damage.

Notified District 6 DME Jonathan Mormon of needs and assigned to him. Also noted to check navigation lighting in back ground of photo which appears to be rotated out of position 7/12/2018 CSL

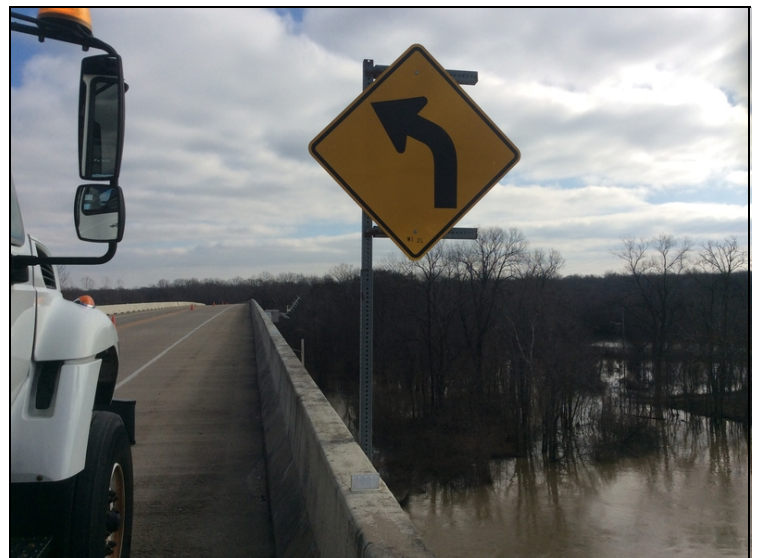
Warning sign has been repaired since the last inspection

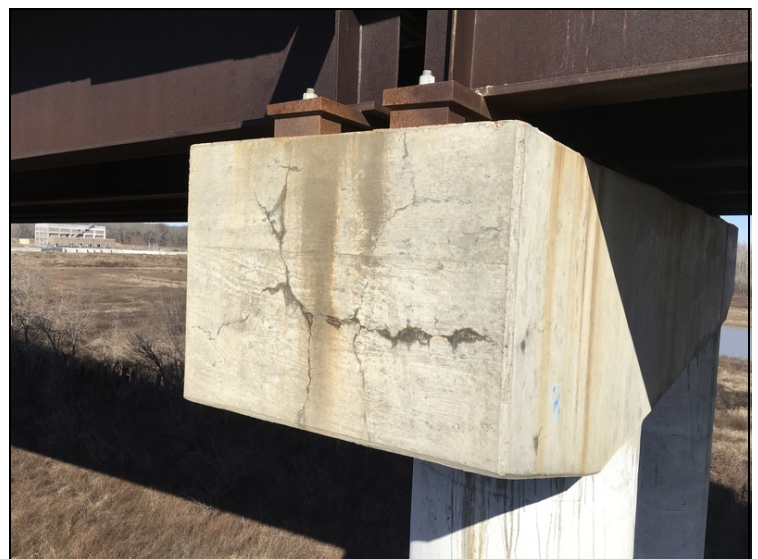
Bent 7 rt. End of cap: small vertical cracking in the ends of the caps

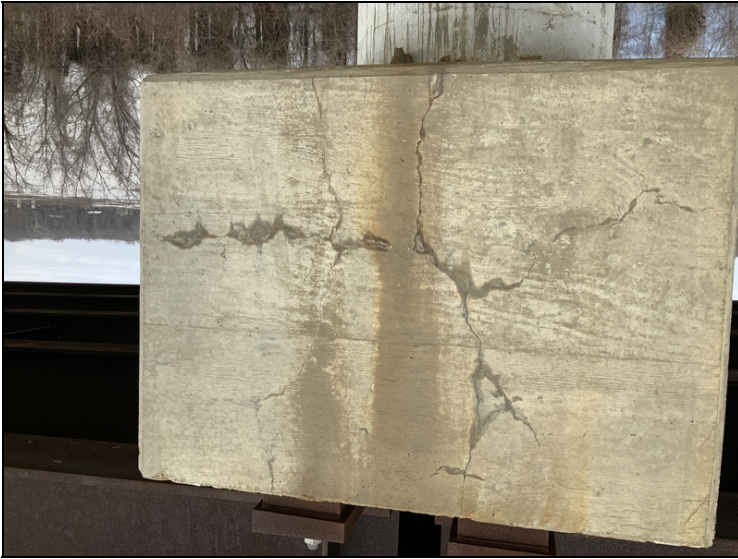
Bent 8 right end of cap epoxy repair that has failed.

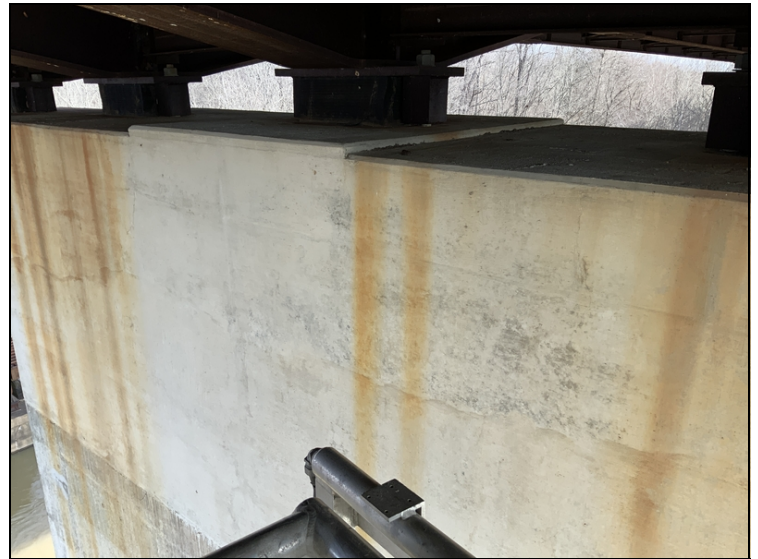
Bent 14 vertical cracking in face of cap typical with all caps.

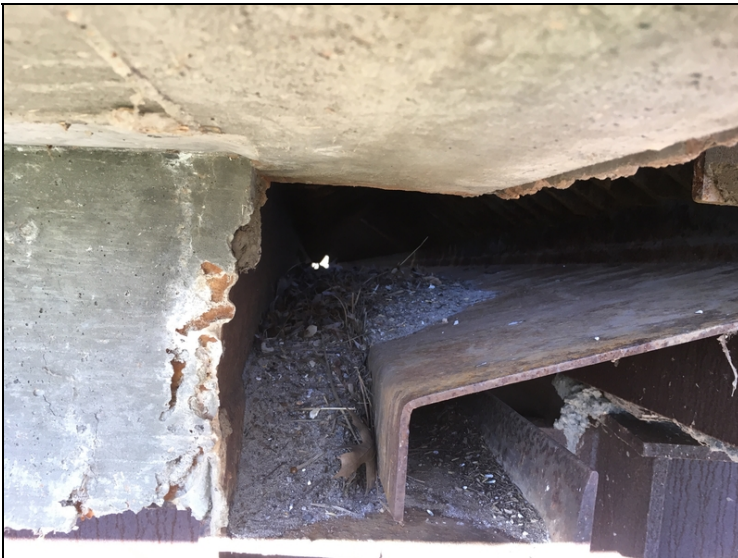
Bt. 4, Bt. 8, Bt.12, Bt.15, Bt. 18& Bt. 21: Debris in metal trough at expansion joint at the gutter line.

Bent 18 joint partially full.

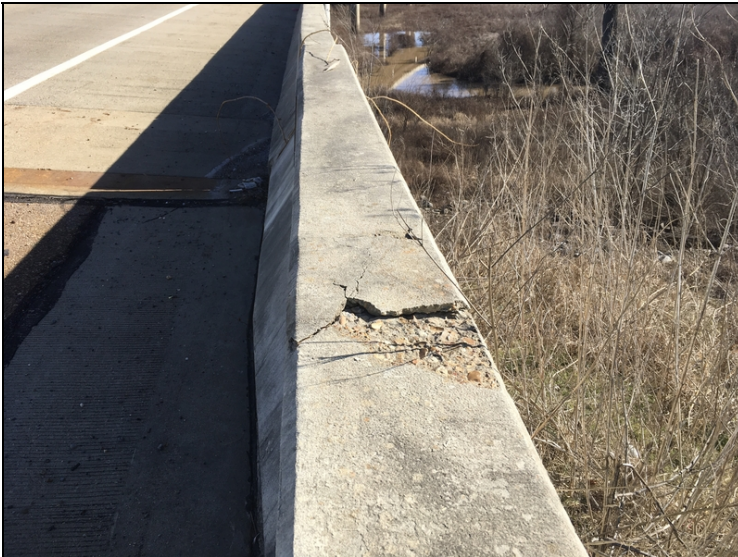
Abutment 1, Rt: Shallow spall on top of bridge rail.
Bent 17, Lt: Vertical open crack in bridge rail.

Bent 1 small spall on top of approach bridge rail.

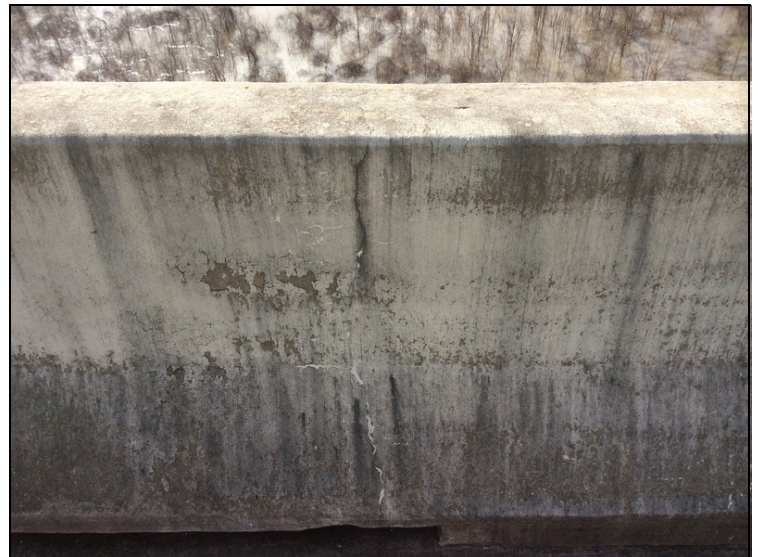
Typical vertical cracking in various locations throughout the structure

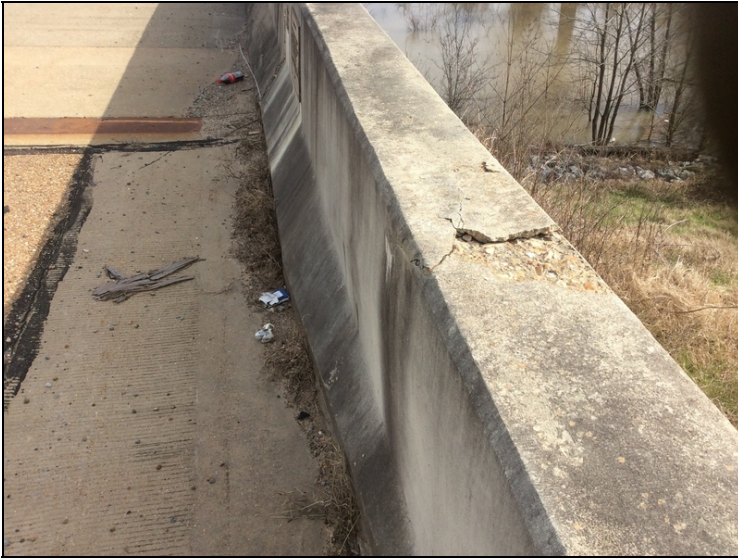
Approach railing at Bent 1 (RT) has one spall on top of the bridge railing

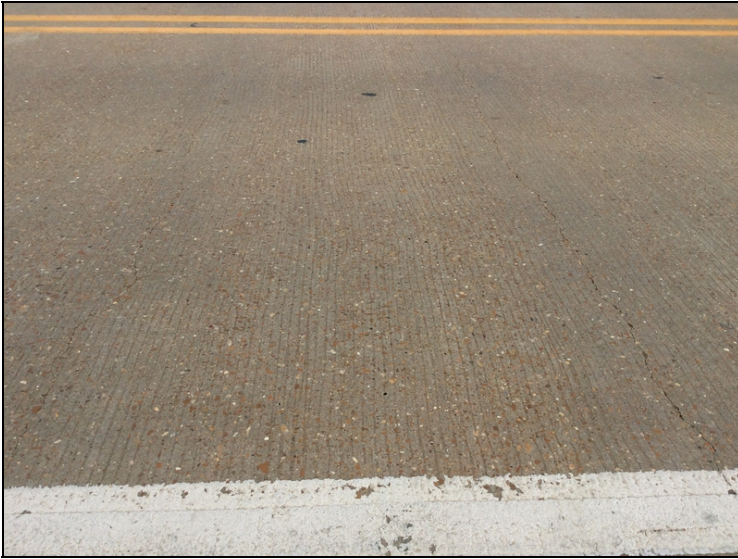
Typical transverse cracking at various spacing throughout the driving surface.

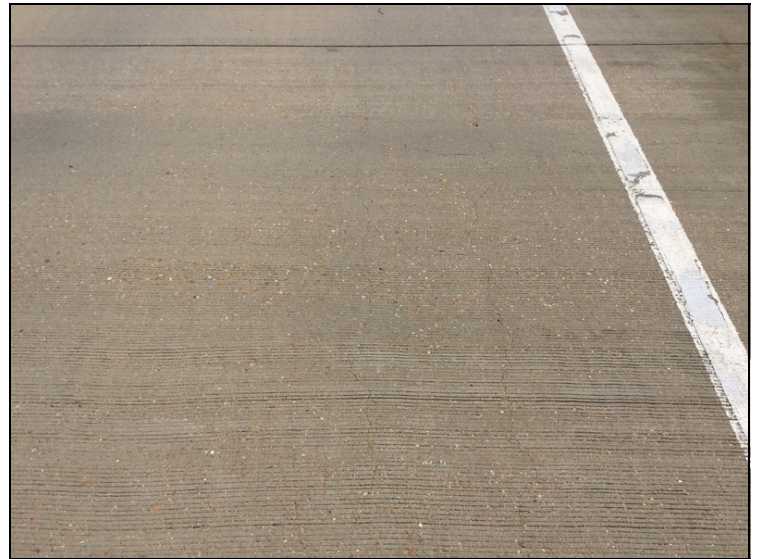
Typical map cracking in spans 12 thru 13

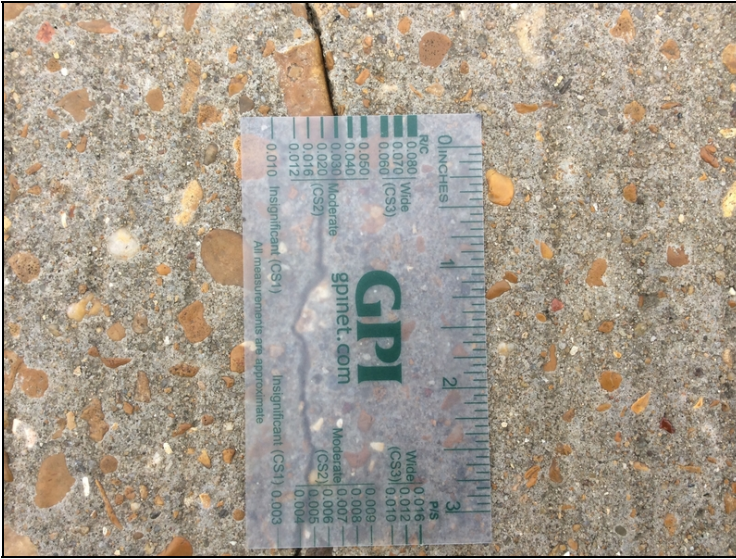
Typical size of cracking measures at approximately 0.030 inches at this inspection.
