Asset #05504(Routine)

I-30 WB FRONTAGE over I-430 LOG 0.22

Location: 2.8 MI SW JCT SH 338

Team Lead: Bryan Saunders, Inspection Date: 07/26/2021

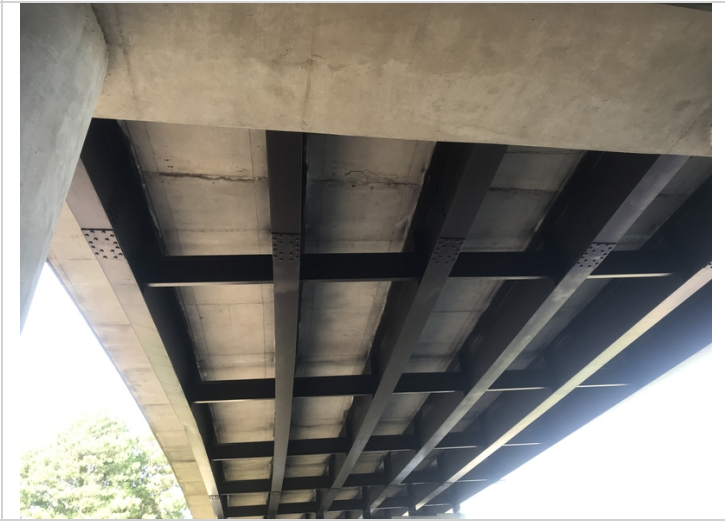
Delamination right of beam 4, second splice plate in span 3

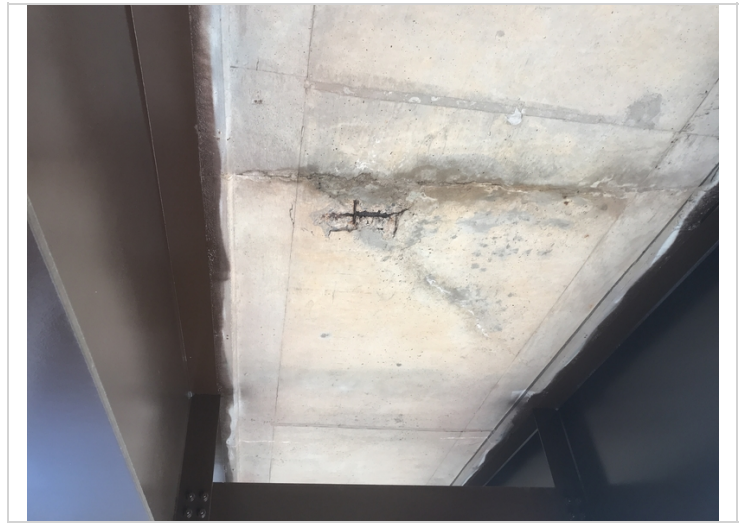
(12) Deck. All spans have small spalls and spalls filled with asphalt Some deck cracks have been sealed by state forces The soffit at mid span of spans 1 & 4 have small spall with rebar.							
107	Steel Open Girder/Beam	LF	1602	1600	0	2	0
7000	Damage	LF	2	0	0	2	0
515	Steel Protective Coating	SF	16020	16020	0	0	0

Spalls with rebar in the soffit

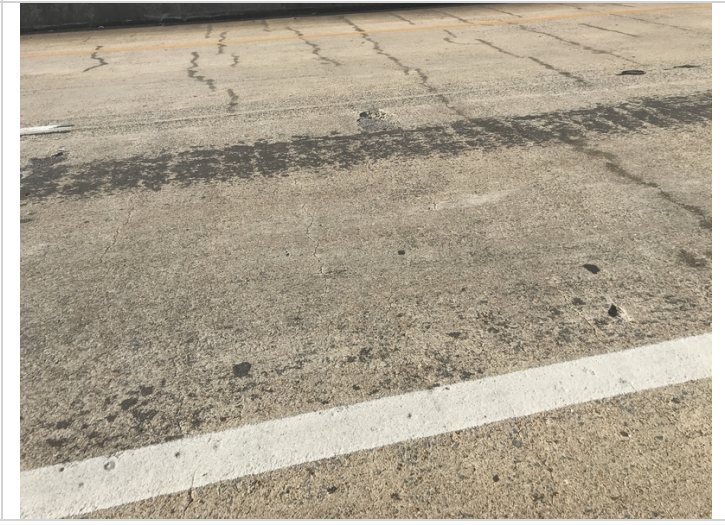
Cracks in span 2

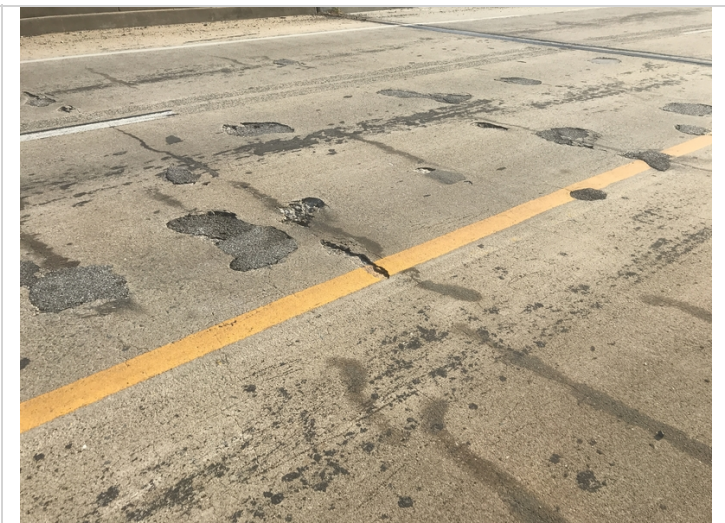
Spalls and spalls filled with asphalt

Deck All spans have spalls, spalls with rebar and spalls filled with asphalt

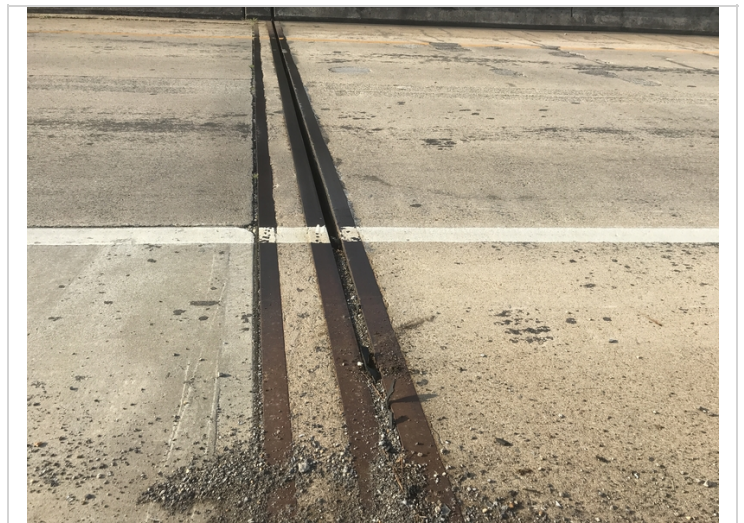
(302) The joint seal at bents 1 & 5 has fallen out..							
311	Movable Bearing	EA	24	24	0	0	0
(311) 2021 Bearings at bents 1&5 have active corrosion due to joint seal failure. See photo. Bearings have been repainted and are free of any active corrosion. 7/18/2017							
313	Fixed Bearing	EA	6	6	0	0	0
321	Reinforced Concrete Approach Slab	SF	3200	2853	347	0	0
1130	Cracking (RC and Other)	SF	347	0	347	0	0
330	Metal Bridge Railing	LF	540	540	0	0	0
331	Reinforced Concrete Bridge Railing	LF	540	540	0	0	0

Joint at bent 5

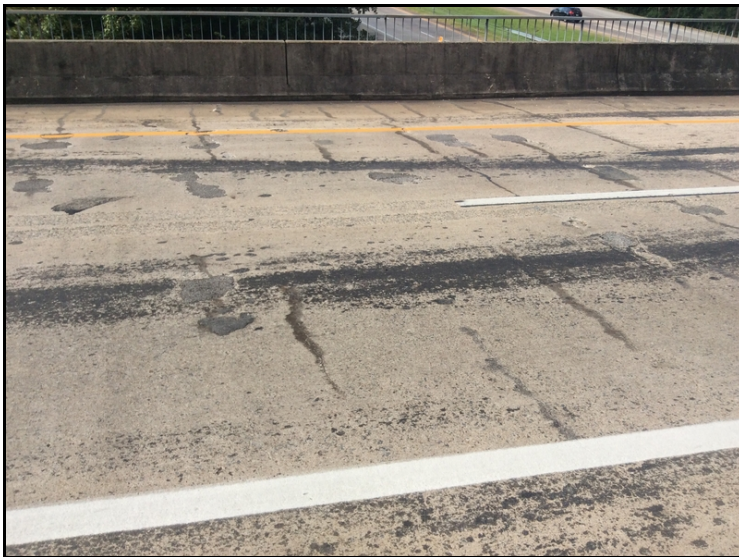
Span 4 spalls filled with asphalt

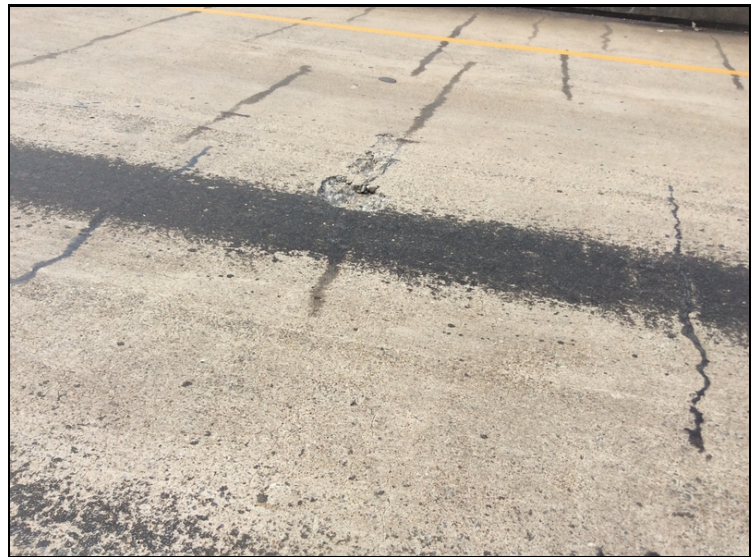
Span 2 spall with exposed rebar

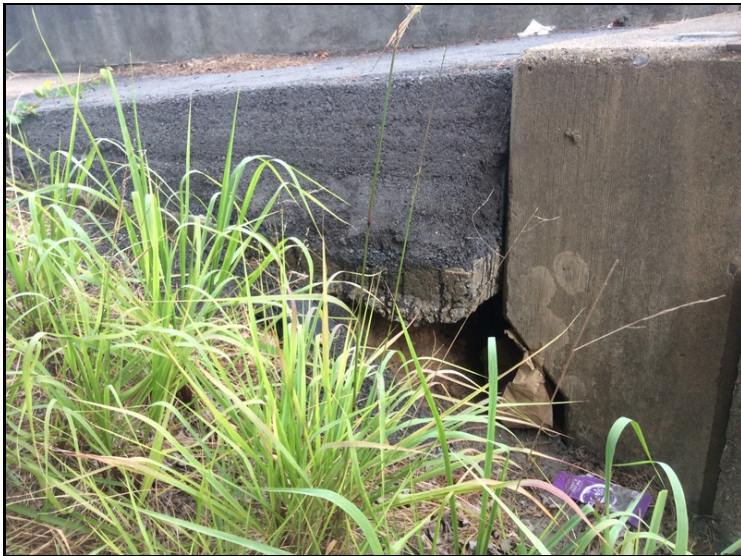
At bent 1 and at bent 5
Concrete bridge rail has settled due to void under footing.

Bent 1 void under approach rail and sidewalk

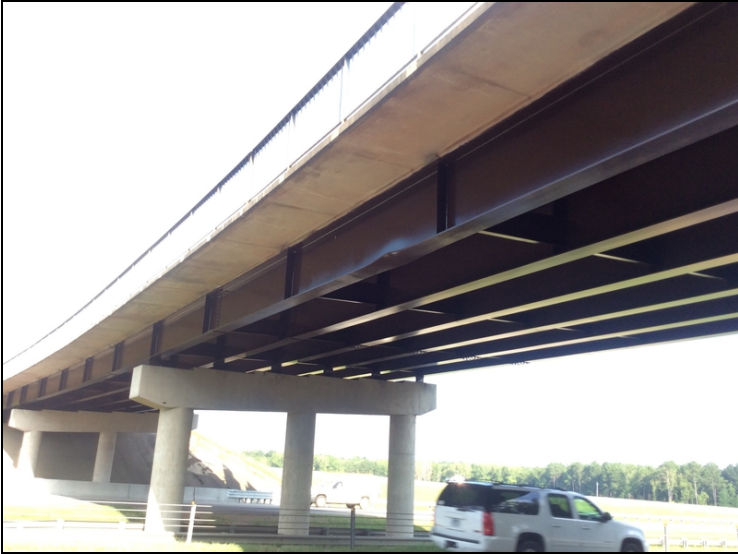
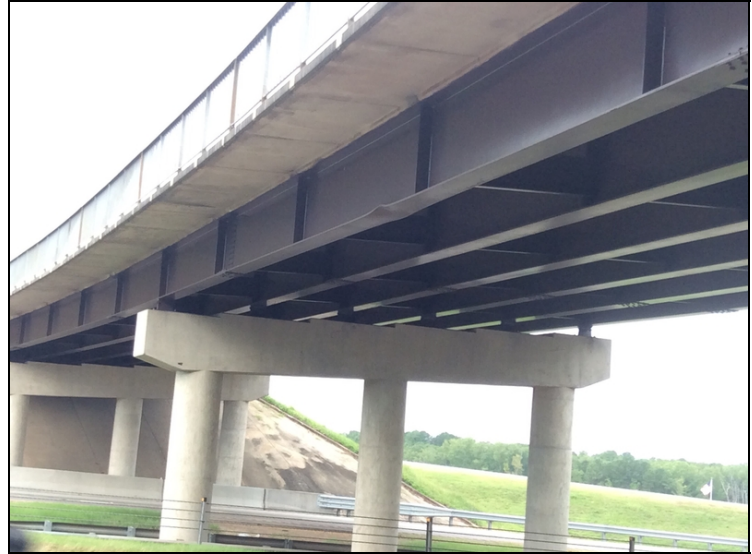
(107) Span 3 girder 6 has traffic impact to bottom flange. All steel superstructure has been repainted by contractor as per job #061505. (515-107) girders were painted in 2017							
205	Reinforced Concrete Column	EA	9	9	0	0	0
215	Reinforced Concrete Abutment	LF	93	80	13	0	0
1130	Cracking (RC and Other)	LF	13	0	13	0	0
234	Reinforced Concrete Pier Cap	LF	108	108	0	0	0
302	Compression Joint Seal	LF	82	0	0	0	82
2310	Leakage	LF	82	0	0	0	82

Span 3 girder 6 at mid span.
Girder has been hit by traffic .

Span 3 beam 6 traffic damage

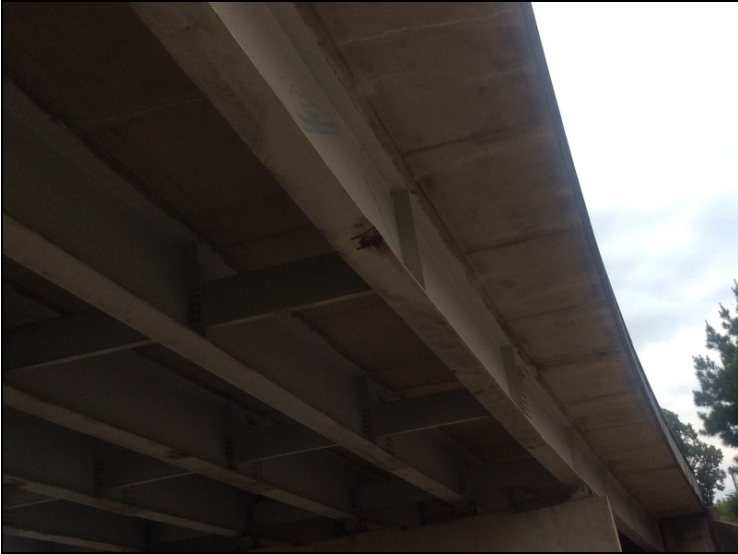
Span 3 girder 6 bottom flange is misaligned due to traffic impact.

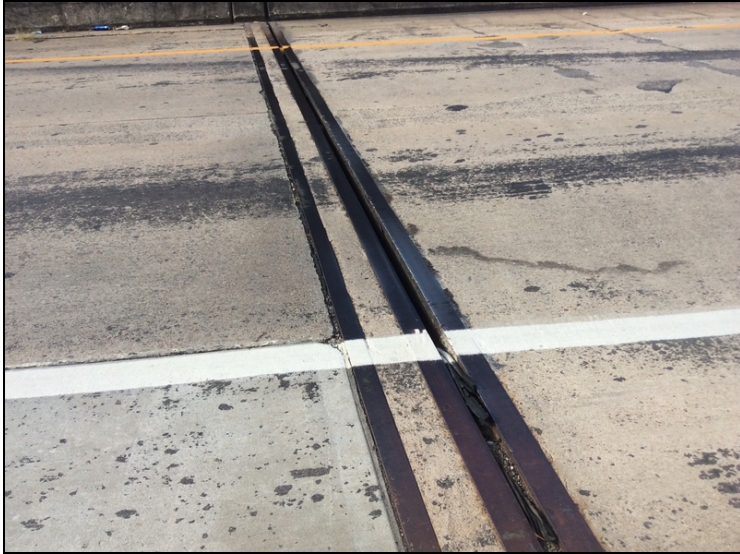
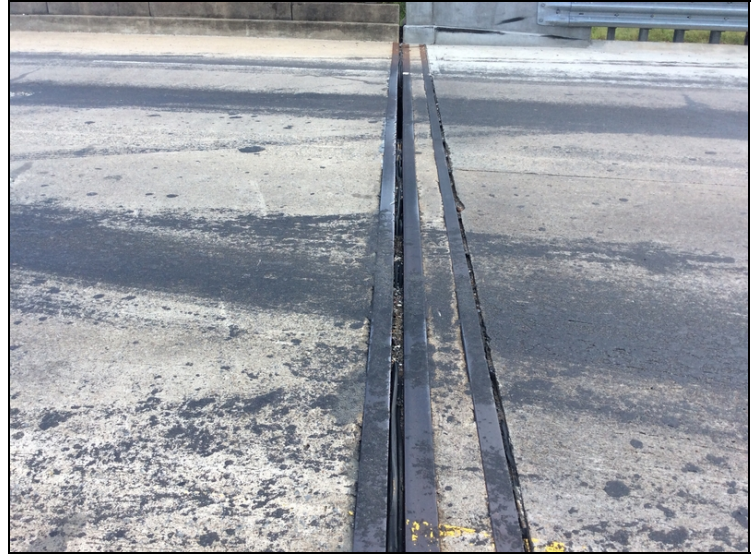
Joint seal at bent 1 & 5 are missing

Bent 5 joint seal missing

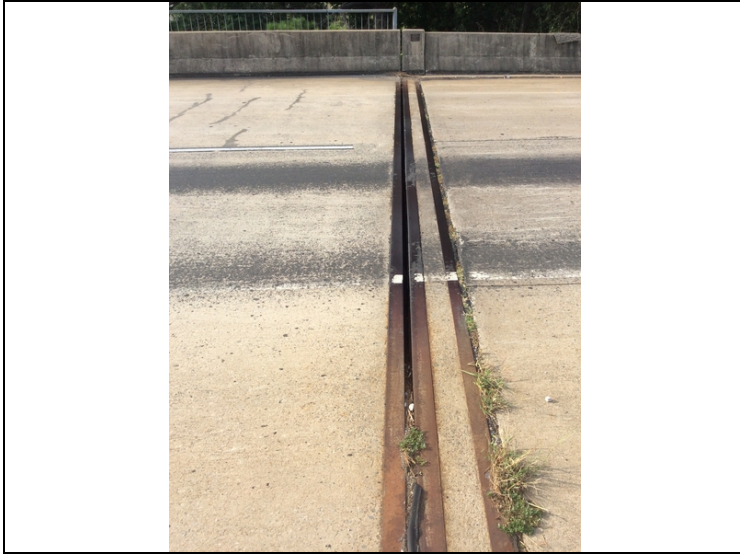
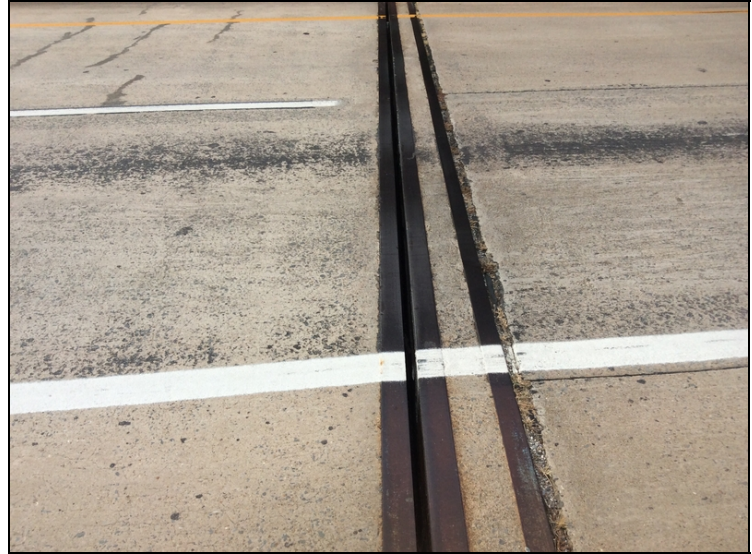
Bent 1 joint seal missing
