Asset #B2811 (Routine)

I-30 WB FR Road over HURRICANE CREEK

Location: 1.6 MI SW OF SH 183

Team Lead: Bryan Saunders, Inspection Date: 03/29/2022

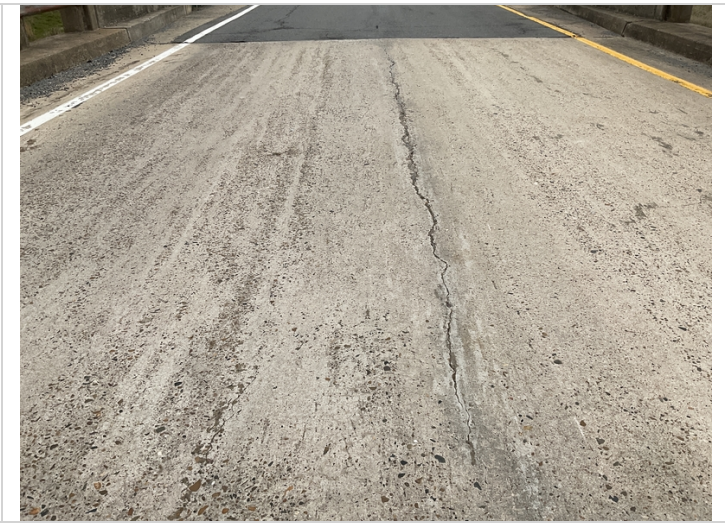
Deck cracks span 6

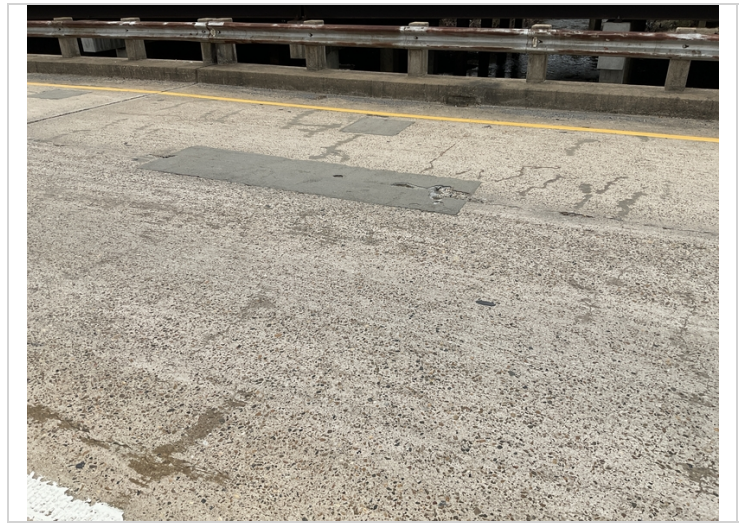
Spall in the deck span 3

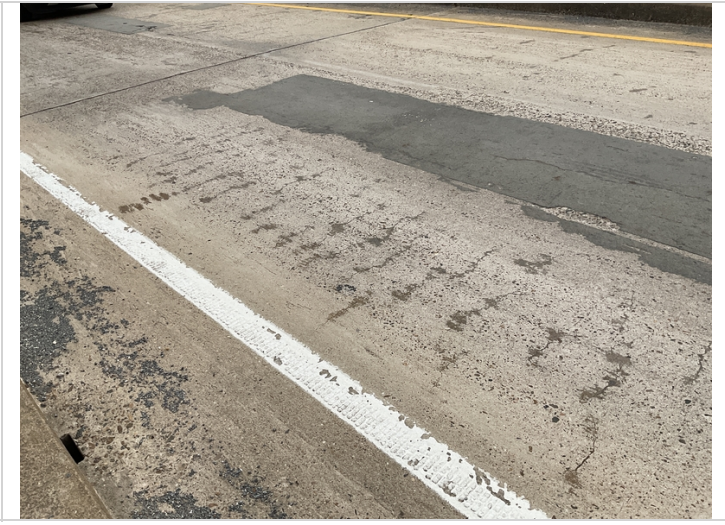
Sealed deck cracks span 2

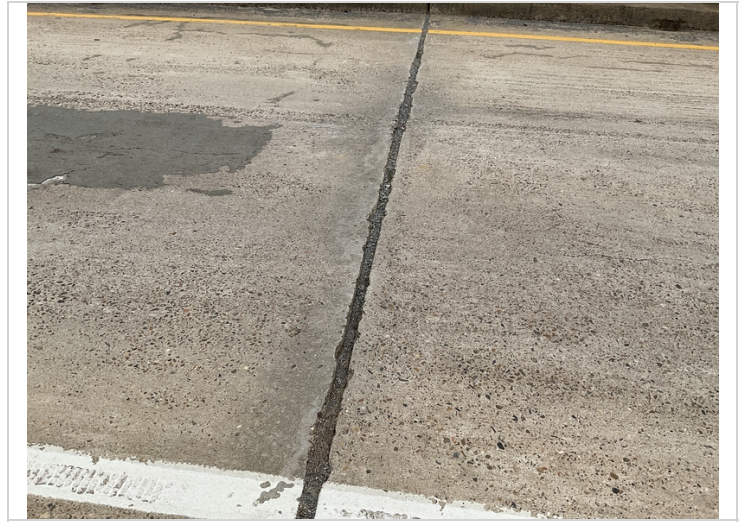
Joint at bent 2

(301) All joint seals are missing allowing debris impaction								
330	Metal Bridge Railing		LF	360	360	0	0	0
515	Steel Protective Coating		SF	720	0	460	260	0
3410	Chalking (Steel Protective Coatings)		LF	720	0	460	260	0

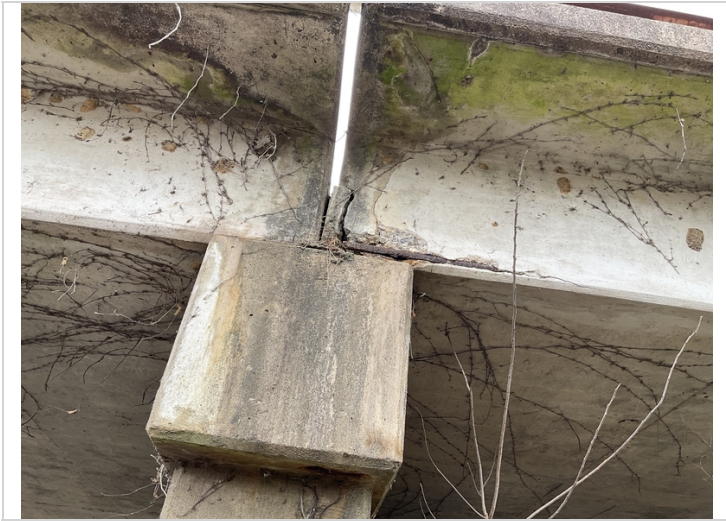
Bent 2 left side large vertical crack and exposed rebar

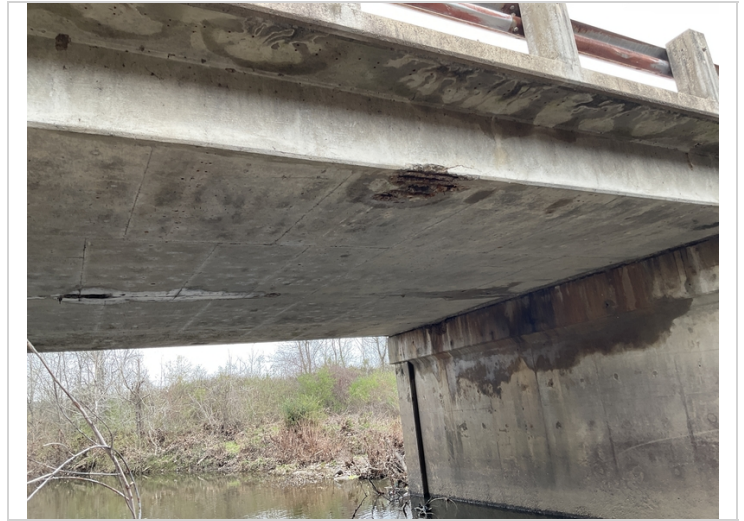
Spall with rebar span 3

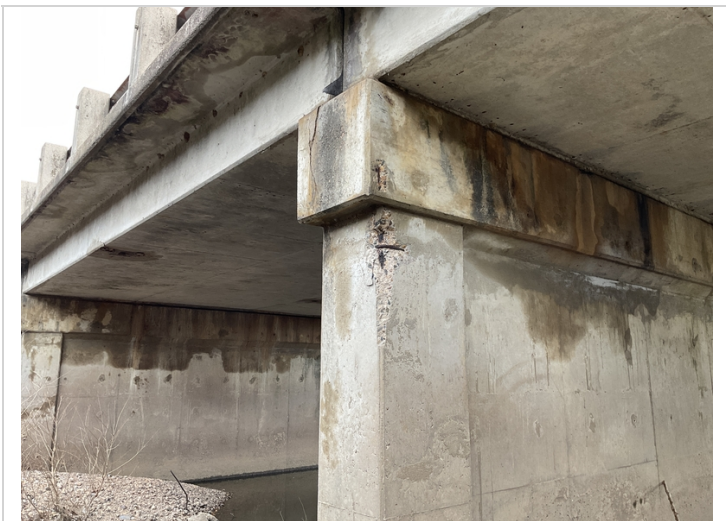
Bent 5 column 2 rebar

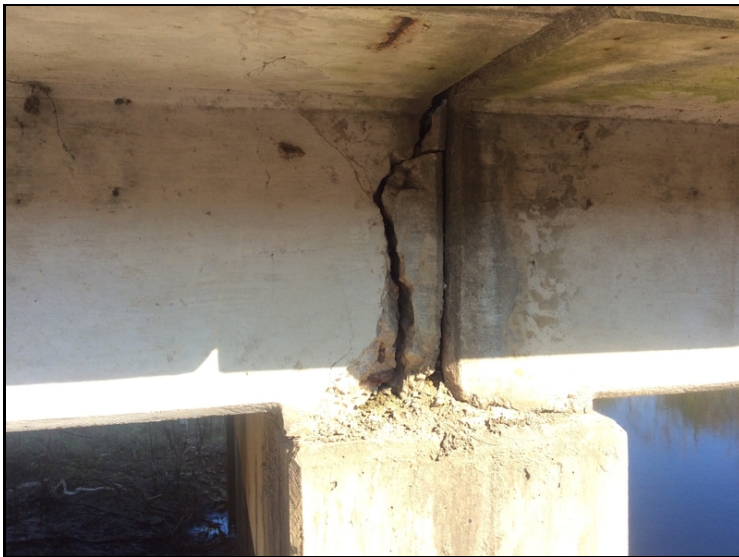
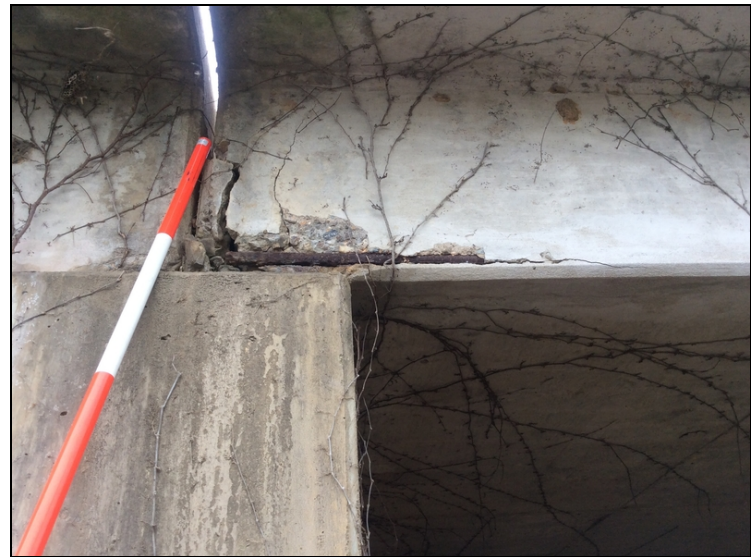
The ends of the slab spans at Bents 2,3,4,5 & 6 have cracks and delaminations.

Bent 2 span 1 right side spall with exposed rebar.

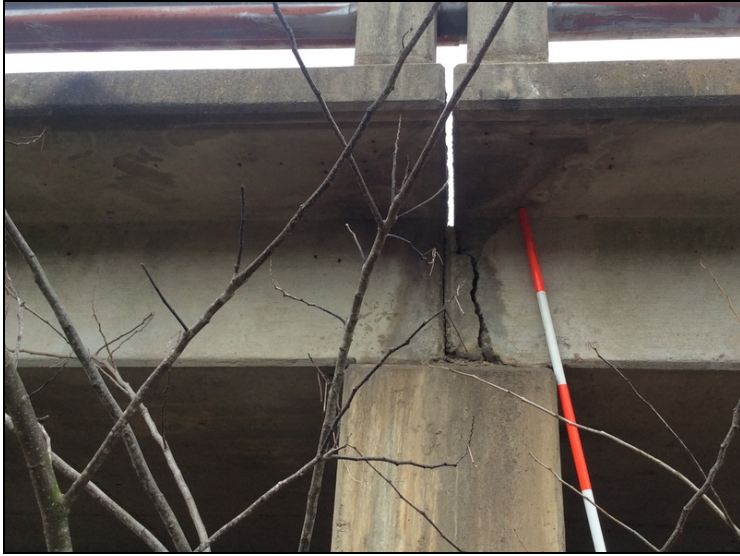
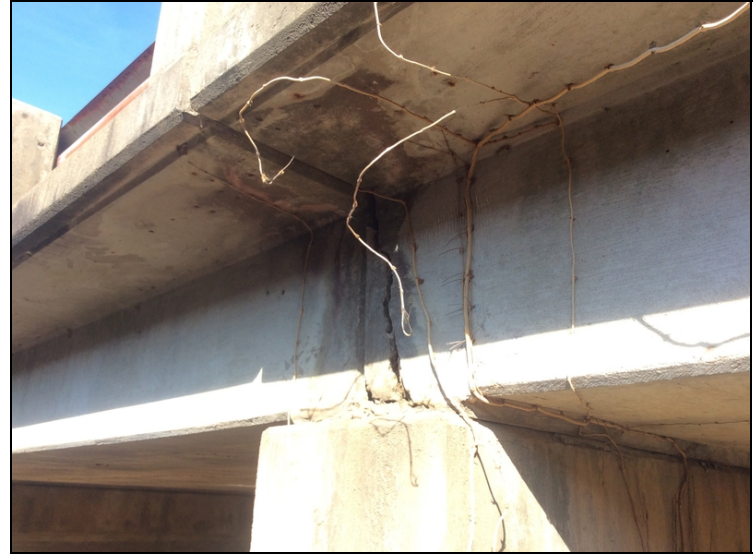
Span 6 at bent 6 right side of slab has large delam

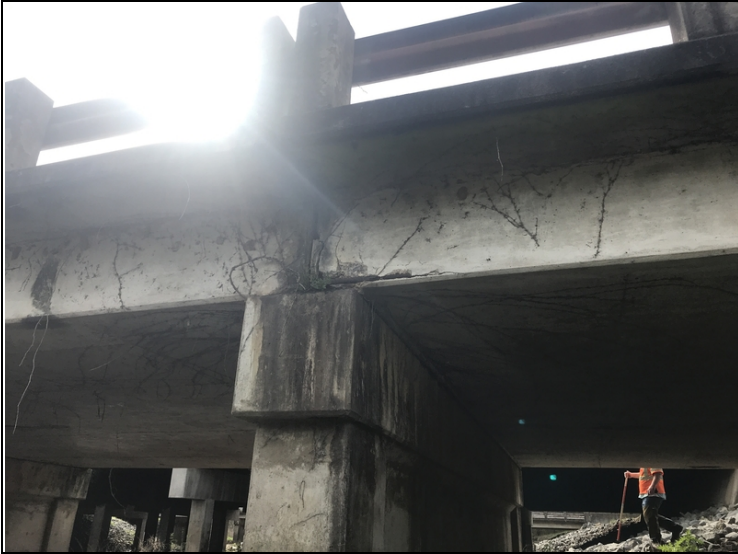
Left end of span 1, Bt. 2, spall with exposed rebar.

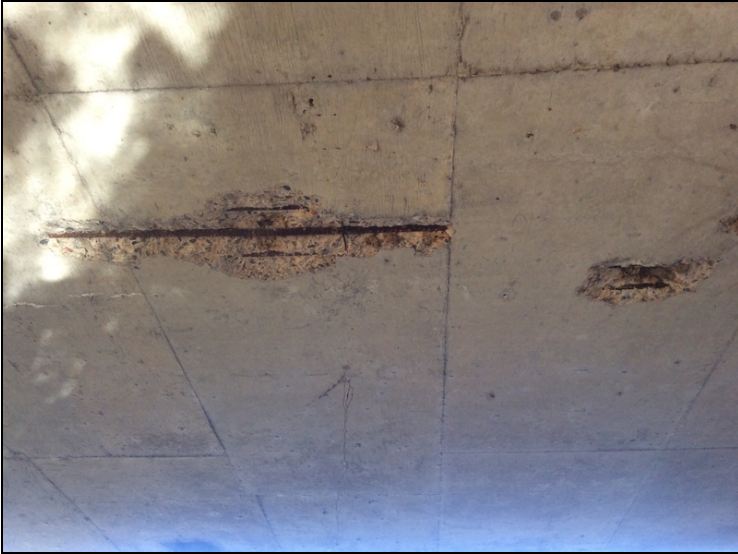
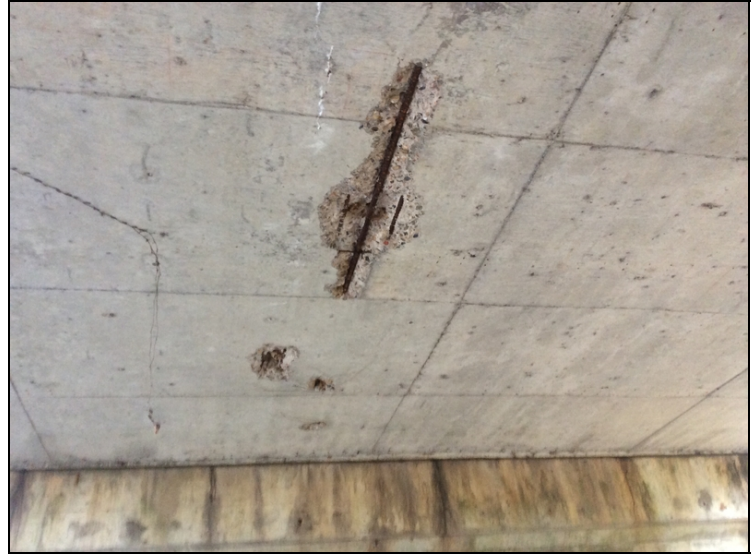
Bottom of slab spans have spalls with exposed rebar.

Span 2 spalls with exposed rebar.

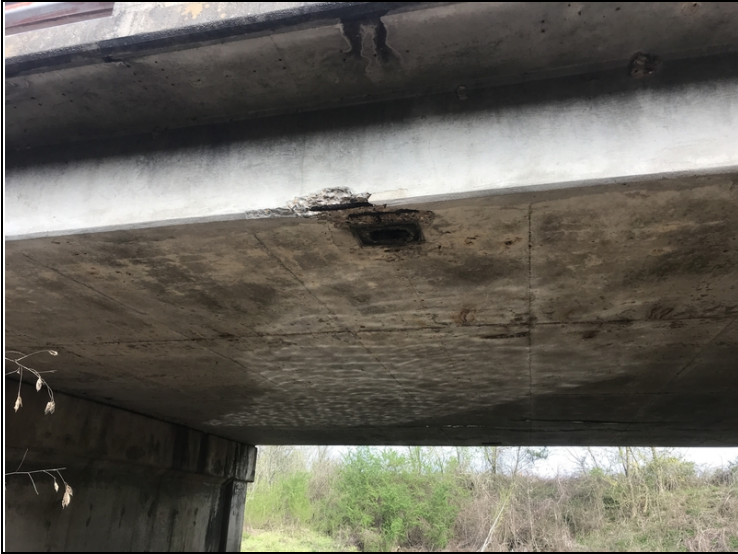
Span 5, right side , exposed rebar.

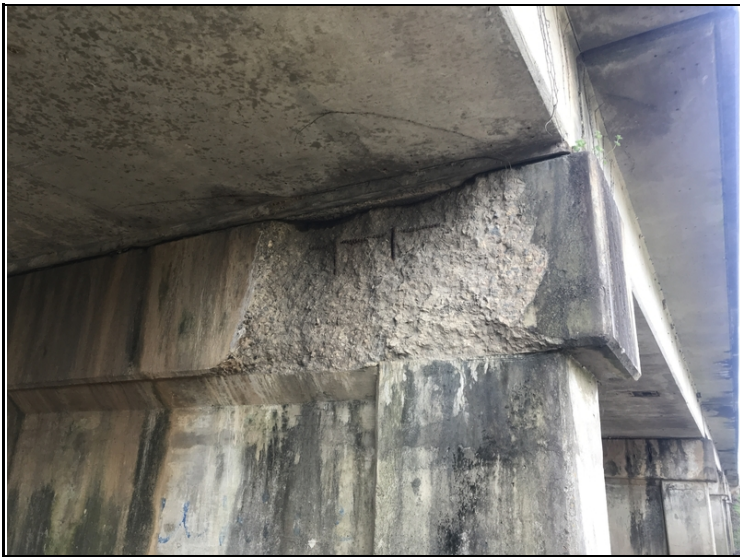
Bent 6 cap has a large spall with exposed rebar on the ahead left end.
Bent 3, cap has a spall with exposed rebar on the ahead right end.

Bent 6 cap has a large spall with exposed rebar on the ahead left end.

Date Reported: 03/27/2020
Priority: C - Important
Type of Work: Repair (General)
Status: Monitor
Component:

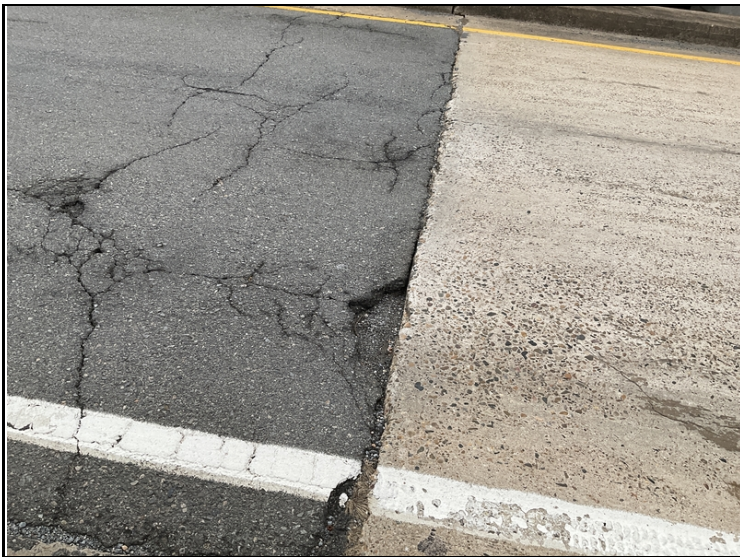
potholes in the approach roadway at bent 7 abutment

Potholes at bent 7 approach

Date Reported: 03/30/2022
Priority: B - Pressing
Type of Work: Repair (General)
Status: Open
Component: Approach
