Asset #C2804(Routine)

I-30 EB FRONT RD over CROOKED CREEK

Location: 1.2 MI E OF SH 111

Team Lead: Chris Doggett, Inspection Date: 08/16/2021

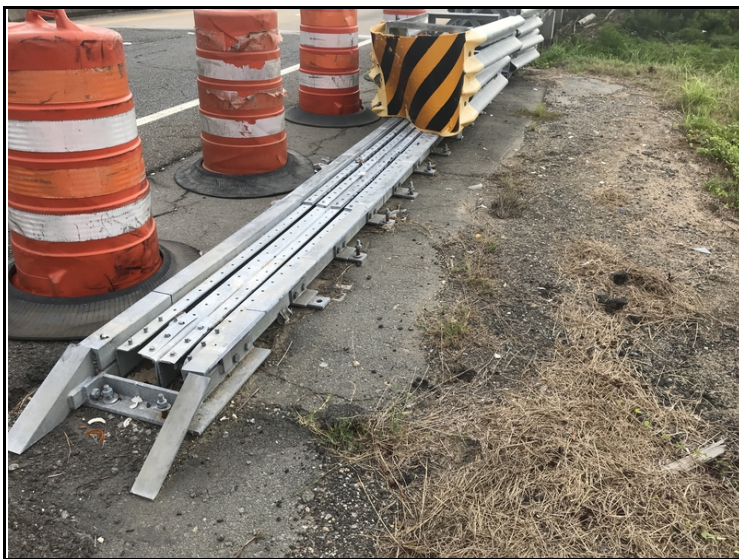
West end of bridge guard rail crash barrier damaged. See photo.

West end of bridge guard rail crash barrier damaged.

Guardrail has been repaired by state forces.

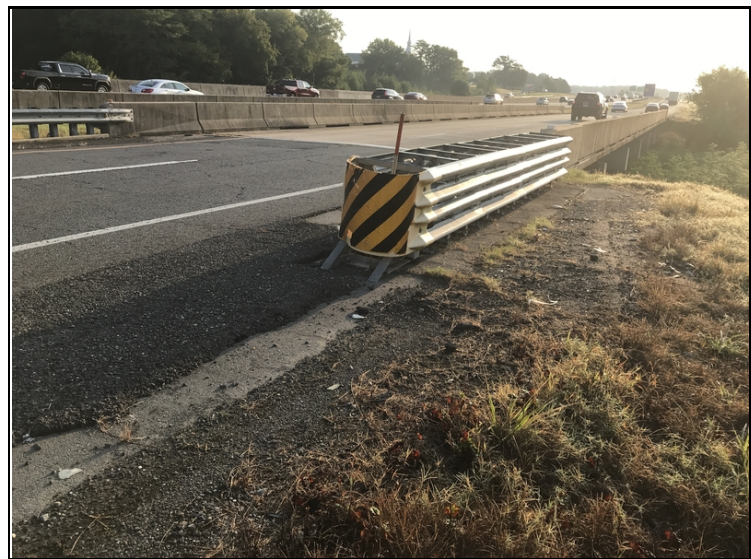
Guard rail has been repaired

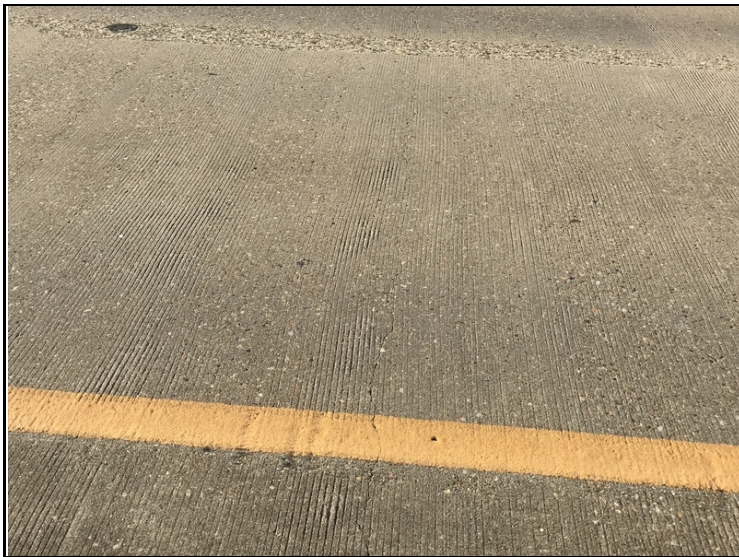
Unsealed deck cracks in all spans up to 0.050 inch.

Bent 4: large unsealed transverse cracks. Similar cracks at spans 5&6 also.

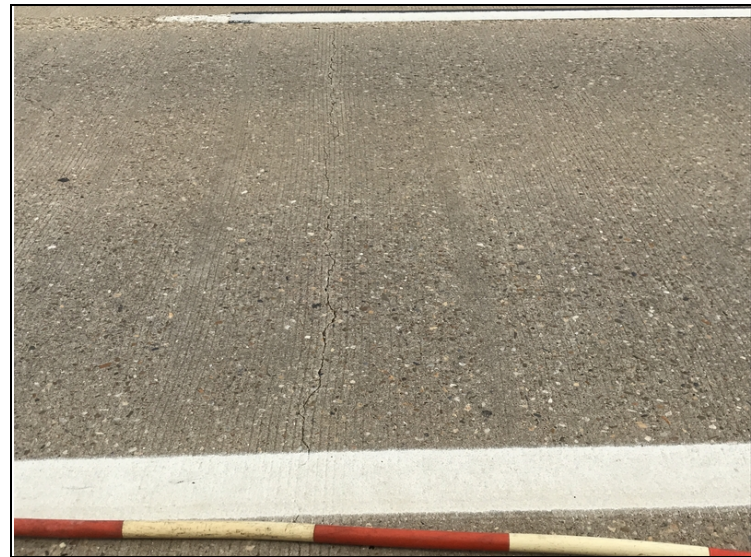
Deck span 4 transverse cracks up to 0.050 wide.

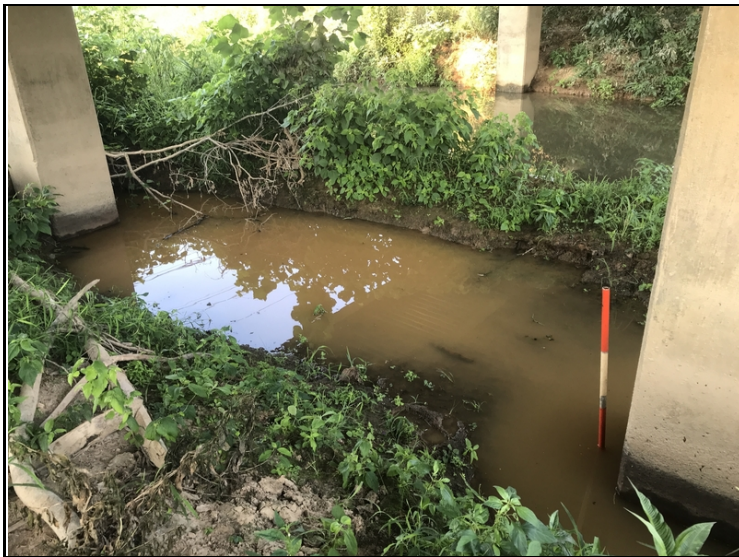
Most interior bents have local scour action at the columns.

Local scour action at bent 3.

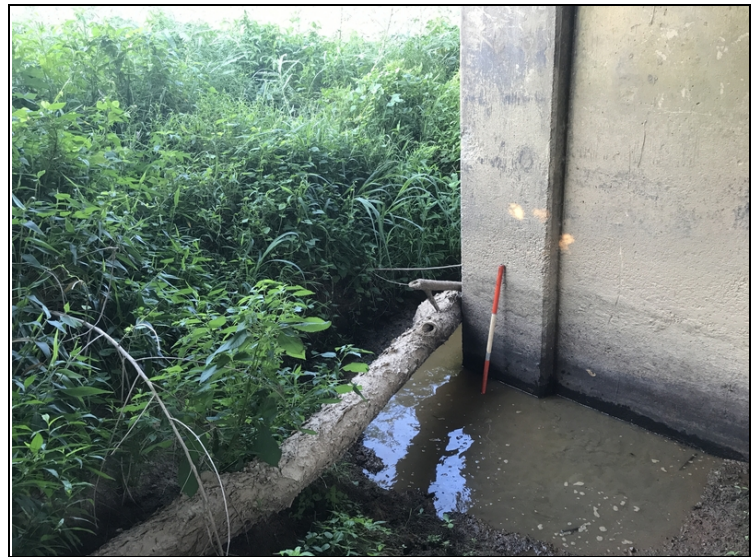
Bent 4: right side of pier 4 local scour action and log resting against pier.

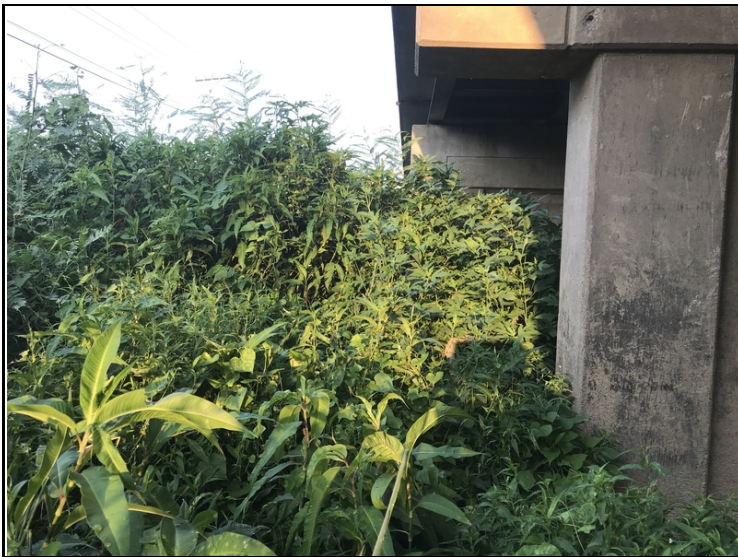
Right side of bridge with heavy growth of vegetation.
