Asset #C2811 (Routine)

I-30 EB FR Road over HURRICANE CREEK

Location: 1.6 MI SW SH 183

Team Lead: Bryan Saunders, Inspection Date: 03/29/2022

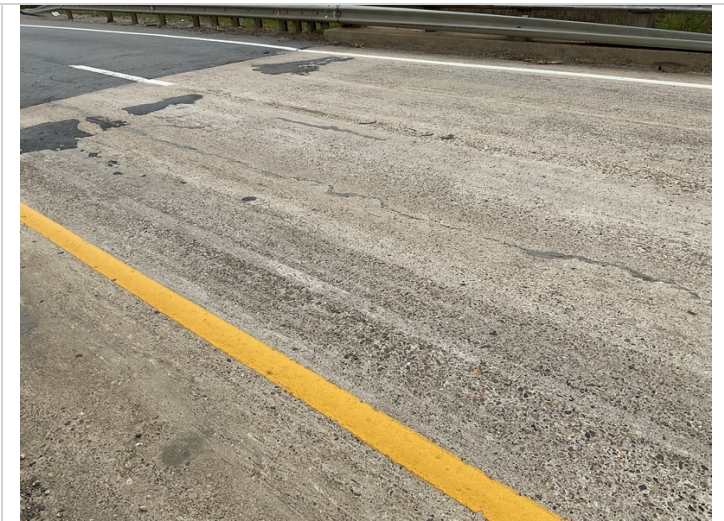
Deck cracks span 6

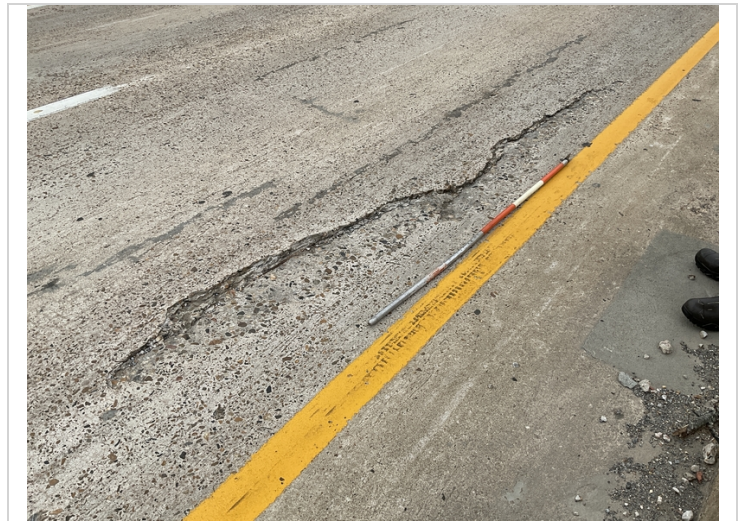
Rebar exposed in span 5

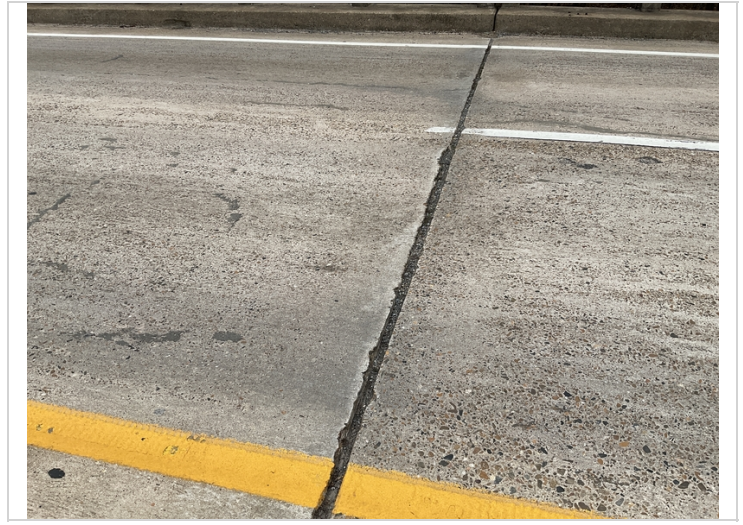
Joint at bent 2

(301) All the pourable joint seals are missing and are full of debris.								
330	Metal Bridge Railing		LF	360	360	0	0	0
515	Steel Protective Coating		SF	720	0	600	120	0
3410	Chalking (Steel Protective Coatings)		LF	720	0	600	120	0
(515-330) All the protective coating on the metal bridge rail is chalky and peeling

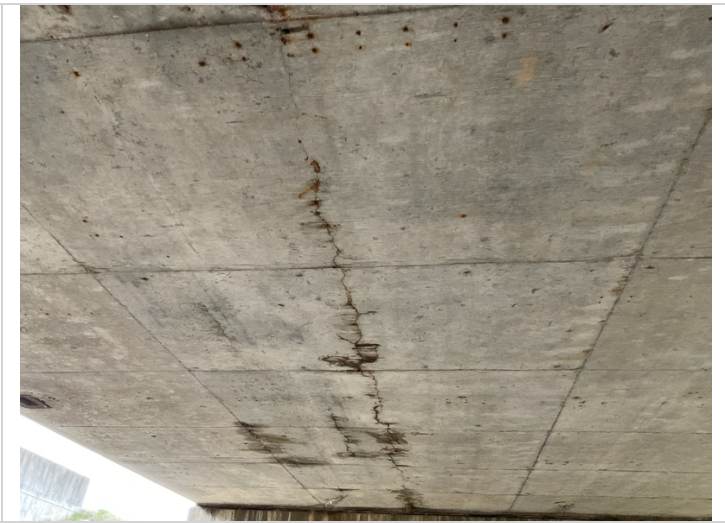
Cracks with rust staining span 5

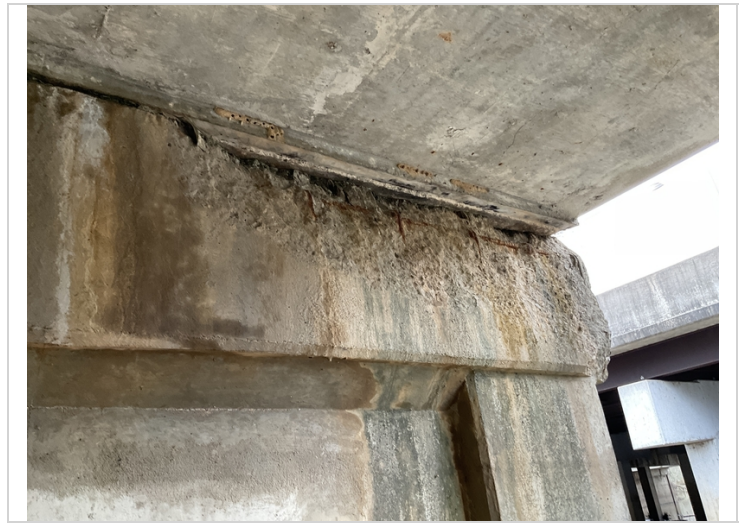
Spall with rebar in the cap at bent 6

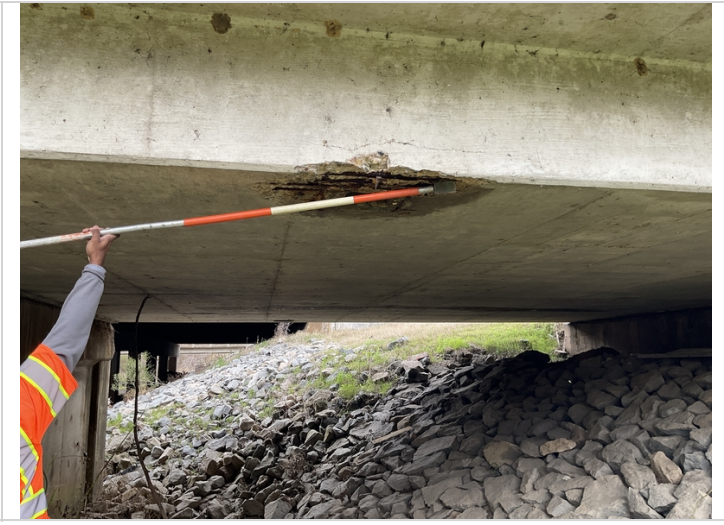
Spall with rebar in span 6

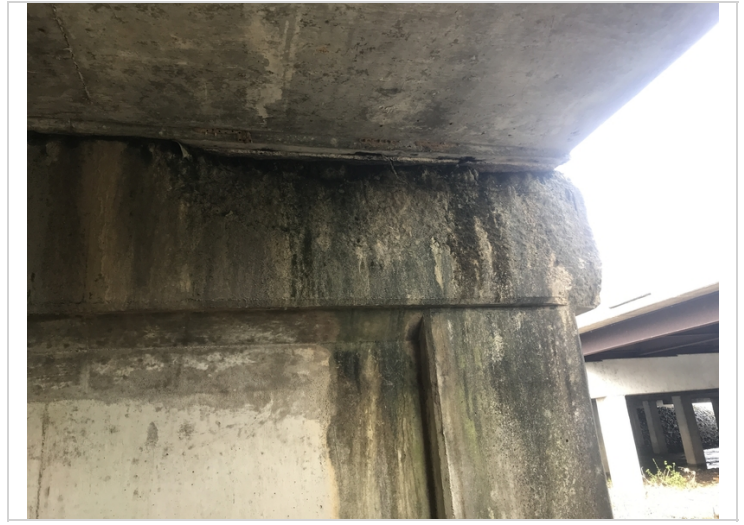
Bt. 6 ahead left end, spall with exposed rebar.

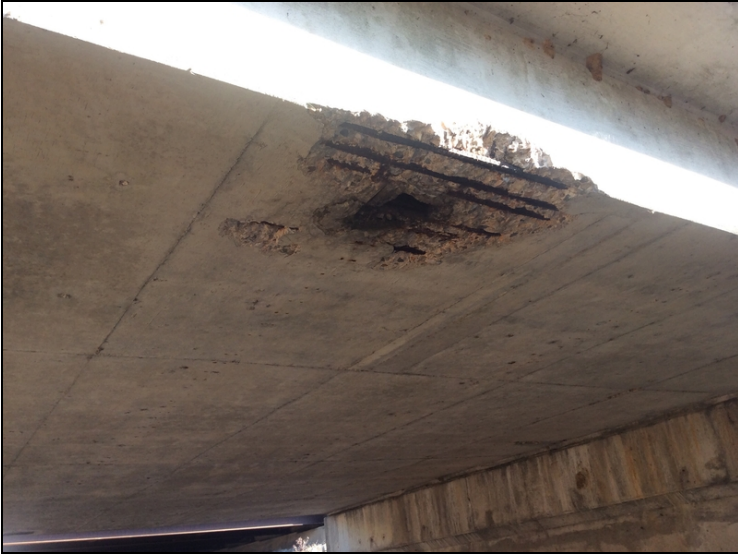
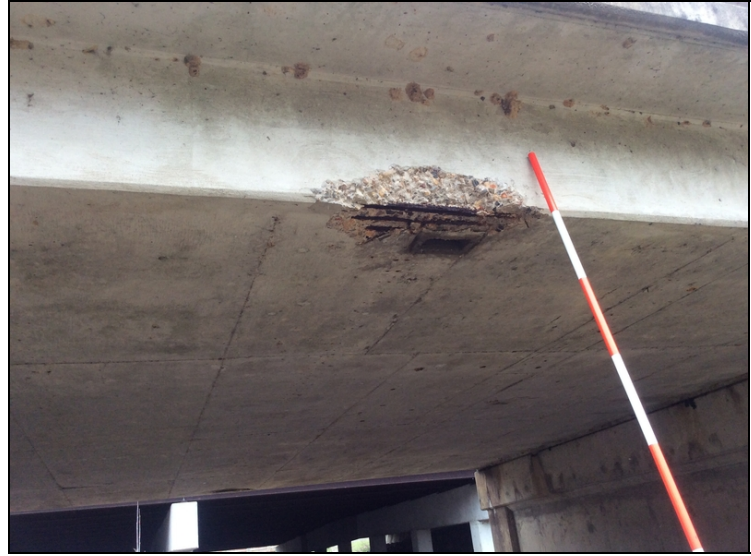
The "soffit" or bottom of the slab spans, have longitudinal cracks and delaminations with rust stains.

Span 4 right side spall with exposed rebar.

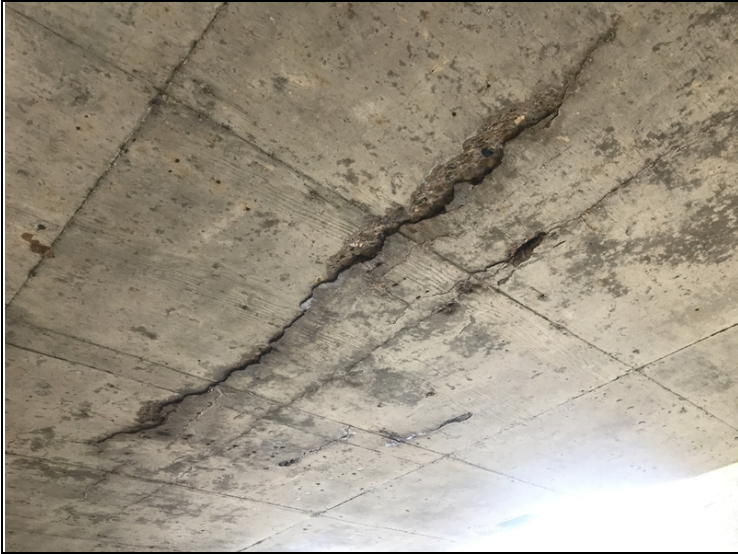
Span 2, delam with rust staining.

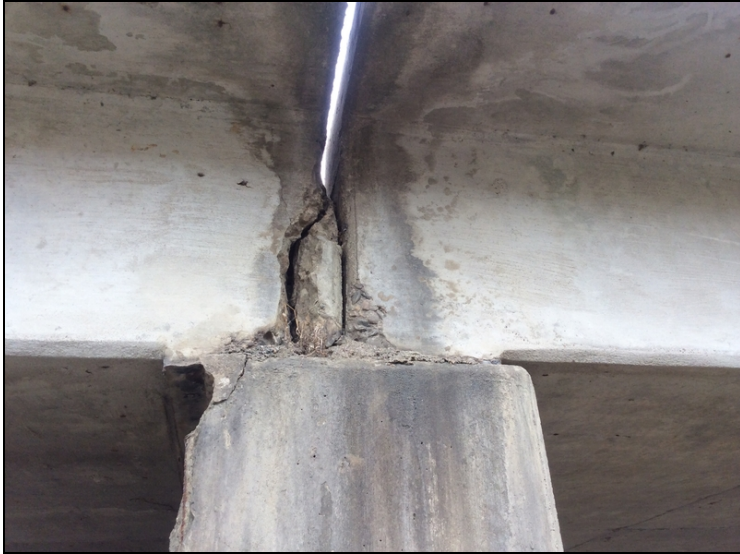
The ends of the slab spans at Bents 2,3,4 and 6 have vertical cracks with delaminations.

Span 6 left side delamination on end of slab.

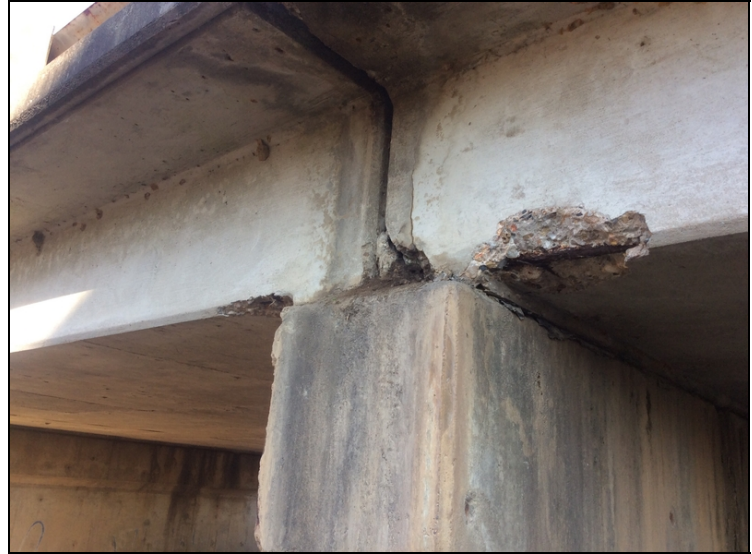
Right side bent 6: the end of span 7 is spalling.

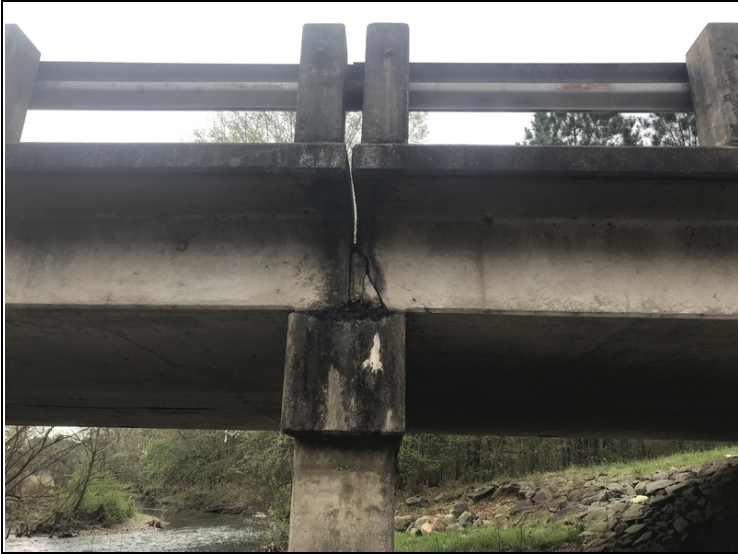
Span 1 left end, at Bt. 2, spall at the end of the slab.

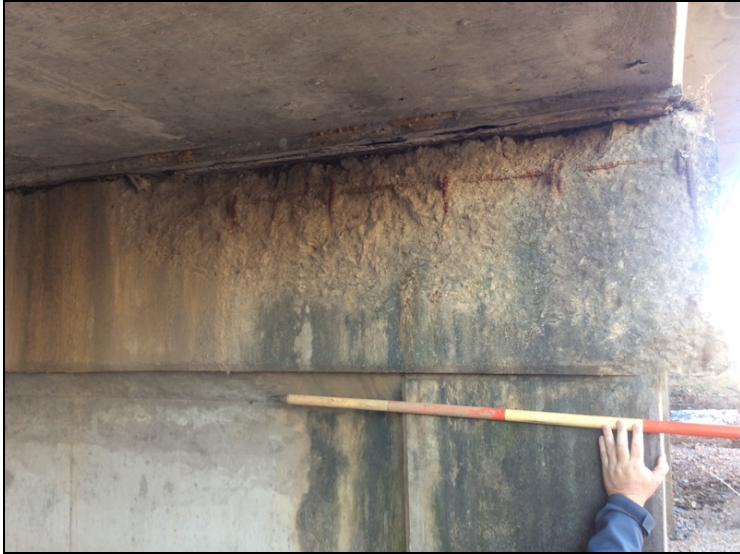
Bent 4 and 6, spalls with exposed rebar on the ahead face at the top.  
Left ahead end of Bent 6 has loss 2 inches of bearing area.

Bent 6 ahead side: large spall with exposed rebar.

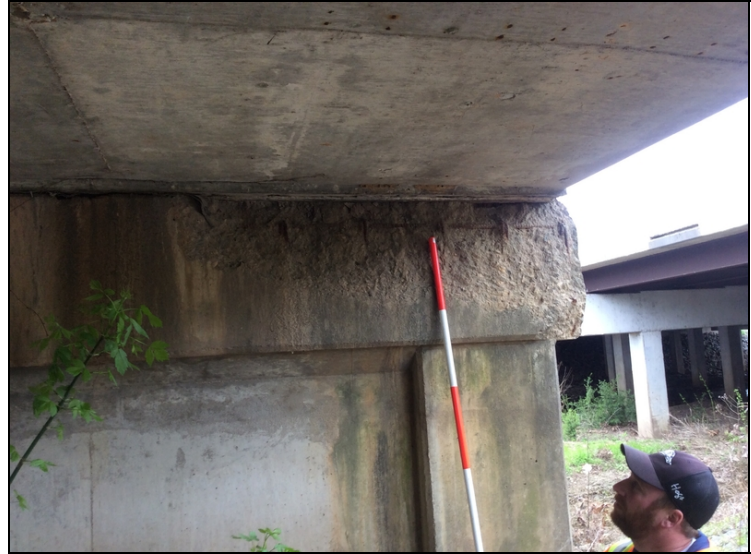
Bent 6 pier wall ahead spall with exposed rebar.

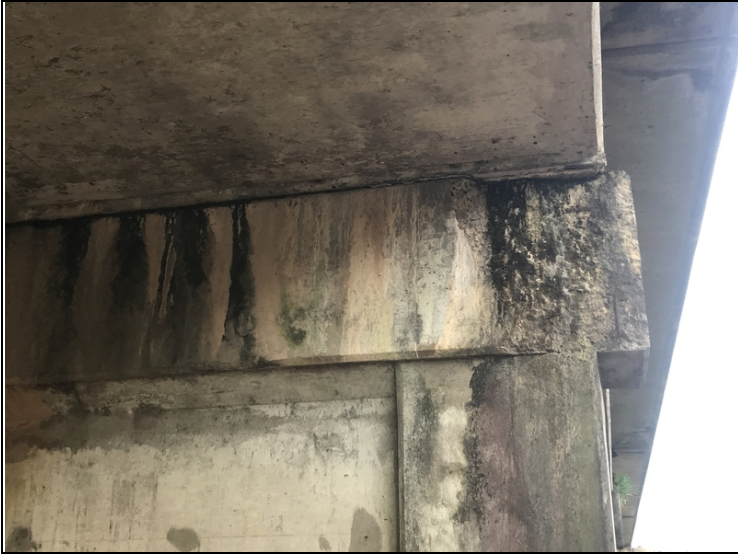
Bt. 4, ahead left en of cap, spall with exposed rebar.

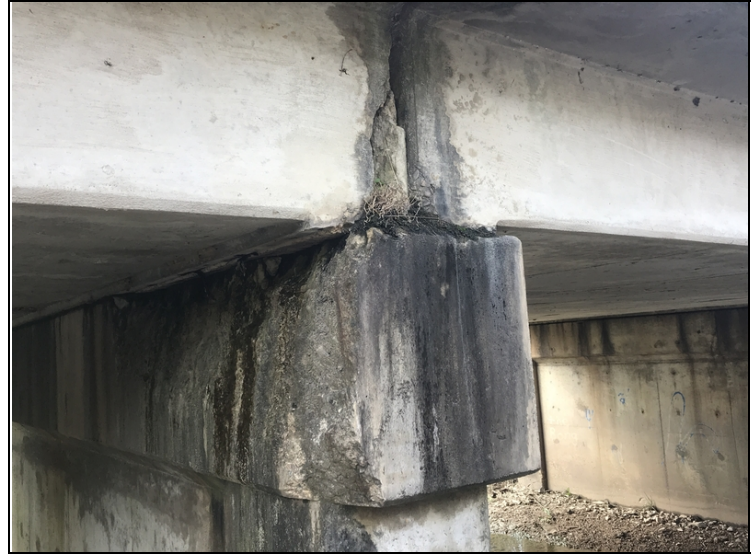
Left ahead end of Bent 6 has loss 2 inches of bearing area.

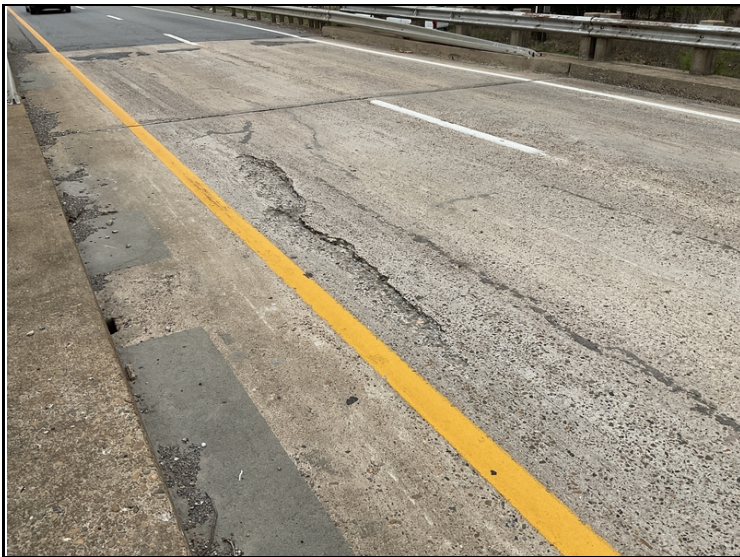
spall with exposed rebar showing in bridge deck located in span 5

Scaling span 5

**Date Reported:** 03/31/2022  
**Priority:** B - Pressing  
**Type of Work:** Repair (General)  
**Status:** Open  
**Component:** Deck
