Asset #C6357(Routine)

I-30 EB FRONTAGE over OTTER CREEK

Location: 1.8 MI E OF HWY 111

Team Lead: Bryan Saunders, Inspection Date: 05/19/2021

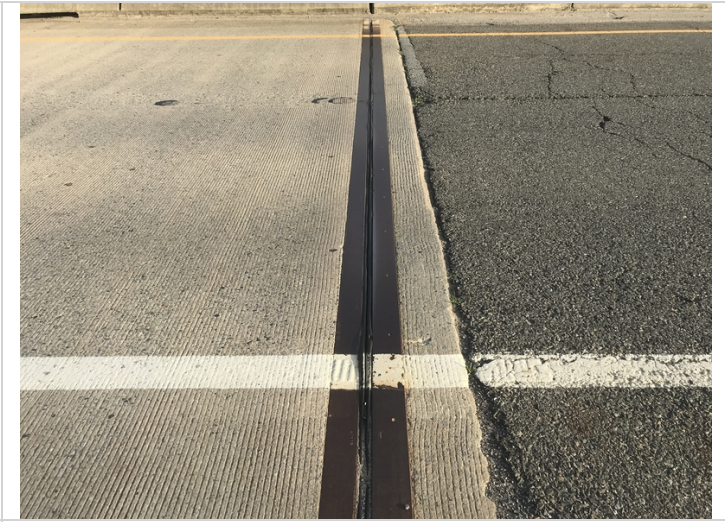
(302) Joint leaking at bent 1. Seal damage at bent 6.							
311	Movable Bearing	EA	20	12	5	3	0
1000	Corrosion	EA	8	0	5	3	0
(311) Bearings at abutment 1 have corrosion. Bent 6 bearings 1-3 have corrosion.							
313	Fixed Bearing	EA	10	10	0	0	0

Bent 6, joint seal is bulging and damaged.

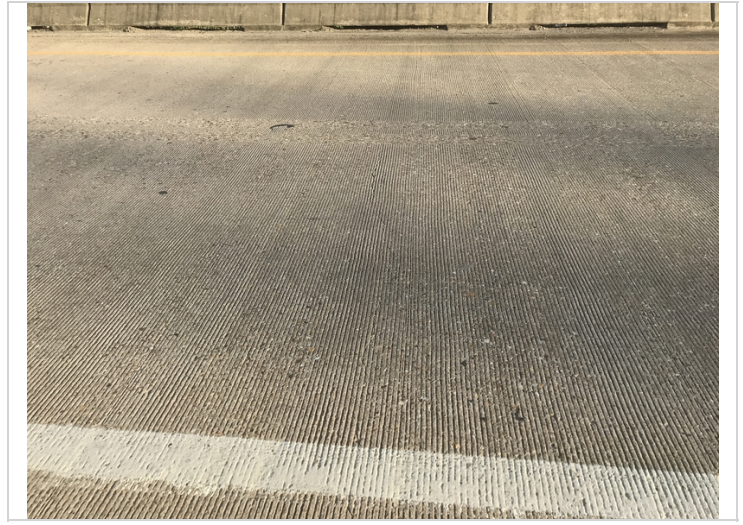
Span 4, transverse crack.

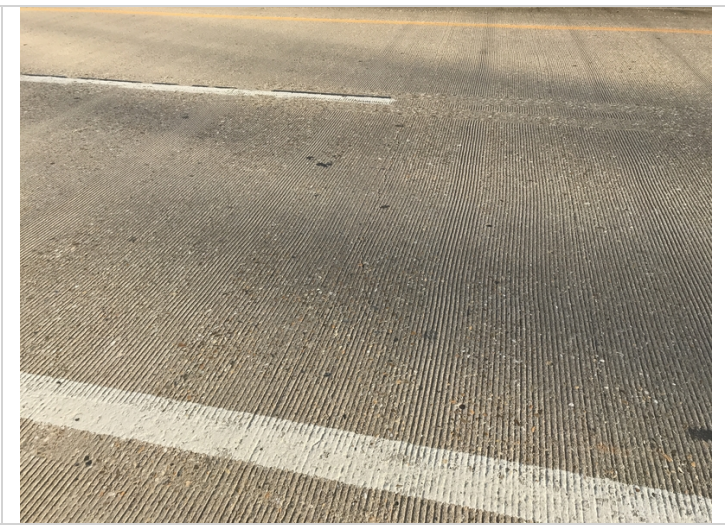
Span 2, transverse crack.

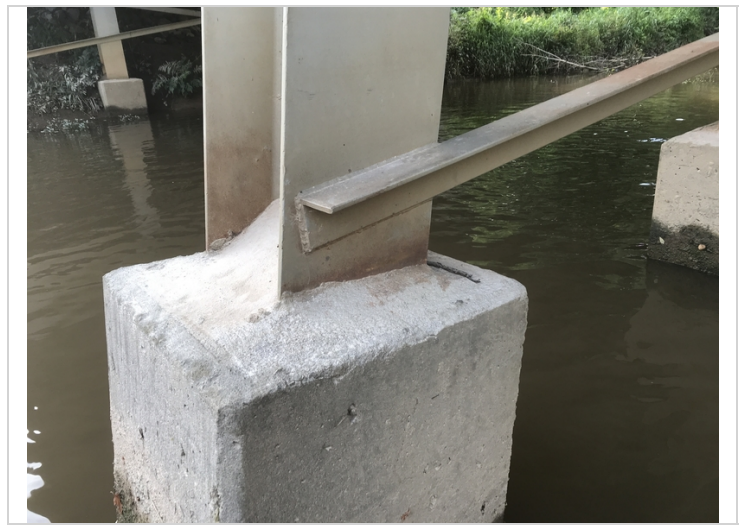
Bent 4 pile 1.

(225) Dirt and silt sitting on top of the concrete encasement is causing the protective coating of the steel pile to lose its effectiveness. (515-225) The protective coating above the concrete encasement is beginning to lose effectiveness.							
234	Reinforced Concrete Pier Cap	LF	132	132	0	0	0
302	Compression Joint Seal	LF	70	43	3	24	0
2310	Leakage	LF	24	0	0	24	0
2330	Seal Damage	LF	3	0	3	0	0

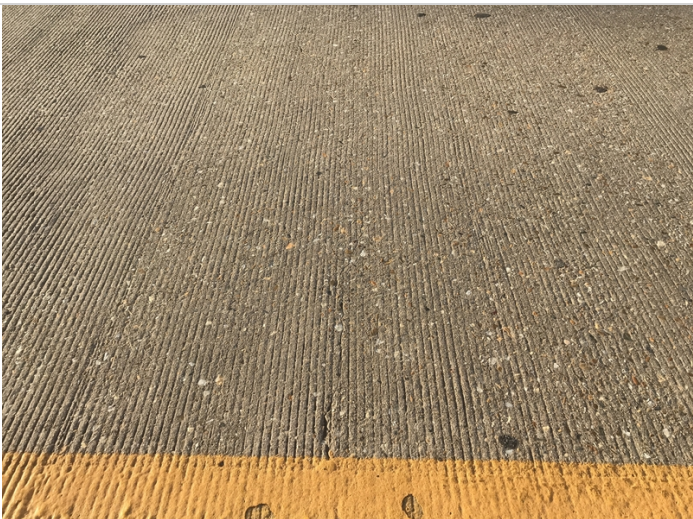
Span 3, transverse crack.

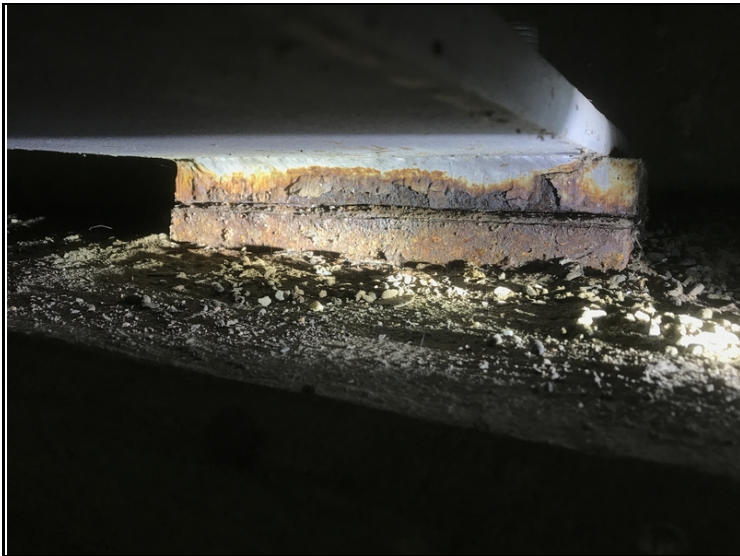
Bent 1 bearing 3

West abutment
Joint seal has lost bond allowing dirt & moisture to accumulate on bearings.

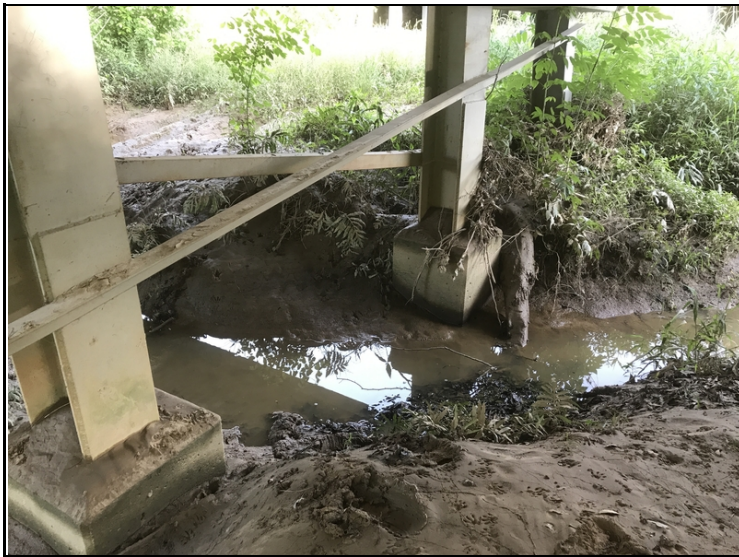
Bent 3

Steel Pile at bents 2,3,4 & 5
Pile at top of encasement, dirt and silt causing rust to form.

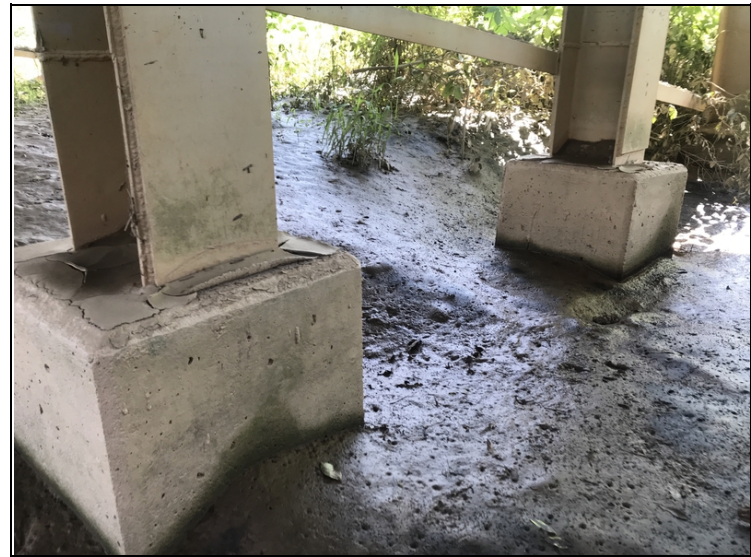
Bent 3 Pile at top of encasement, dirt and silt causing rust to form.

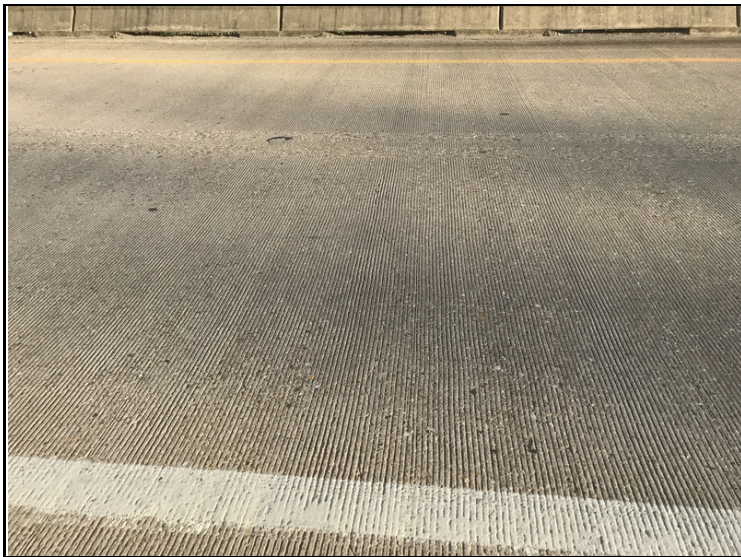
Large unsealed deck cracks up to 0.025"

Span 4, transverse crack.

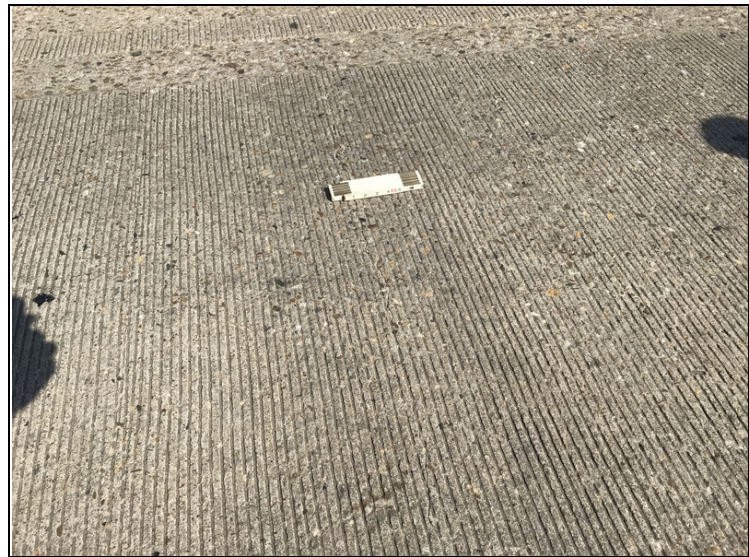
Span 5 crack up to 0.025"
