Asset #D6357(Routine)

I-30 W.B. Service over Otter Creek

Location: 1.67 M. East Sh 111

Team Lead: Bryan Saunders, Inspection Date: 05/19/2021

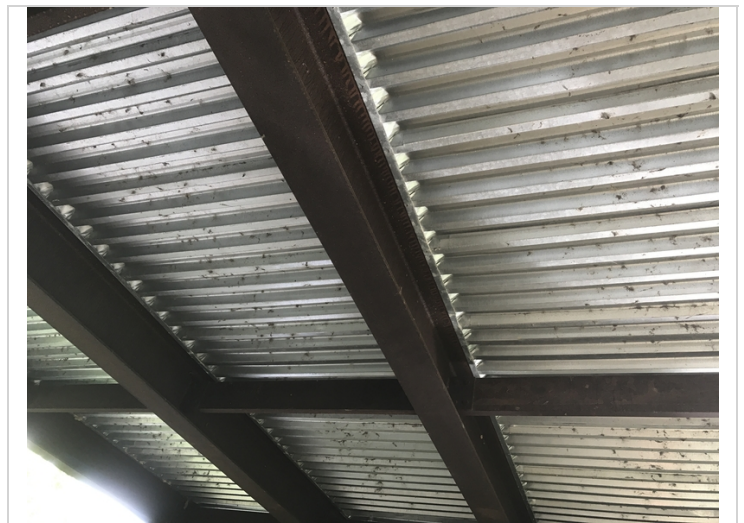
ELEMENTS	DESCRIPTION	UNITS	TOTAL	CS1	CS2	CS3	CS4
107	Steel Open Girder/Beam	LF	700	700	0	0	0
515	Steel Protective Coating	SF	3969	0	3969	0	0
3430	Oxide Film Degradation Color/Texture Adherence(Steel Protective Coatings)	LF	3969	0	3969	0	0
(515-107) The protective coating has a granular texture.

Typical soffit

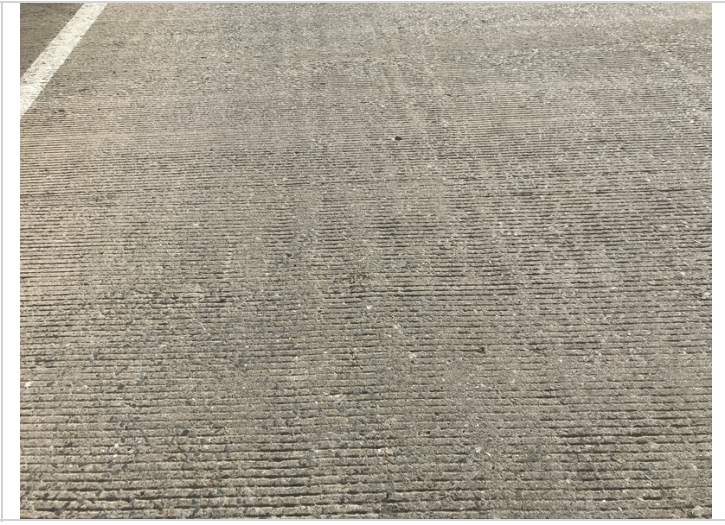
ELEMENTS	DESCRIPTION	UNITS	TOTAL	CS1	CS2	CS3	CS4
12	Reinforced Concrete Deck	SF	4923	4601	322	0	0
1120	Efflorescence/Rust Staining	SF	42	0	42	0	0
1130	Cracking (RC and Other)	SF	280	0	280	0	0
(12) All spans have scattered cracks up to 0.020". Cracks with efflorescence in the overhangs.

Span 5 longitudinal crack

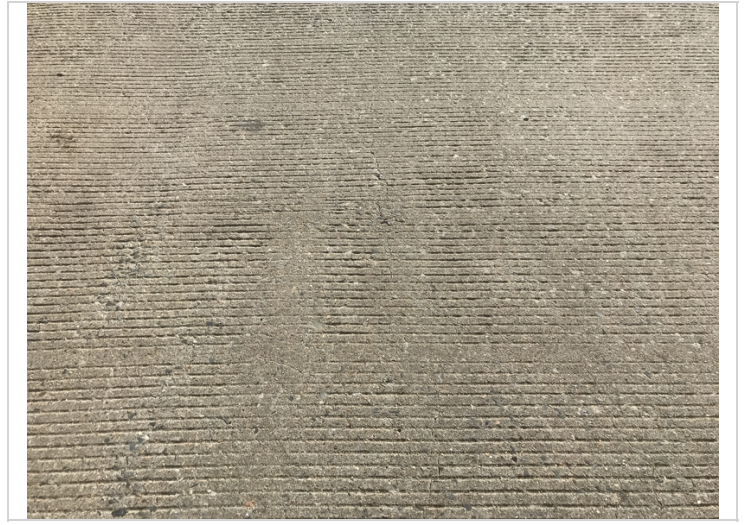
Span 2 longitudinal crack

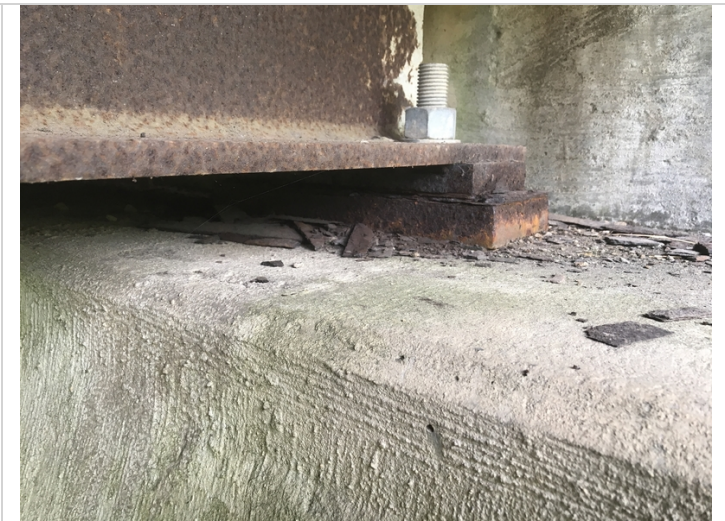
(311) Bearings at bents 1 and 6 have corrosion.							
313	Fixed Bearing	EA	10	10	0	0	0
331	Reinforced Concrete Bridge Railing	LF	280	242	38	0	0
1130	Cracking (RC and Other)	LF	38	0	38	0	0

Bent 1, bearing 1.

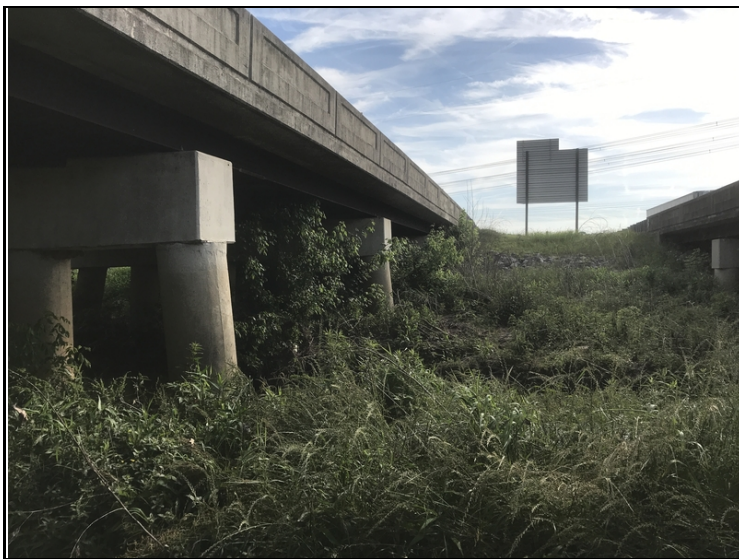
Small trees and bushes growing next to and under the bridge.

Spans 3-5, vegetation

Date Reported: 05/24/2021
Priority: D- Routine
Type of Work: (Inactive) (Inactive) 1 - Clean
Status: Open
Component: Channel
